PROJECT: (P17-015) Tract W2016002 House/Campers, Outbuilding Asbestos Remediation Services
LOCATION: PRRIF Tract W2016002
NEAR: Elm Creek, Nebraska
CONTACT: Tim Tunnell, Land Manager, tunnellt@headwaterscorp.com, 402-219-3883

ASBESTOS SURVEY REPORT

**TRACT W2016002 - HOUSE & OUTBUILDING
ELM CREEK, NEBRASKA 68836**

**B2 ENVIRONMENTAL, INC.
3325 WEST CAPITAL AVE
GRAND ISLAND, NEBRASKA 68803
B2E Project Number: 20355.0001**

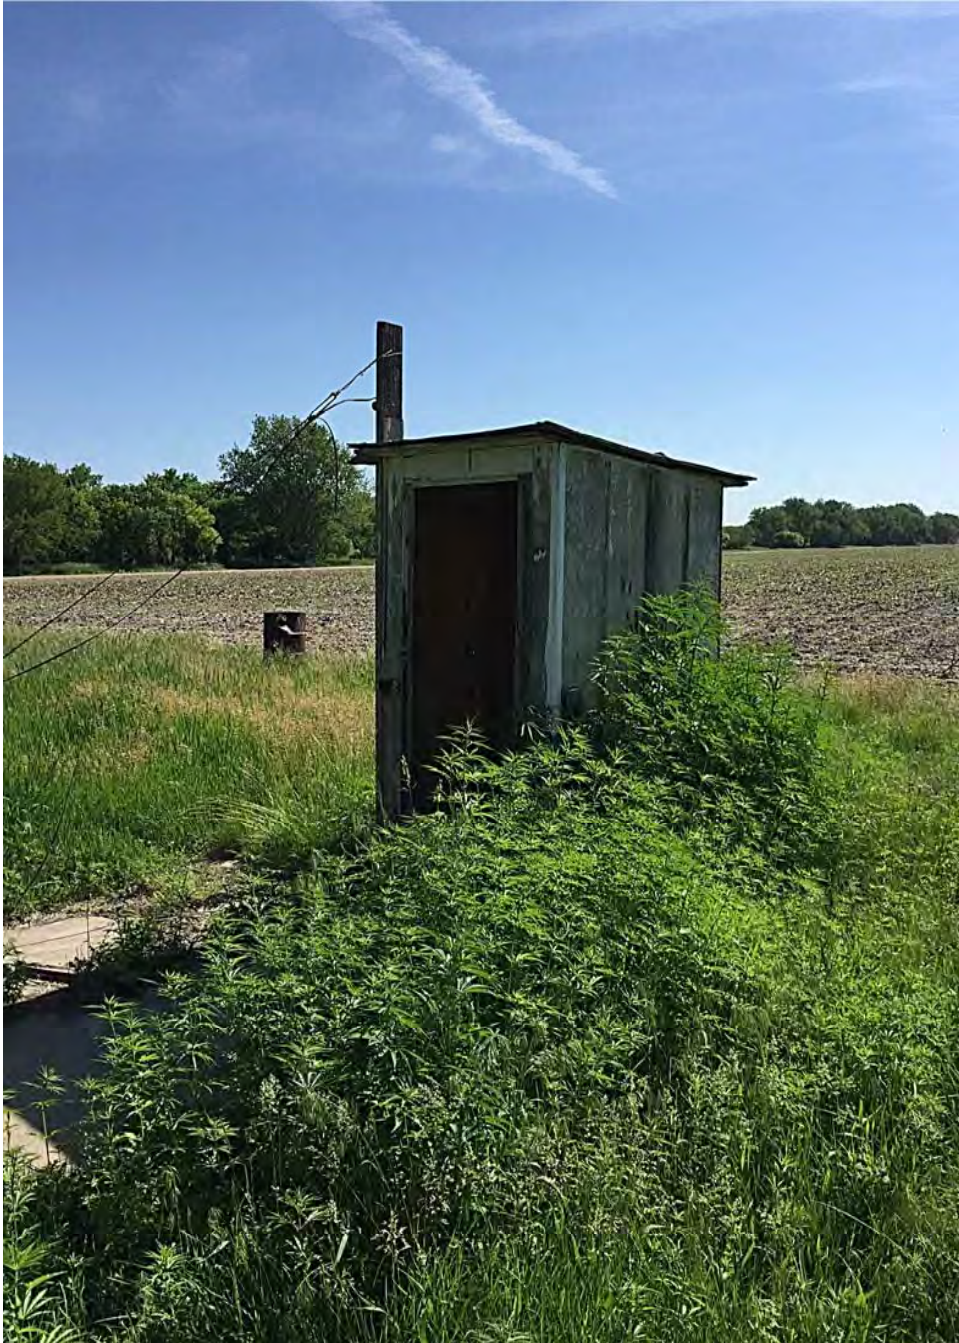
Structure #4

STRUCTURE # 4 (OUT HOUSE) SUSPECT BUILDING MATERIALS		
MATERIAL	LOCATION	SAMPLE NUMBER
Asphalt Shingle with Gray Specks	Roof	#4-1

BUILDING # 4 ASBESTOS-CONTAINING MATERIALS						
MATERIAL	LOCATION	SAMPLE NUMBER	NESHAP CATEGORY	FRIABLE ⁽¹⁾	QUANTITY ⁽²⁾	ASBESTOS CONTENT
The suspect material analyzed as part of this assessment was non-detect for the presence of asbestos.

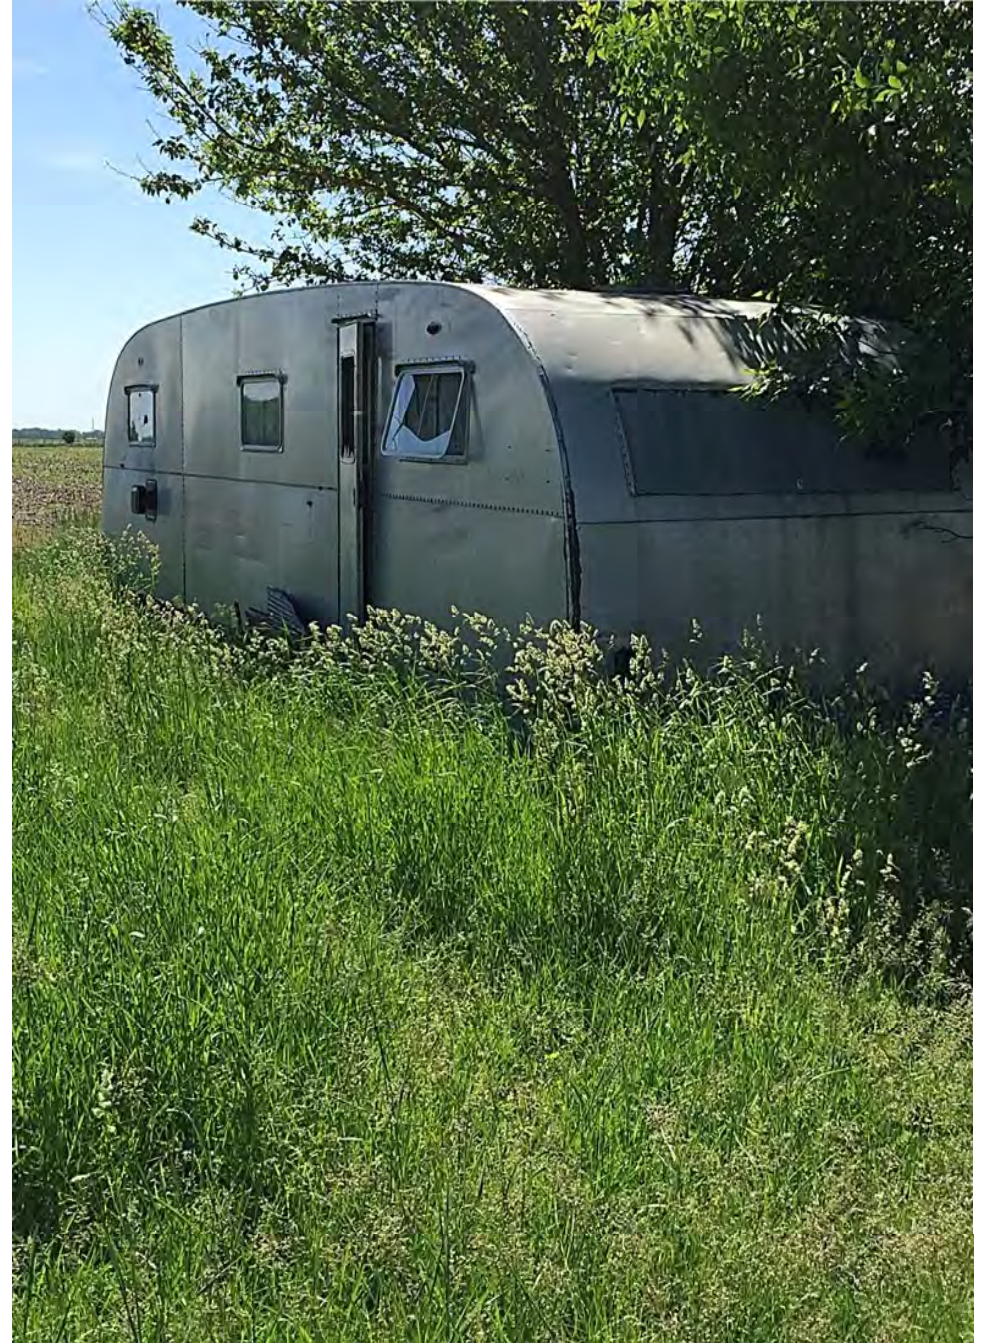
Structure #5

BUILDING # 5 (ALUMINUM CAMPER) SUSPECT BUILDING MATERIALS		
MATERIAL	LOCATION	SAMPLE NUMBER
Gray/Black Roof Seam Tar	Roof of Trailer	#5-1
White Vinyl Sheet Flooring	Bathroom	#5-2
Asphalt Roll	Floors and Walls of Bathroom	#5-3

BUILDING # 5						
ASBESTOS-CONTAINING MATERIALS						
MATERIAL	LOCATION	SAMPLE NUMBER	NESHAP CATEGORY	FRIABLE ⁽¹⁾	QUANTITY ⁽²⁾	ASBESTOS CONTENT
Gray/Black Roof Seam Tar	Roof	#5-1	CAT 2	No	35 lf.	10% Chrysotile
White Vinyl Sheet Flooring	Bathroom	#5-2	CAT 2	No	10 sf	20% Chrysotile

2. CAMPER
(Structure 5 on report)

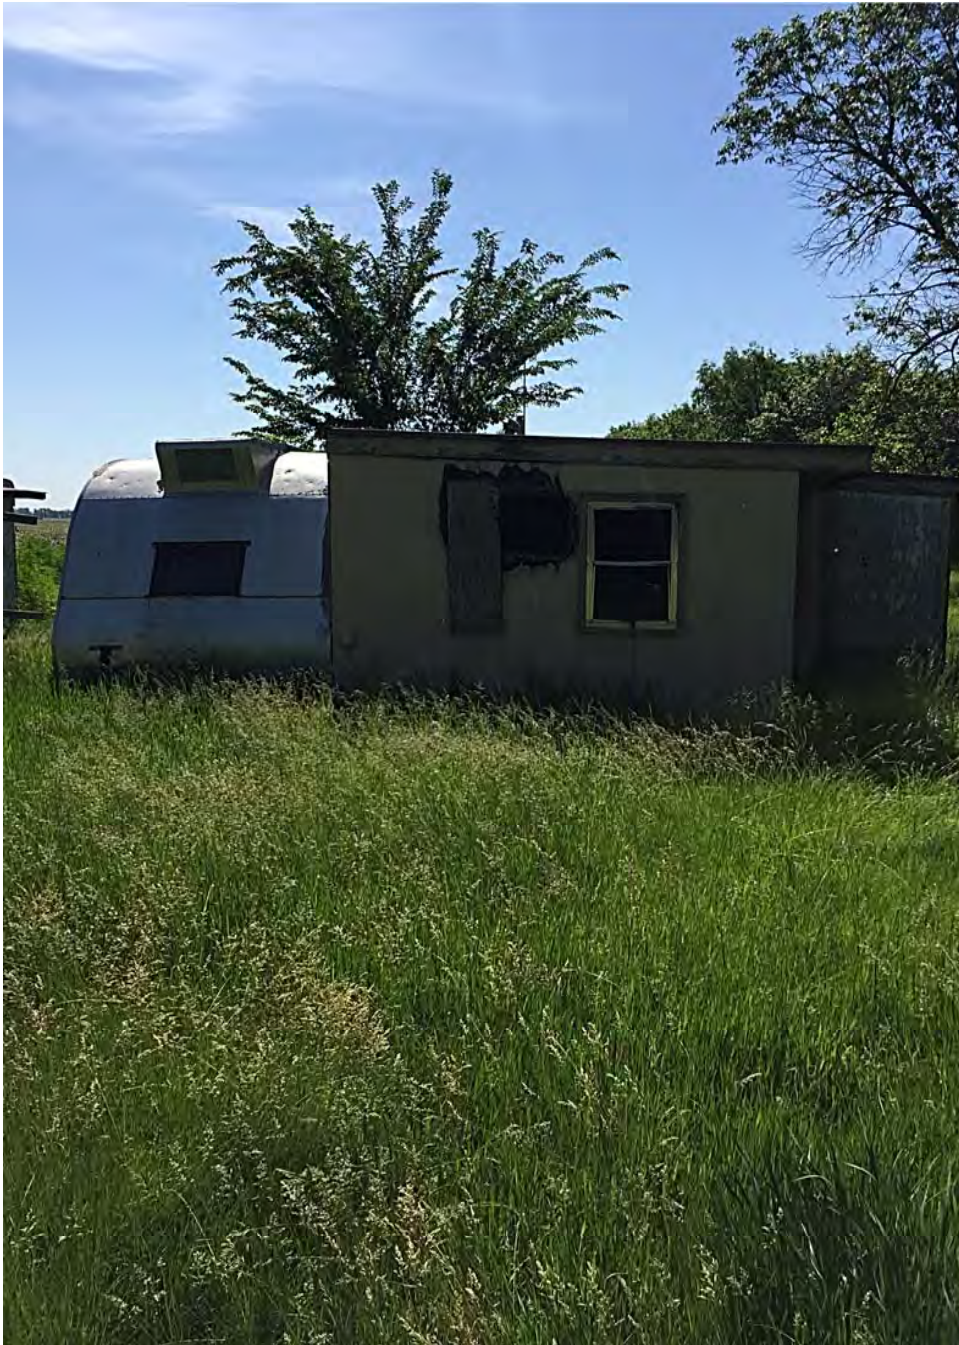
Structure #6

BUILDING # 6 (ALUMINUM TRAILER W/WOOD ADDITION) SUSPECT BUILDING MATERIALS		
MATERIAL	LOCATION	SAMPLE NUMBER
Gray/Black Seam Tar	Roof of Trailer	#6-1
Asphalt Roll Roofing	Wood Addition	#6-2
2'x2' Ceiling Tiles	Wood Addition	#6-3
9"x9" VFT w/ Black Mastic	Aluminum Trailer	#6-4

BUILDING # 6						
ASBESTOS-CONTAINING MATERIALS						
MATERIAL	LOCATION	SAMPLE NUMBER	NESHAP CATEGORY	FRIABLE ⁽¹⁾	QUANTITY ⁽²⁾	ASBESTOS CONTENT
9"x9" VFT	Aluminum Trailer	#6-4	CAT 1	No	180 sf.	Tile 4% Chrysotile Mastic 6% Chrysotile

3. CAMPER W/
WOODEN ADDITION
(Structure 6 on report)

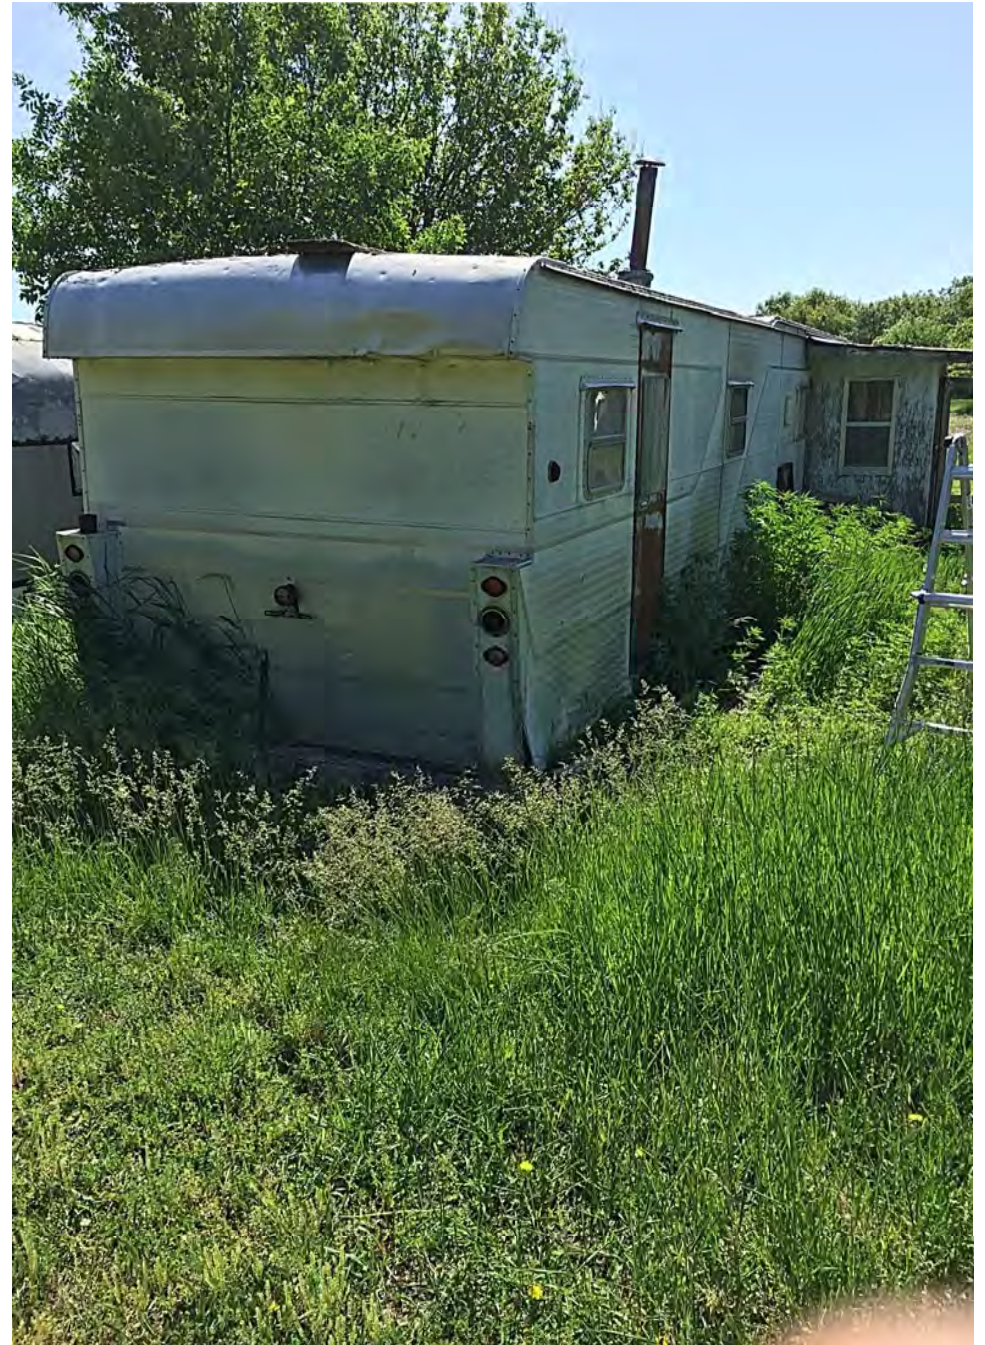
Structure #7

BUILDING # 7 (ALUMINUM TRAILER) SUSPECT BUILDING MATERIALS		
MATERIAL	LOCATION	SAMPLE NUMBER
Black Tar	Roof	#7-1
Tan 9"x9" VFT w/ Brown Mastic	Interior Floor	#7-2
Wood Grained 9"x9" VFT	Interior Floor	#7-3
Green 9"x9" VFT	Interior Floor	#7-4

BUILDING # 7						
ASBESTOS-CONTAINING MATERIALS						
MATERIAL	LOCATION	SAMPLE NUMBER	NESHAP CATEGORY	FRIABLE ⁽¹⁾	QUANTITY ⁽²⁾	ASBESTOS CONTENT
Gray/Black Roof Tar w/Silver Paint	Roof	#7-1	CAT 2	No	400 sf.	Tar = 7% Chrysotile
Tan 9"x9" VAT w/ Brown Mastic	West Half of Trailer	#7-2	CAT 1	No	140 sf.	Tile = 7% Chrysotile Mastic - ND

4. CAMPER W/
WOODEN ADDITION
(Structure 7 on report)

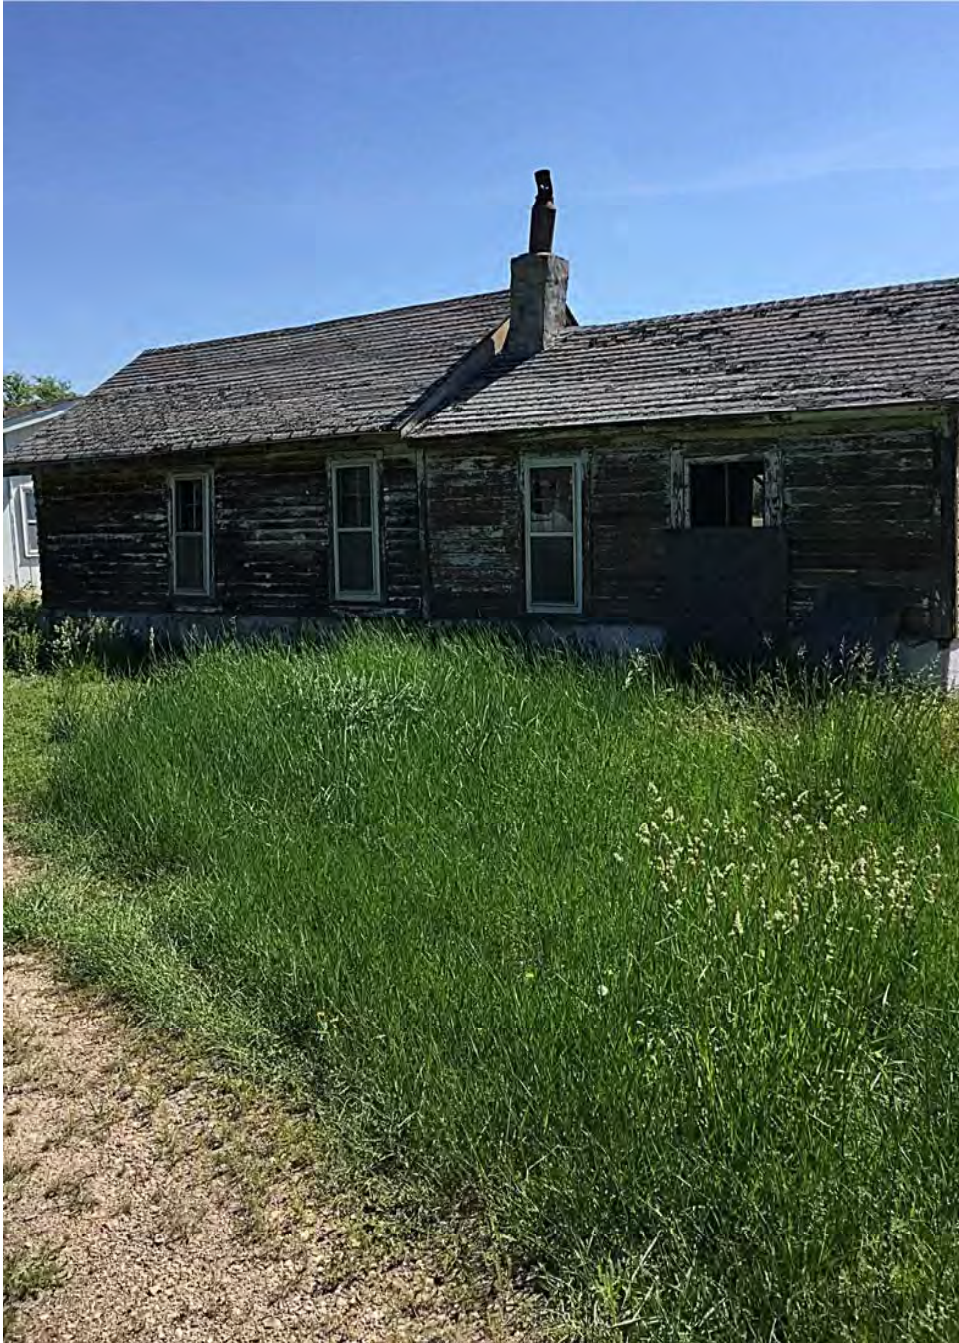
Structure #8

BUILDING # 8 (FARM HOUSE) SUSPECT BUILDING MATERIALS		
MATERIAL	LOCATION	SAMPLE NUMBER
Asphalt Shingle w/ Gray Specks	Roof (top layer)	#8-1
Asphalt Shingle w/ Green Specks	Roof (bottom layer)	#8-2
Asphalt Sheet Flooring	North Floor	#8-3
Drywall	Interior (North Area)	#8-4

BUILDING # 8						
ASBESTOS-CONTAINING MATERIALS						
MATERIAL	LOCATION	SAMPLE NUMBER	NESHAP CATEGORY	FRIABLE ⁽¹⁾	QUANTITY ⁽²⁾	ASBESTOS CONTENT
The suspect material analyzed as part of this assessment was non-detect for the presence of asbestos.

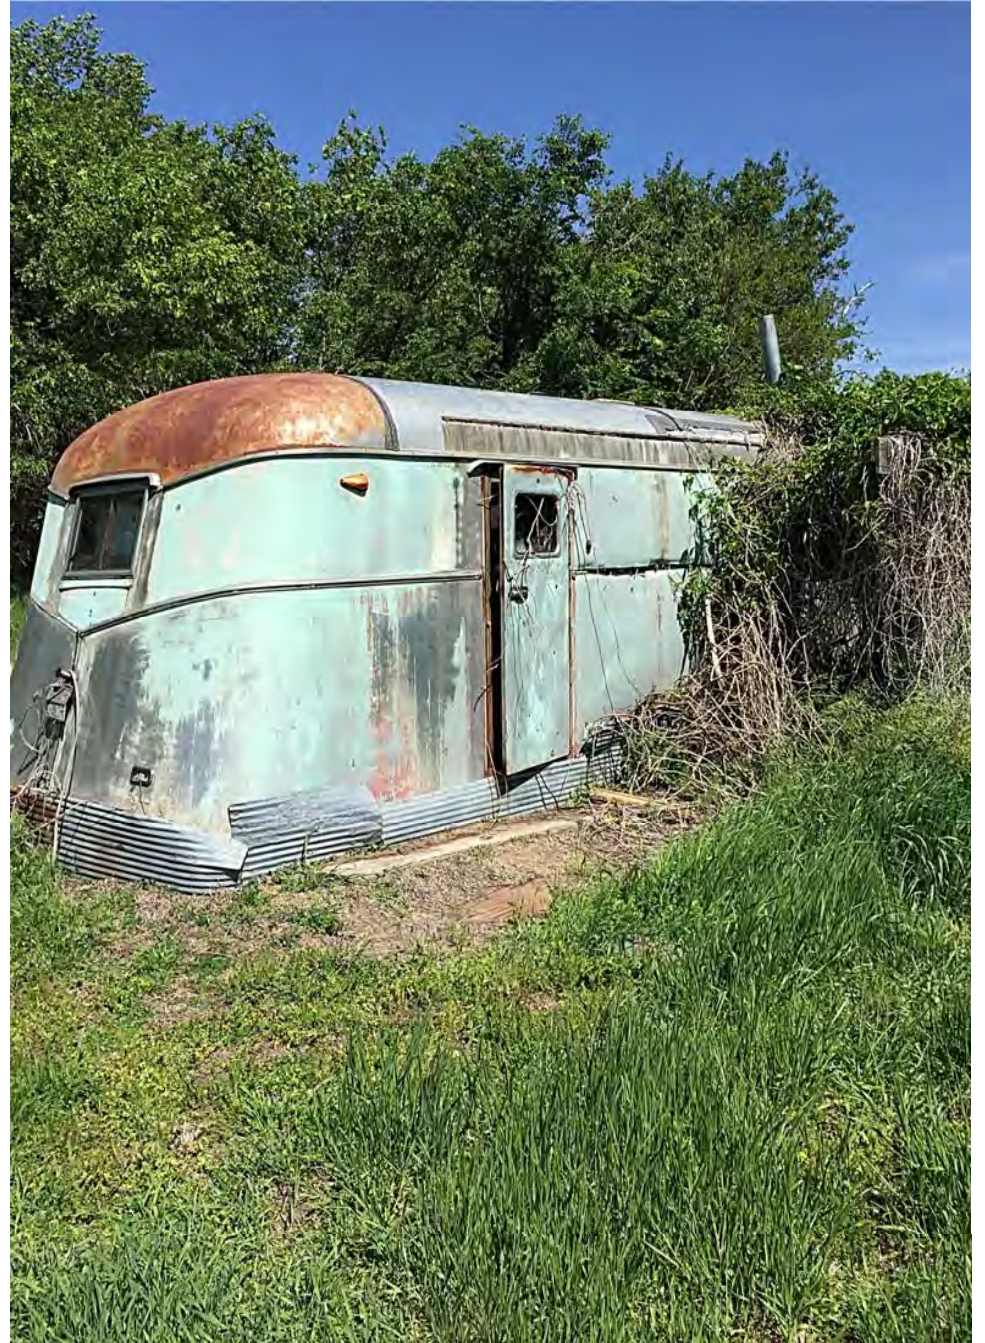
Structure #10

BUILDING # 10 (ALUMINUM CAMPER) SUSPECT BUILDING MATERIALS		
MATERIAL	LOCATION	SAMPLE NUMBER
Gray/Black Roof Seam Tar	Roof	#10-1
9"x9" Asphalt Backed VFT	Floor	#10-2

BUILDING # 10 ASBESTOS-CONTAINING MATERIALS						
MATERIAL	LOCATION	SAMPLE NUMBER	NESHAP CATEGORY	FRIABLE ⁽¹⁾	QUANTITY ⁽²⁾	ASBESTOS CONTENT
Gray/Black Roof Tar	Roof	#10-1	CAT 2	No	50 lf.	15% Chrysotile
sf = Square Feet, ND = Non Detect, NA = Not Applicable, lf = Linear Feet, mf = Mechanical Fittings ⁽¹⁾ Friability is based only on conditions that were observed during B2E's inspection of the site. ⁽²⁾ Actual quantities should be field verified.

1. CAMPER W/
WOODEN ADDITION
(Structure 10 on report)

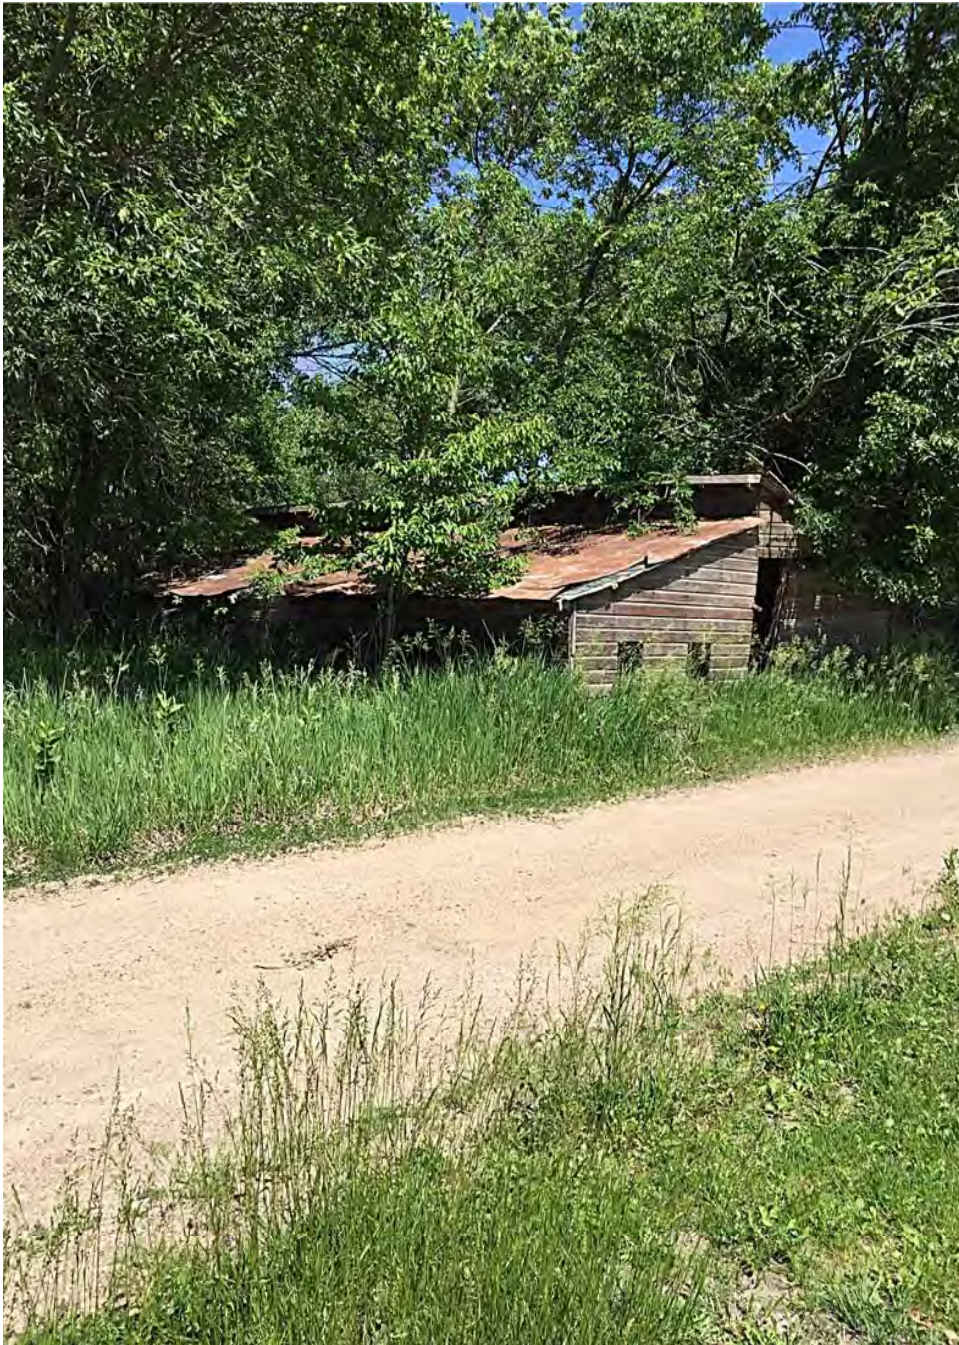
Structure #11

BUILDING # 11 (WOOD BARN) SUSPECT BUILDING MATERIALS		
MATERIAL	LOCATION	SAMPLE NUMBER
Asphalt Shingle w/ Green Specks	Roof	#11-1
Asphalt Shingle w/ Red/Green/Blue	Roof	#11-2

BUILDING # 11 ASBESTOS-CONTAINING MATERIALS						
MATERIAL	LOCATION	SAMPLE NUMBER	NESHAP CATEGORY	FRIABLE ⁽¹⁾	QUANTITY ⁽²⁾	ASBESTOS CONTENT
The suspect material analyzed as part of this assessment was non-detect for the presence of asbestos.

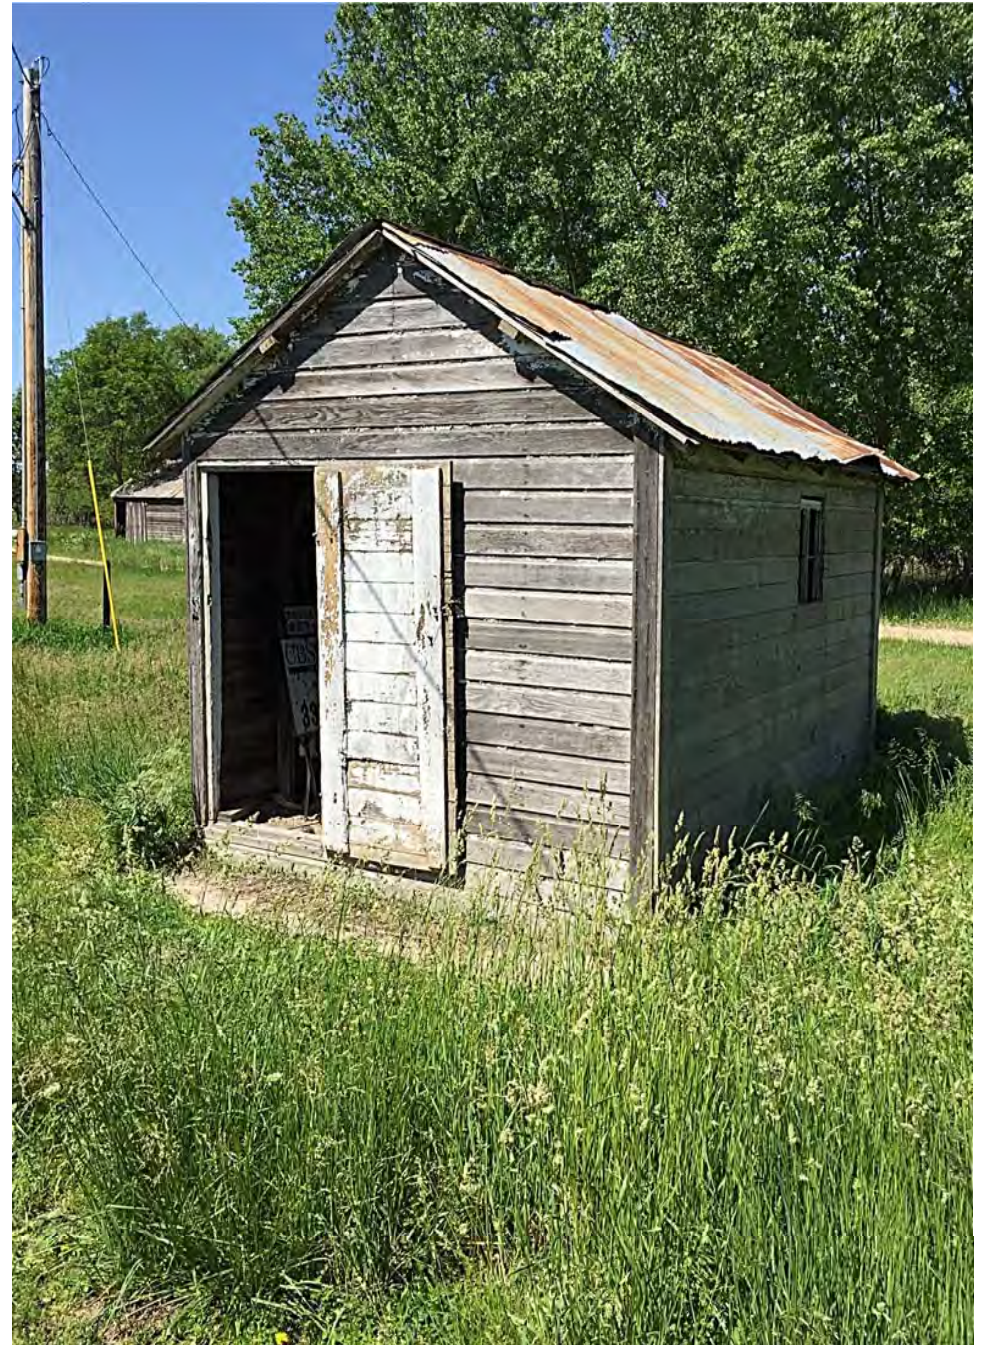
Structure #12

STRUCTURE # 12 (WOOD SHED) SUSPECT BUILDING MATERIALS		
MATERIAL	LOCATION	SAMPLE NUMBER
No suspect asbestos-containing building materials were identified.

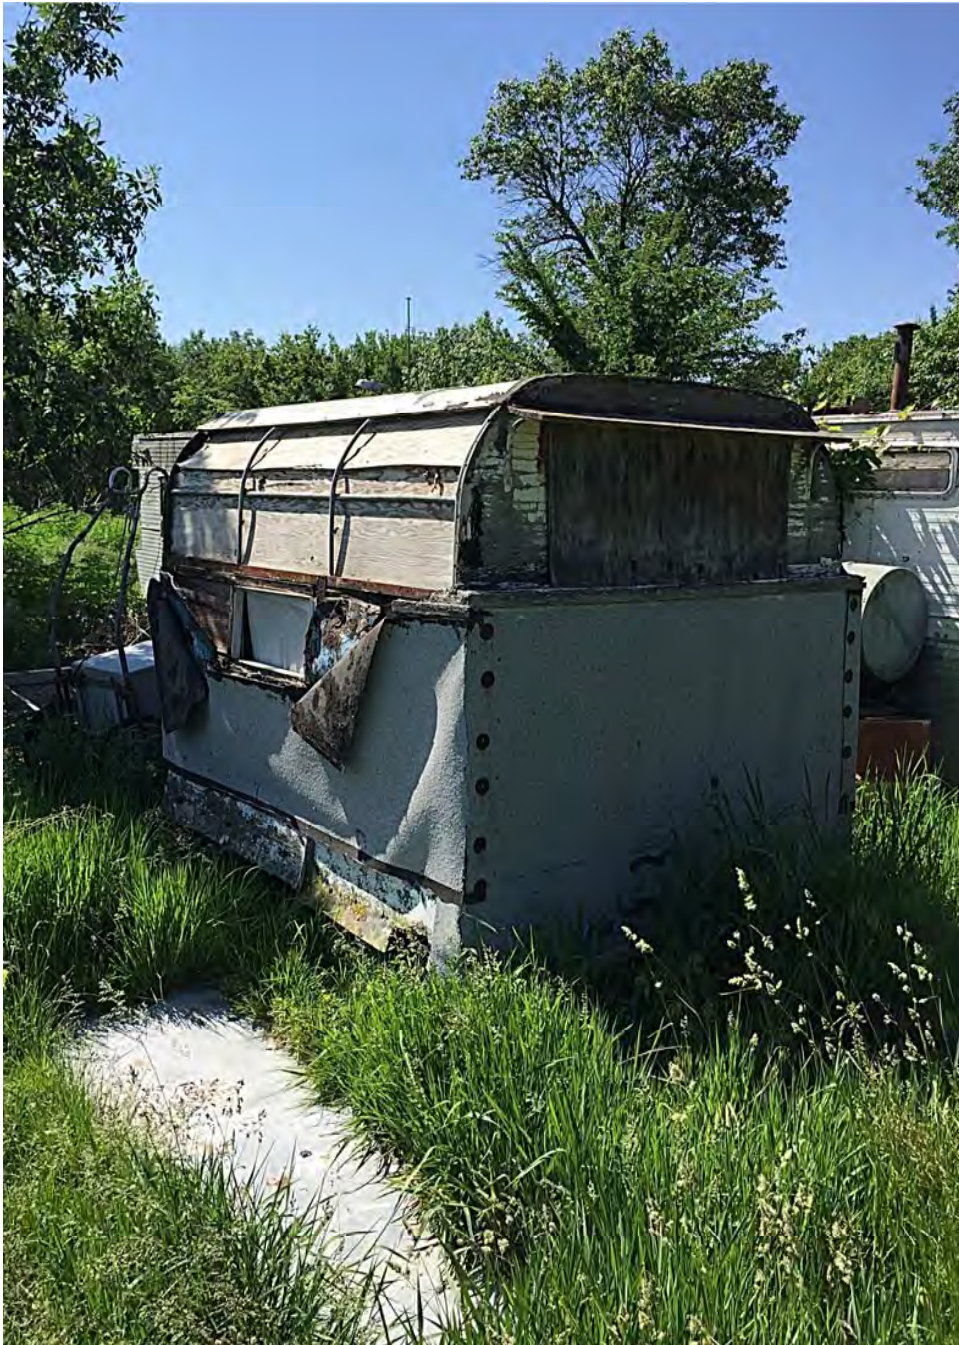
Structure #13

BUILDING # 13 (SMALL CAMPER TRAILER) SUSPECT BUILDING MATERIALS		
MATERIAL	LOCATION	SAMPLE NUMBER
Asphalt Sheet w/ Gray Specks	Siding	#13-1
Black Roof Seam Tar	Roof	#13-2

BUILDING # 13 ASBESTOS-CONTAINING MATERIALS						
MATERIAL	LOCATION	SAMPLE NUMBER	NESHAP CATEGORY	FRIABLE ⁽¹⁾	QUANTITY ⁽²⁾	ASBESTOS CONTENT
The suspect materials analyzed as part of this assessment were non-detect or below regulatory action level of 1.5% asbestos.

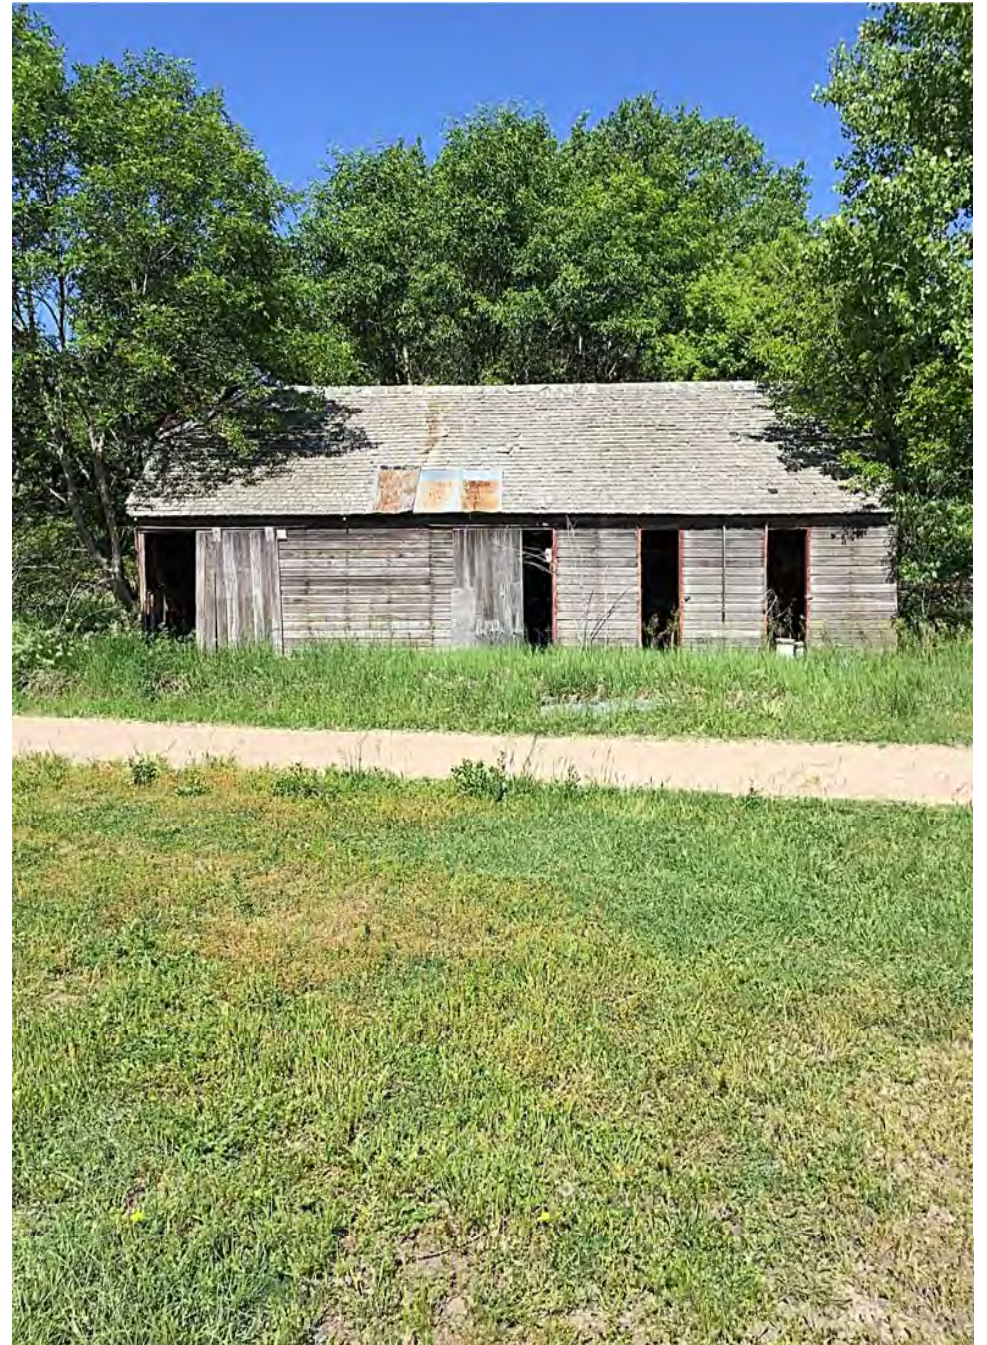
Structure #2

STRUCTURE # 2 (WOOD BARN) SUSPECT BUILDING MATERIALS		
MATERIAL	LOCATION	SAMPLE NUMBER
No suspect asbestos-containing building materials were identified.

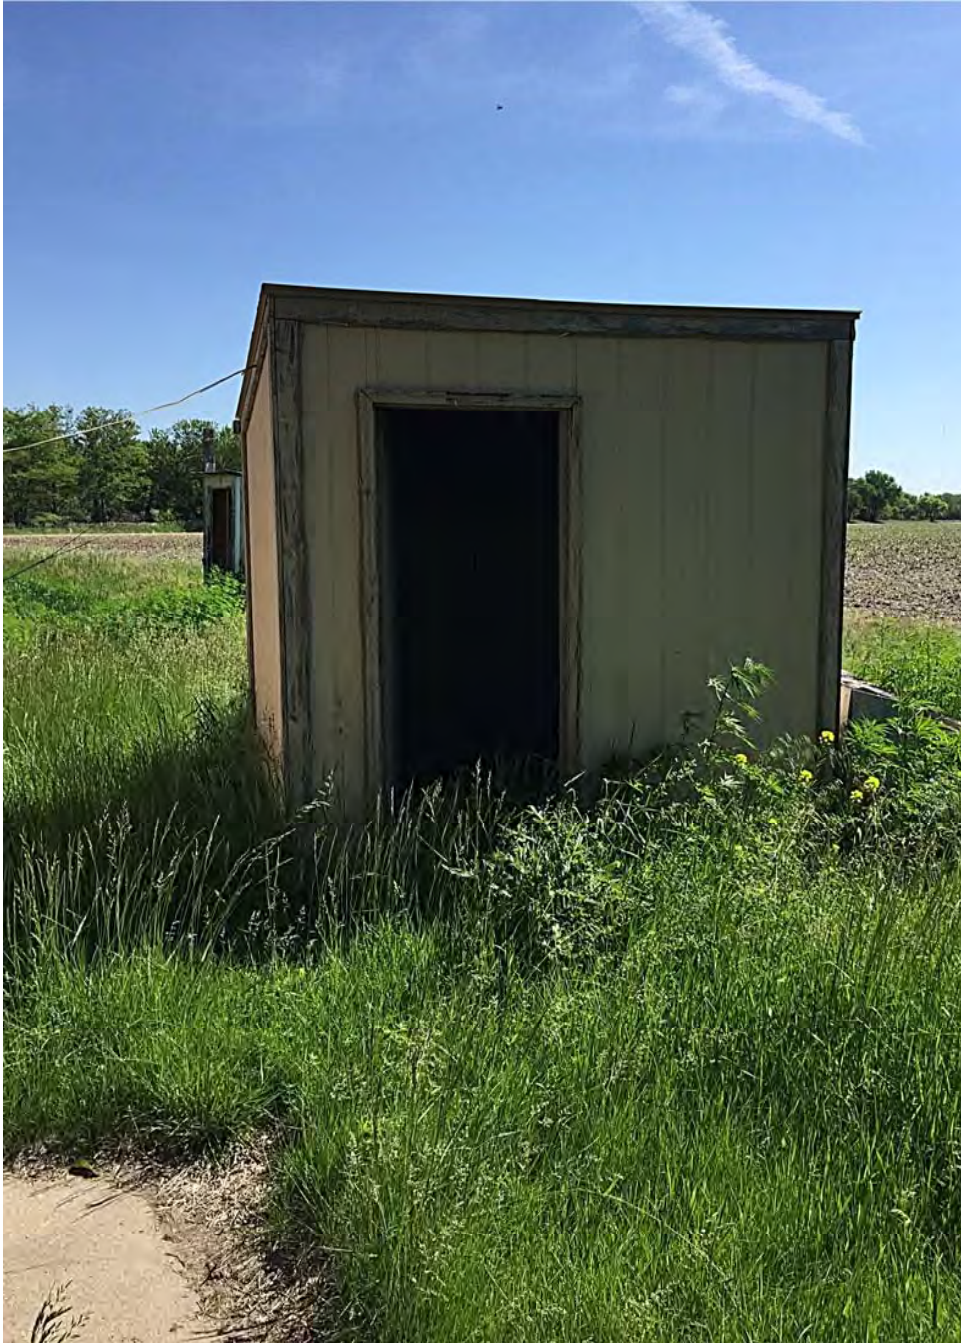
Structure #3

STRUCTURE # 3 (WOOD SHED) SUSPECT BUILDING MATERIALS		
MATERIAL	LOCATION	SAMPLE NUMBER
Asphalt Shingle with Tan Specks	Roof	#3-1

BUILDING # 3 ASBESTOS-CONTAINING MATERIALS						
MATERIAL	LOCATION	SAMPLE NUMBER	NESHAP CATEGORY	FRIABLE ⁽¹⁾	QUANTITY ⁽²⁾	ASBESTOS CONTENT
The suspect material analyzed as part of this assessment was non-detect for the presence of asbestos.

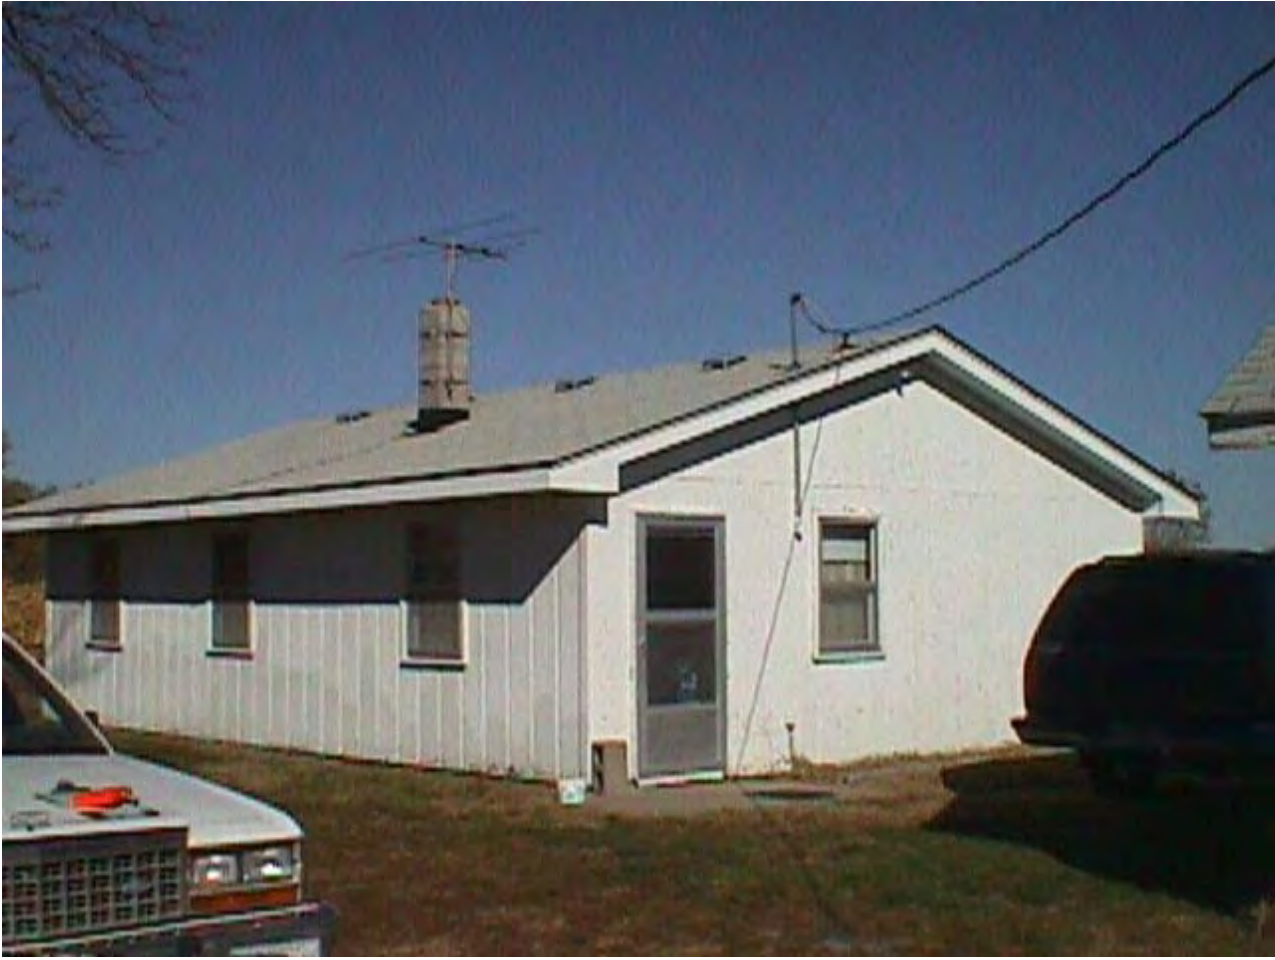
Structure #9

BUILDING # 9 (CABIN) SUSPECT BUILDING MATERIALS		
MATERIAL	LOCATION	SAMPLE NUMBER
Asphalt Shingle	Roof	#9-1
12"x12"VFT w/ Yellow Mastic	Kitchen	#9-2
Drywall and Joint Compound (Composite)	Throughout	#9-3

BUILDING # 9 ASBESTOS-CONTAINING MATERIALS						
MATERIAL	LOCATION	SAMPLE NUMBER	NESHAP CATEGORY	FRIABLE ⁽¹⁾	QUANTITY ⁽²⁾	ASBESTOS CONTENT
The suspect material analyzed as part of this assessment was non-detect for the presence of asbestos.
