PLATTE RIVER RECOVERY IMPLEMENTATION PROGRAM

Data Synthesis Compilation

Sediment Augmentation

Peer Review Updates September 30, 2024

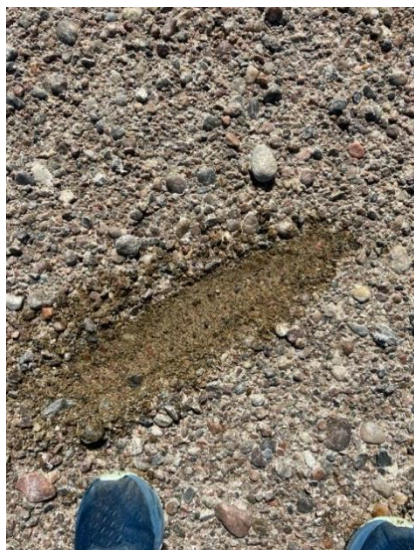
Figure D.4. Visual comparison of coarse armor layer overlaying finer sand on the channel bed approximately 500 feet downstream from the J2 Return

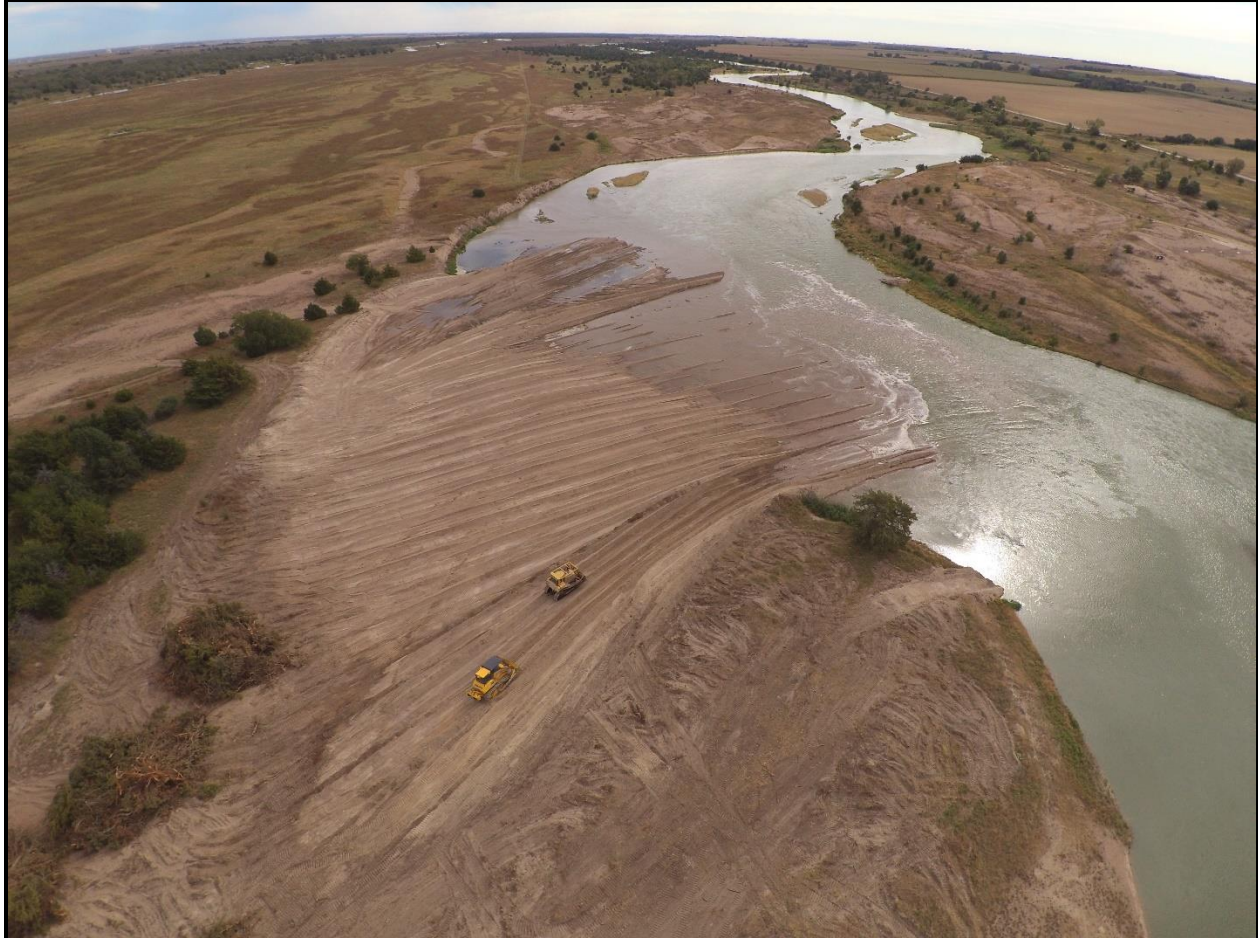
Figure 1.6 Construction of 2019 Sediment Augmentation Project (42,300 yd³).

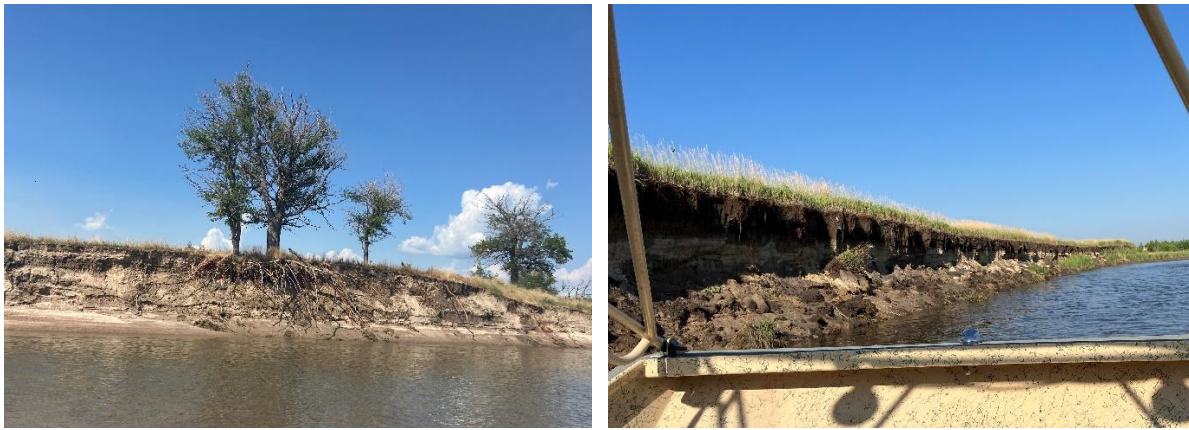
Figure 2.4. Field photos from July, 2024 depicting high eroding banks in the J2 Return Channel.
