EXECUTIVE SUMMARY

The purpose of this addendum is to add data from 2022 to previously presented figures, tables, and analysis contained in the Sediment Augmentation Data Synthesis Compilation from August 2023. The text of this document only refers to the 2022 data. The original report should be referenced for full methods and discussion. The List of Figures and Tables presents the updated items. Figure and table numbers have been preserved from the August 2023 report to enable easy comparison.

CHAPTER 3 Evaluation of longitudinal change after sediment augmentation

CHAPTER 4 Volume change analysis

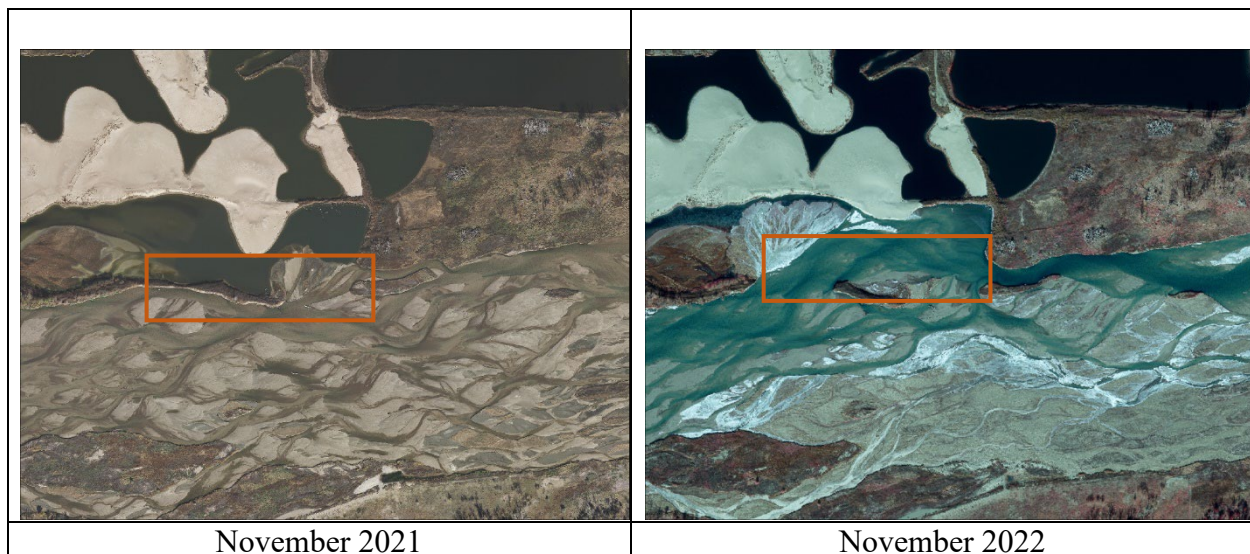
Figure E1. Aerial imagery from 2021 (left) and 2022 (right). The red box shows the levee breach location.

Table 4.6 Post-augmentation year-by-year volume change divided into two reaches at Overton Bridge. Negative values indicate net degradation or erosion. In 2022, less erosion occurred in the upstream reach, while more occurred in the downstream reach compared to the previous year. The downstream increase was primarily due to the levee breach at Blue Hole East (see Figure E1).

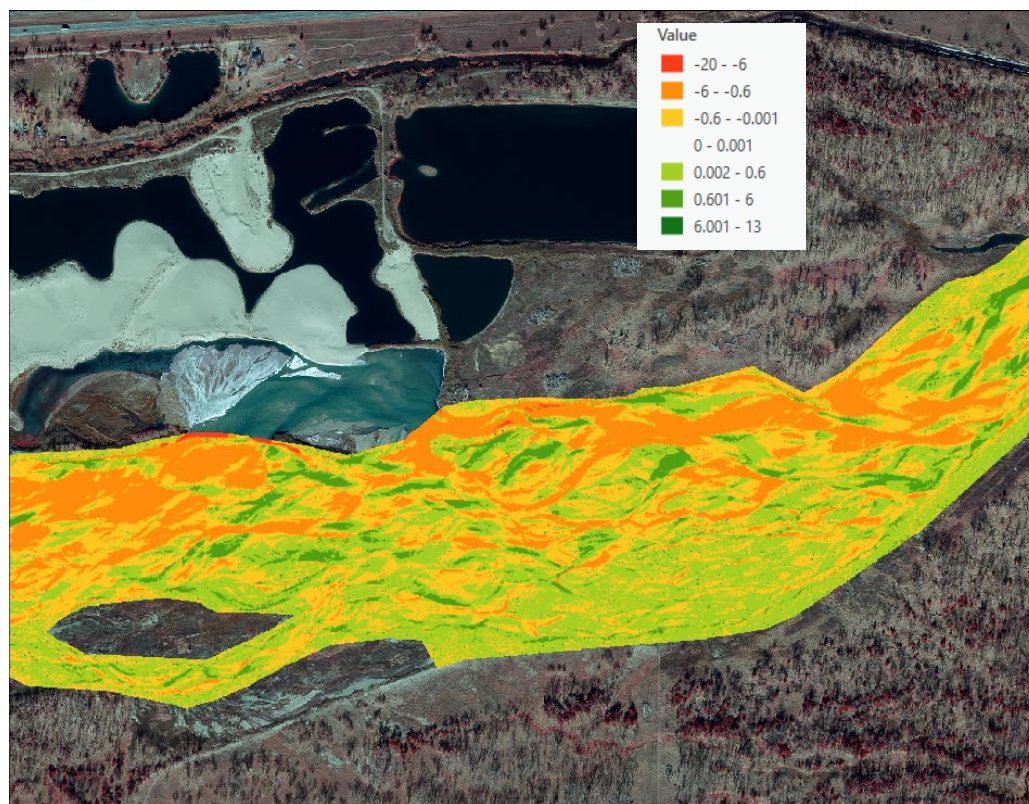
Figure E2. Difference raster from 2022 to 2021 at the breach site. The raster is clipped to the analysis area. Orange, red, and yellow indicate erosion, while green indicates aggradation. The legend gives the magnitude of elevation change in feet. Widespread erosion is visible in the northern half of the channel, upstream and downstream of the breach.

2022 was the driest year since sediment augmentation began in 2017. Lower flow resulted in reduced sediment transport along the reach. Evidence of this can be seen in the higher than usual aggradation in the augmentation project area and along the J2 channel (Figures 3.7 – 3.9). The erosional “hot spot” at station 70,000 continues to be an area with lower average cross-sectional elevations (Figure 3.13) and active lateral erosion (Figure 4.11B), however, bed aggradation occurred in that area over the last year (Figure 4.11C) and thalweg elevations recovered to match the surrounding grade. Downstream of the Overton Bridge, little change occurred except for the area between Elm Creek Bridge and the KCD. That area experienced erosion due to a levee breach and associated channel adjustment at the Blue Hole East habitat area (Figure E1). Water was drawn through the breach and into a sandpit where a large depositional splay formed. Water then re-entered the river channel, reshaping it to accommodate the new dominant flow path. As shown in Figures 4.11- 4.12, this change had a net erosional effect on the river as bed and levee material remained in the sandpit (outside our analysis area) and erosion occurred in the channel downstream from the breach (Figure E2).

Figure 4.12 Cumulative year-by-year volume change in the post-augmentation period. (A) Lines represent the running sum of all change starting at the downstream end of augmentation projects. The nearly flat lines downstream of Overton Bridge indicate very little lateral erosion occurred (B). Steep slopes indicate high local change, such as the high bed degradation at Cottonwood Ranch from 2017–2019 (C). In 2022, little change occurred except for downstream of Elm Creek Bridge where a levee breach caused lateral erosion and channel adjustment resulted in high bed degradation (see Figure E2).

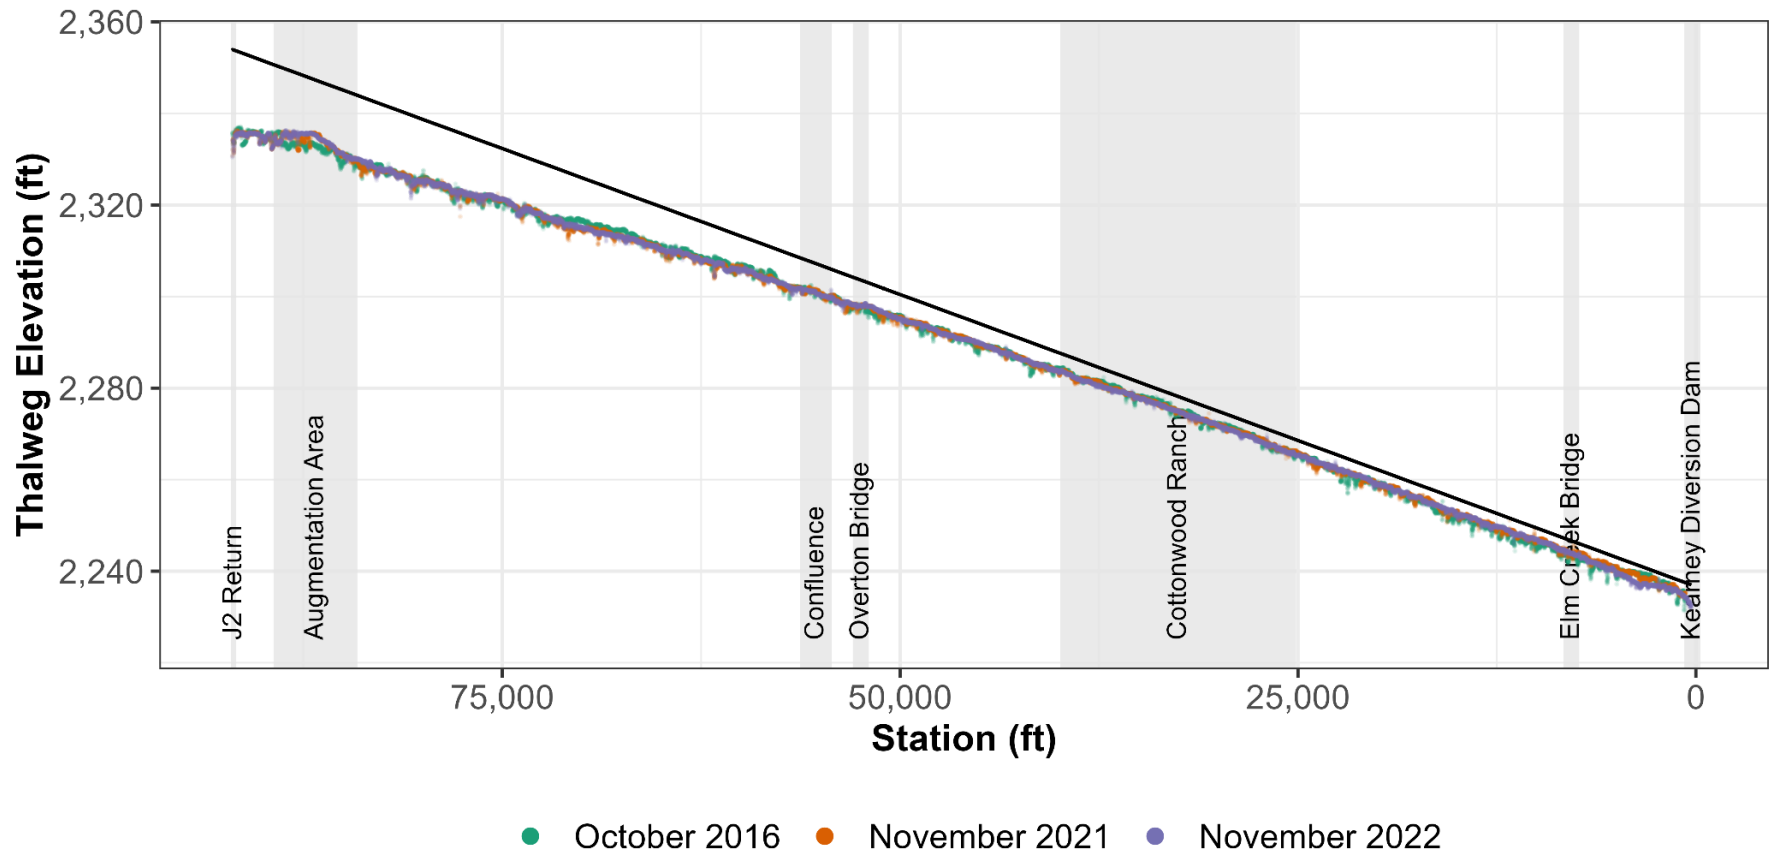
Figure 3.6. Longitudinal profiles of thalweg elevation in 2016 (green), 2021 (orange), and 2022 (purple). The Geomorphic Grade Line (GGL) is shown in black as a reference for the magnitude of channel incision. The addition of the 2022 profile shows that thalweg elevations continue to diverge from the GGL upstream of the Overton Bridge.

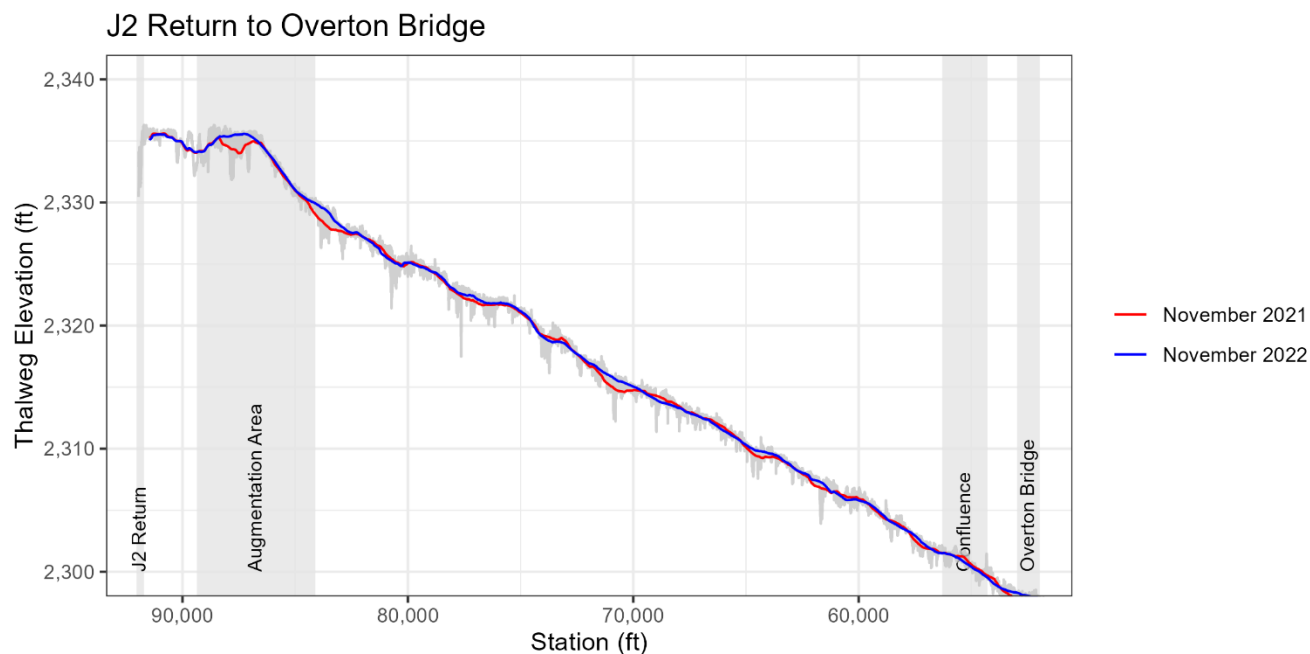
Figure 3.7. 2021–2022 annual moving average (1,005 ft) longitudinal profiles between J2 Return and Overton Bridge. Gray area behind profiles indicates the range of values for 2021–2022. Several low-elevation areas (Stations 96,000, 70,000) have seen aggradation over the past year.

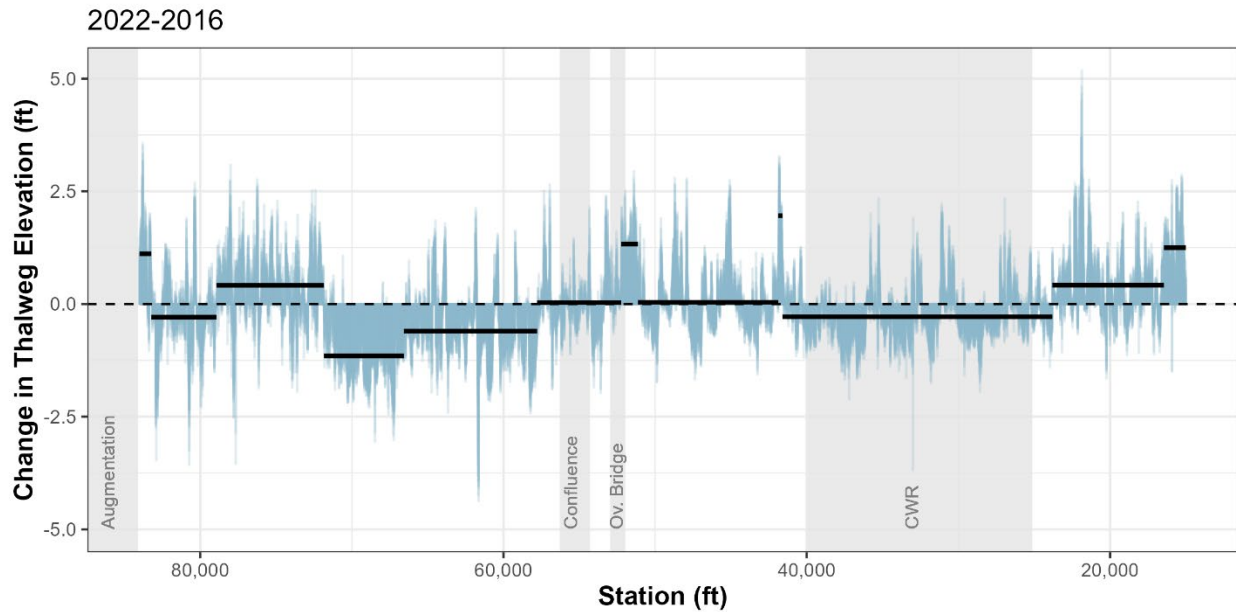
Figure 3.8 2016–2022 thalweg changepoint analysis results. Differences in thalweg elevations are shown in blue. Mean segment change values are shown in black. Negative numbers indicate thalweg incision and positive indicate thalweg aggradation. Compared to the 2016 – 2021 analysis, there is a new region of positive change in the augmentation area, and two areas of average positive change became more positive near Overton Bridge and the Kearney Diversion.

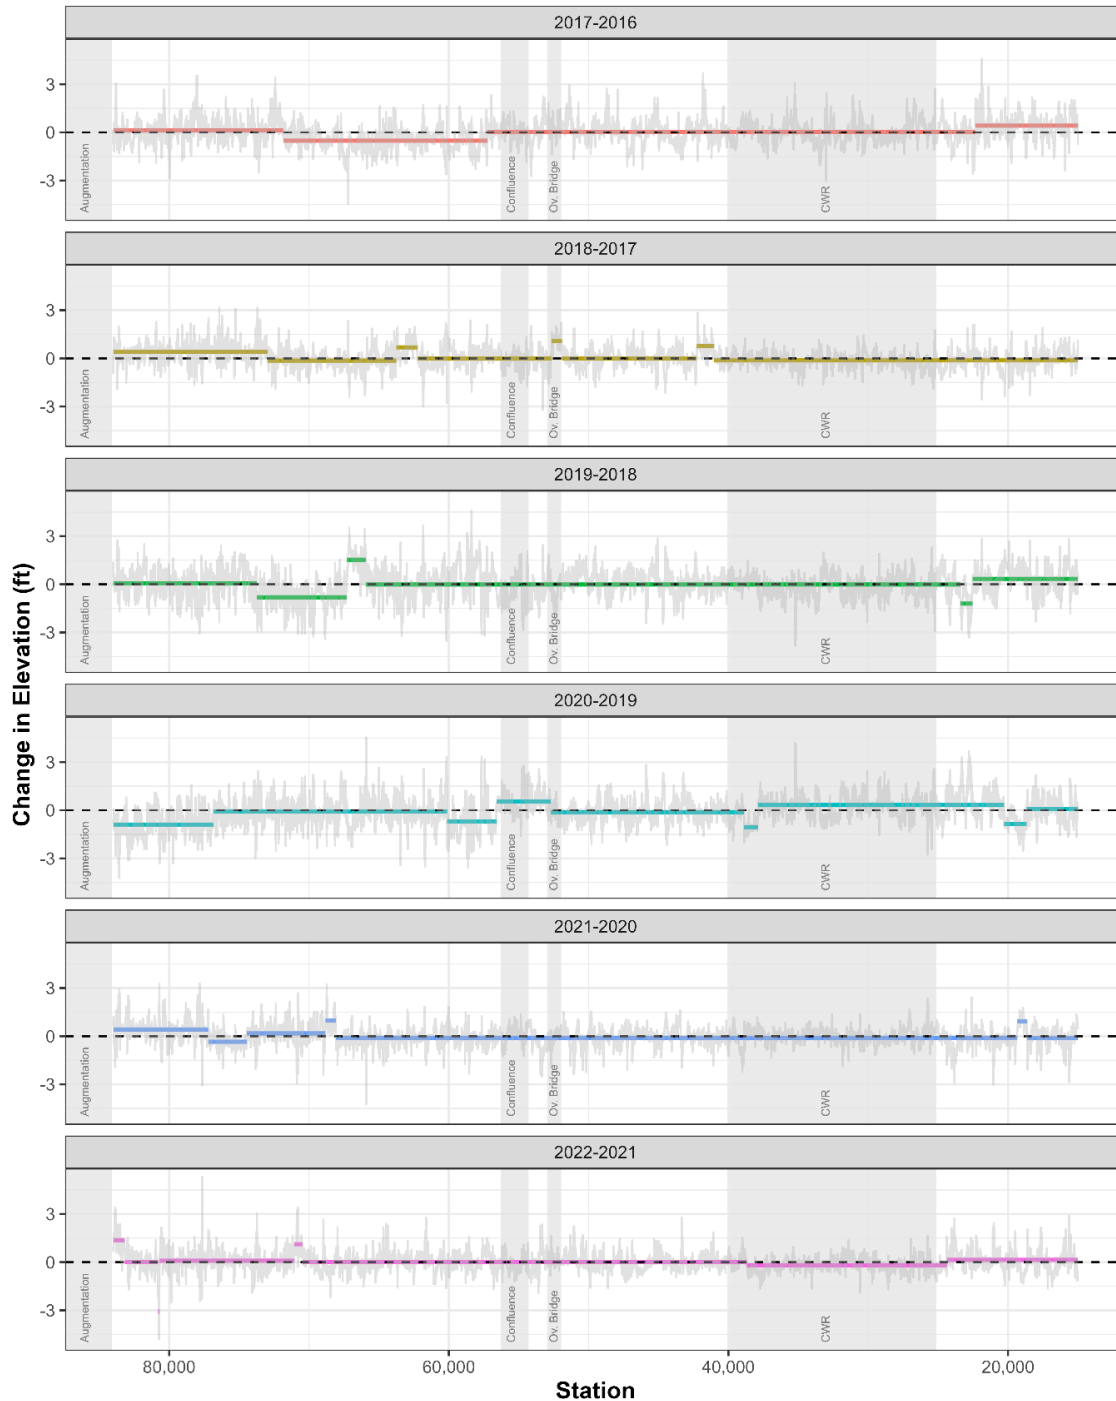
Figure 3.9. Annual changepoint analysis results of change in thalweg elevation between years. Colored lines show mean change values of changepoint segments. Light gray lines show at-a-station thalweg elevation difference. Average changes in 2022 remained close to zero with the exception of two aggradational areas: one in the augmentation project area and another at station 70,000.

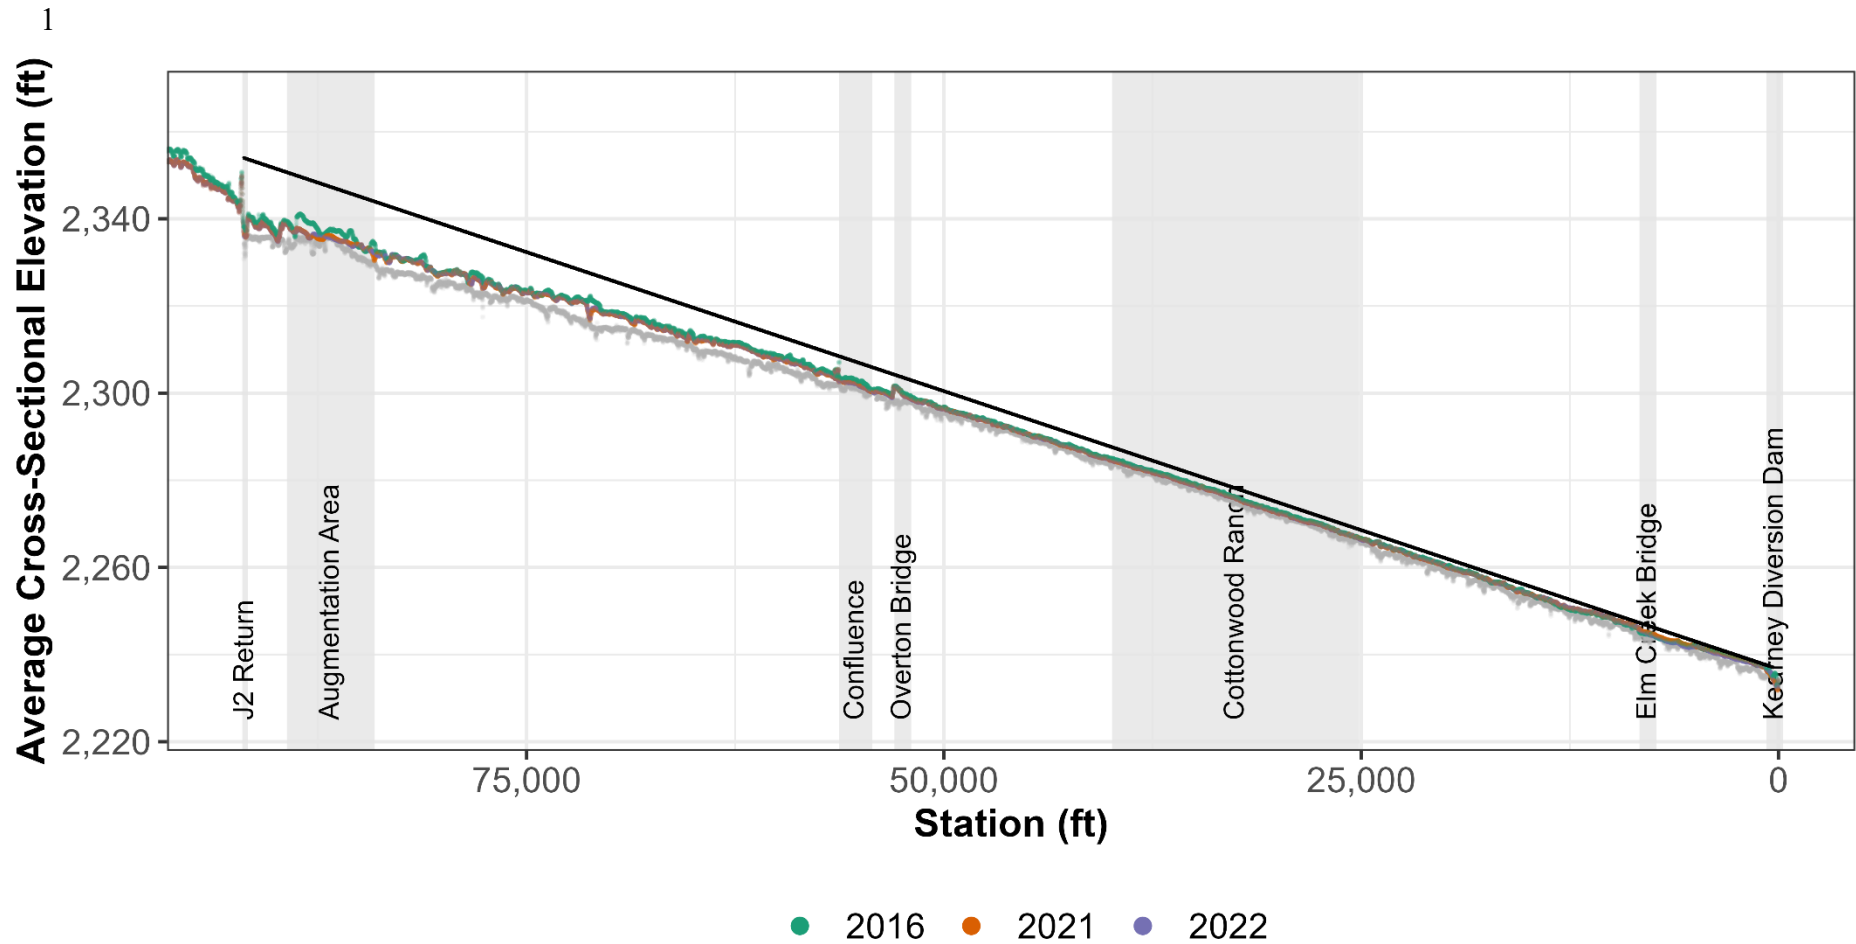
2 **Figure 3.12.** Average cross-sectional elevation longitudinal profile. Very little change occurred between 2021 (orange) and 2022
 3 (purple). Elevations upstream of the Overton Bridge continue to diverge from the slope of the GGL (black).

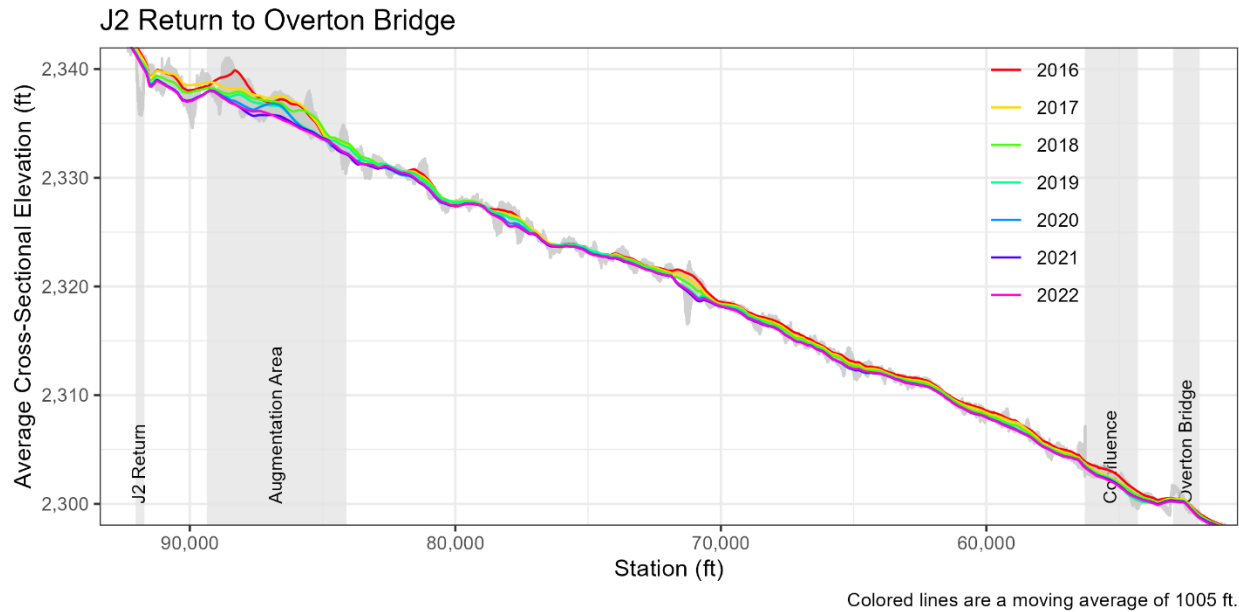
Figure 3.13. Average cross-sectional elevation longitudinal profile in the J2 Return channel. Colored lines are a moving average of 1005 ft and gray lines show the range of values for 2016–2022. Very little changed occurred from 2021 to 2022.

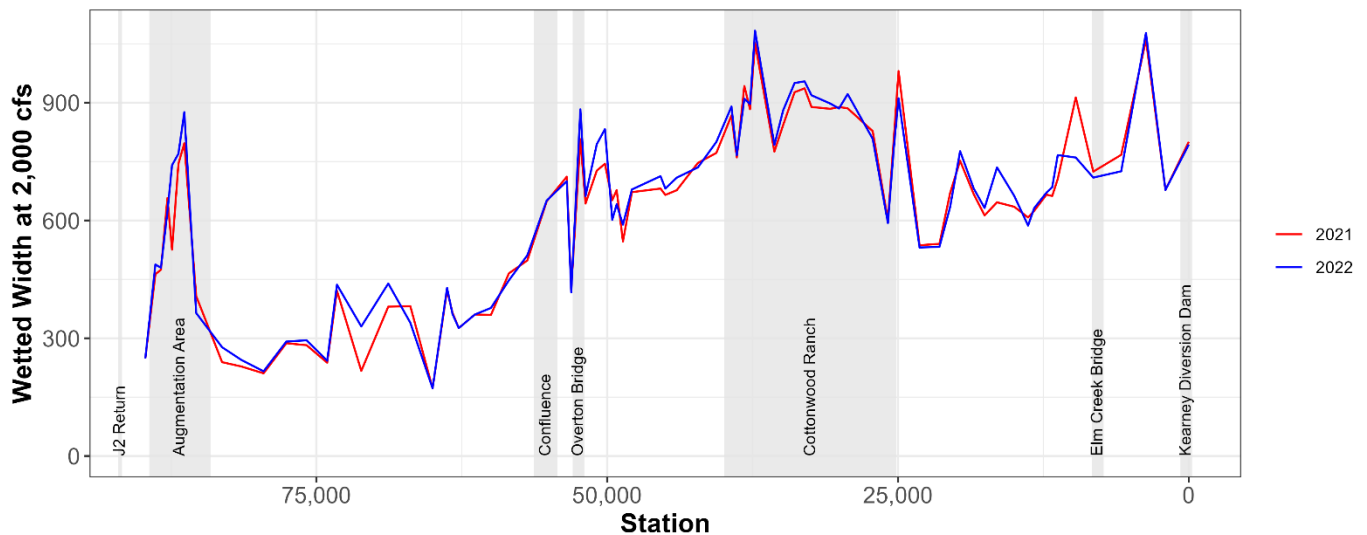
Figure 3.15 Wetted width at HEC-RAS cross-sections in 2021–2022. In most areas, wetted width was stable. Two larger changes occurred at stations 9,715 and 71,140. In the first case, wetted width increased near station 70,000 due to apparent reconnection of a side channel. In the second case, wetted width decreased in 2022 as an off-channel pond became inaccessible to flow.

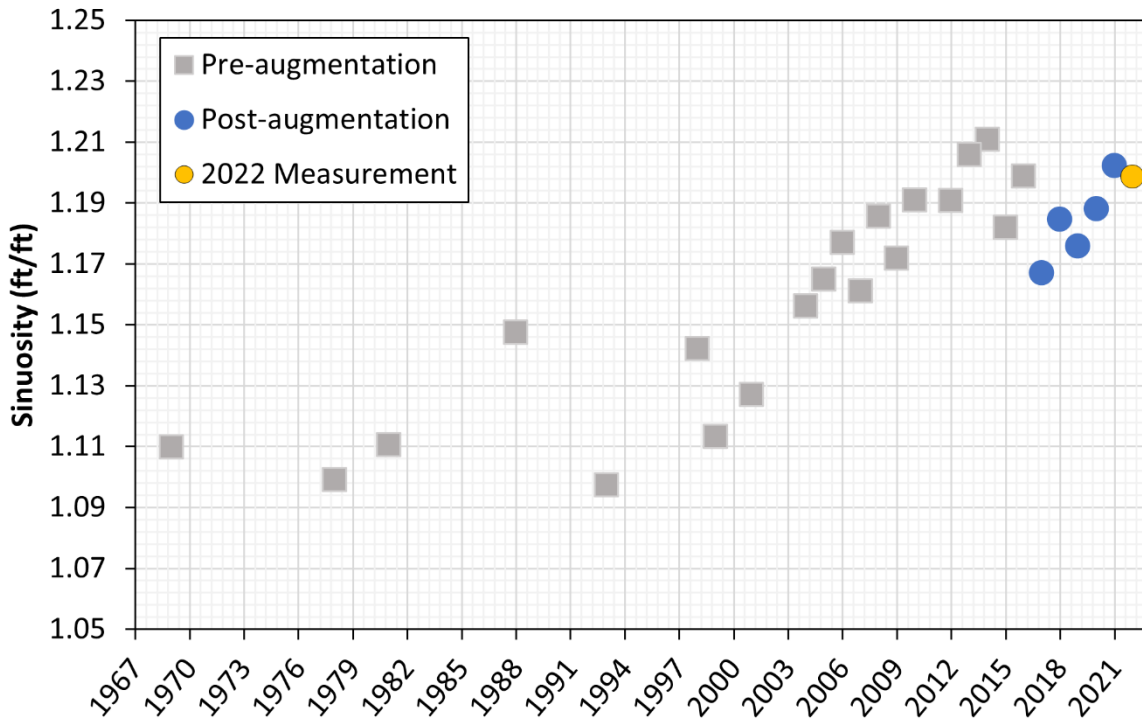
Figure 3.17 Ratio of thalweg to straight-line length (sinuosity) in the J2 Return Channel between 1969 and 2022. Figure shows a trend in increasing sinuosity beginning in the early 2000s. Sinuosity declined in 2017 due to the construction of a meander cutoff as part of augmentation operations. Despite the cutoff, the trend of increasing sinuosity continued during the augmentation experiment. 2022 sinuosity remained in-line with the current increasing pattern, though the value is slightly lower than 2021.

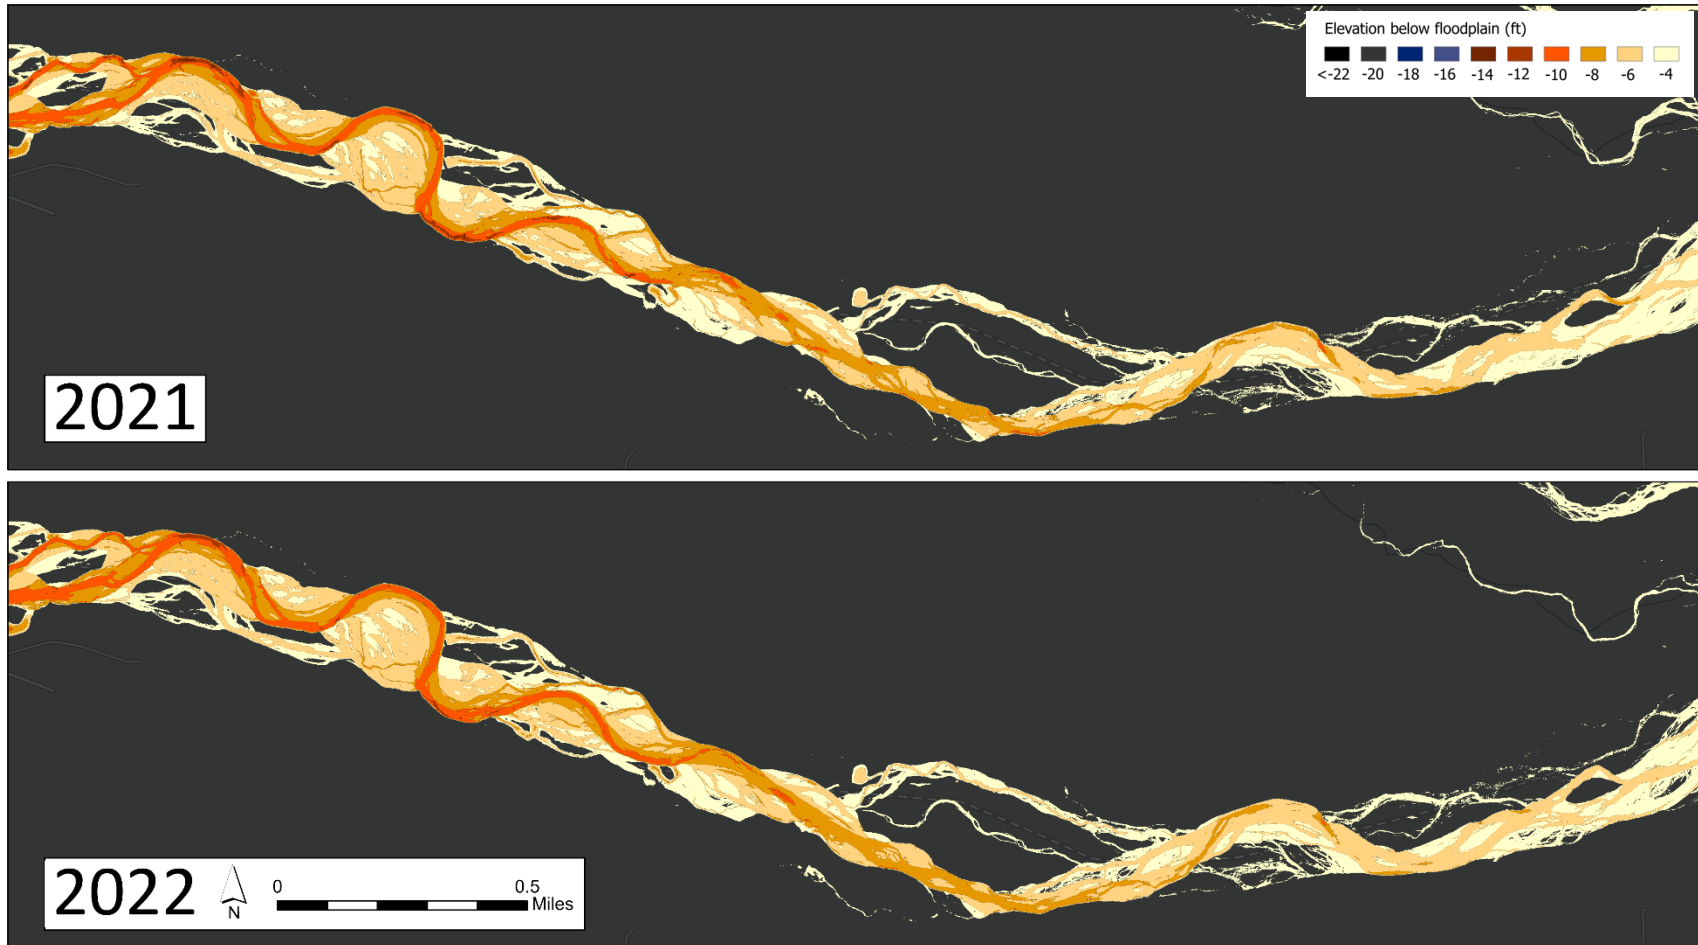
3 **Figure 3.19.** Relative elevation models (REMs) of the downstream section of the J2 Return Channel ending at Station 58,000. The
4 relative elevation model is contoured into 2 ft intervals below -4 ft relative to the floodplain. Only slight changes occurred since last
5 year. Downstream progression of incision is not apparent, and a few deeper holes have shifted from dark red (-12 ft) to red (-10 ft).

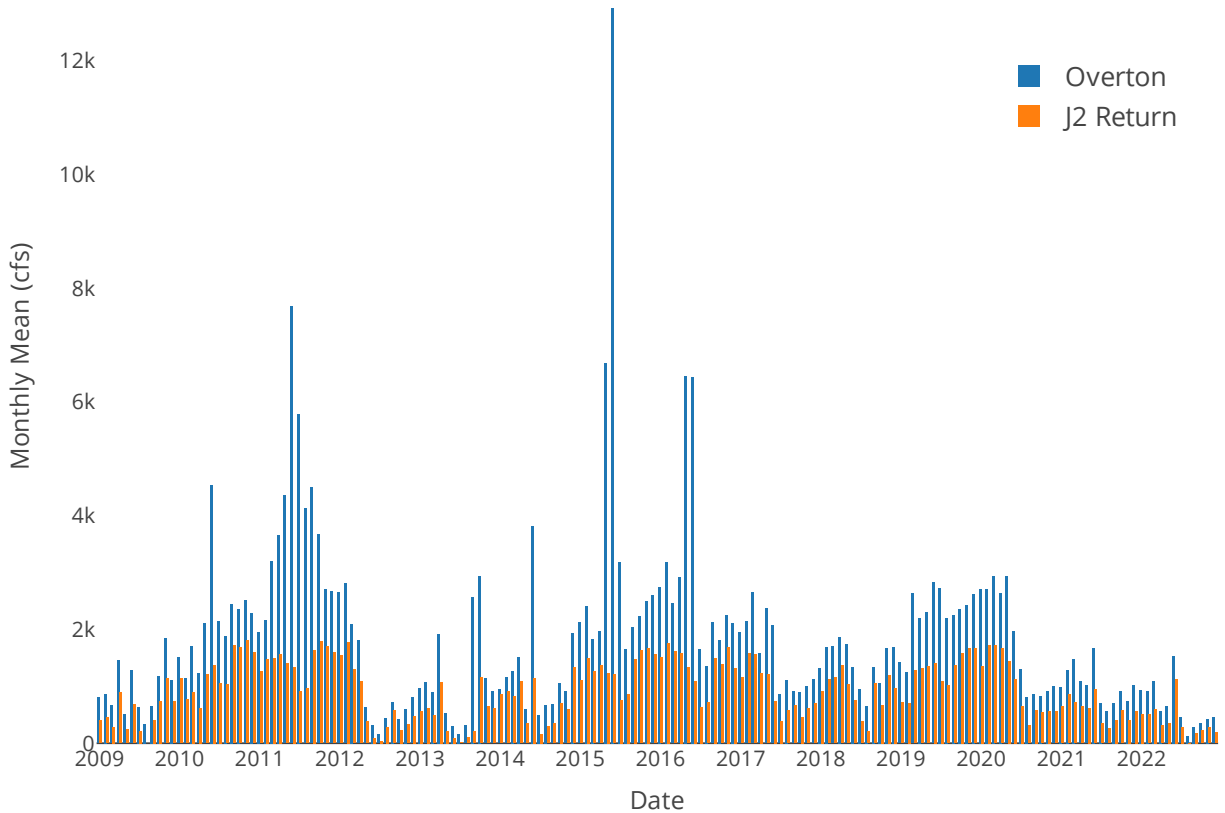
Figure 4.2 Monthly mean discharge from CNPPID to the J2 Return Channel and at the USGS Overton gage from 2009 to 2022. Flows at both locations were low in 2022.

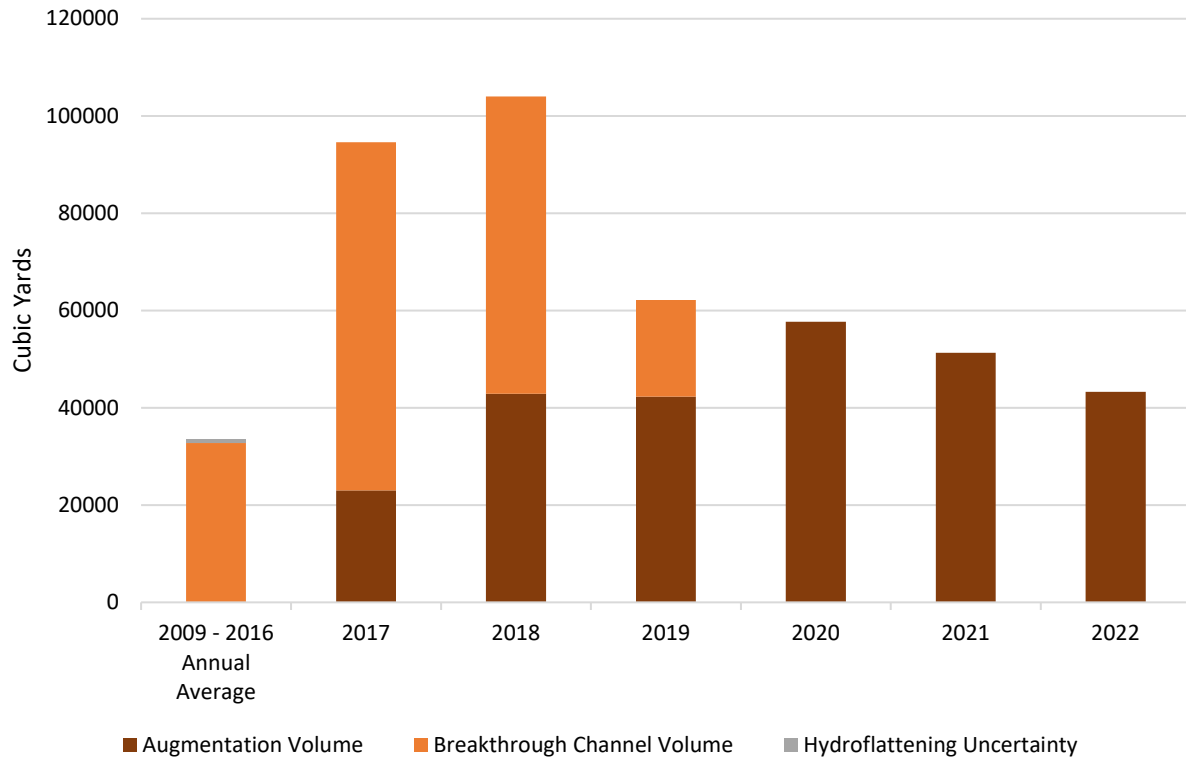
Figure 4.3 In 2022, 43,300 yd³ were augmented into the channel. This is within our target range of 40,000 – 60,000 yd³.

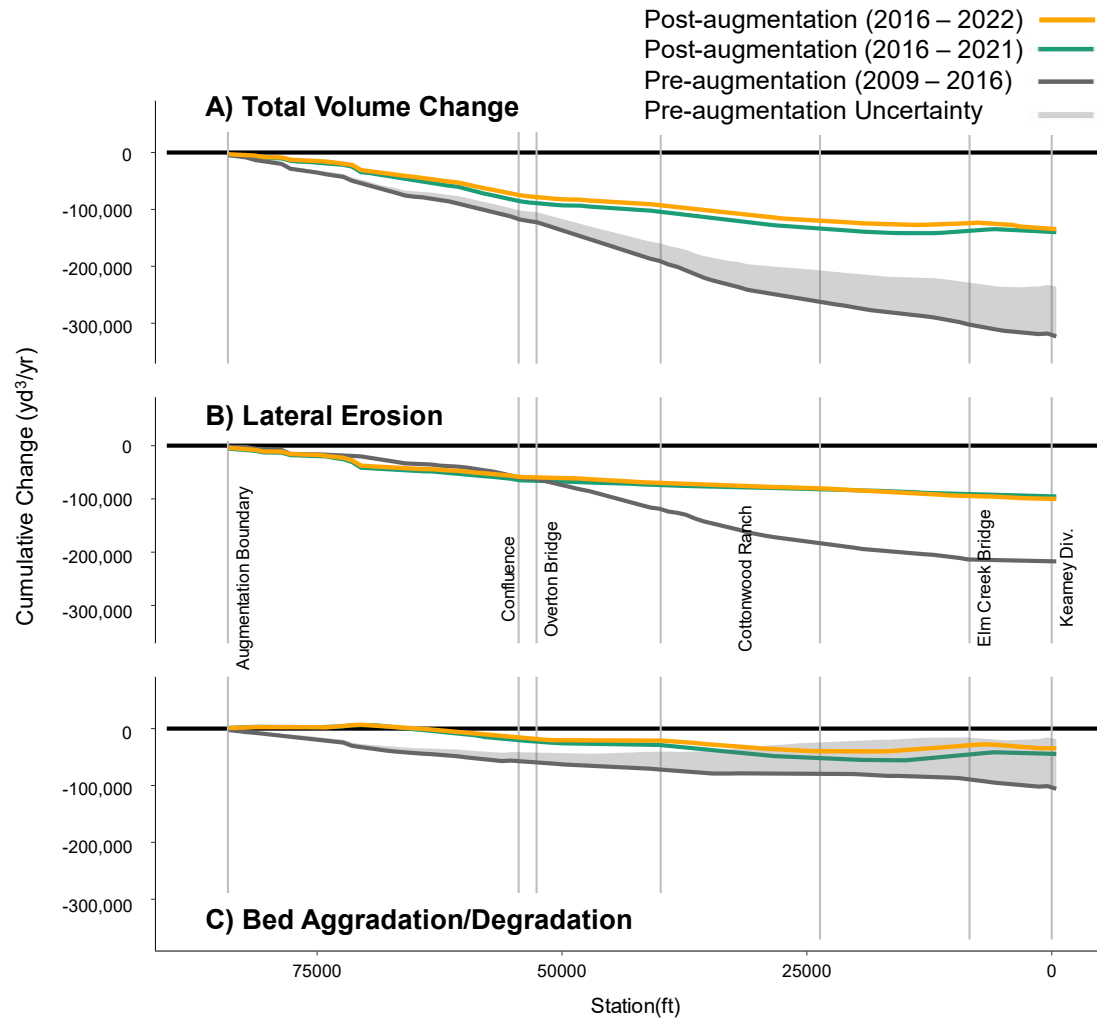
Figure 4.8. Cumulative volume change in the pre- and post-augmentation time periods. Lines represent the running sum of all change starting at the downstream end of augmentation projects. Gray shaded area represents the uncertainty in the pre-augmentation period due to lacking bathymetry data. Inclusion of the 2022 data (orange) led to very slight changes that for the most part decreased the yearly averages.

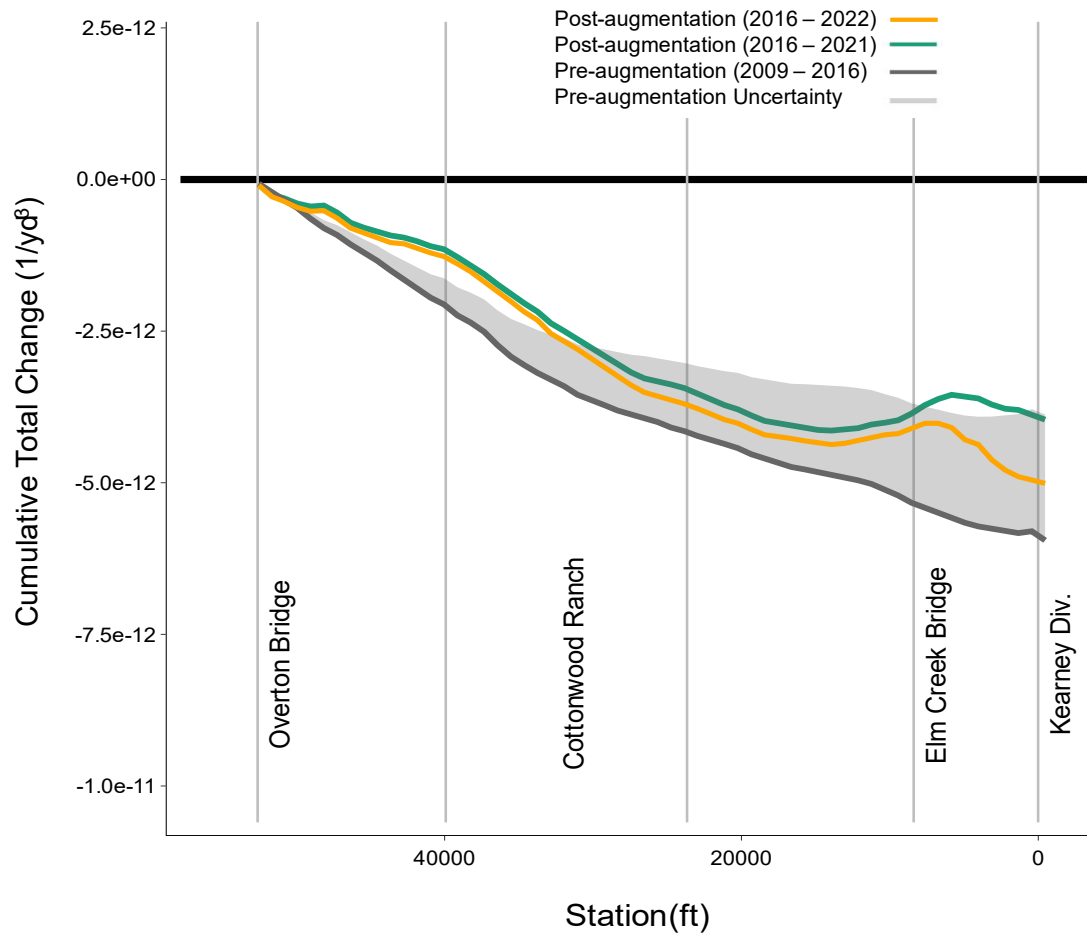
Figure 4.9. Cumulative total volume change downstream of the Overton Bridge. Values are normalized by flow at the Overton USGS gage. Pre- and post-augmentation total volume changes are very similar when normalized for the different amounts of flow that occurred during these periods. This pattern is maintained with the inclusion of 2022 data. The drier conditions enhanced degradation slightly compared to 2016 – 2021 data (green)

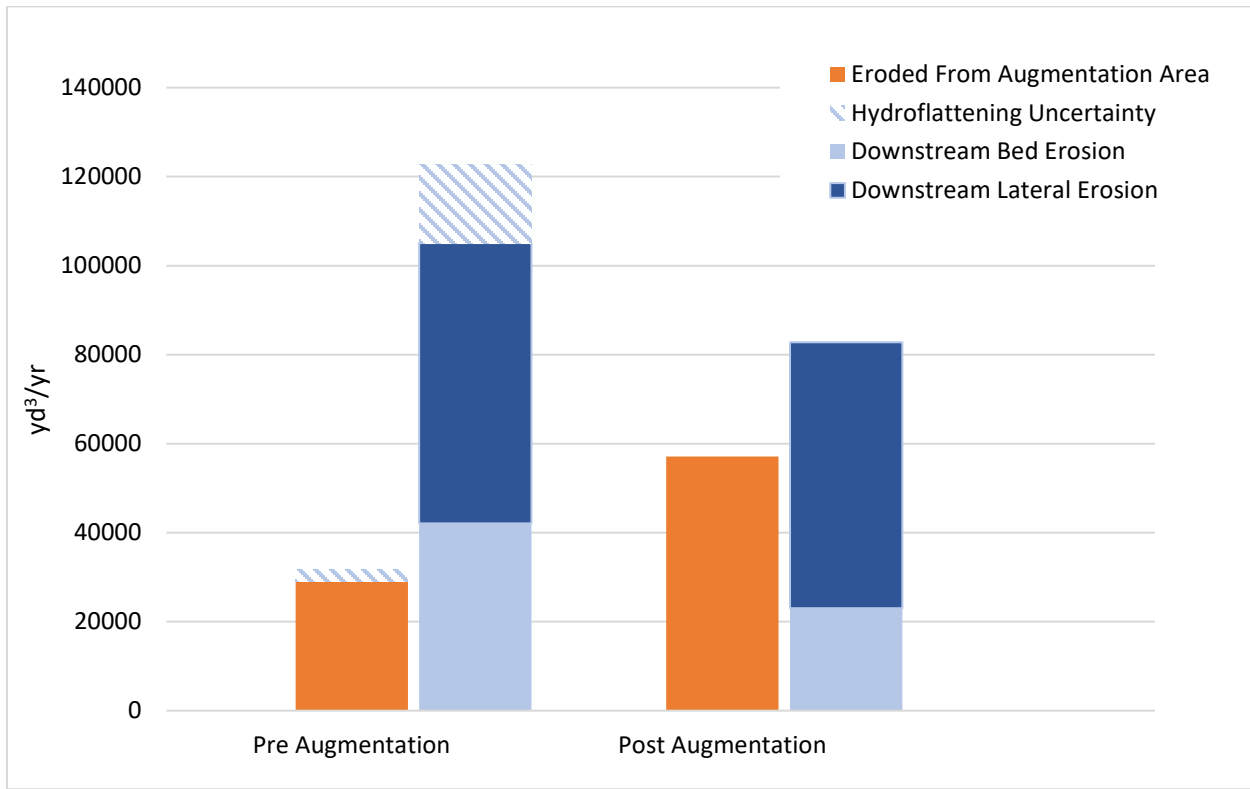
Figure 4.10 Volumes eroded from the J2 Return Channel upstream and within the augmentation project area (orange), and downstream of augmentation projects to the Overton Bridge (blue) in pre- and post-augmentation periods. In the post augmentation period, upstream sediment supply increased and downstream bed erosion decreased. The similarity between the values of increase and decrease indicate that sediment is leaving the augmentation area and reducing bed erosion downstream. Inclusion of 2022 data shows slightly less average erosion from the augmentation area. This is reasonable given lower J2 Return flows in 2022.

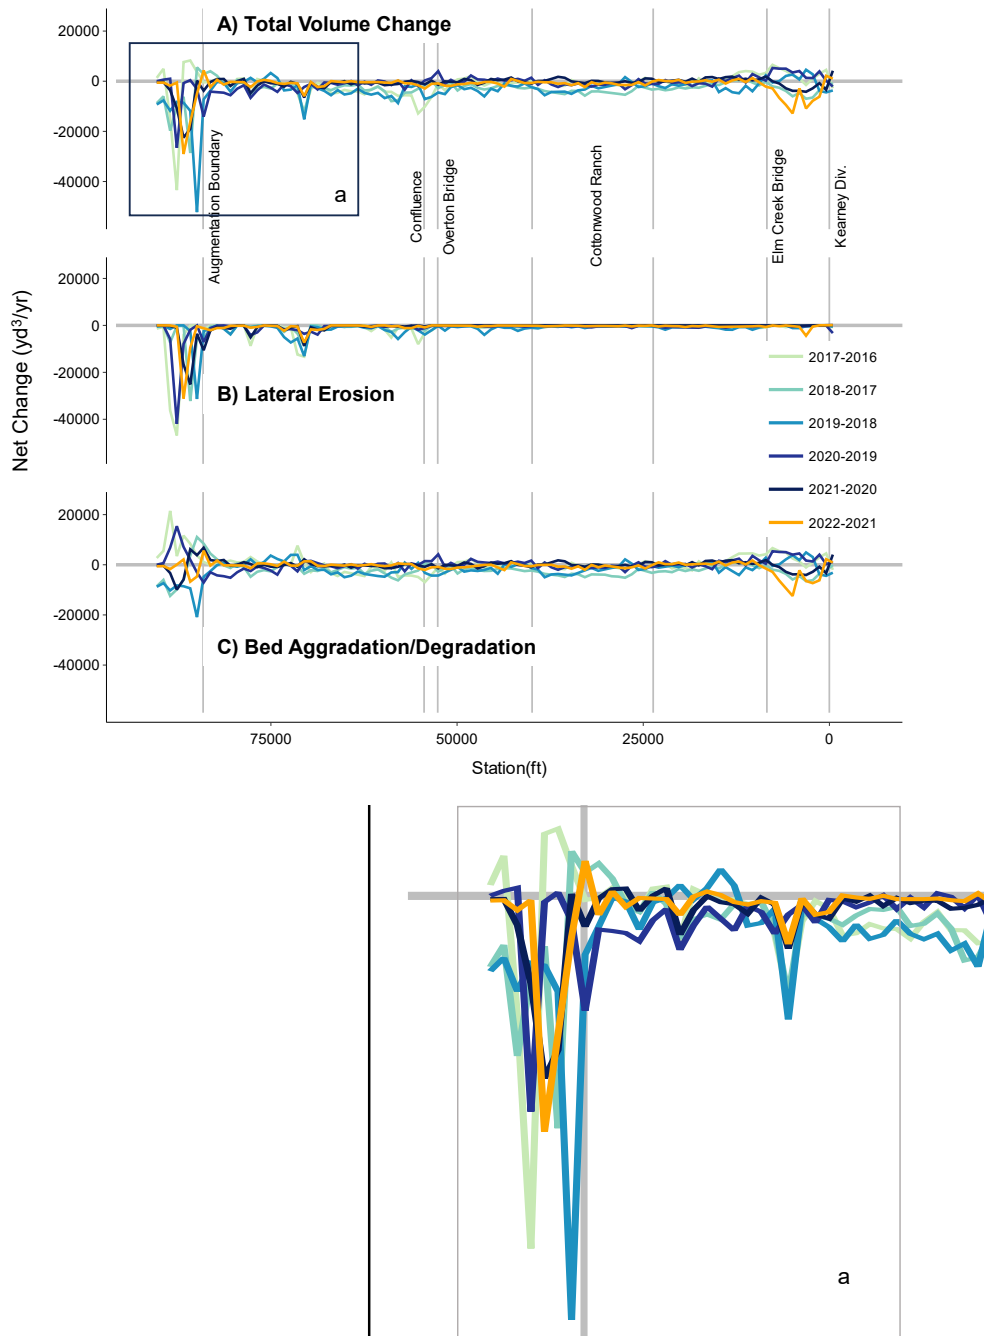
Figure 4.11 Post-augmentation year-by-year net volume change. Inset 'a' depicts change near the augmentation project site. In 2022, bed and lateral erosion decreased compared to previous years.
