Phragmites Study

Malia Volke
Malinda Henry

Management Hypothesis

Study Design

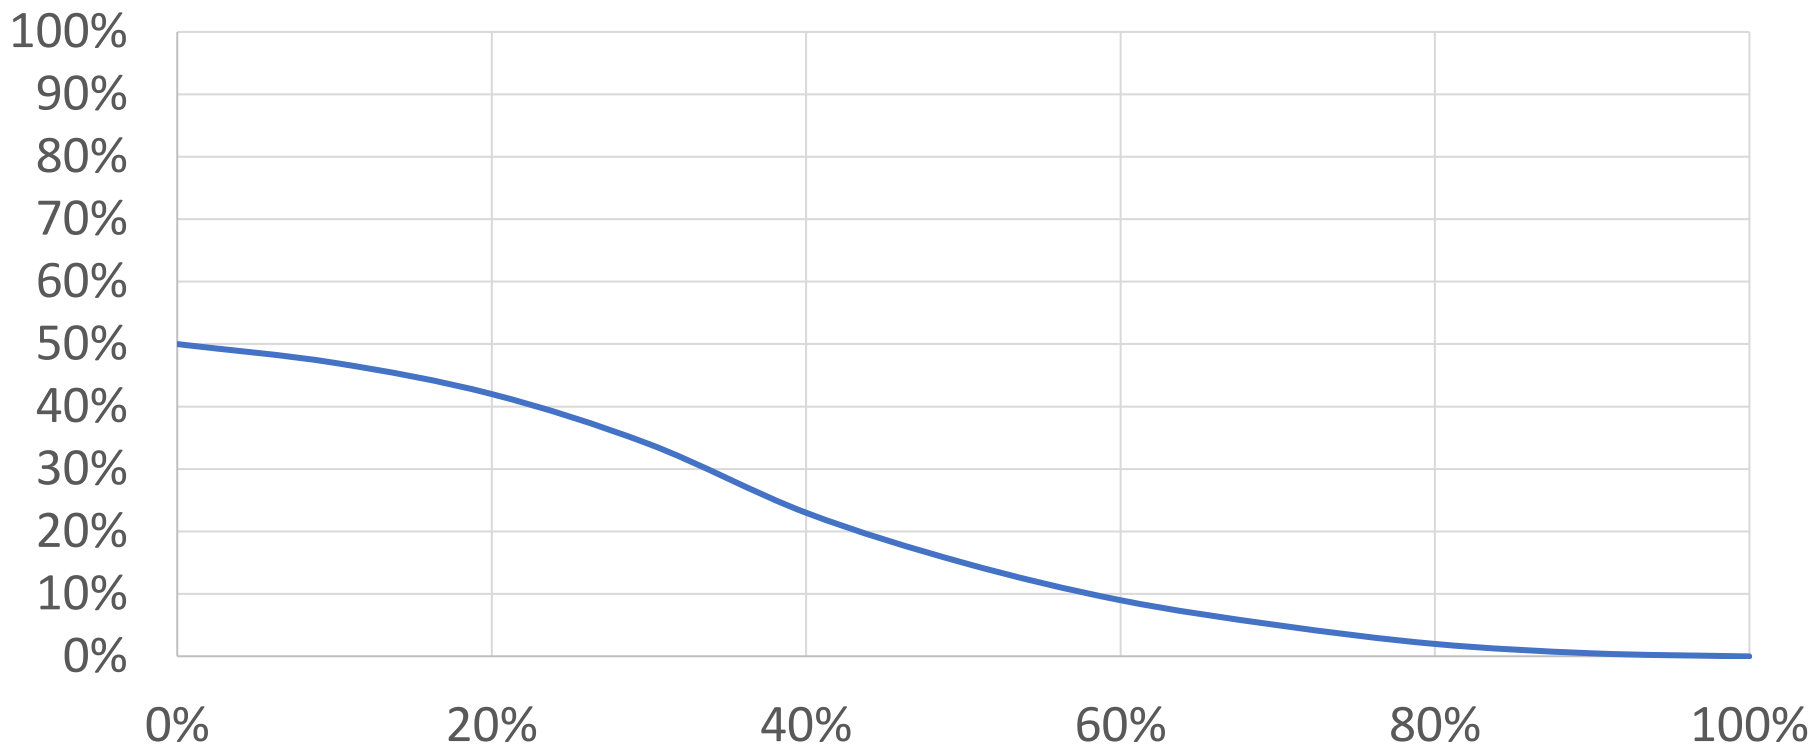
Area of *Phragmites* Patch

% Annual Increase in
Phragmites Patch Size

Percent of Time Substrate Inundated
(30-day period between June 1 - July 15)

Number of Days Inundated
% of Patch Area Inundated

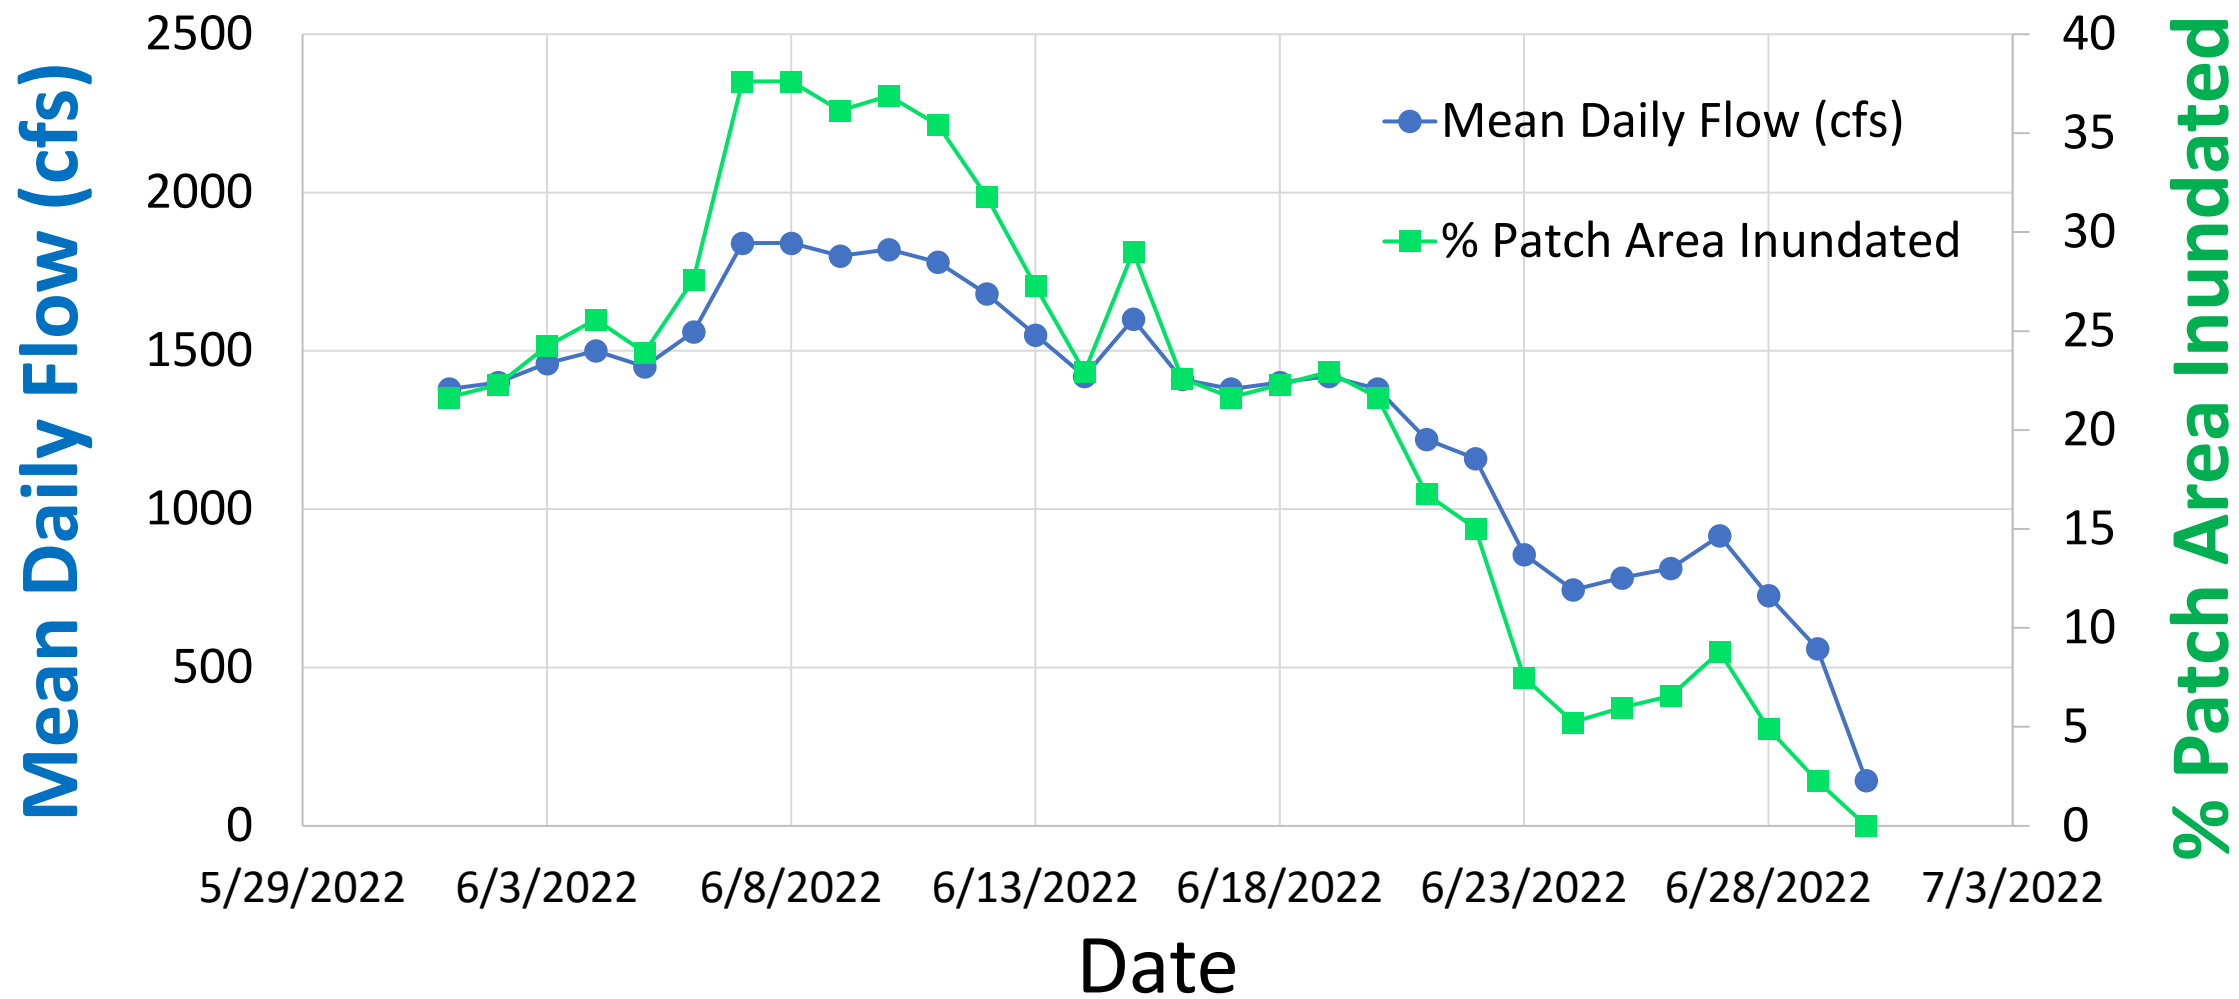
Patch 47

% Area Inundated

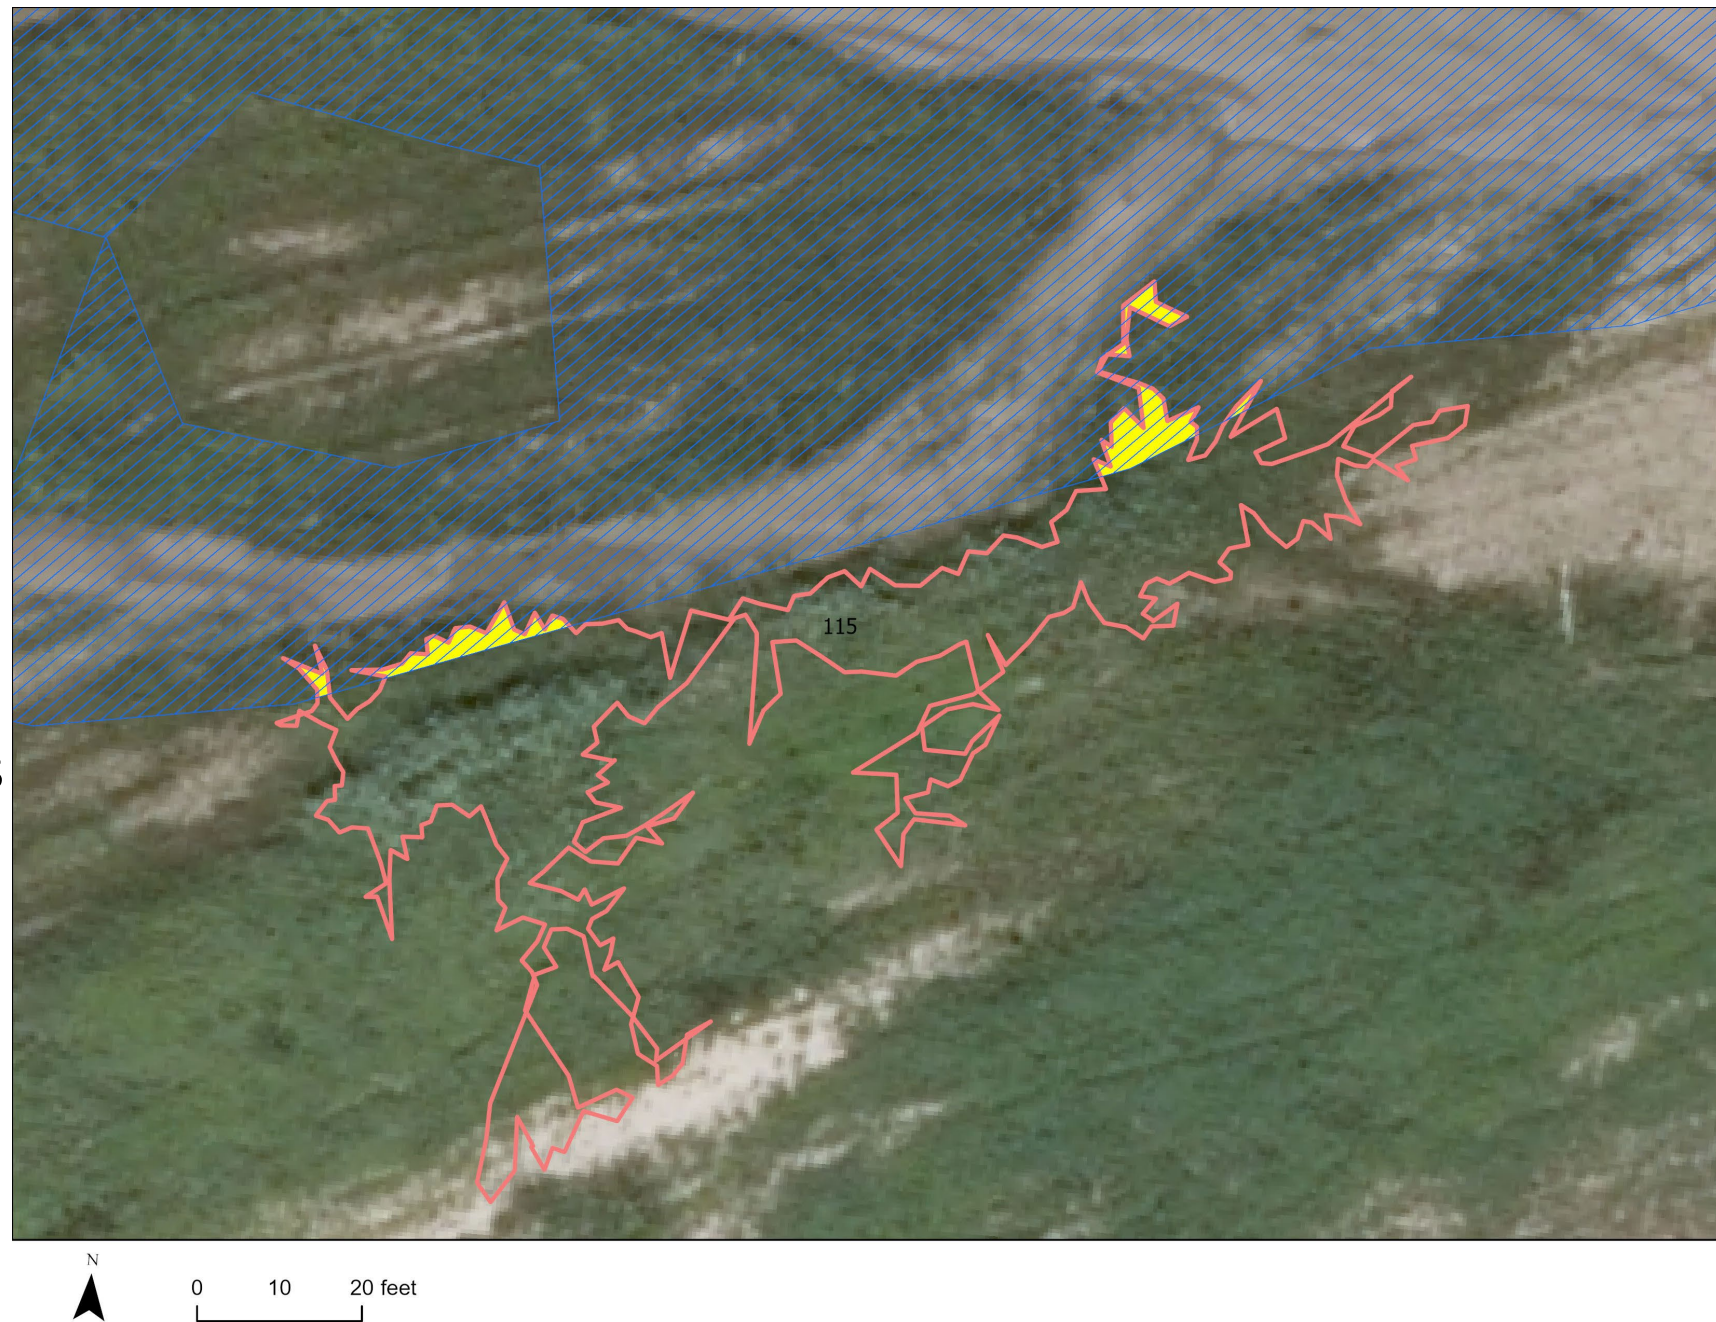
Bankline Patch 115 Chapman

June area = 2319 ft²

1500 cfs WSE

Area inundated @ 1500 cfs
= 149 ft²
6% of patch

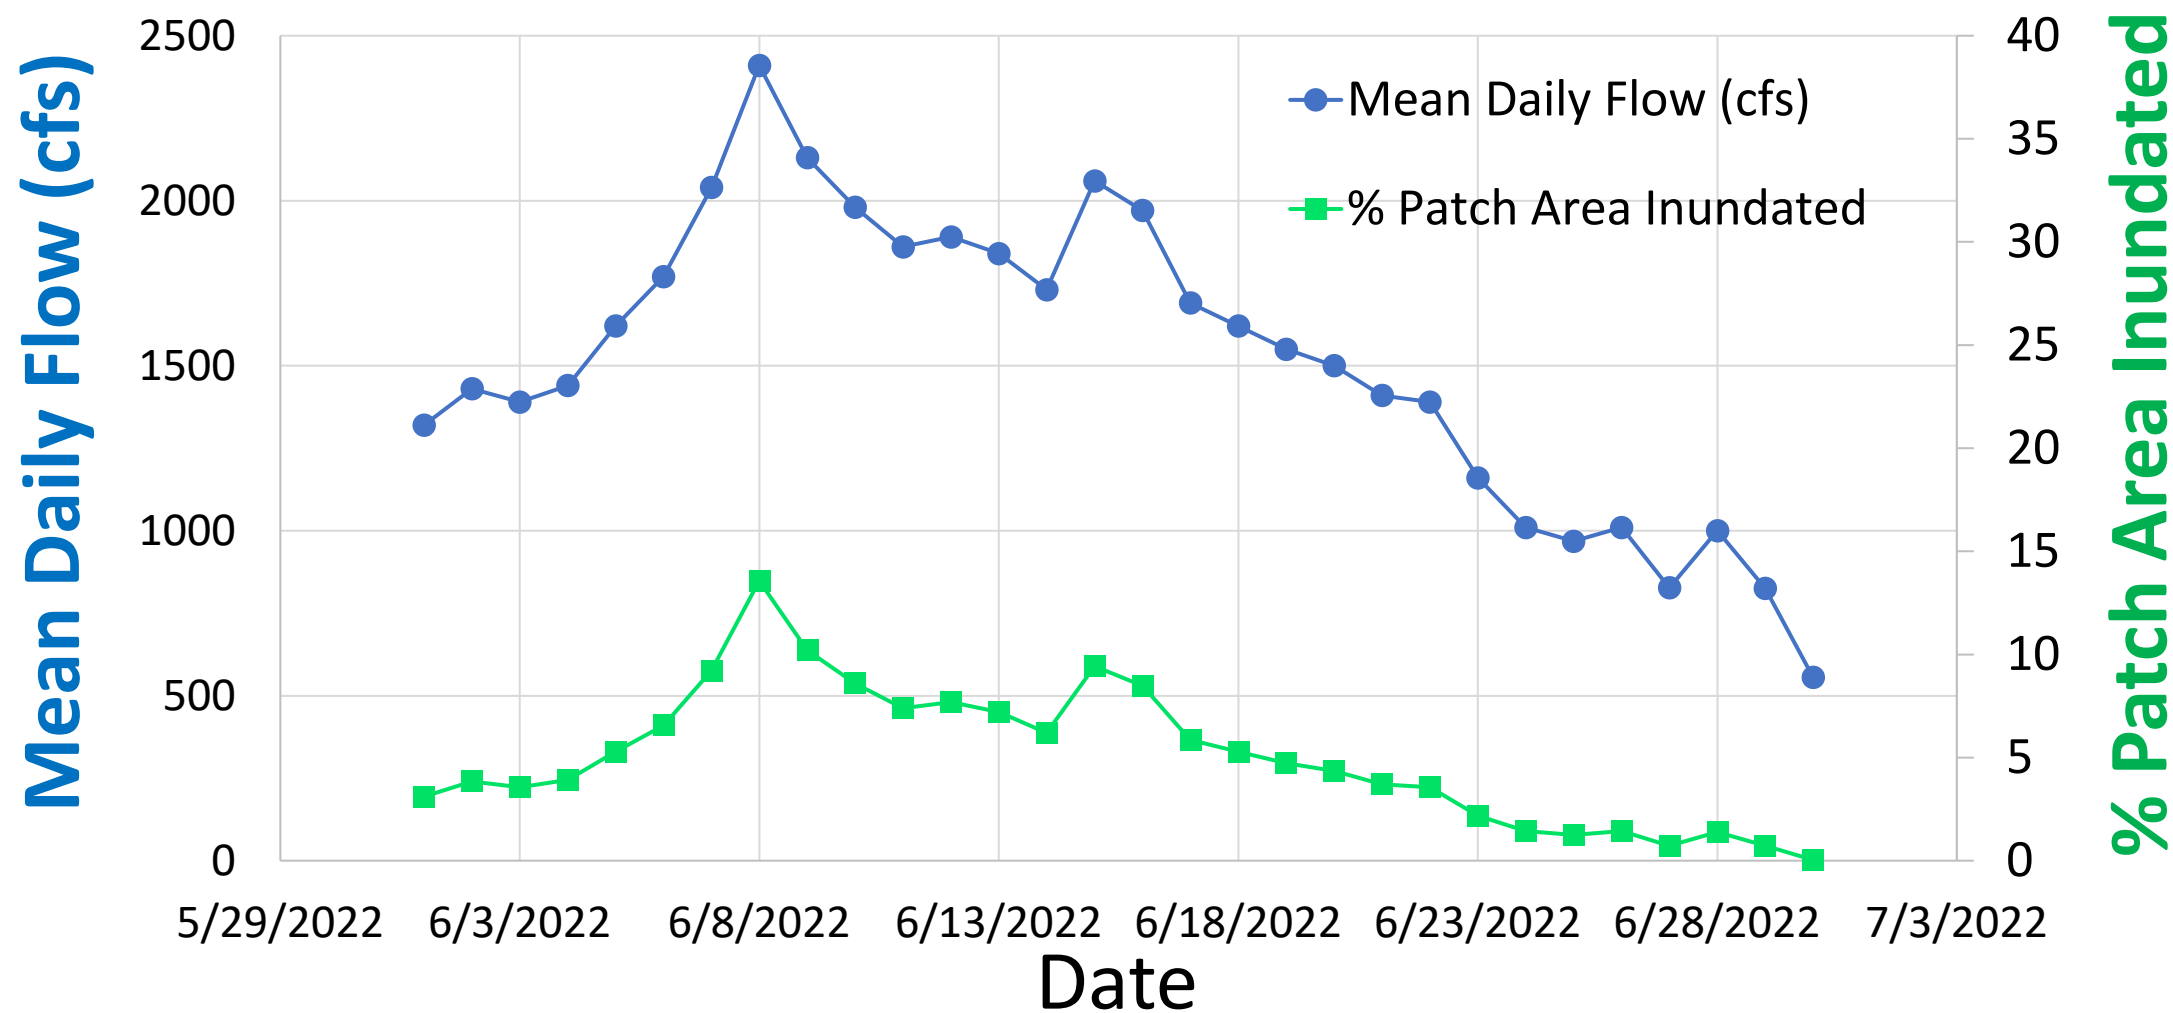
Patch 115

% Area Inundated

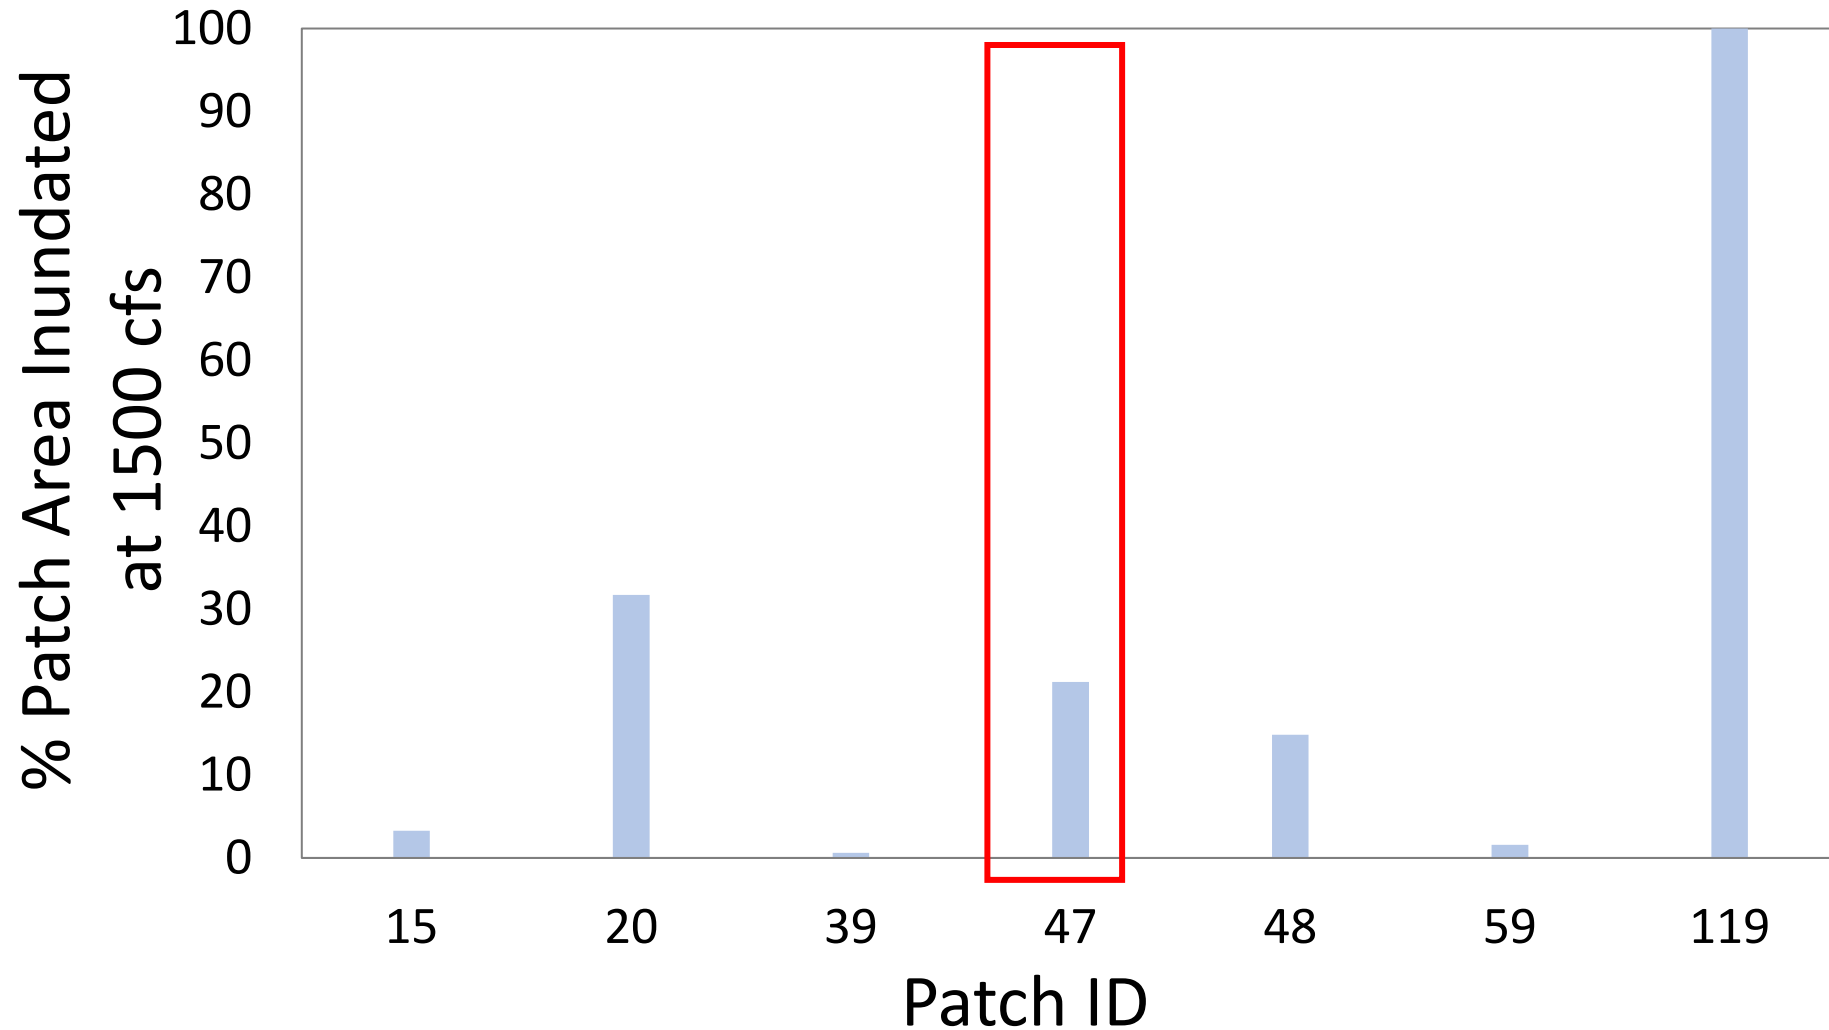
Chapman

7 intersect with 1500 cfs

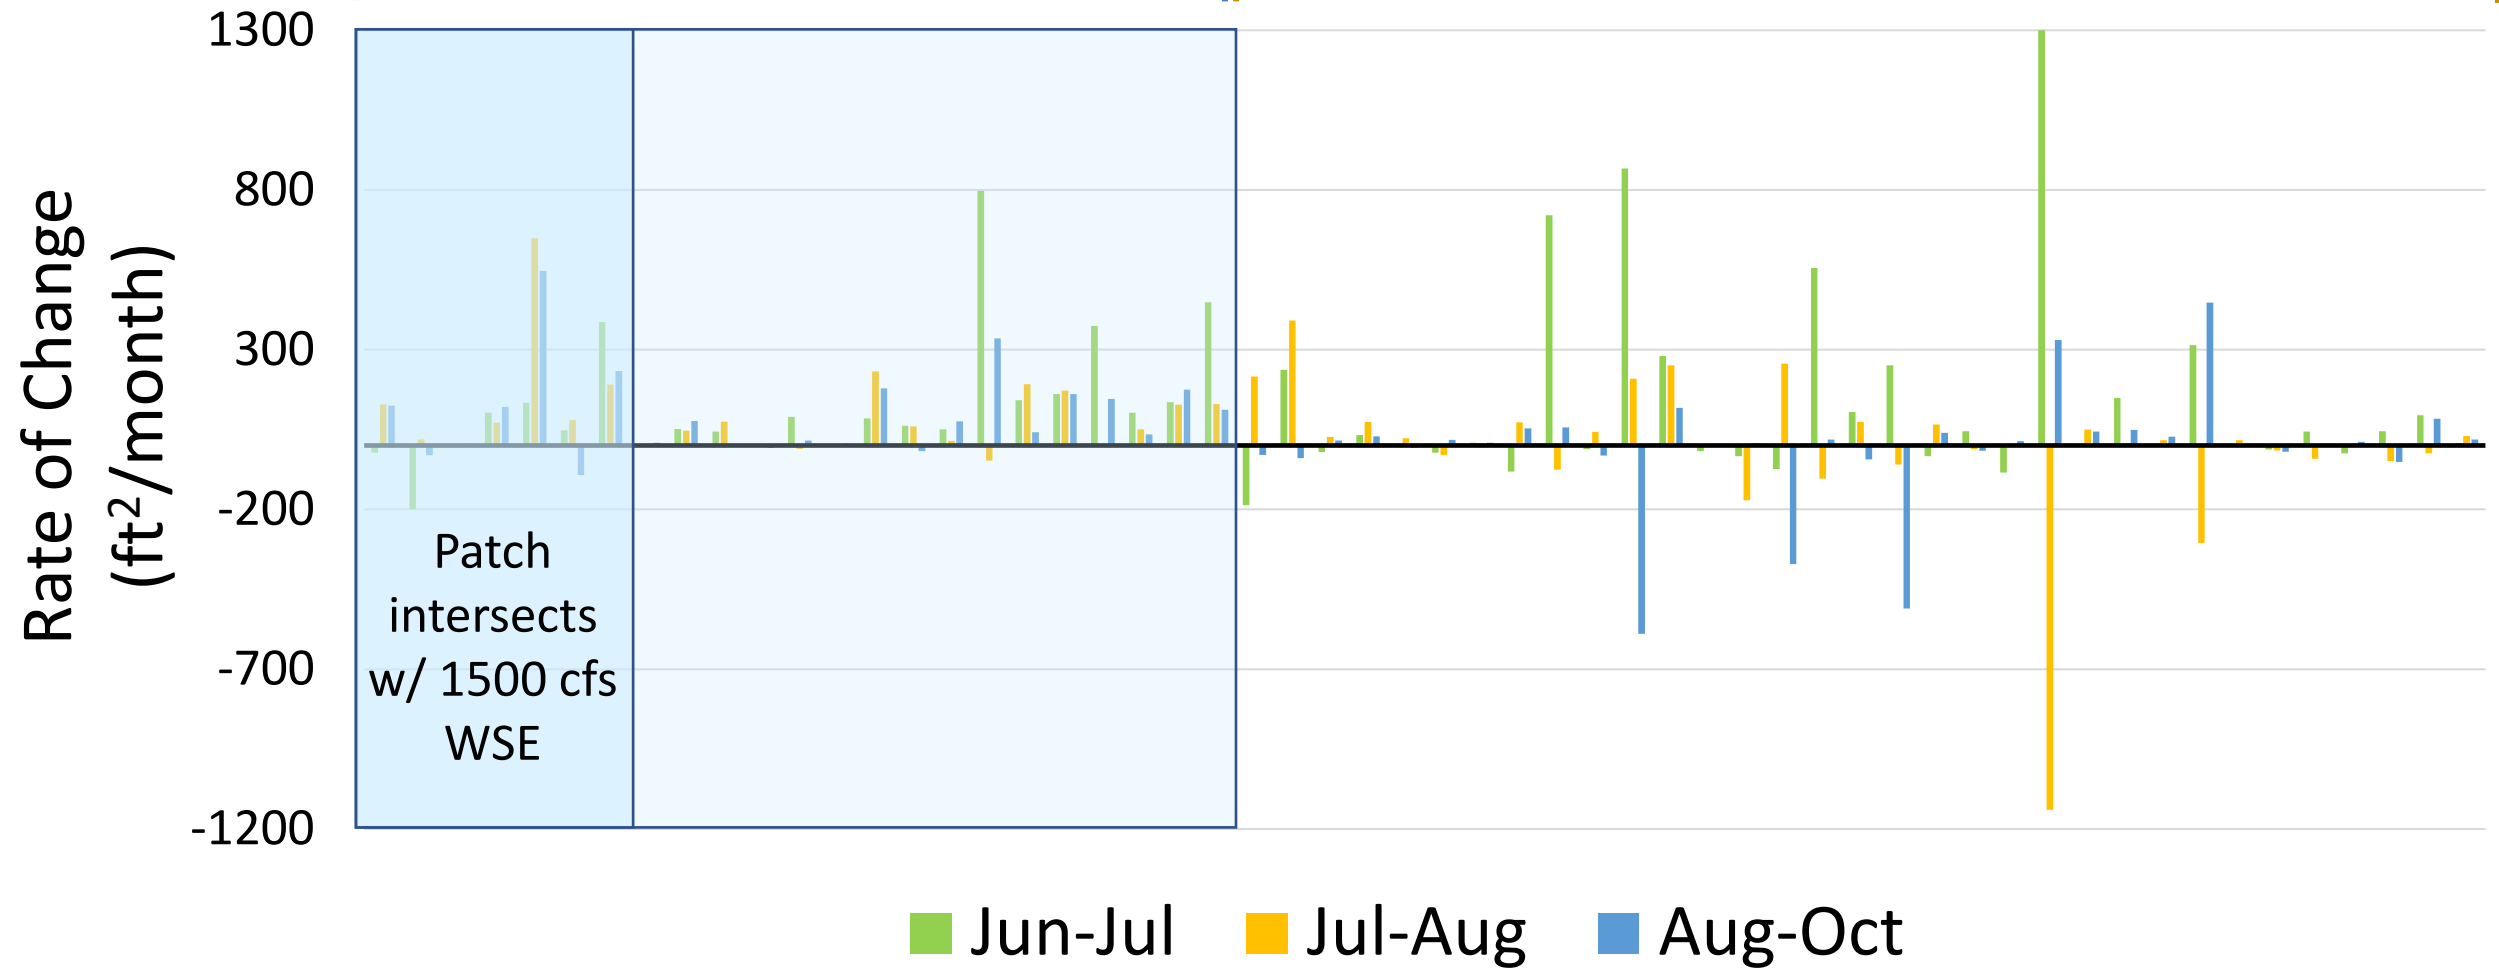
2022 Pilot Study	Number of patches						
	Plum Creek herbicide (23)	Plum Creek no herbicide (25)	Fort Kearny herbicide (24)	Fort Kearny no herbicide (32)	Chapman herbicide (27)	Chapman no herbicide (25)	Total
Received herbicide June 2022	0	0	5	0	6	0	11
Received herbicide Sept 2022	1	0	0	0	0	1	2
