PLATTE RIVER RECOVERY IMPLEMENTATION PROGRAM

Data Synthesis Compilation

Sediment Augmentation

August 2023

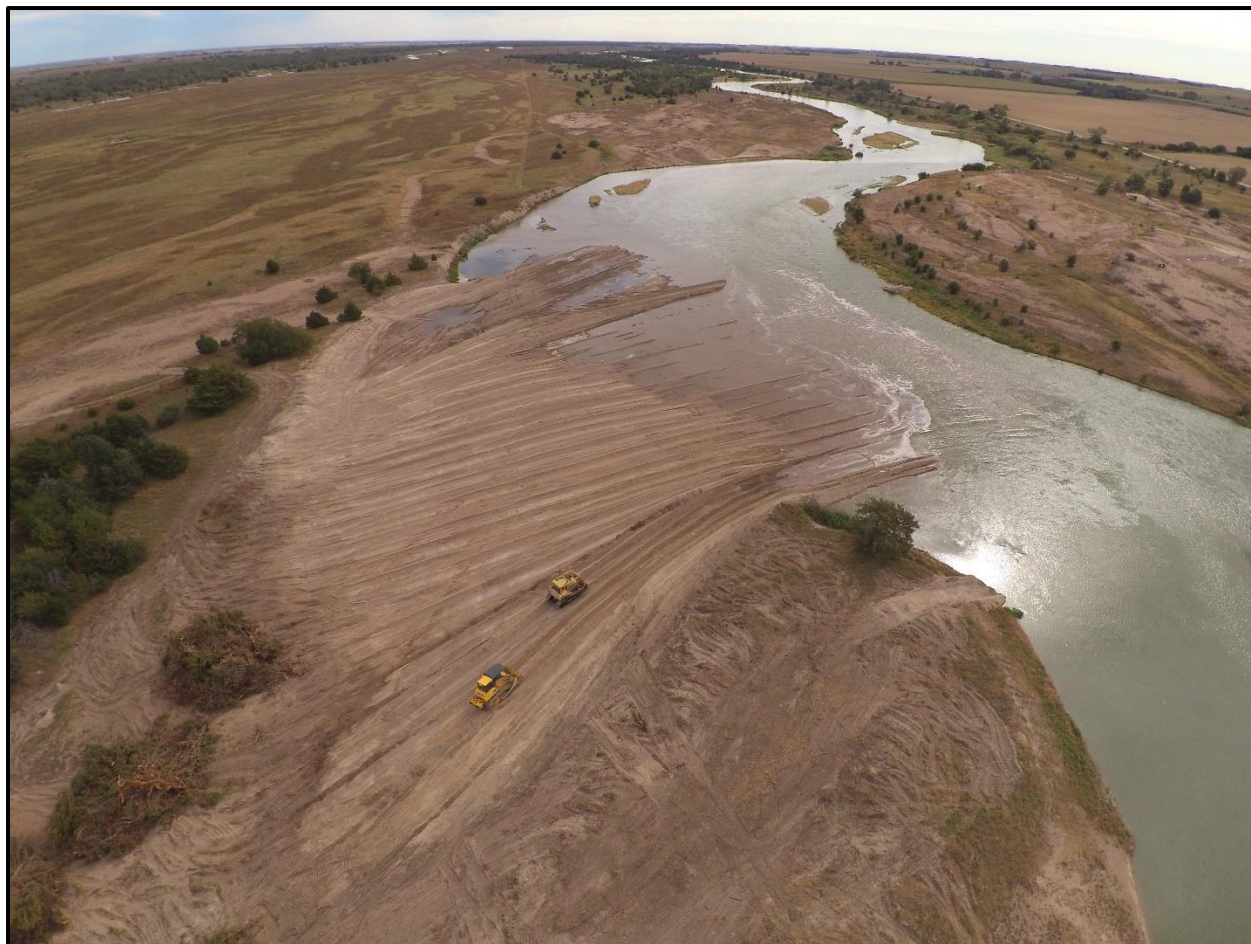
Figure 1.6 Construction of 2019 Sediment Augmentation Project (42,300 yd³).
