TO: Governance Committee (GC)
FROM: Executive Director's Office (EDO)
RE: Executive Summary – 2020 North Platte Chokepoint Test Flow Report
DATE: September 3, 2020

Executive Summary

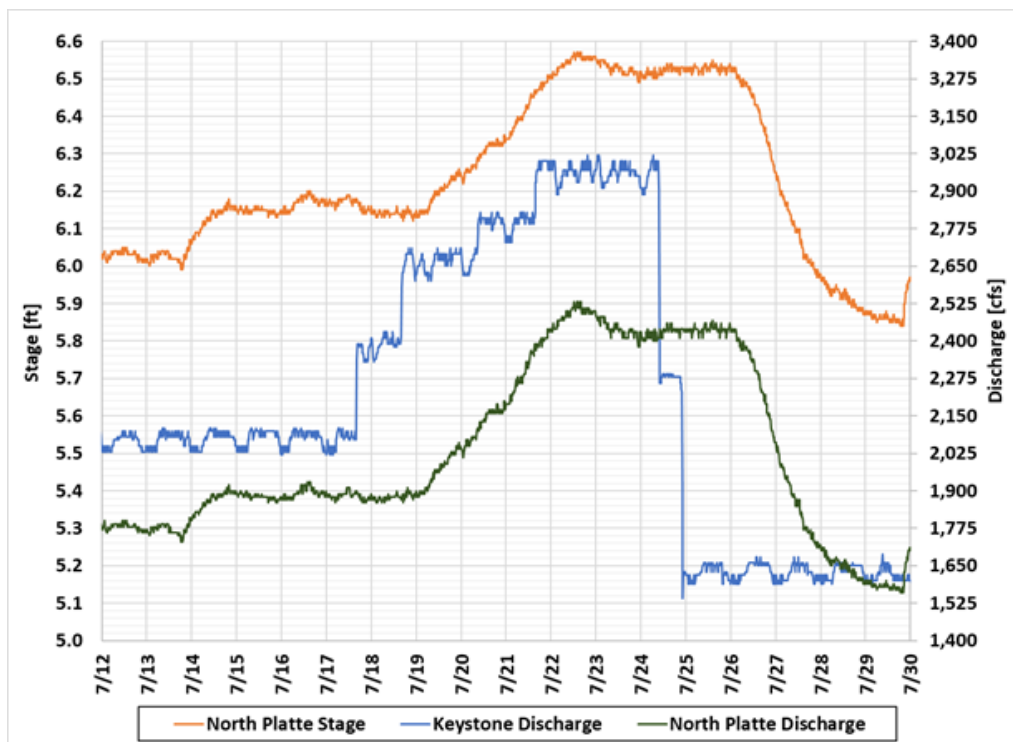
Figure ES-1. Chokepoint Test Stage and Discharge Measurements, July 12-30, 2020.

Extensive observations were made while the North Platte River at North Platte was at or near stage targets of 6.0 ft and 6.5 ft, but planned observations at a stage of 6.75 ft did not happen because the chokepoint test was ended early. Exact stages were difficult to maintain because of both heavy precipitation events downstream of Lake McConaughy and higher than expected transit losses once the river was above flood stage. **Figure ES-1** charts the adjustments to the EA release during the chokepoint test as reflected in the North Platte River near Keystone gage along with stage and discharge observed at the North Platte gage.

At the start of the chokepoint test, river stage at North Platte was already hovering around 6.0 ft, as it had been for the previous week. After a slower-than-expected climb, stage reached 6.5 ft late in the evening

on July 21 and peaked at 6.57 ft on July 22 before settling closer to 6.5 ft for a few days. The EA release for the chokepoint test ended on July 24, stage began to drop at North Platte two days later, and a steady decline was observed for several days until rainfall late on July 29 abruptly reversed the downward trend and effectively erased any lingering effects of the chokepoint test.

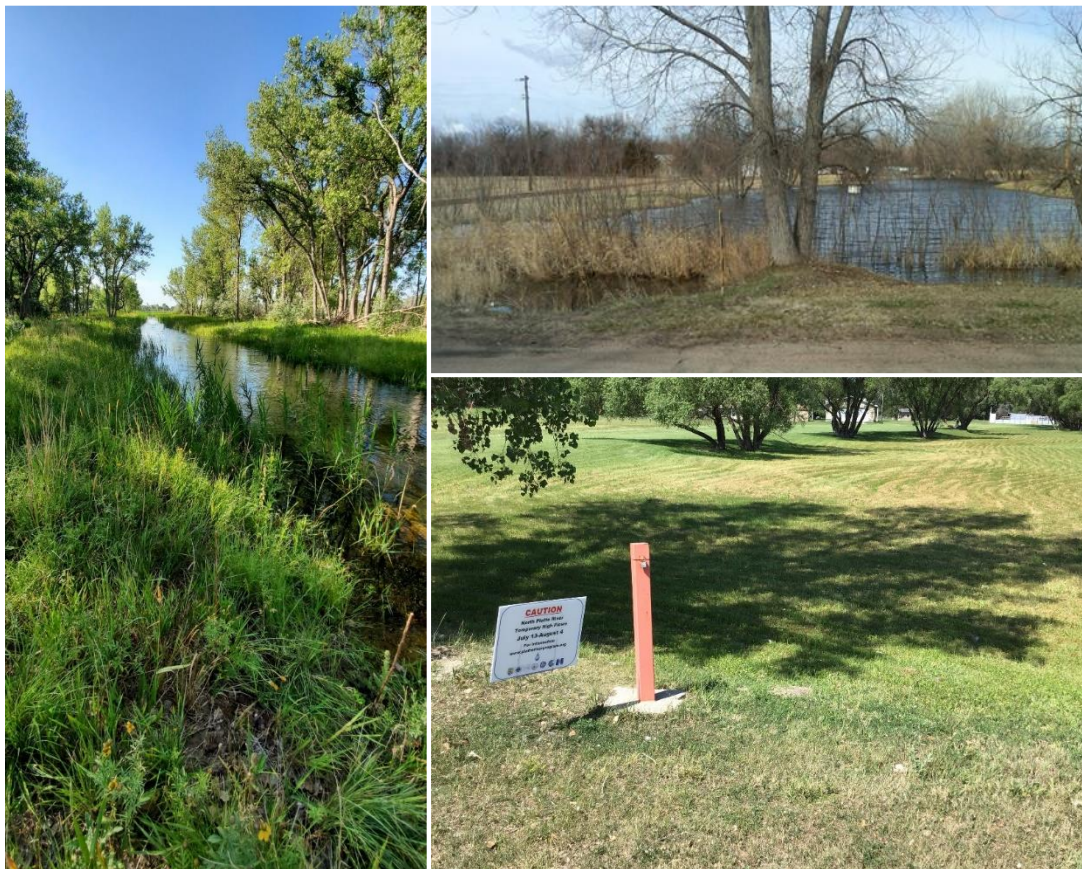
Figure ES-2. State Channel (left), Land at N. River Rd. & N. Washboard Rd., March 31, 2011, River Stage at 6.30 ft (top right), and Land at N. River Rd. & N. Washboard Rd., July 20, 2020, River Stage at 6.29 ft (bottom right).

Low-lying areas of Cody Park, especially at and near the boat ramp, flooded to an extent consistent with expectations. The image on the left side of **Figure ES-2** shows flow in the State Channel, looking downstream with the berm on the left, on July 20 when the average stage for the North Platte River at North Platte was 6.29 ft. In contrast to prior flood events, no standing water of concern was observed anywhere in the area of North River Road and North Washboard Road. This is illustrated by the images on the right side of **Figure ES-2**, both of which show the same location in the southwest quadrant of that intersection when the river was at nearly identical stages during the spring 2011 flood and during the summer 2020 chokepoint test. That the berm appears to have diverted river flows entirely away from an area that experienced significant flooding in the past indicates successful performance of the restored State Channel Berm under high flow conditions.

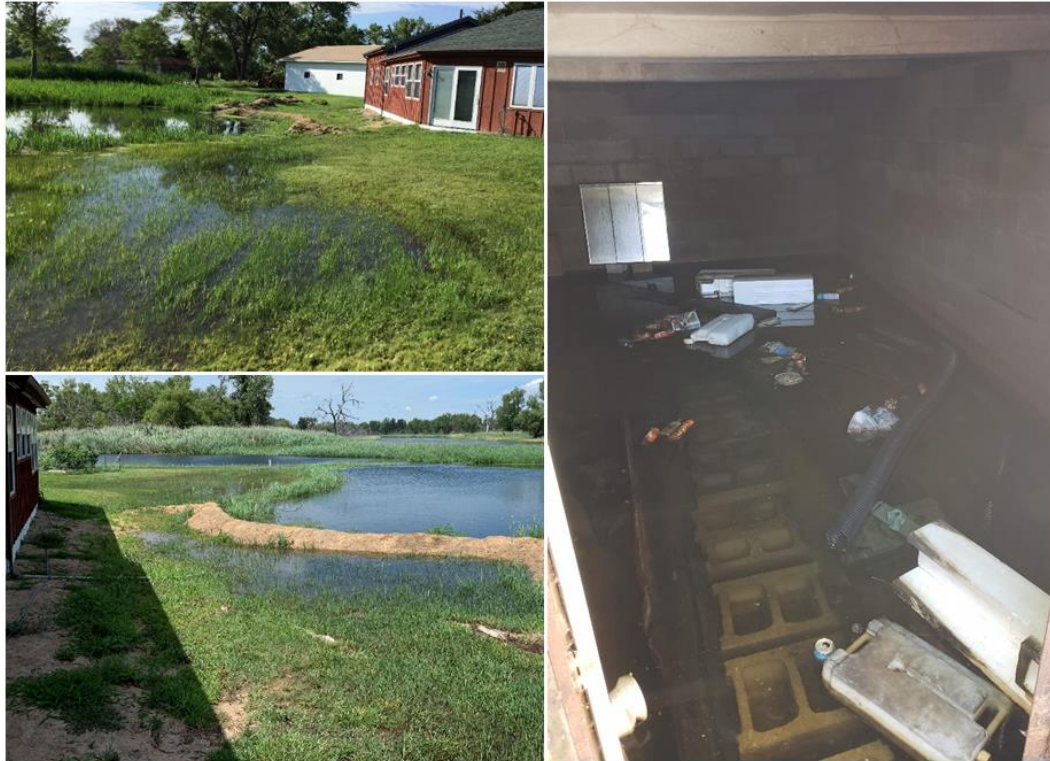
Figure ES-3. Observed high water impacts at Red Fox Lane (left) and Darlene Road (right) properties.

closer to North Platte near the Muskrat Run State Wildlife Management Area. Owners of residential properties along the south bank of the North Platte River in the Vieyra Drive-Red Fox Lane-Darlene Road neighborhood of North Platte reported issues stemming from high river (and groundwater) levels that included water overtopping the banks of backyard ponds, water encroaching to within a few feet a house foundation, septic system problems, inaccessible outbuildings due to soggy ground, and a partially-flooded below-grade storm cellar. **Figure ES-3** shows some of these impacts in photos taken by the EDO and NWS.
