Full-Scale Sediment Augmentation - UPDATE

Water Advisory Committee Meeting
August 4, 2020

PLATTE RIVER
RECOVERY IMPLEMENTATION PROGRAM

North Platte Chokepoint Test Flow Release

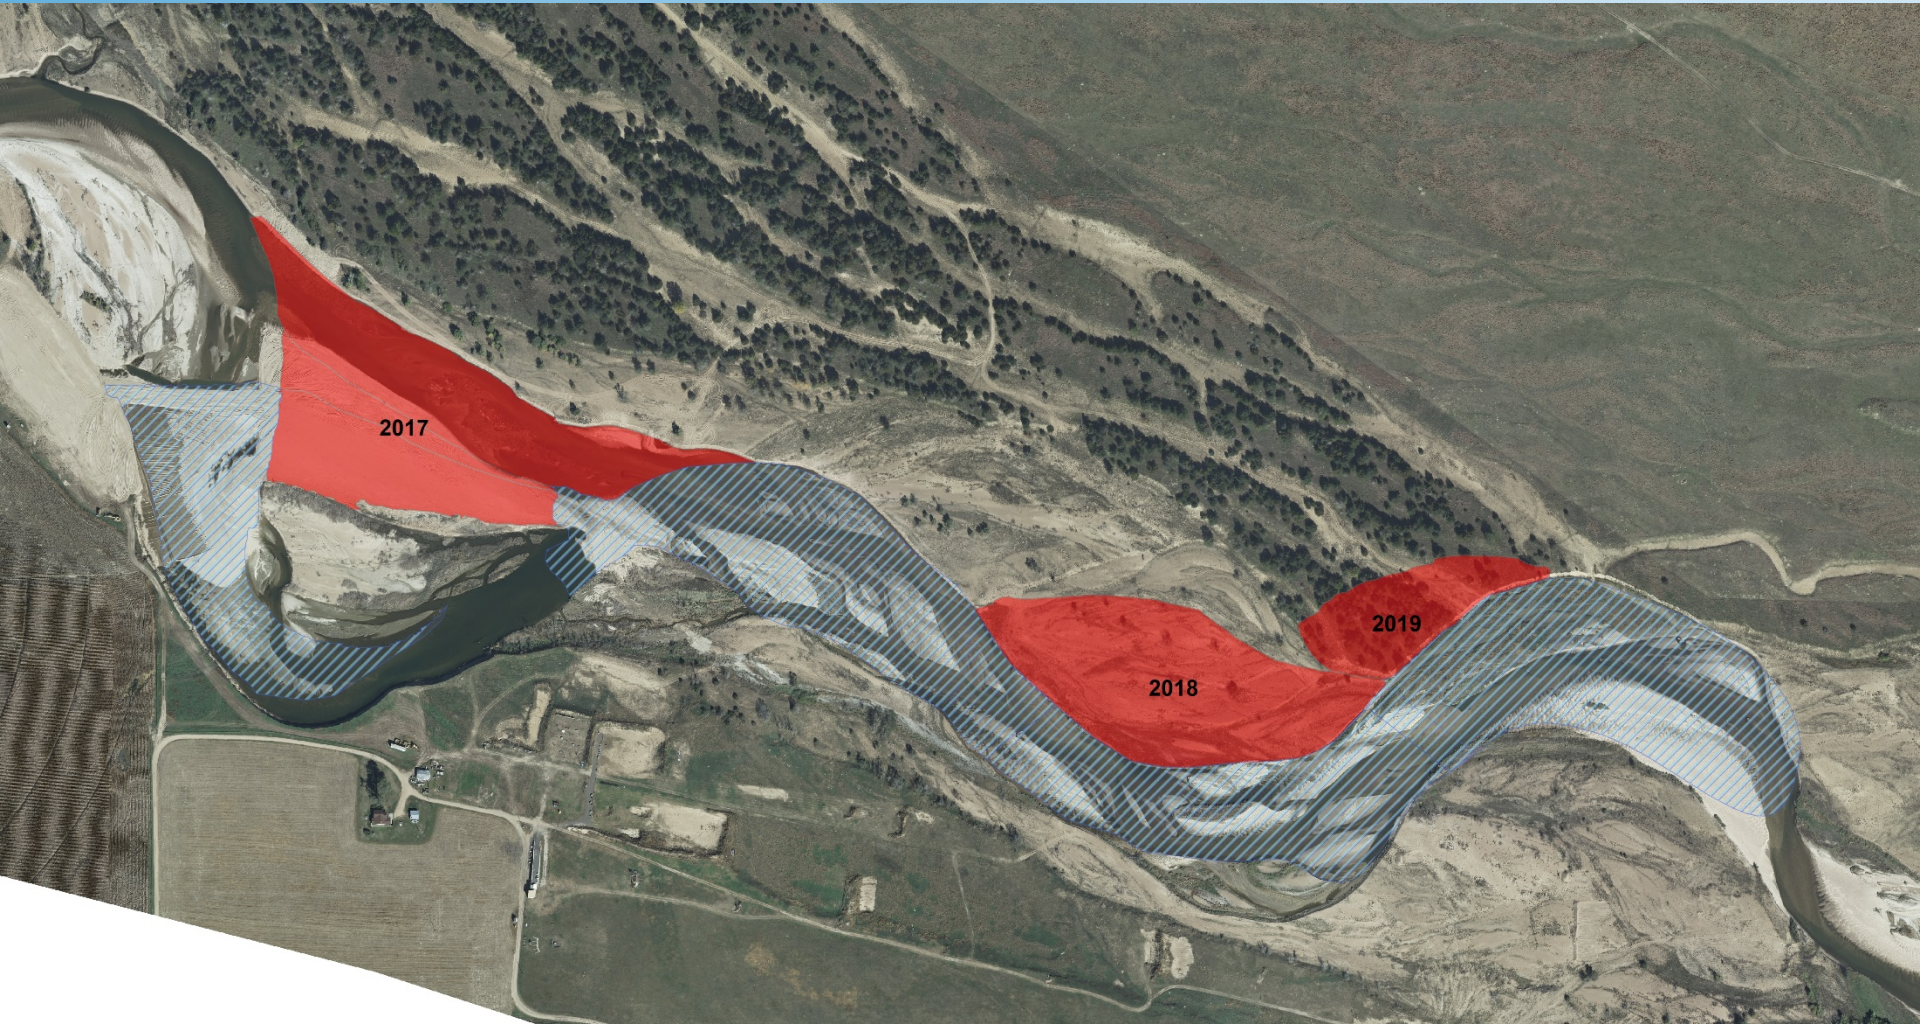
2017 through 2019

- 55,200 tons directly augmented to the main channel with more coming in laterally
- 18,500 tons augmented to the cutoff meander

- 60,000 tons augmented to the main channel

- 63,500 tons augmented to the main channel

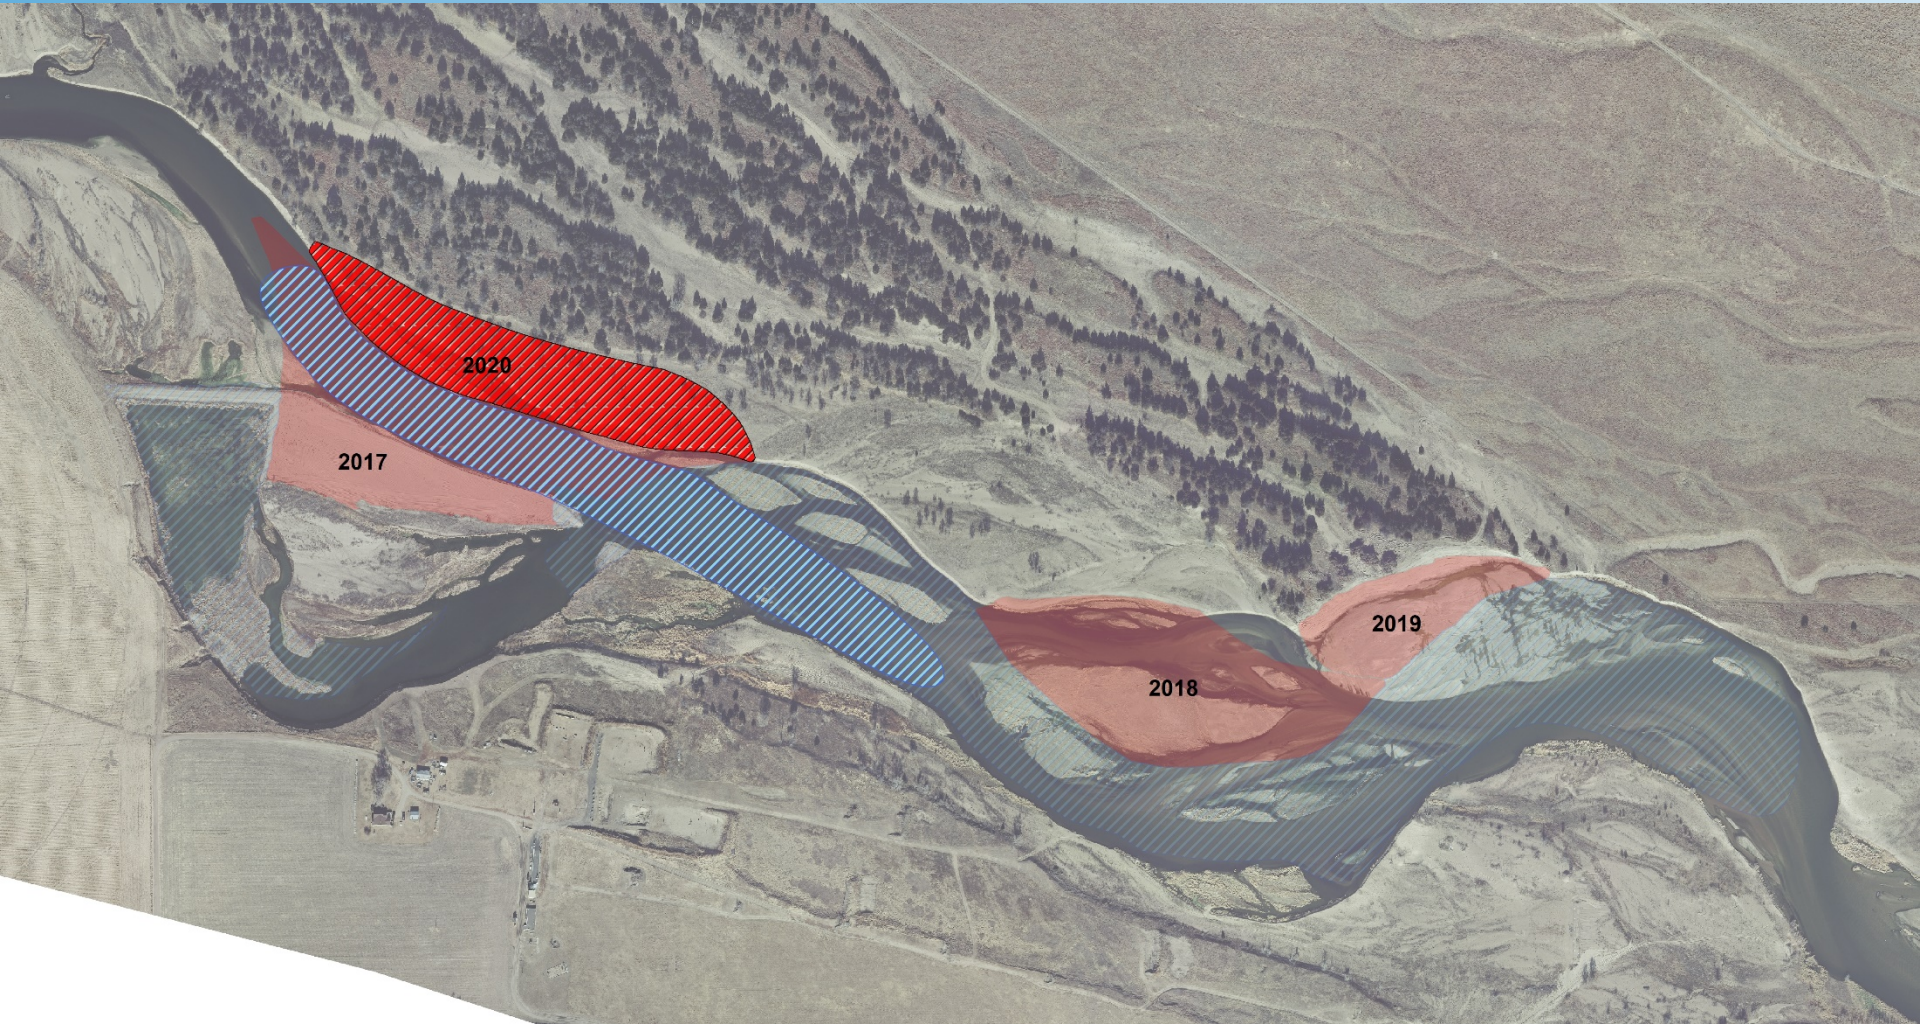
2020 Design Approach

- Increase to 75,000 tons (49,300 CY)
- Move upstream and widen into high terrace.
- Arrest incision and knock down the energy.
- Pre-Bid last week – Bid Opening 8/10/2020

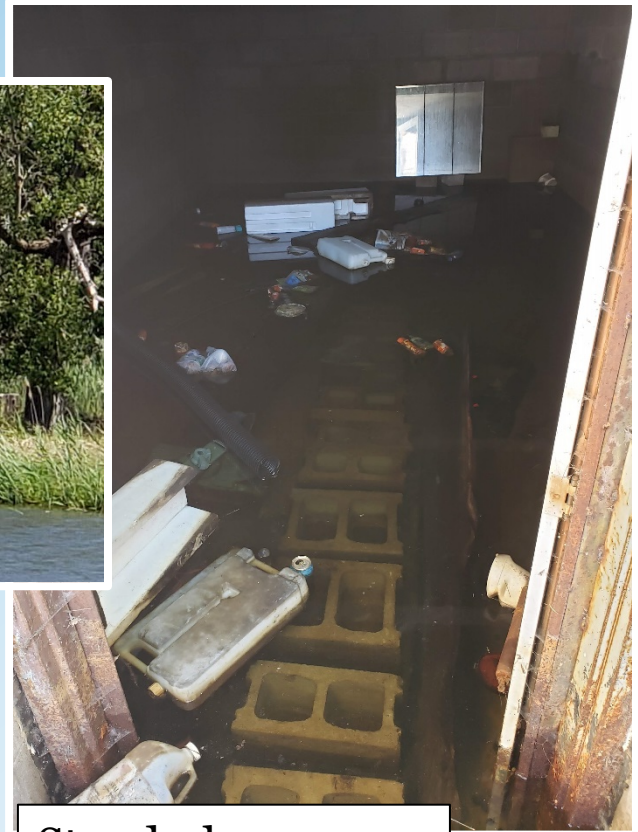
Darlene Road Property – July 24

Stand-alone
cellar, about 2/3
underground

- On Vieyra Drive, floodwaters surrounded an abandoned structure with water flowing from the river.
- On Darlene Road, we observed a cellar with about two feet of water inside that appeared to be caused by groundwater. The homeowner reported septic tank issues and said toilets would not flush. A barn on the northeast side of the property was inaccessible due to water flowing across the access road. The homeowner stated the structure was flooded with a couple of feet of water.
