2014 Platte River Final Data Analysis Report

Channel Geomorphology and In-channel Vegetation

**Platte River Recovery
Implementation Program**

December 22, 2015

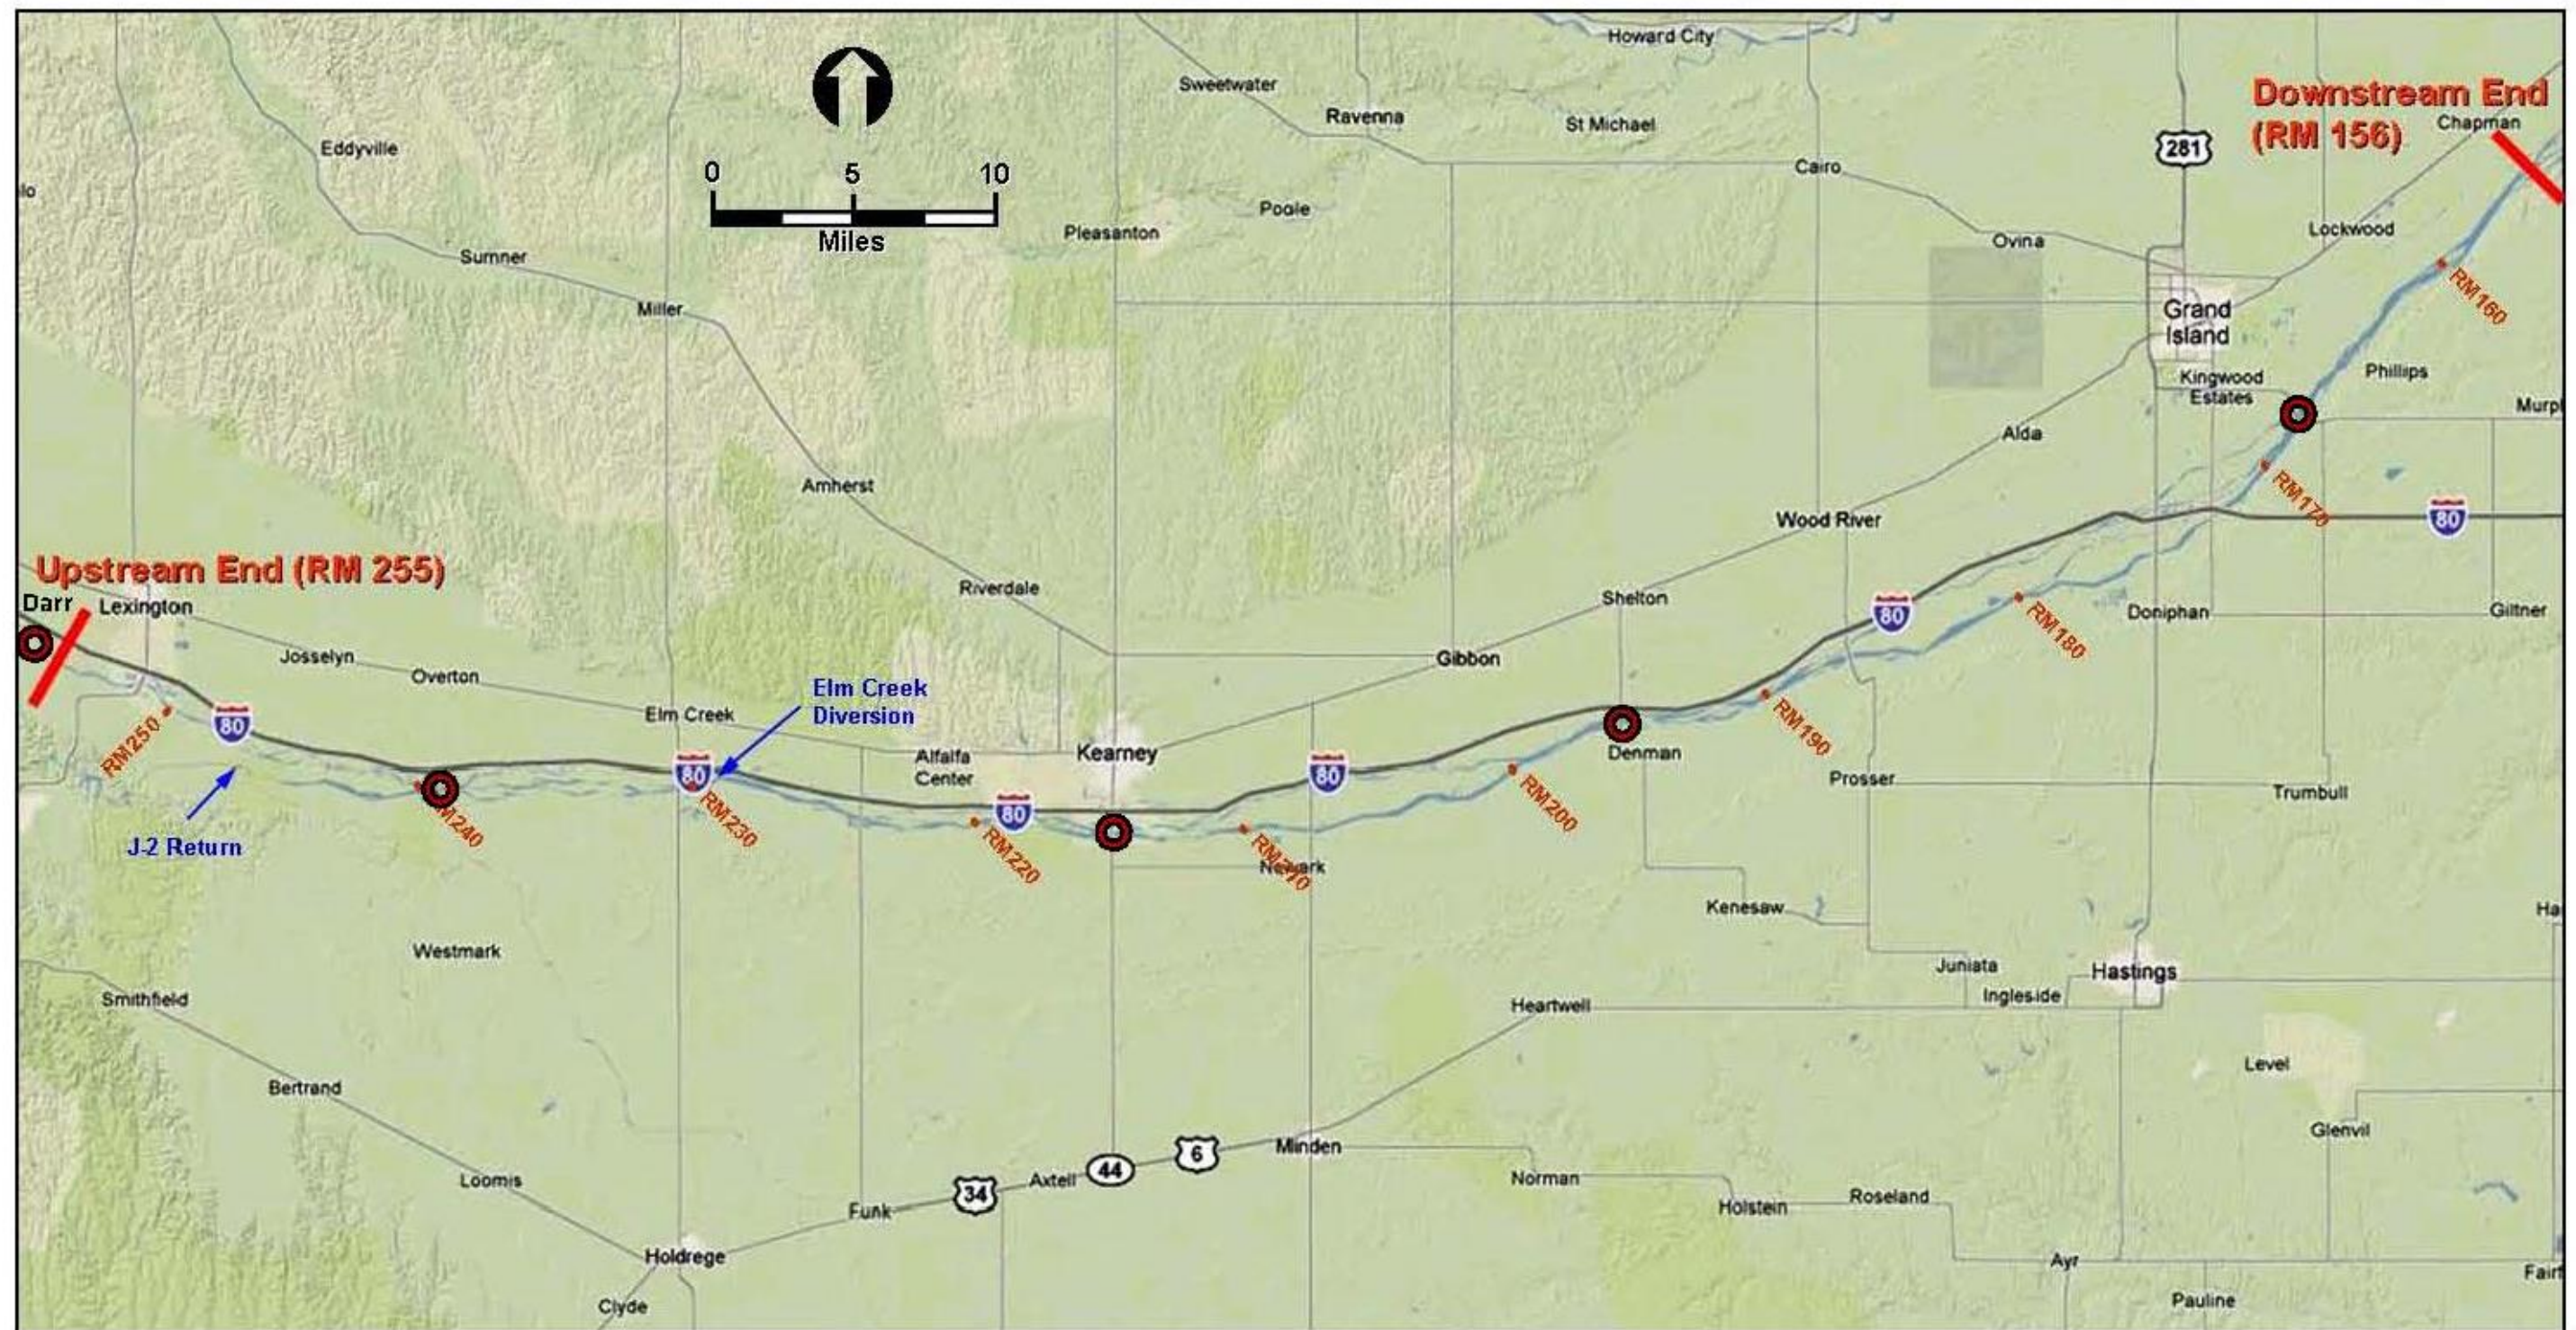
Figure 1.1. Location map showing the project reach for the Channel Geomorphology and In-channel Vegetation Monitoring. Bed-load and suspended-sediment sampling bridge sites are shown as red circles.

To facilitate quantification of the suite of hydrologic performance measures, a record of mean daily flows from October 1, 2008, through the date of the last 2014 monitoring survey was compiled for all of the USGS and NDNR mainstem and tributary gages within the reach (Figure 1.1). These flow records were then used to estimate an equivalent record for each of the APs by distance-weighted interpolation between the measured mainstem flows, taking into account measured tributary inflows and diversions, as described in Chapter 2. Flow-duration curves at the mainstem gages for each the flow-duration related metrics are provided in Appendix A.

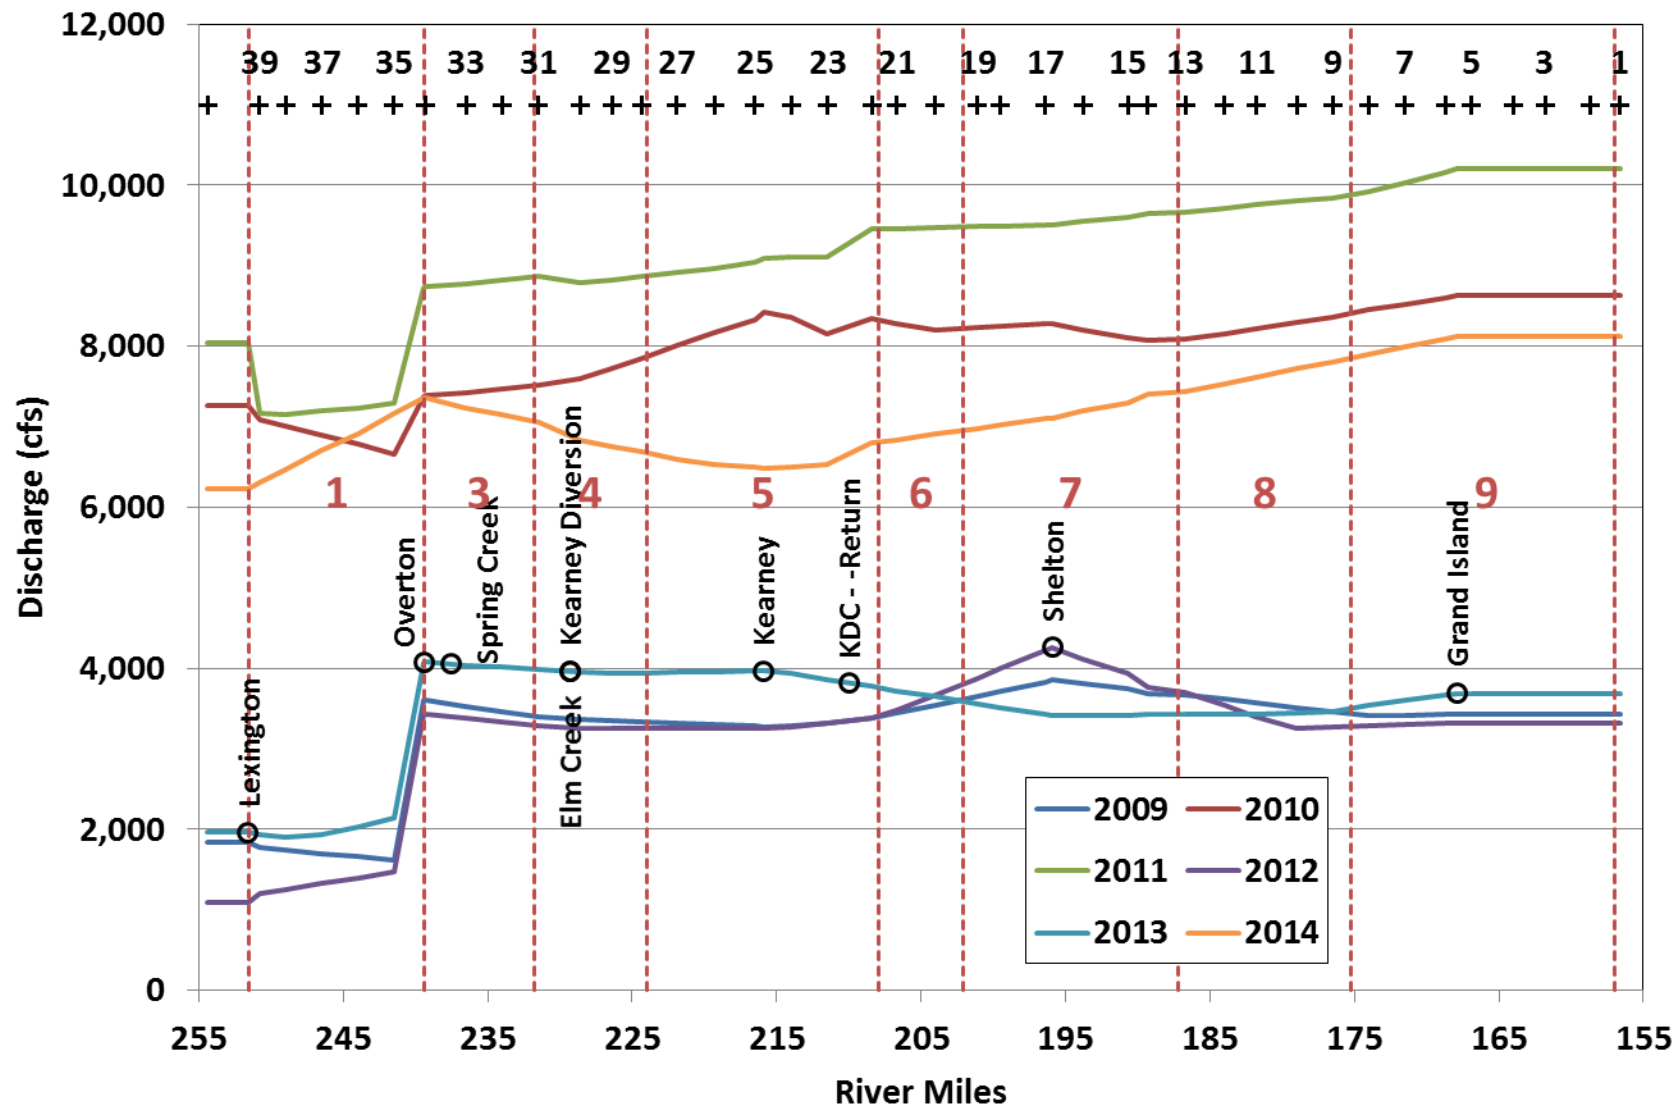
Figure 3.1. Maximum mean daily discharge (Q_p) between January 1 of each year and the dates of the 2009 through 2014 monitoring surveys.

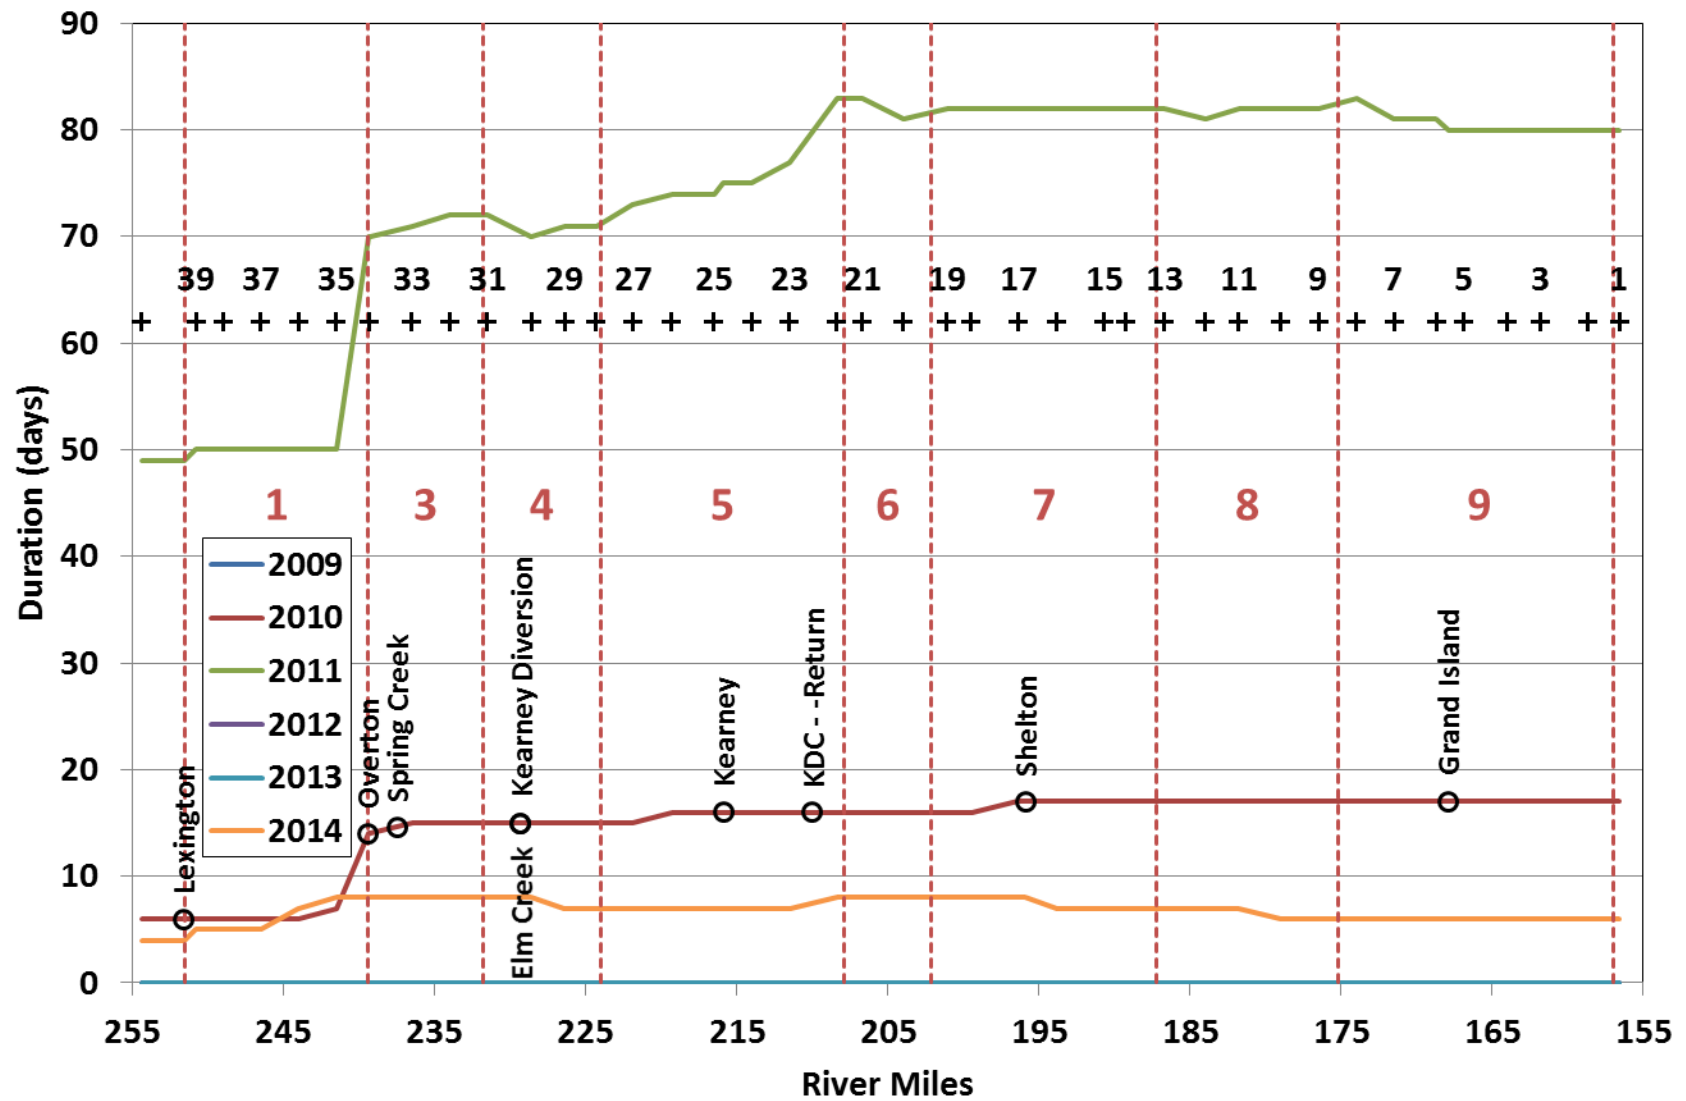
Figure 3.2. Duration of flows exceeding 5,000 cfs between January 1 of each year and the dates of the 2009 through 2014 monitoring surveys (DUR₅₀₀₀).

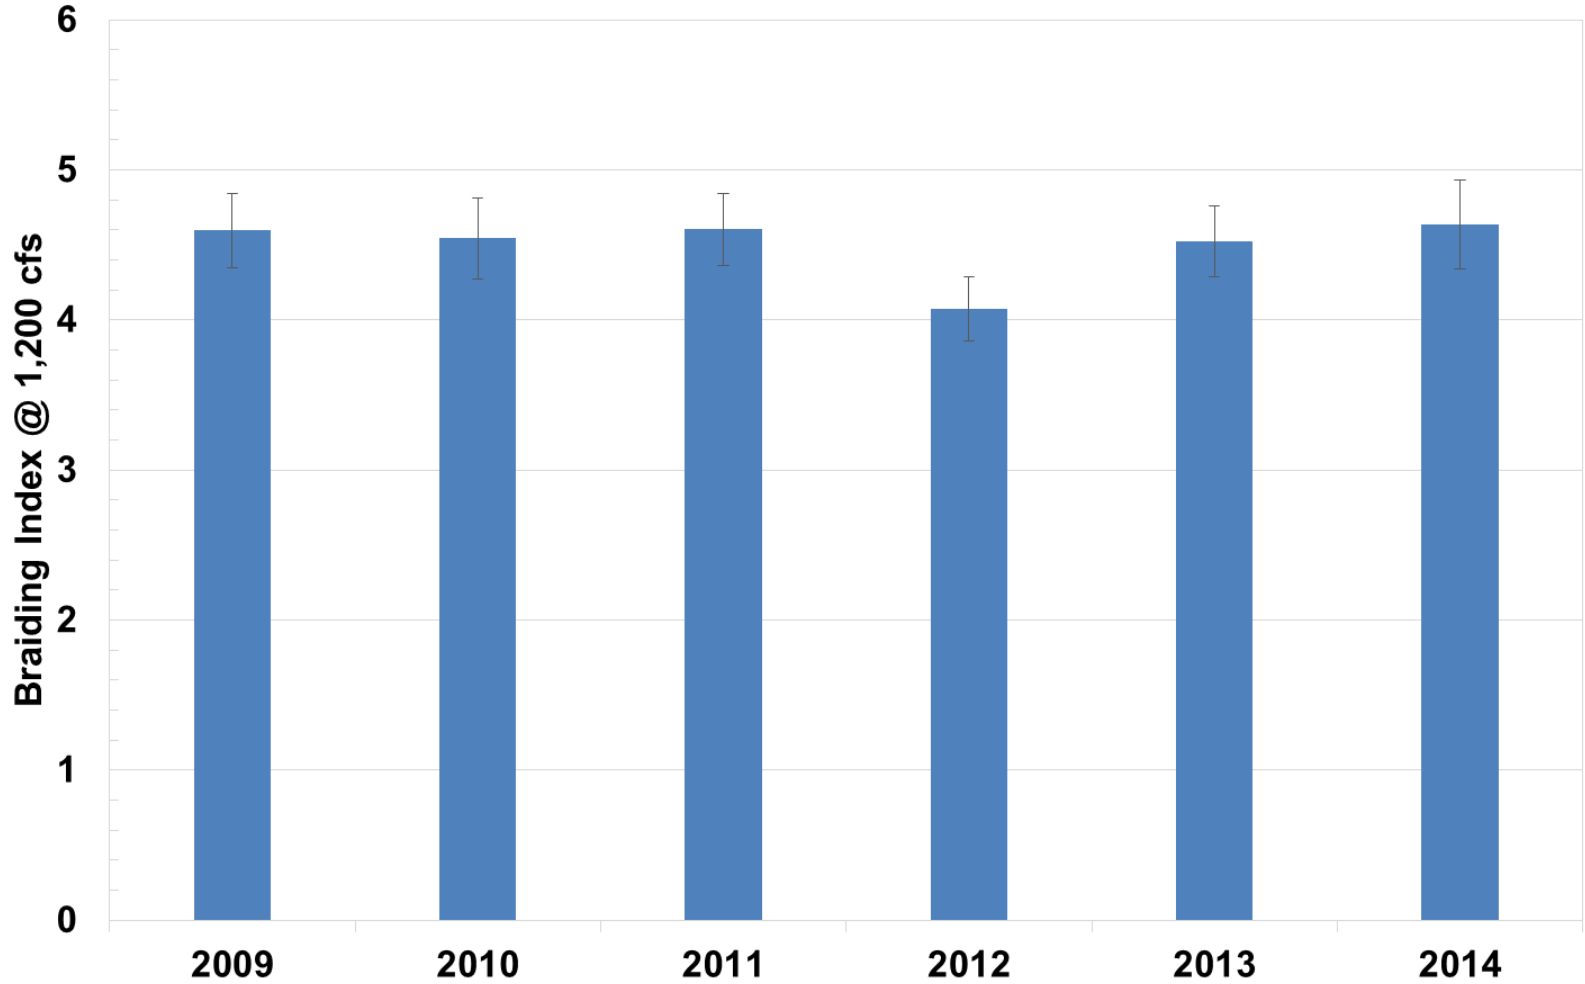
Figure 3.6b. Average braiding index for the overall study reach, based on the pure panel AP data from 2009 through 2014. Whiskers represent ± 1 standard error on mean value.

The reach-wide average braiding index showed some variation throughout the survey period, although it remained between 4.1 and 4.7 (**Figure 3.6b**)⁴. The lowest average value occurred in 2012, but the difference from the other years is not statistically significant. Geomorphic Reach 6 (Minden to Gibbon) consistently had the highest braiding index, followed by Reaches 4 (Elm Creek to Odessa) and 7 (Gibbon to Wood River) (**Figure 3.6c**). Reach 9 (Grand Island to Chapman) also had relatively high braiding indices. The braiding index for Reach 6 is derived from only AP21 that, as noted above, is located at the Rowe Sanctuary and has a very high braiding index. Rotating AP20 that was surveyed only in 2011 had a braiding index of 4.7, and AP22 that was surveyed in 2010 and 2014 had braiding indices of 3.0 and 4.0, suggesting that AP21 may not be representative of the remainder of Reach 6. Reaches 1, 2 and 8 (Lexington to Overton, south channel at Jeffreys Island, and Wood River to Grand Island, respectively) consistently had the lowest braiding index, although Reach 8 has become progressively more braided during the first increment.

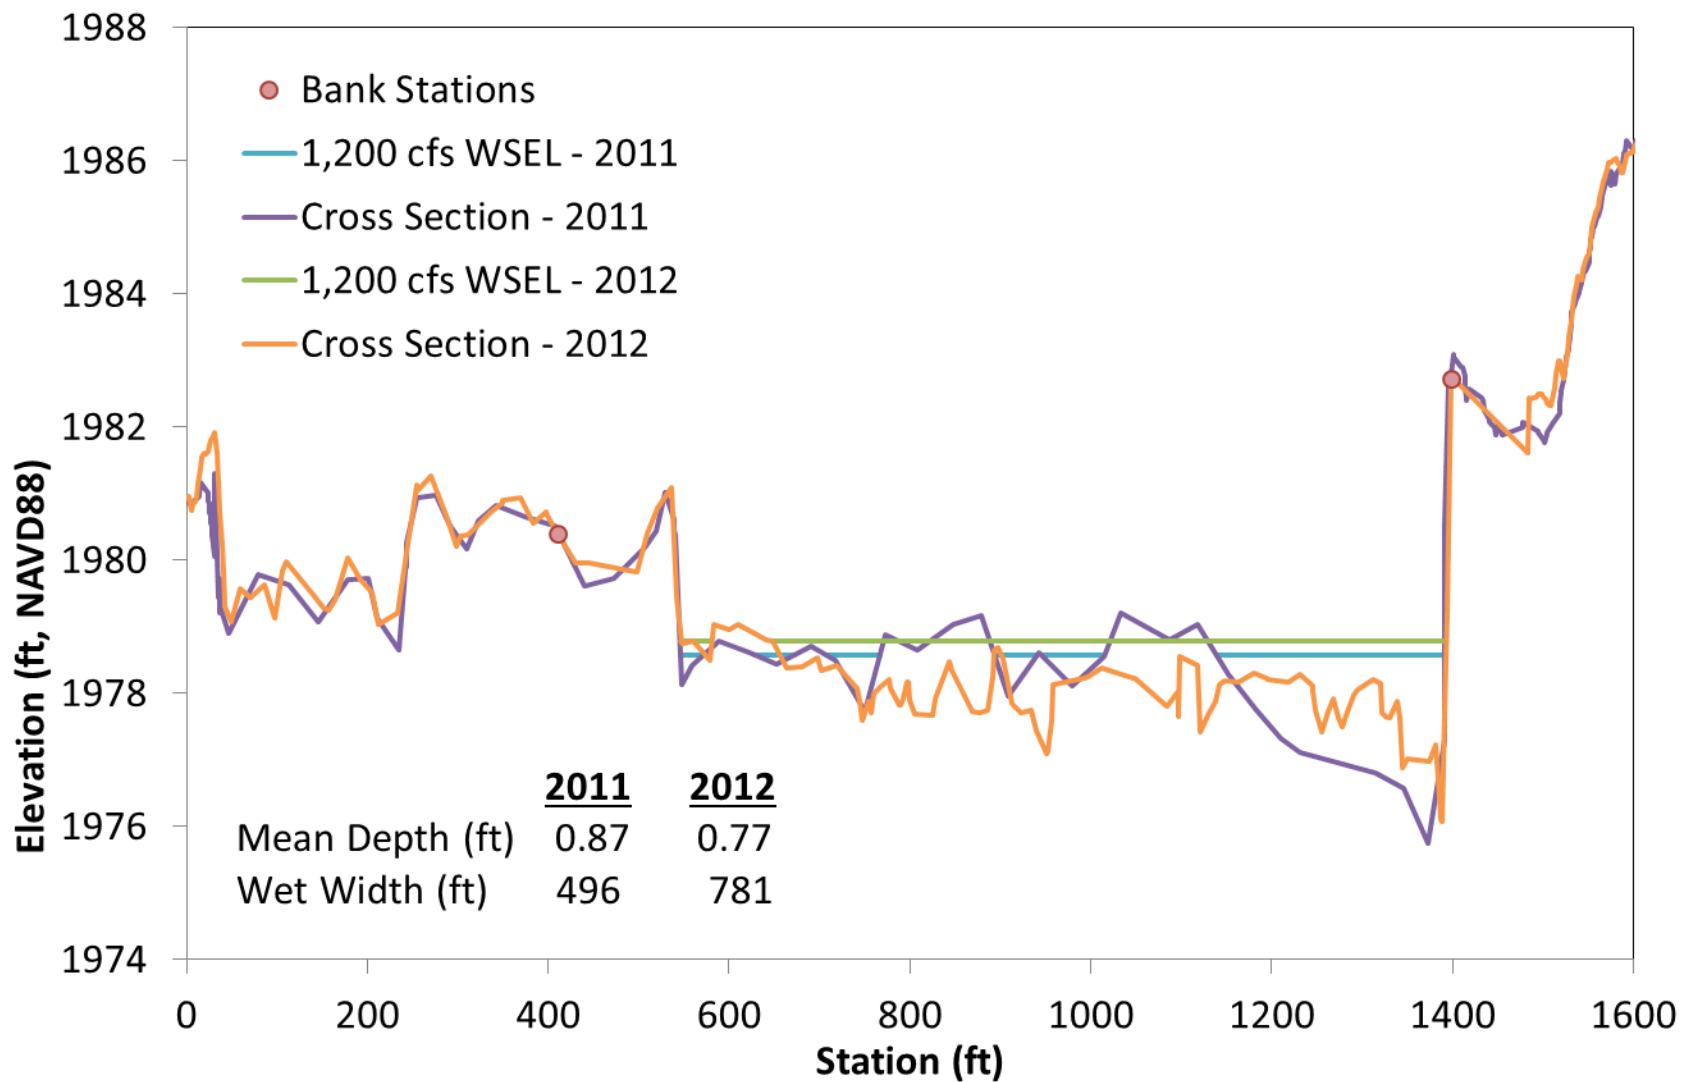
Figure 3.9d. Surveyed cross-section profiles at AP15, transect four in 2011 and 2012. Note the removal of instream bars and the aggradation of the thalweg, which resulted in a wider, shallower channel.

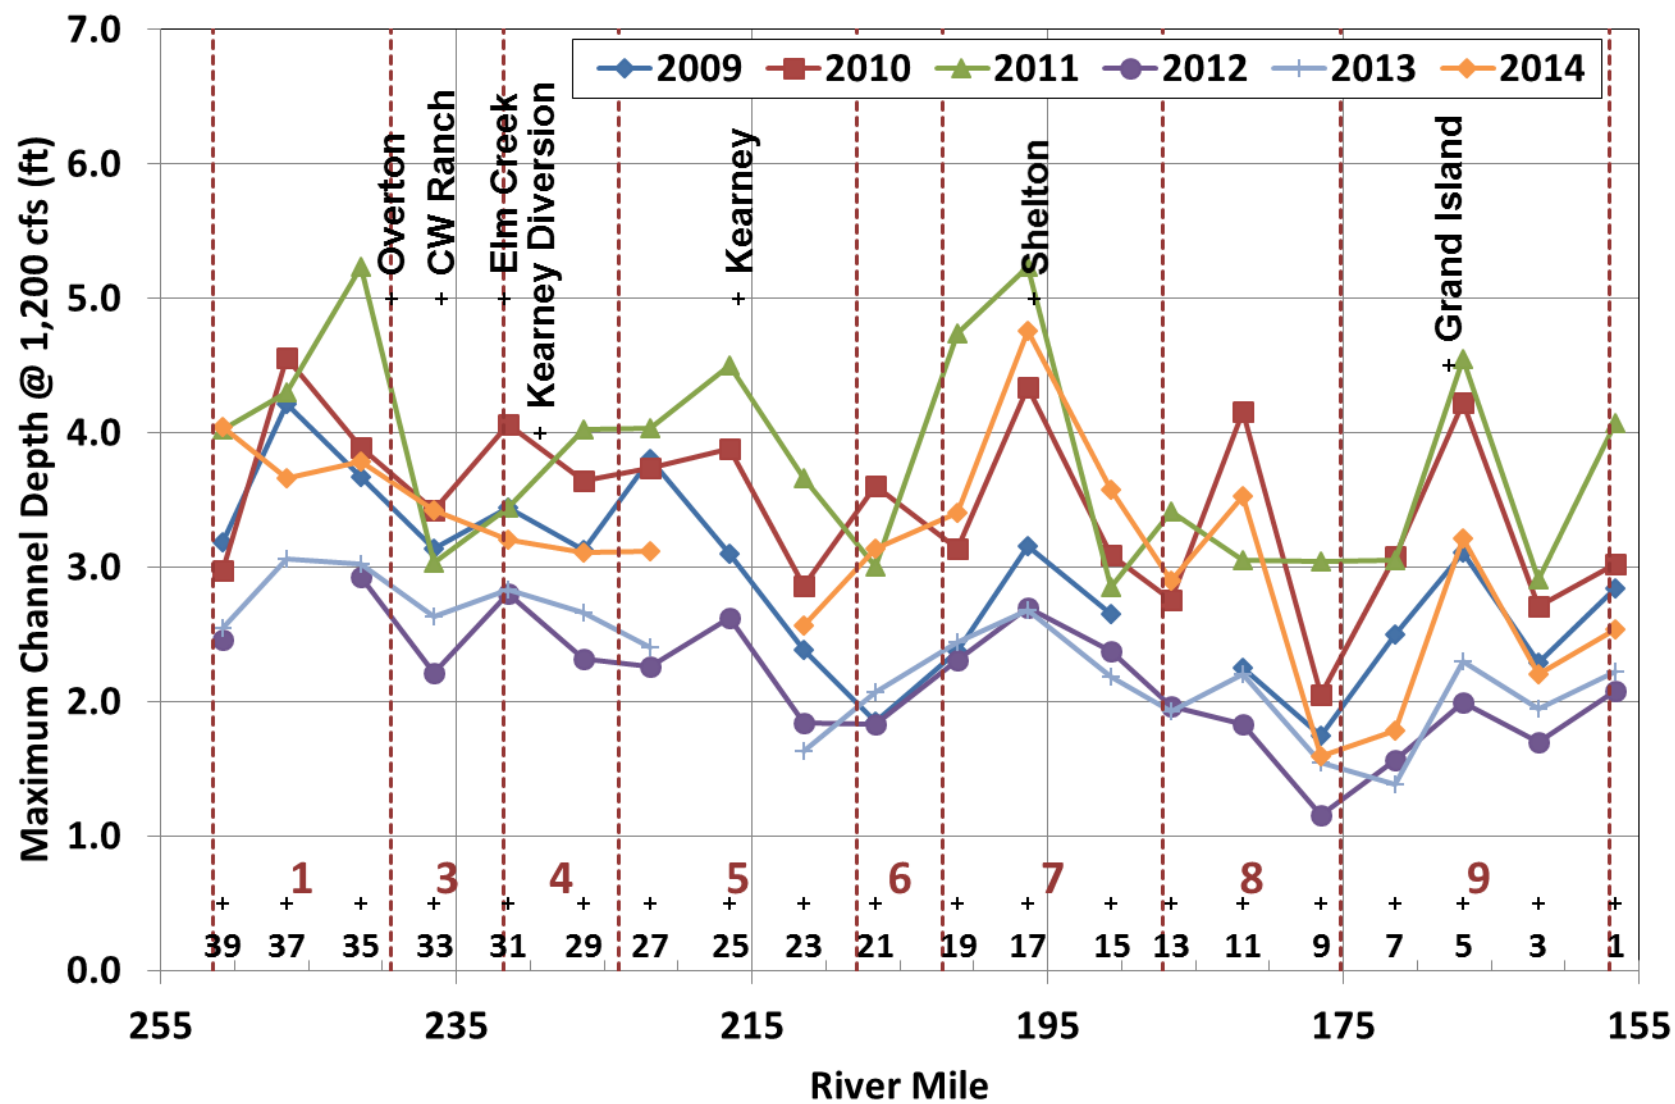
Figure 3.10a. Average maximum channel depth at 1,200 cfs at pure panel APs from 2009 through 2014.

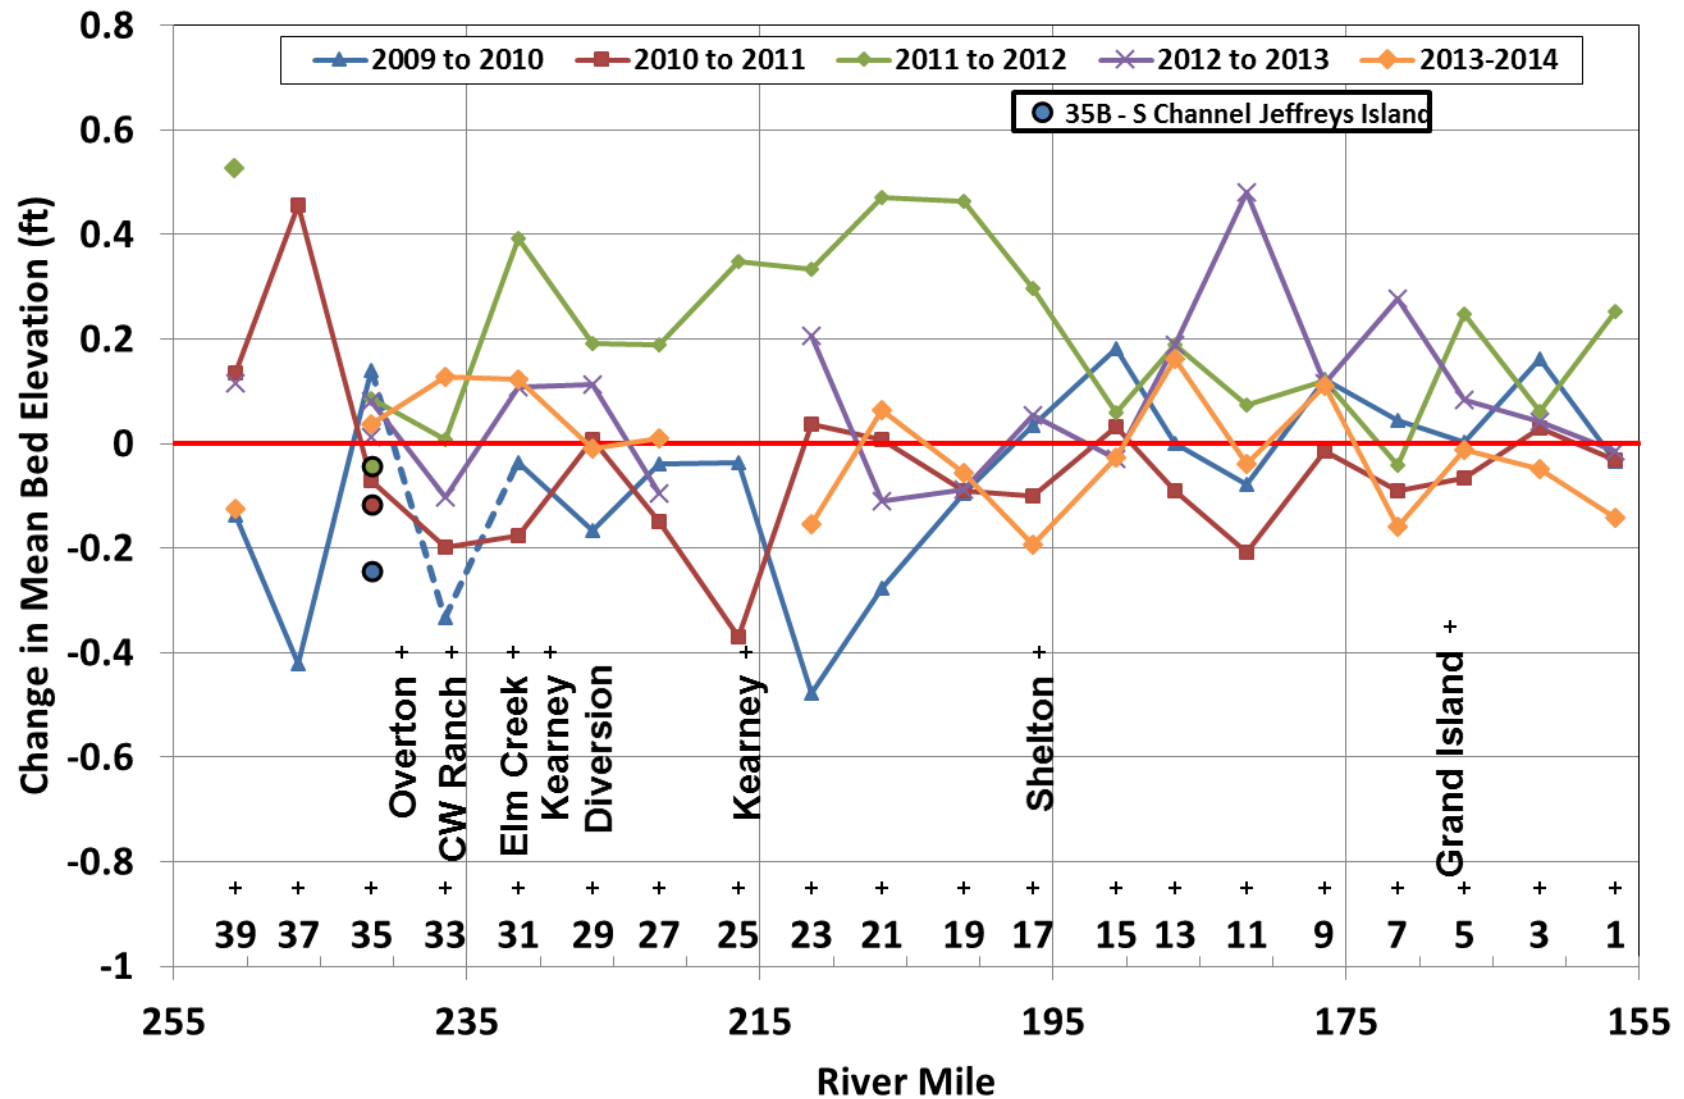
Figure 3.12b. Year-to-year change in mean bed elevation at the pure panel APs from 2009 through 2014. Line connecting AP33 on the 2009 to 2010 series is dashed to show effect of mechanical bar removal. [Aggradation (+), Degradation (-)]

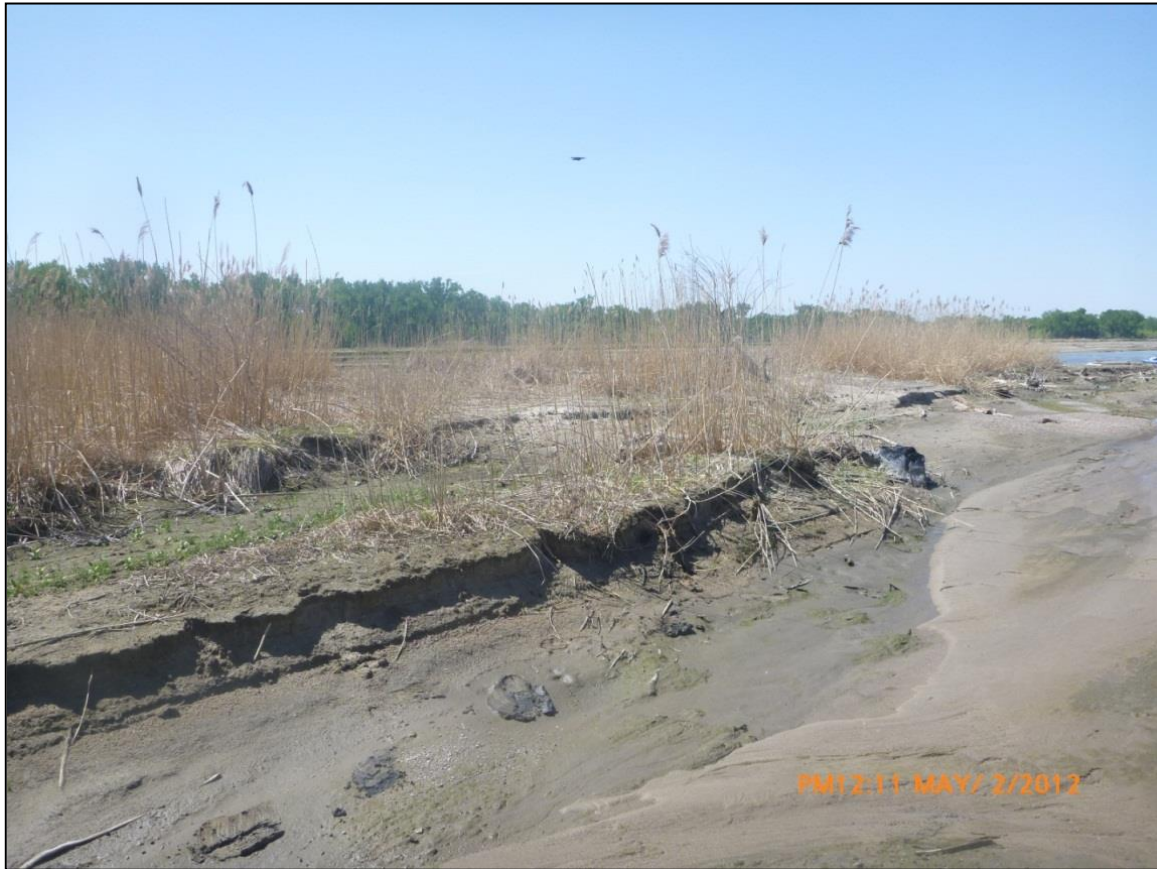
Figure 4.33. Typical lateral erosion and undercutting of the edge of a sand bar with common reed in the Elm Creek Complex.

Based on results from the Elm Creek 2D model, maximum velocities at locations with depths in the 1-foot to 3-feet range are about 6 fps, and most areas have velocities between 1.5 and 4 fps (**Figure 4.31**). Pollen-Bankhead et al. (2011) found that very high velocities, well above those that occur in the Platte River, are required to uproot established common reed plants (**Figure 4.32**); thus, it is unlikely that this process is responsible for the reduction in common reed during the monitoring period. If common reed is removed by the direct action of the water, this most likely occurs through lateral erosion and undercutting of the sandbars and banklines on which the plants are growing (**Figure 4.33**). While this does occur in the study reach, field observations indicate that it occurs only in limited areas, primarily on the heads, and to a lesser extent, along the margins, of sand bars. The thick, rhizomatous root structure appears to be very effective in binding the soil and limiting the rate and magnitude of lateral erosion and undercutting in areas where common reed is abundant.
