SEDIMENT AUGMENTATION FINAL PILOT STUDY REPORT

PLATTE RIVER RECOVERY IMPLEMENTATION PROGRAM

April 2014

**The Flatwater Group, Inc.
In association with
HDR Engineering, Inc. and Tetra Tech, Inc.**

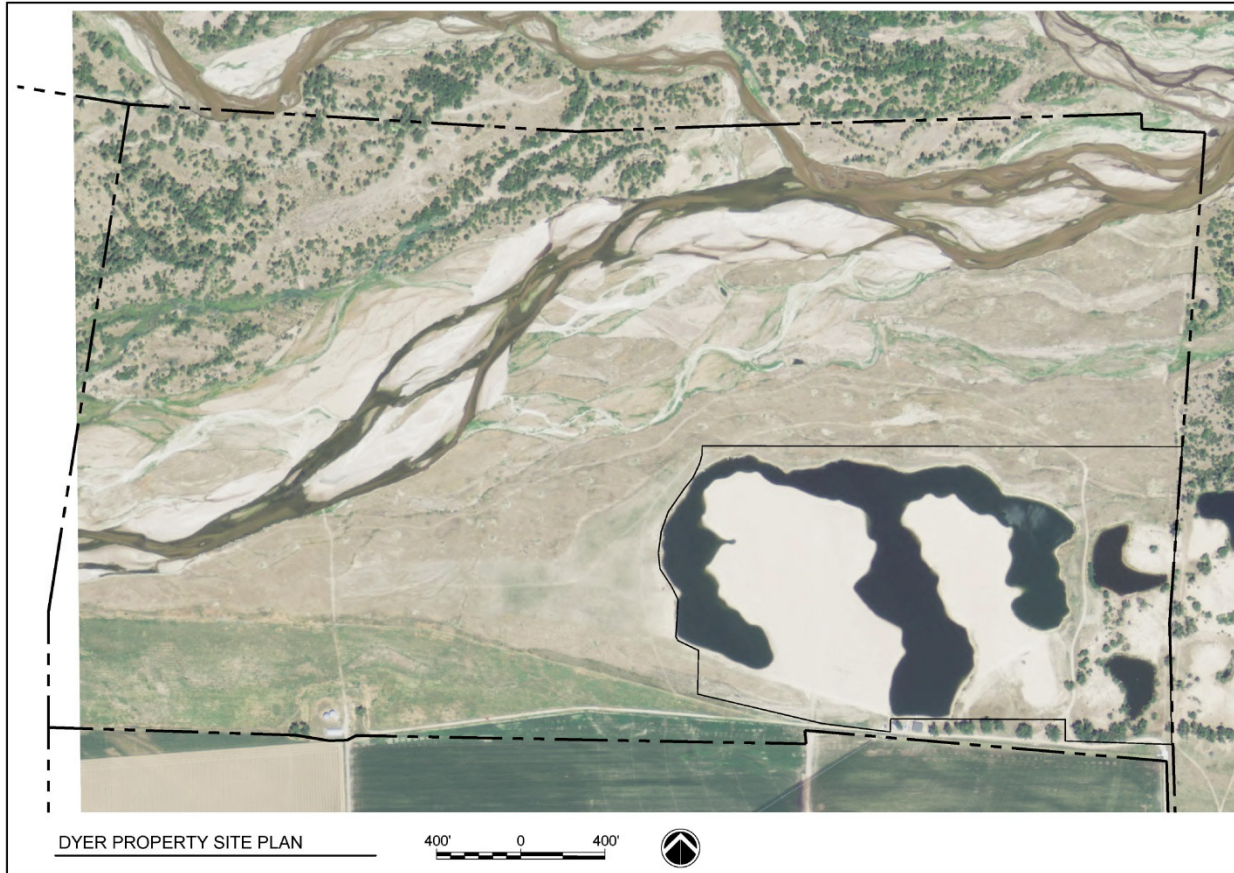
Dyer Property

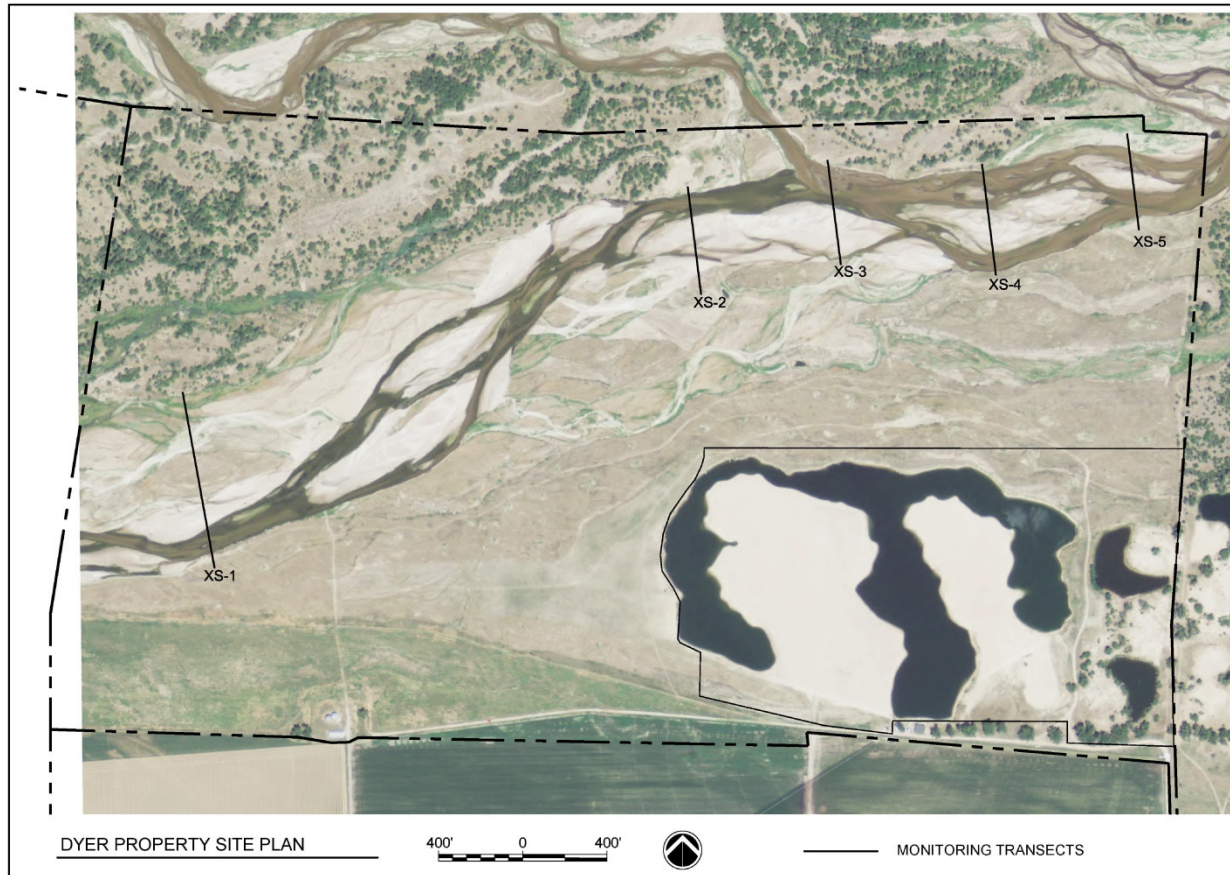
Dyer Monitoring Plan Cross Section Locations

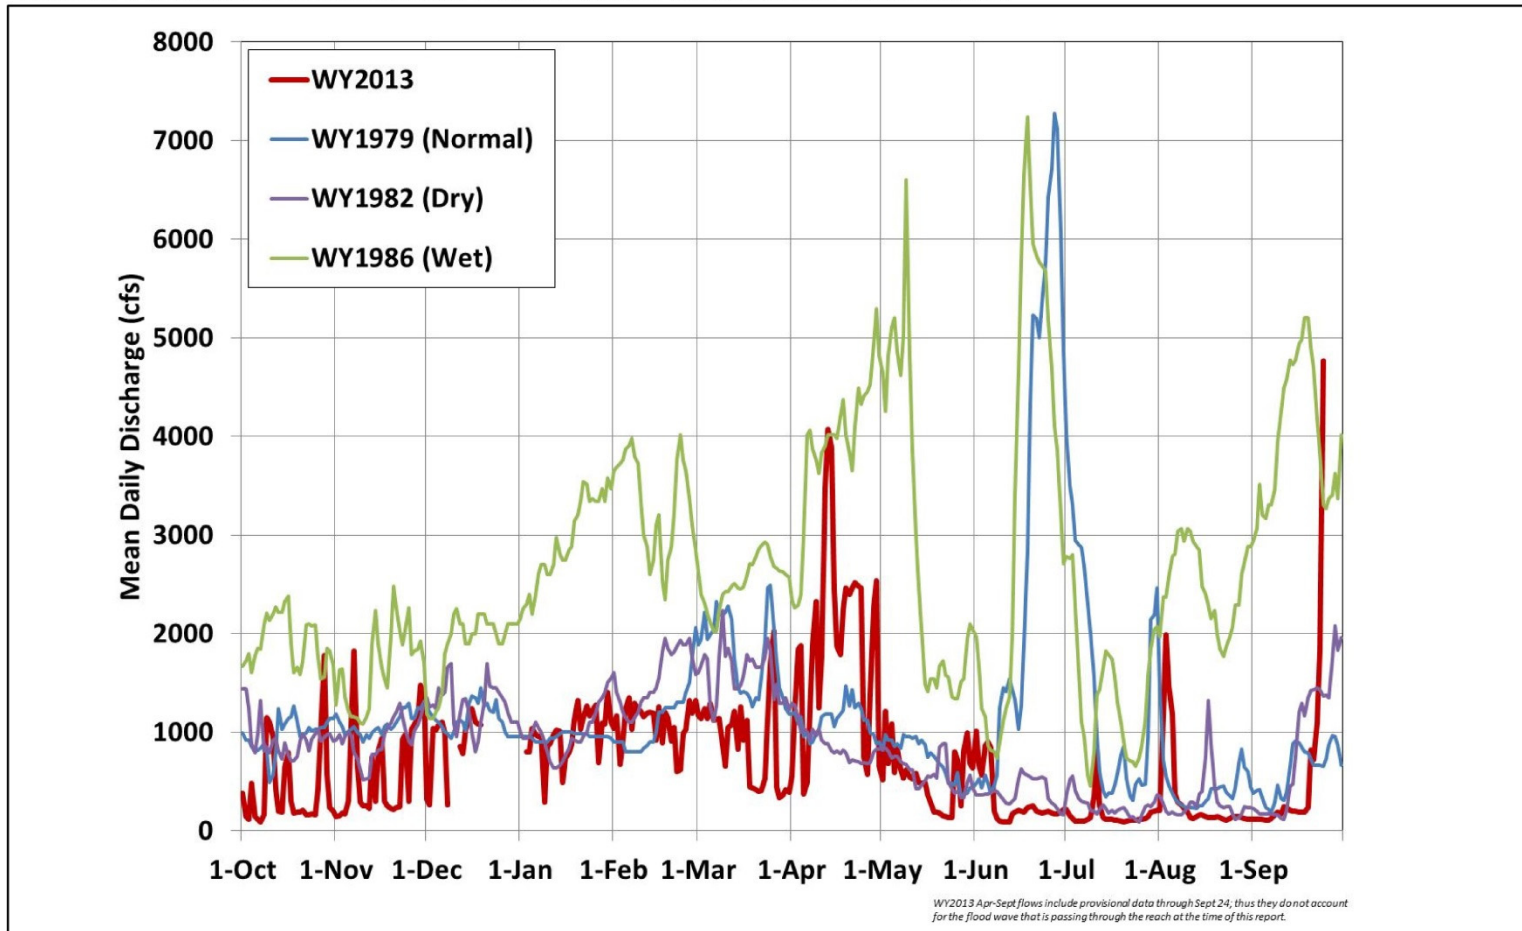
Mean Daily Flows at the Overton Gage for an Average Wet, Dry, and Normal Year

The flow conditions during and after input of additional sediment are a key driver of the channel response. As discussed in Section 3.6, the modeling was conducted for three flow sequences that were intended to encompass the range of flows that could reasonably be anticipated in the study reach. The river flows that contribute to the Overton gage (both from the North Channel at Jeffrey Island and the J-2 return) were in the median to low range during Phase I of the management action from September through November 2012 (Figure 7). The total flow volume passing the Overton gage during these 3 months was only about 71,000 acre-feet, compared to 191,000 acre-feet for the same period used in the dry year model simulations (Water Year [WY] 1982) (Figure 8). The flows during this period of 2012 were the third lowest in the 72 years of recorded data at the Overton gage. The subsequent 3 months, from January through March 2013, were slightly higher, but still well below the volume for the dry year simulation (~176,000 acre-feet in 2012 versus ~245,000 acre-feet in WY 1982). A combination of lower flows and the limited ability to distribute the material during pumping limited the ability of the river to entrain and transport the augmented sediment downstream away from the pump outfall.

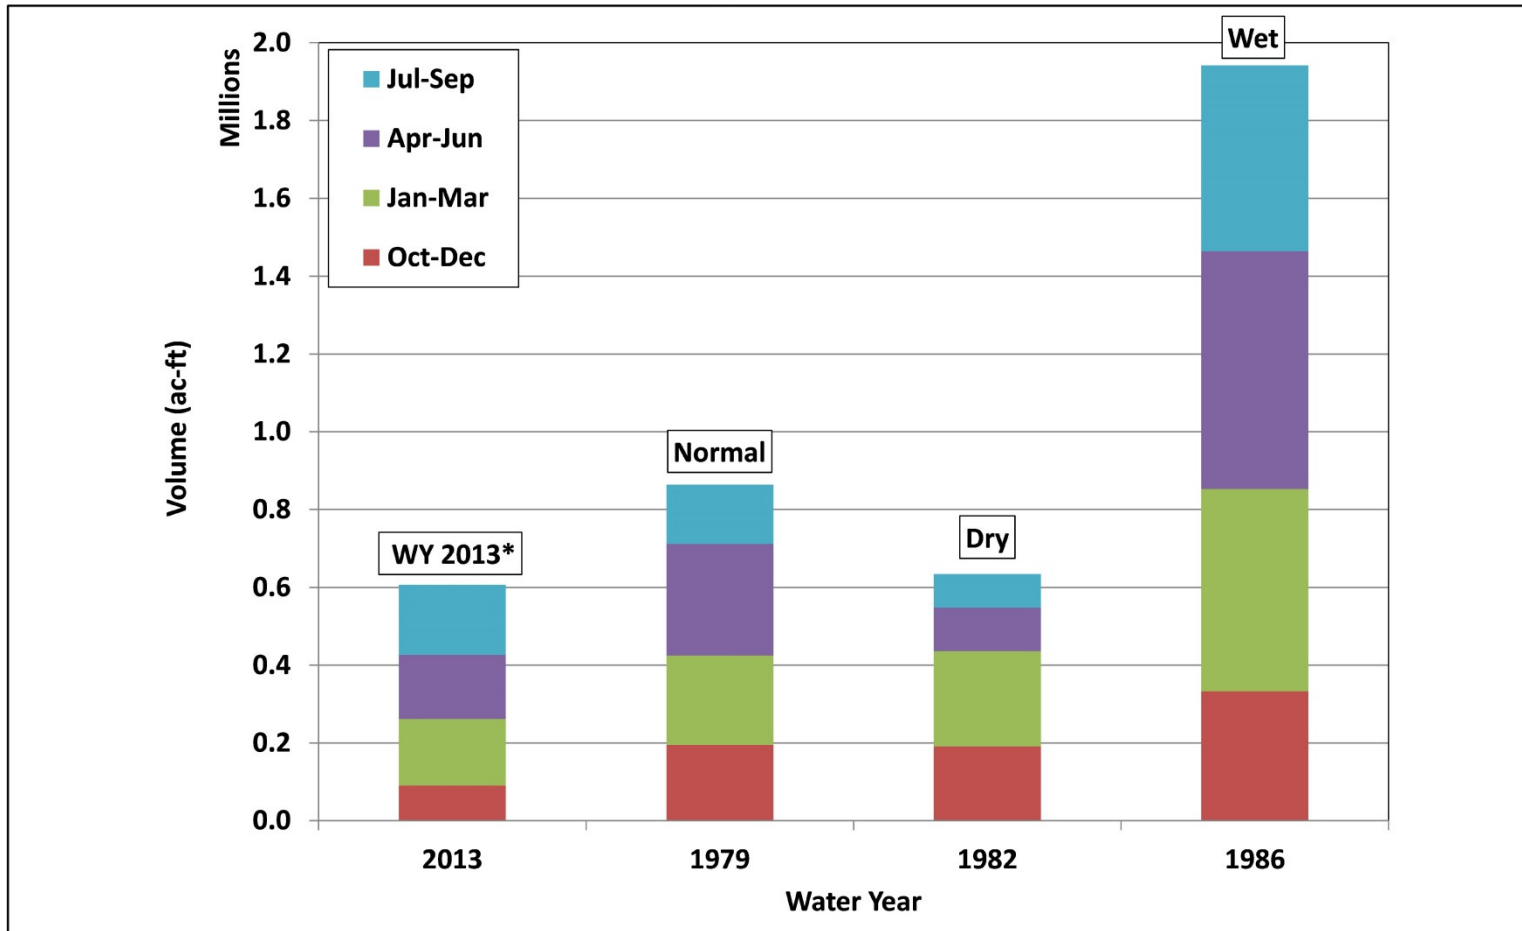
Flow Volumes at the Overton Gage

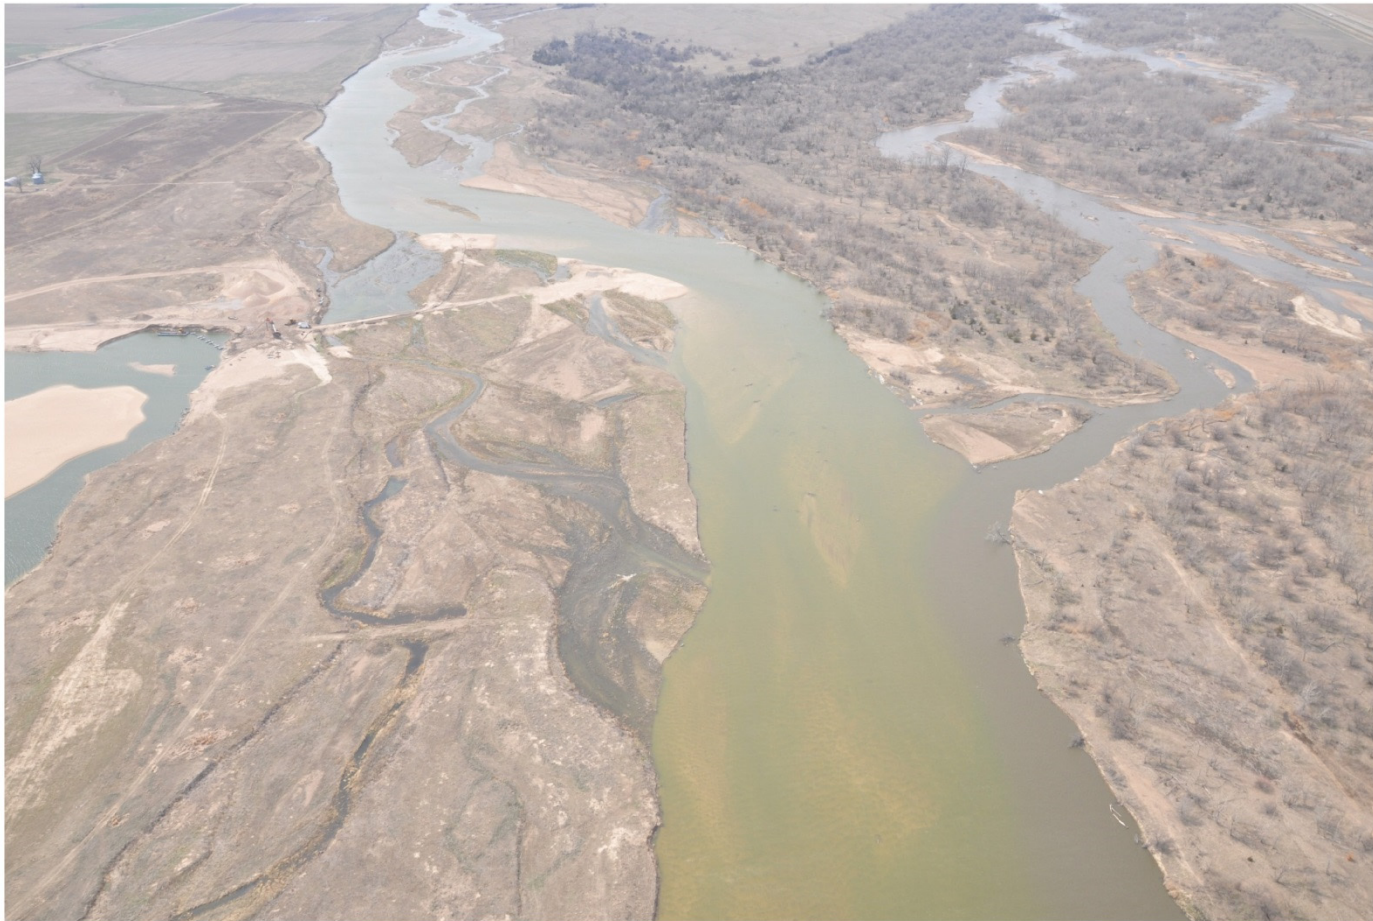
Oblique Aerial Photo of the Dyer Sand Pumping Site (Taken 4_13_2013)

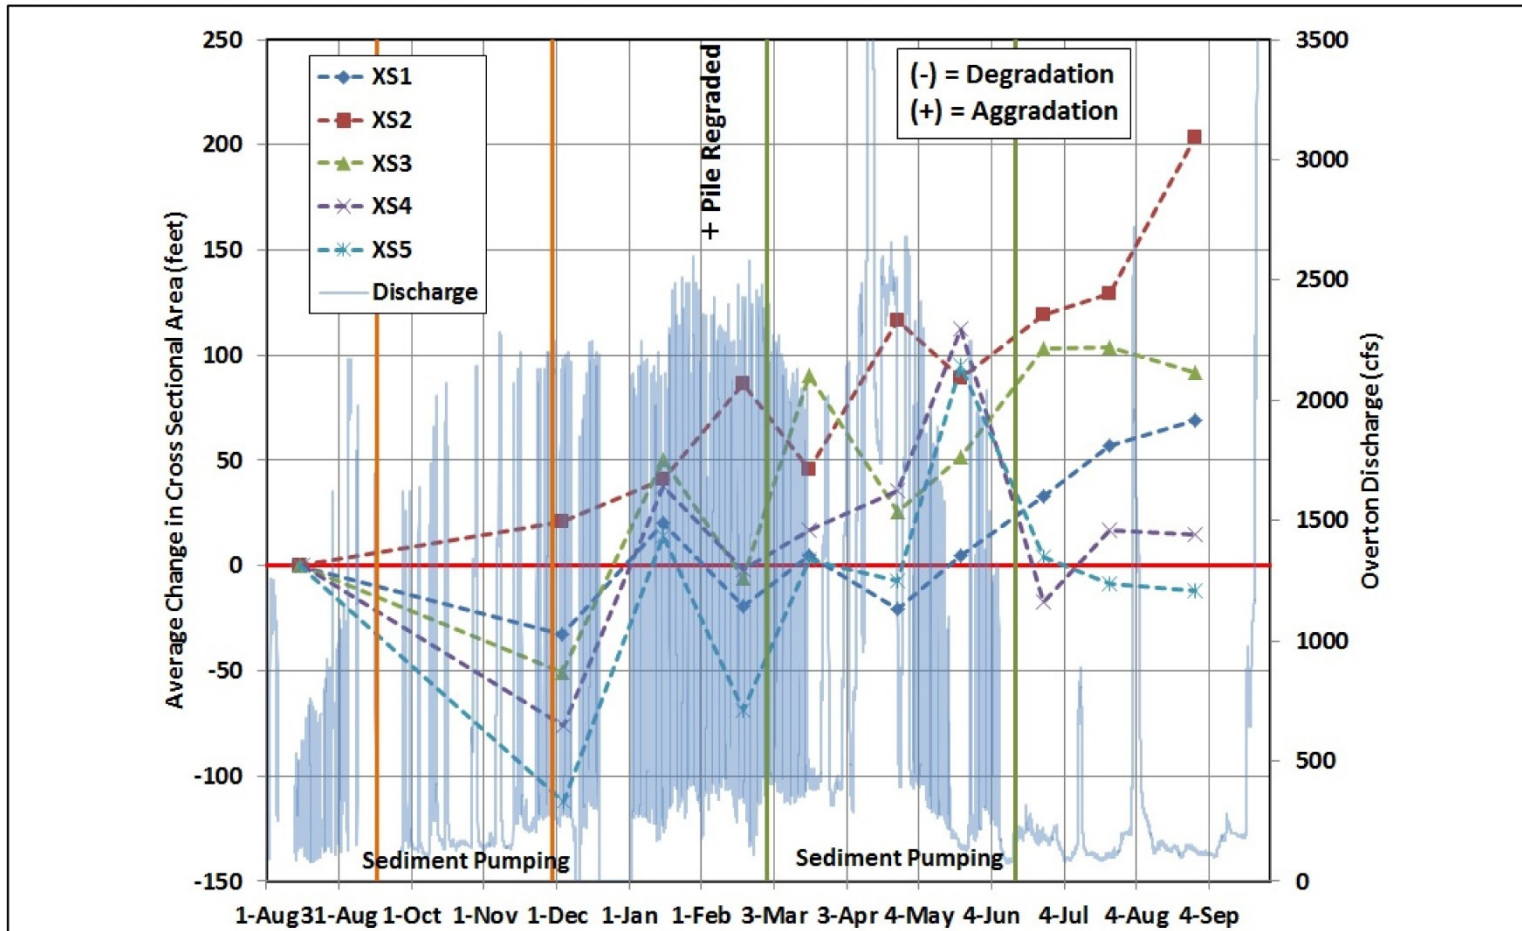
Average Change in Cross Sectional Area at the Monitoring Plan Cross-Sections

1 The changes at XS-1 through XS-5 were relatively modest (Figures 12a and b). All of the cross
2 sections except XS-2 (D-10) showed net degradation of a few tenths of a foot between August
3 and early December 2012, aggradation back to an average elevation slightly above the baseline
4 surveys by mid-January 2013, and then degradation by the mid-February 2013 survey. XS-2
5 shows an aggradational trend after mid-January 2013.

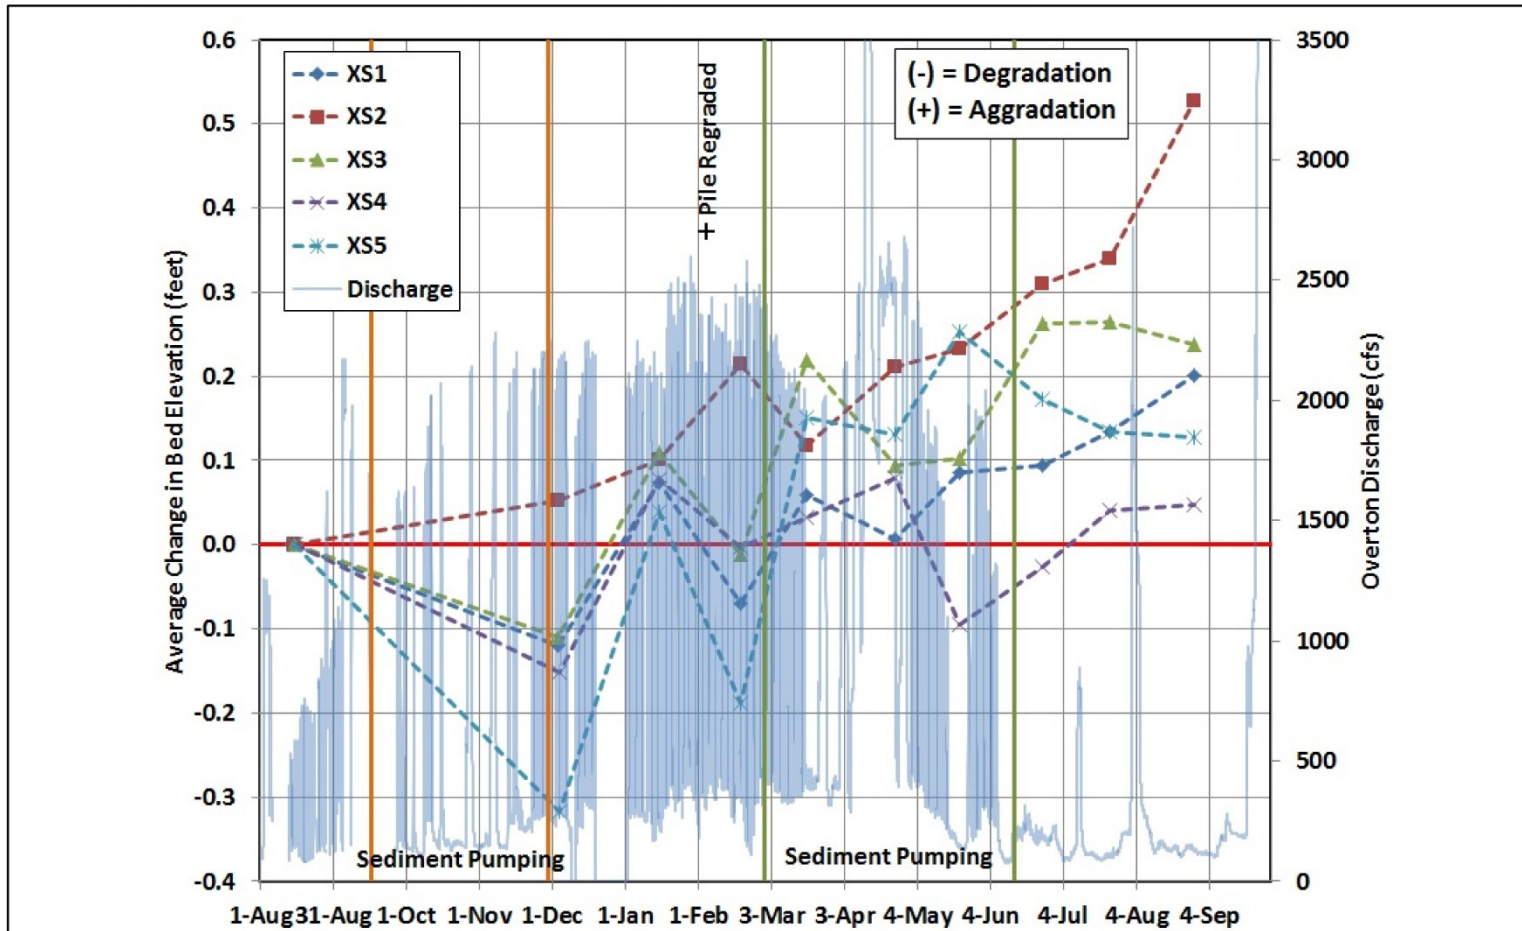
Average Change in Bed Elevation at the Monitoring Plan Cross-Sections

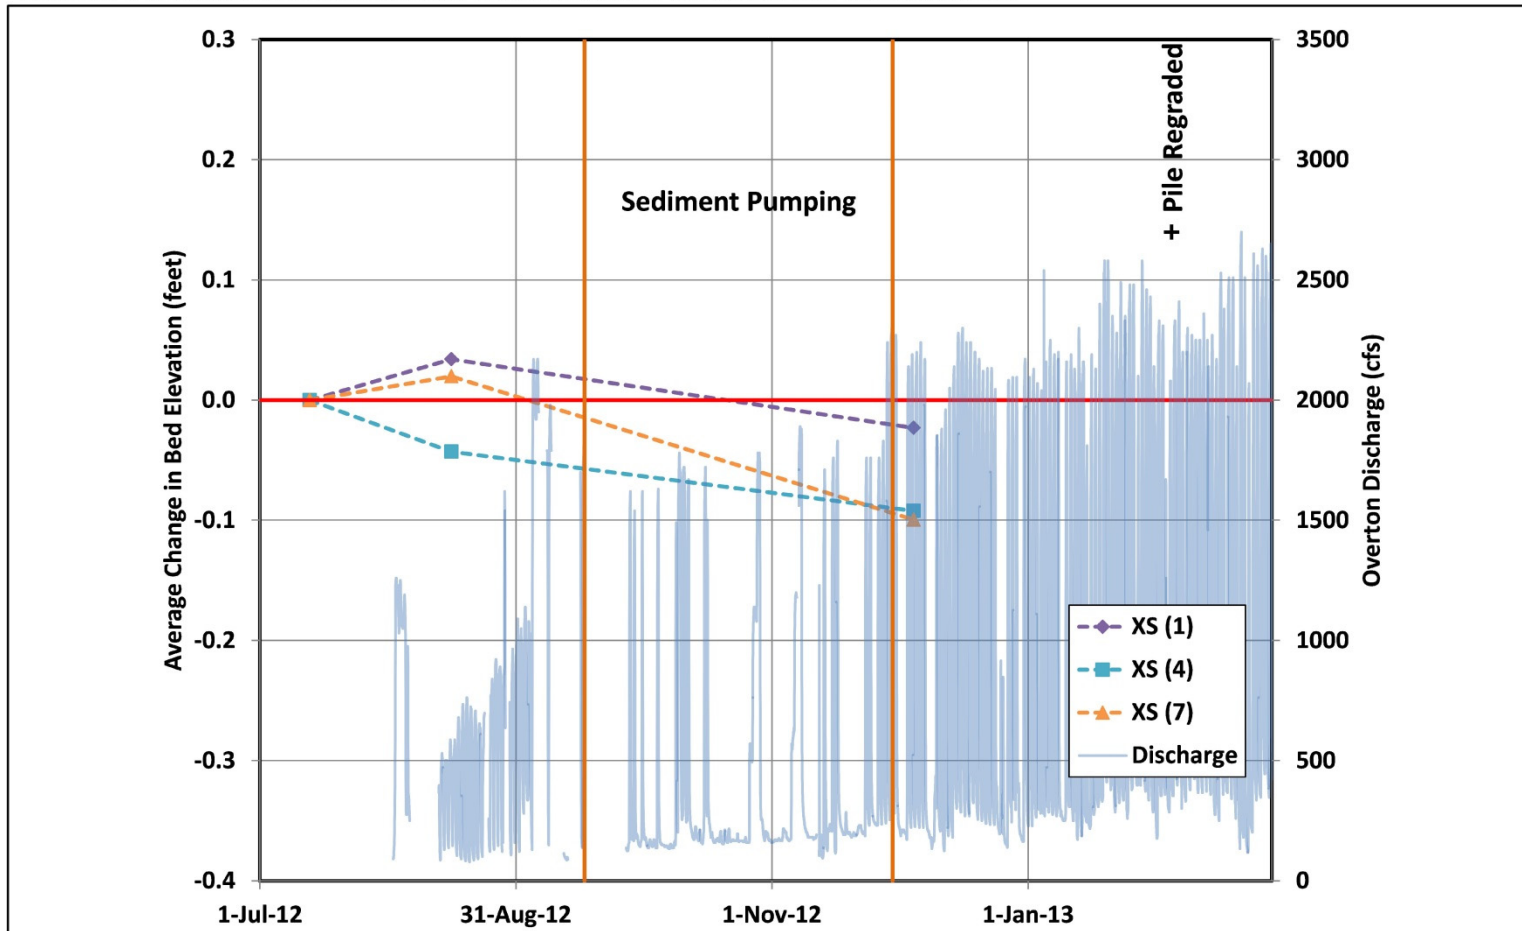
Average Change in Bed Elevation at AP34

6 In addition to the surveys in the vicinity of the pump outfall, the three primary monitoring cross
7 sections at AP 34 were also surveyed in August and December 2012 as part of this study. The
8 survey data indicate that AP 34, which is located about 1,000 feet downstream of the Overton
9 Bridge (Figure 13), aggraded slightly between the July and August 2012 surveys at XS-1 and
10 XS4, but degraded slightly at XS4 (Figure 14). All three cross sections showed a slight
11 degradational trend between August and December 2012. All of the indicated changes in
12 average bed elevation were less than 0.1 foot, and probably within the error bands of the data;
13 thus, no definitive conclusion can be drawn about the long-term trends or possible impacts of
14 the pilot-scale augmentation.

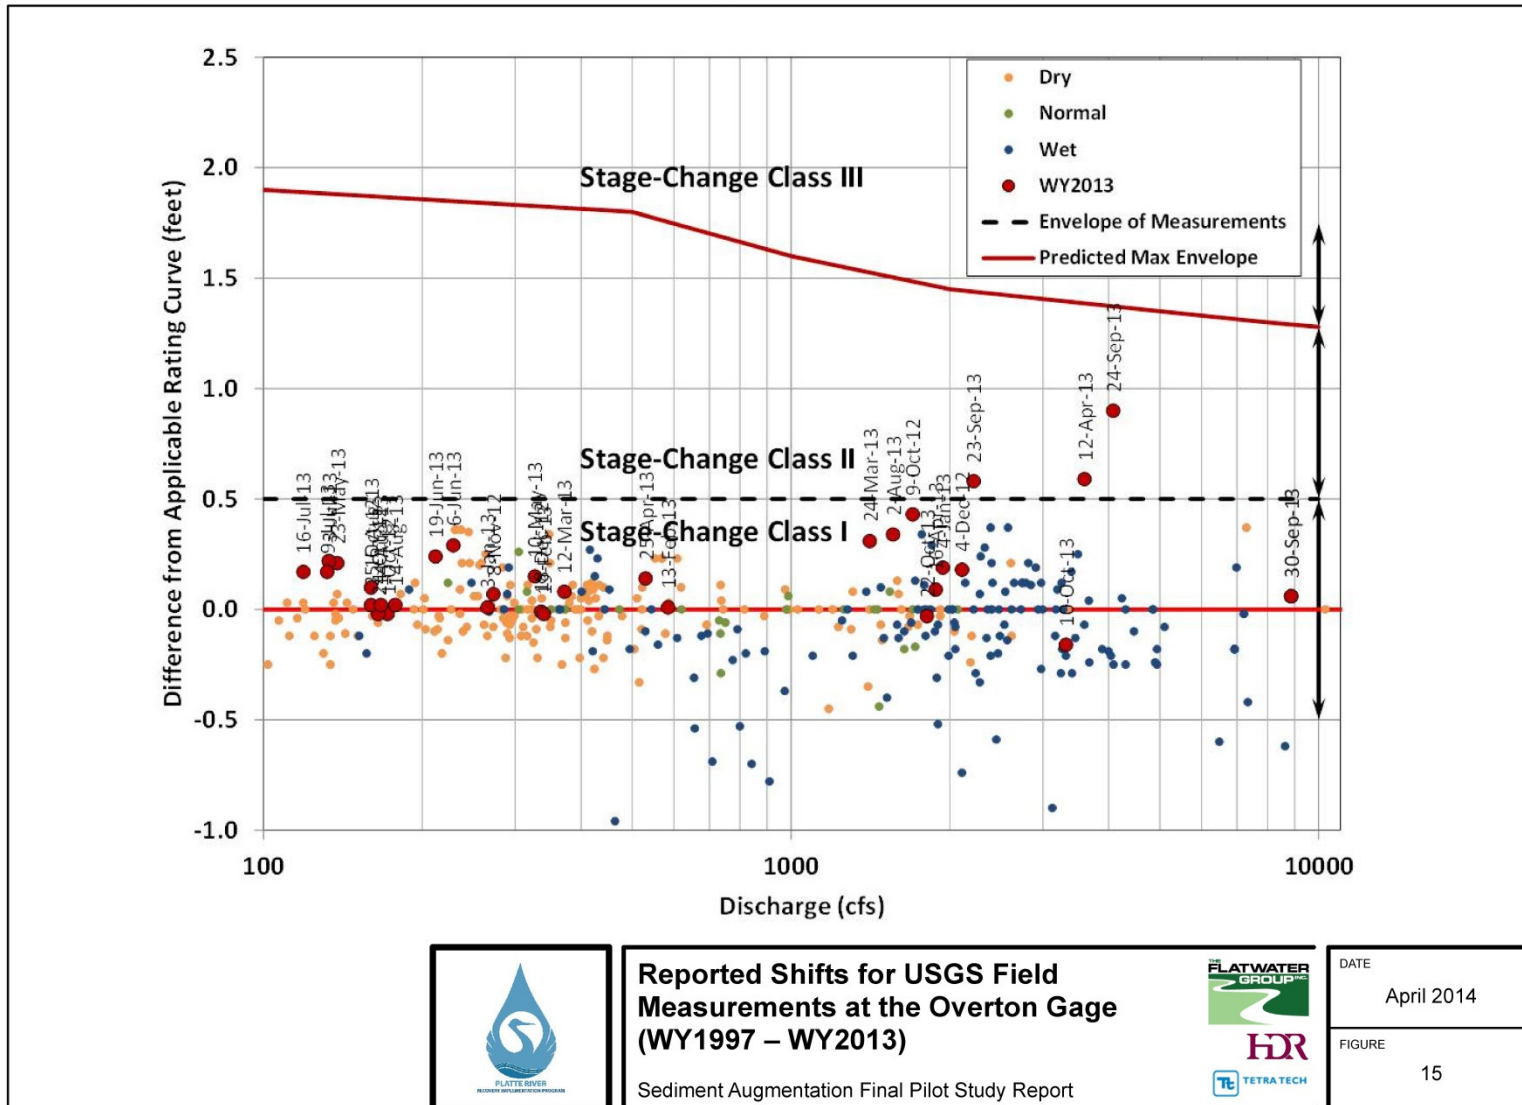
Reported Shifts for USGS Field Measurements at the Overton Gage (WY1997 – WY2013)

12 The Overton gage data were also used to provide a near-real-time assessment of changes that
13 could trigger modifications to the augmentation activities to avoid damage to adjacent
14 properties. The shifts that are applied by USGS to the gage rating curve for purposes of
15 computing the discharge represent the variability in individual measurements from the current
16 rating curve. The vast majority of the reported shifts² for gage measurements taken since
17 WY 1997 vary from about -1 to +0.5 foot (Figure 15); thus, the boundary between Class I and
18 Class II stage changes was set at 0.5 foot. The variability appears to be somewhat greater
19 during wet and dry years than it is during normal runoff years (as defined by Anderson and
20 Rodney, 2006). The sediment transport model results described above indicate maximum
21 variability in the water surface elevation for a given discharge ranging from 1.6 to 1.9 feet at

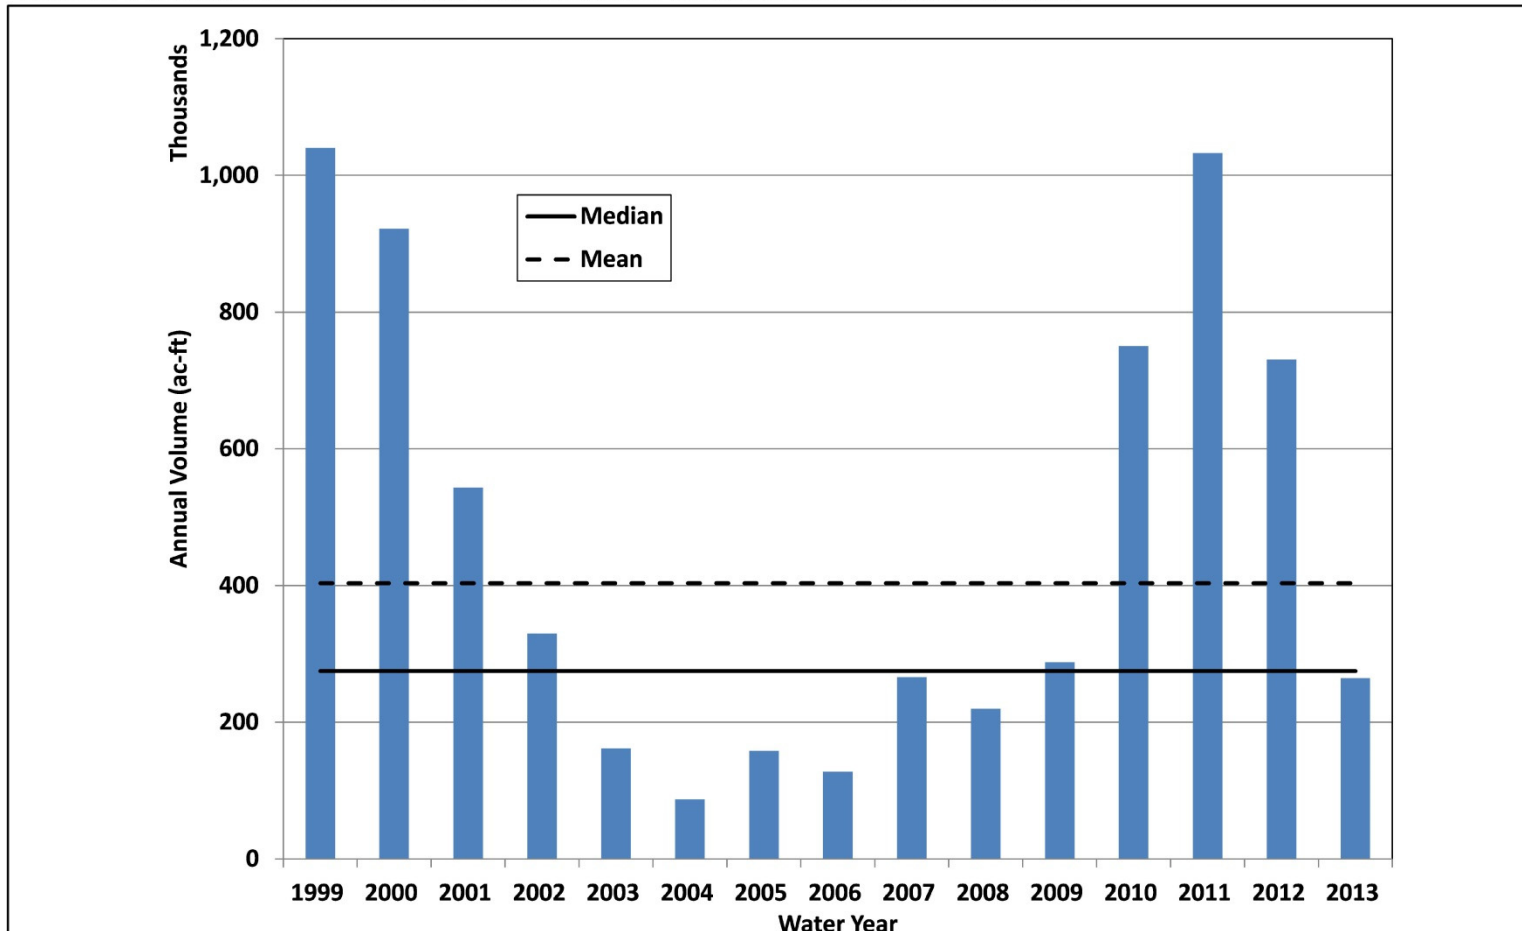
Annual Release Volumes from the J-2 Return

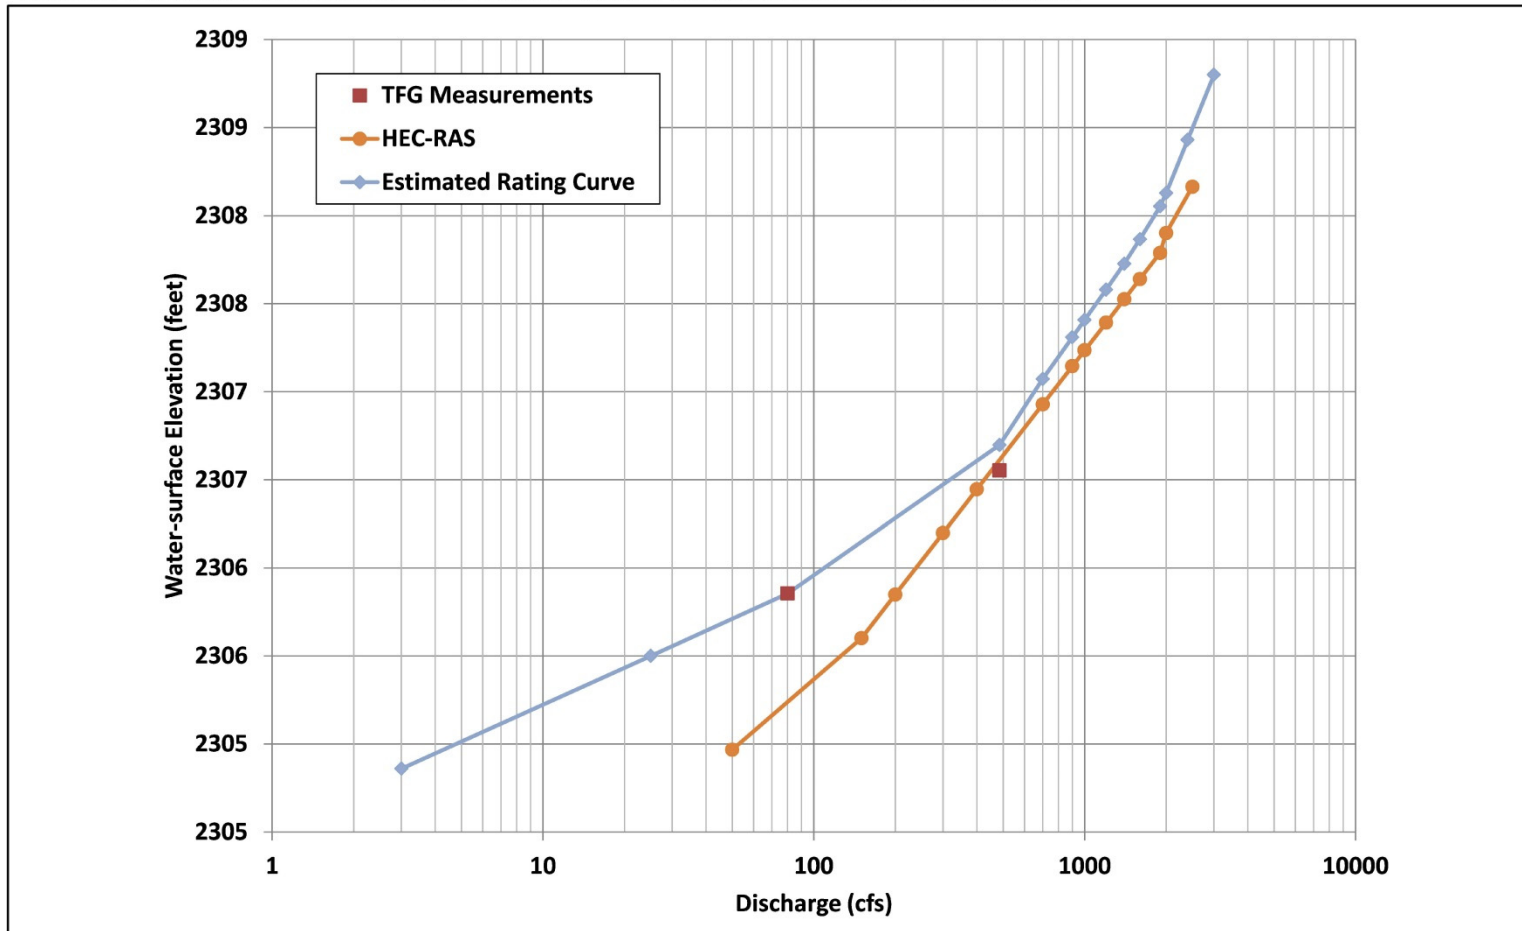
Stage-Discharge Rating Curves at the Pressure Transducer Upstream from the Dyer Outfall

11 augmentation caused backwater during at least some periods that could influence the stage-
12 discharge relationship, particularly at low flows (Figure 27). To facilitate development of the flow
13 record for the South Channel, an initial rating curve was developed from the existing conditions
14 HEC-RAS model, and this curve was shifted during the augmentation period to match the
15 November flow measurement and to provide high flows that are consistent with the typical J-2
16 peaking releases of about 1,700 cfs. The curve was also periodically adjusted to ensure that
17 the low flows in the South Channel and the corresponding flows in the North Channel were
18 reasonable based on the available information. The resulting estimated flow record follows the
19 recorded pattern of J-2 releases indicated by the Dyer Property transducer, with typical
20 maximum flows in the South Channel at the Dyer Property in the range of 2,000 cfs or less

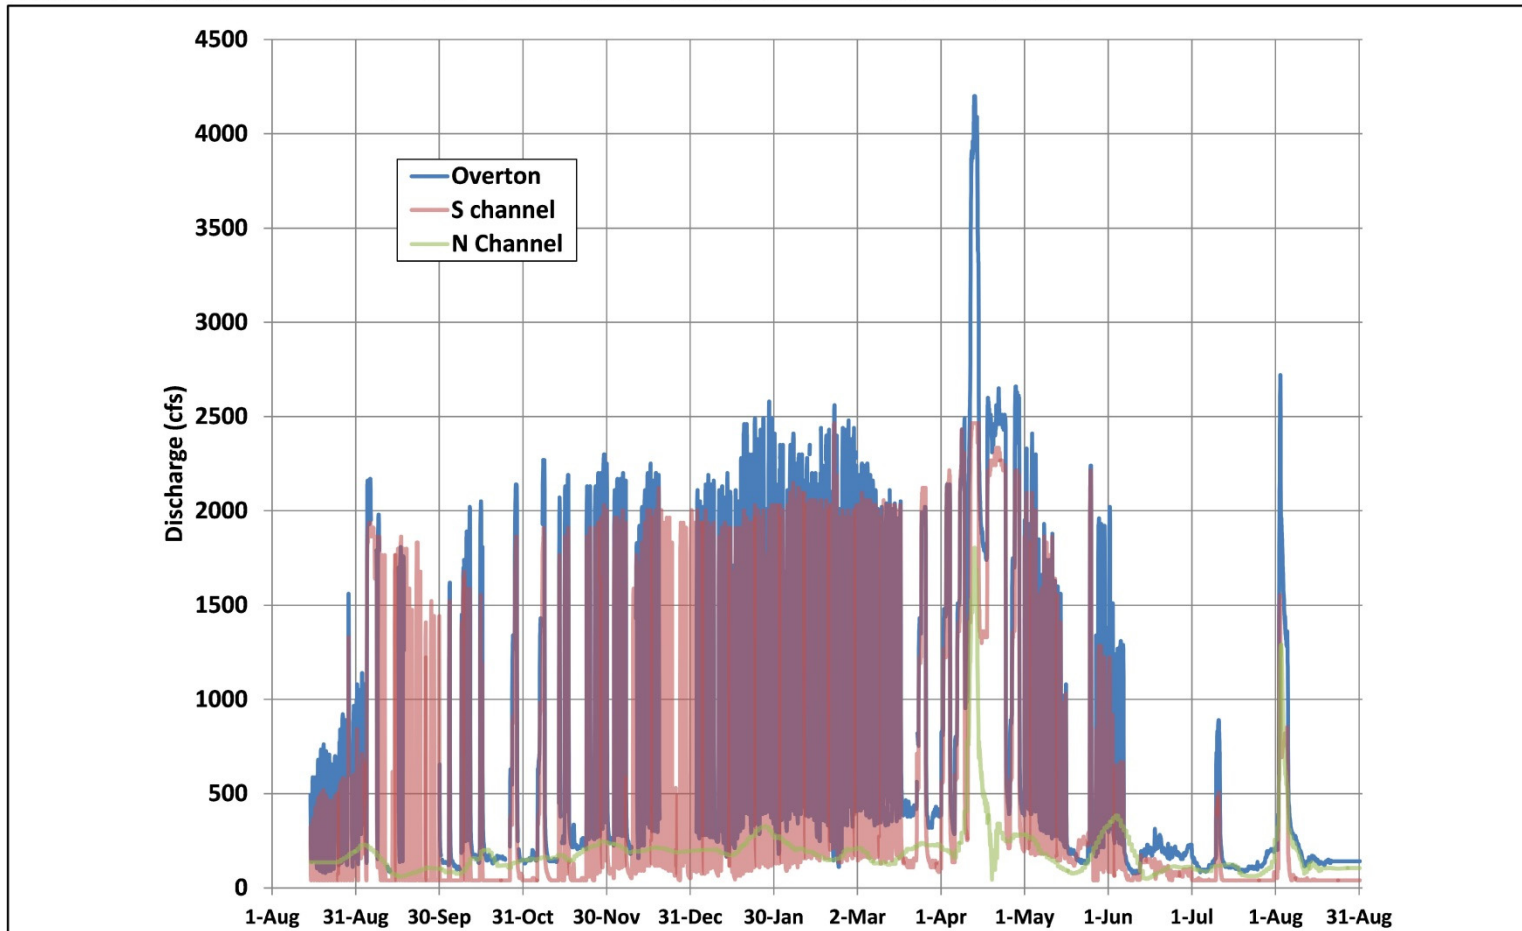
Provisional Hourly Discharges at the USGS Overton Gage and the Estimated Hourly Discharges in the South Channel at the Dyer Property and in the North Channel
Sediment Augmentation Final Pilot Study Report

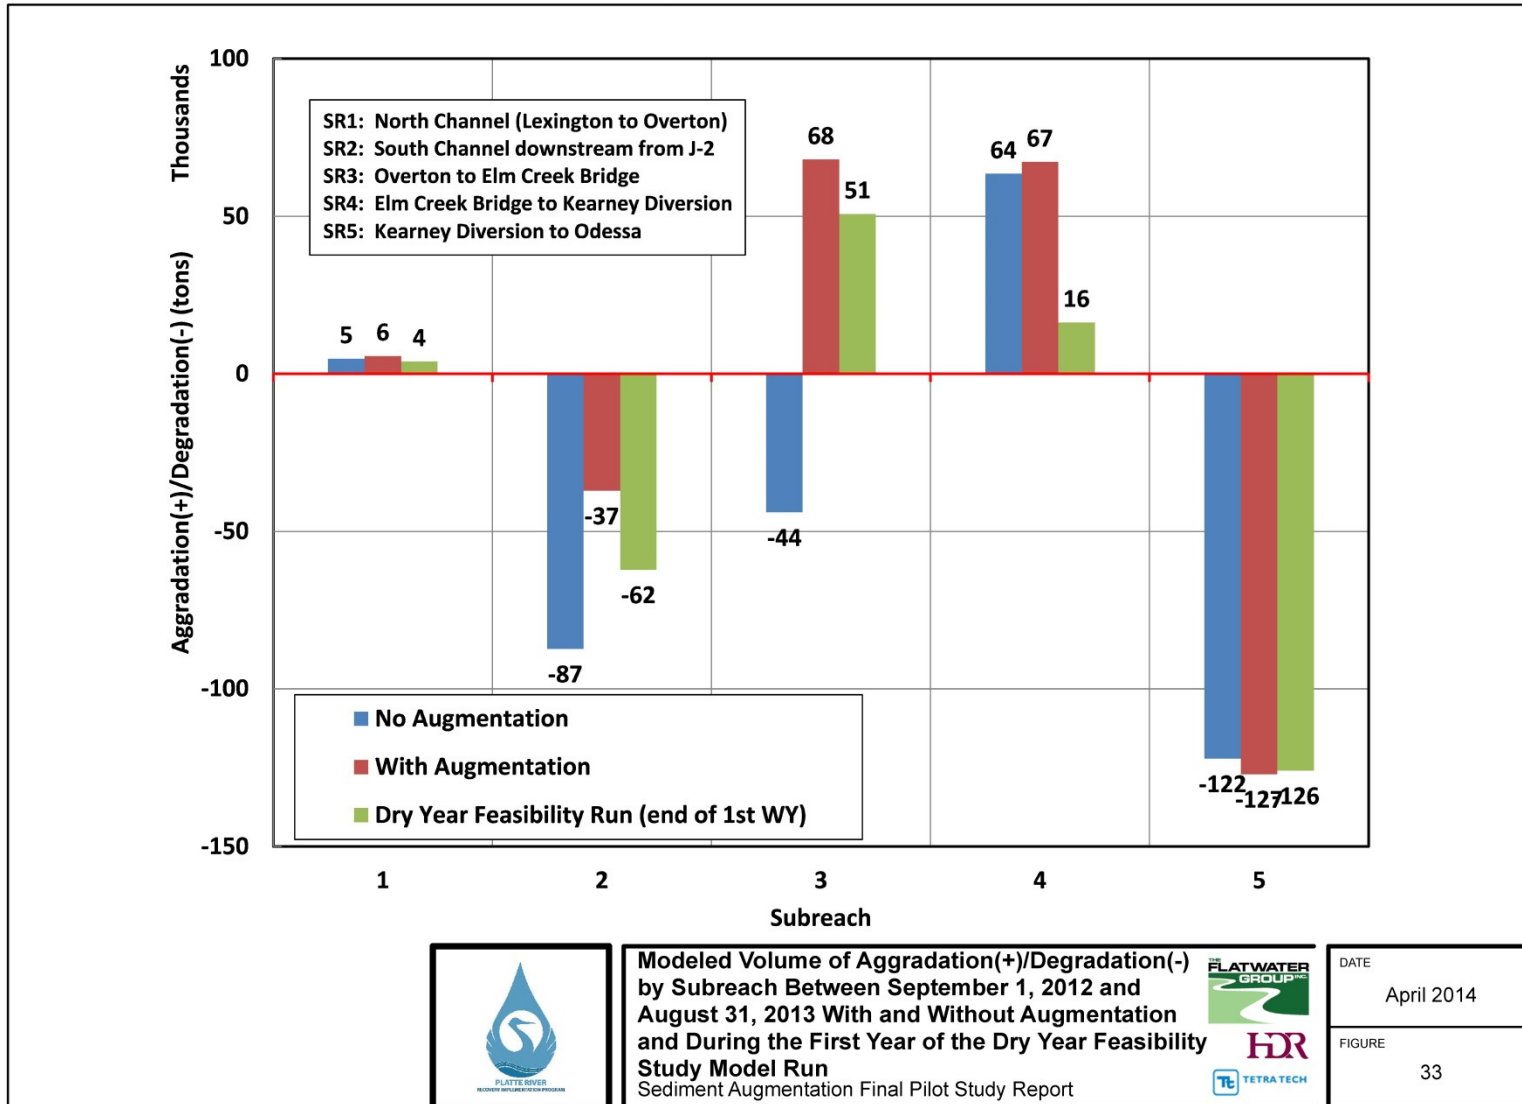
Modeled Volume of Aggradation(+)/Degradation(-) by Subreach Between September 1, 2012 and August 31, 2013 With and Without Augmentation and During the First Year of the Dry Year Feasibility Study Model Run
 Sediment Augmentation Final Pilot Study Report

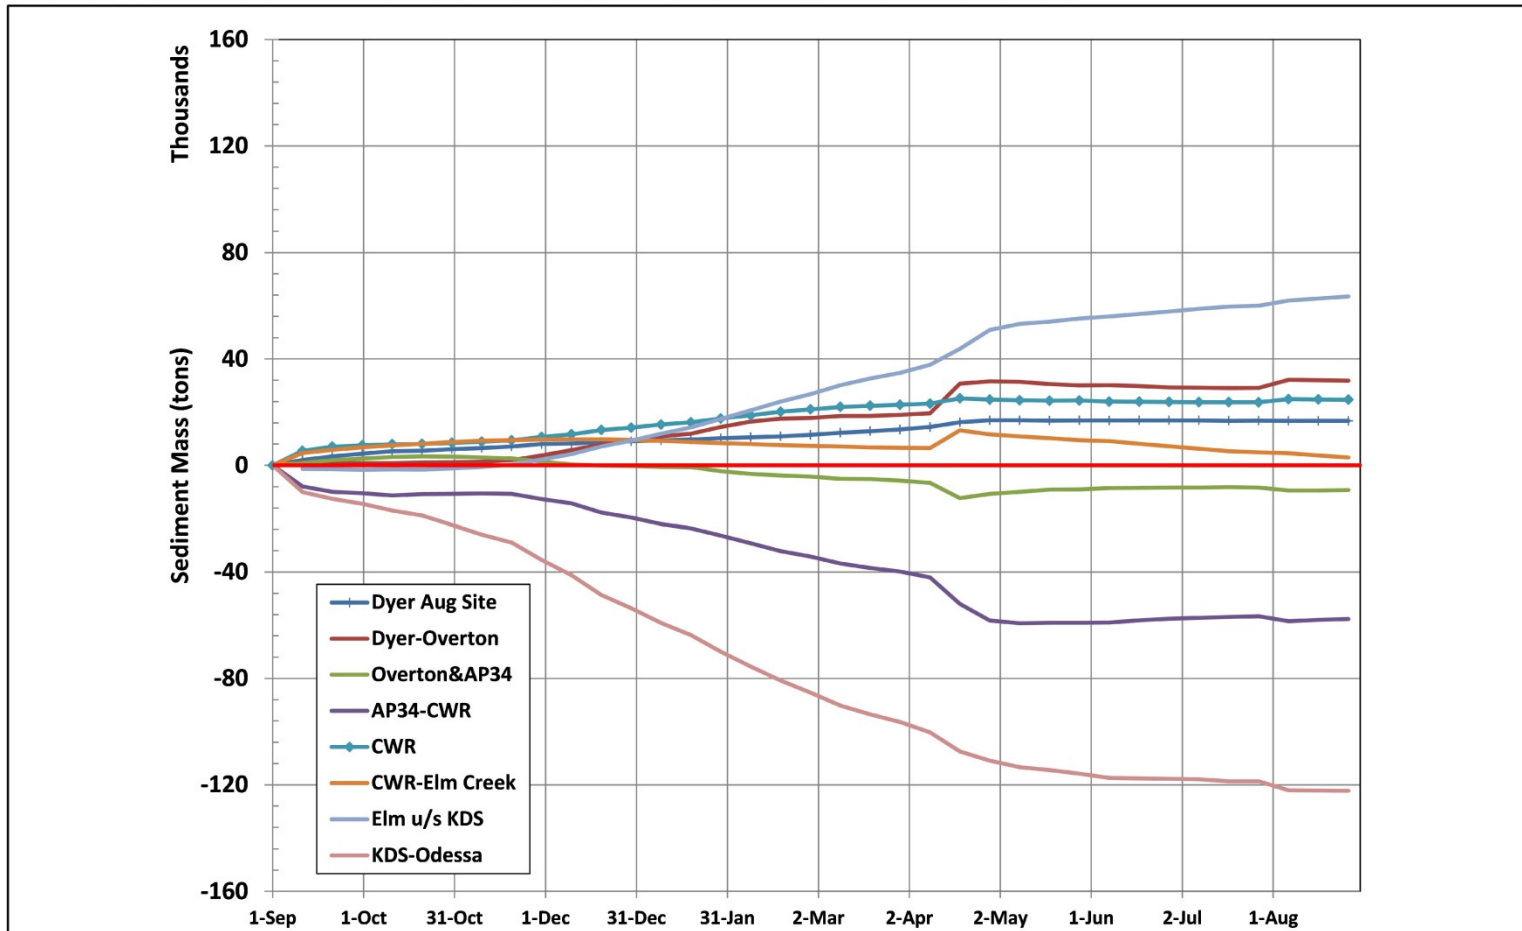
Modeled Cumulative Aggradation(+)/Degradation (-) Mass in Eight Subreaches Between the Dyer Pump Outfall and Odessa Between September 1, 2012 and August 31, 2013 Without Augmentation
Sediment Augmentation Final Pilot Study Report

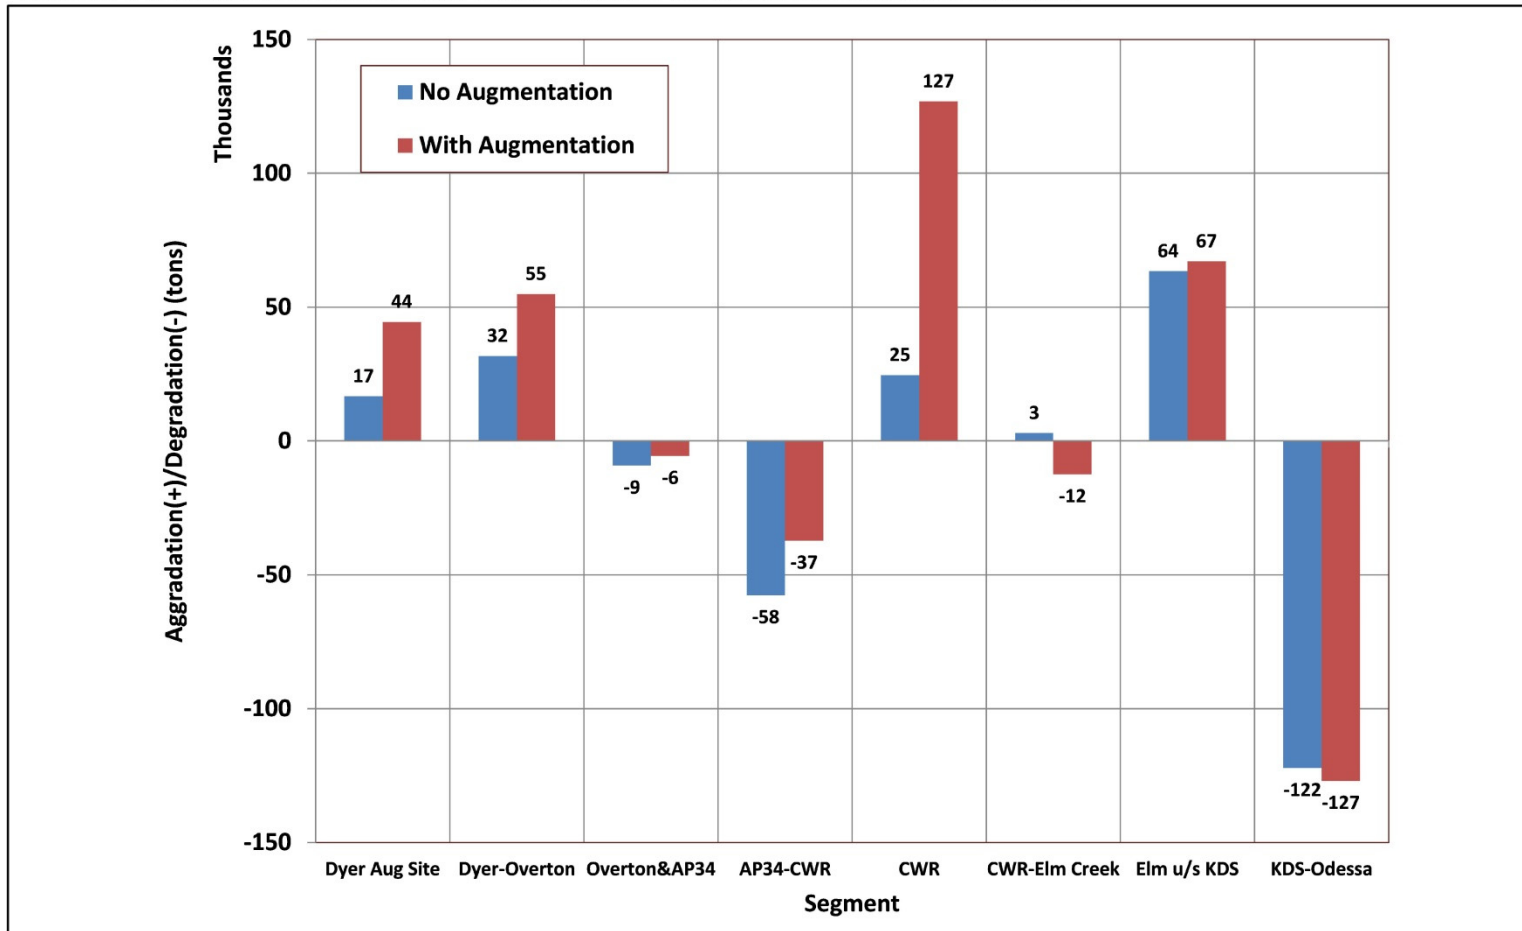
**Modeled Aggradation(+)/Degradation(-)
in Specific Segments of the Study Reach**
