SEDIMENT AUGMENTATION FINAL PILOT STUDY REPORT

PLATTE RIVER RECOVERY IMPLEMENTATION PROGRAM

April 2014

**The Flatwater Group, Inc.
In association with
HDR Engineering, Inc. and Tetra Tech, Inc.**

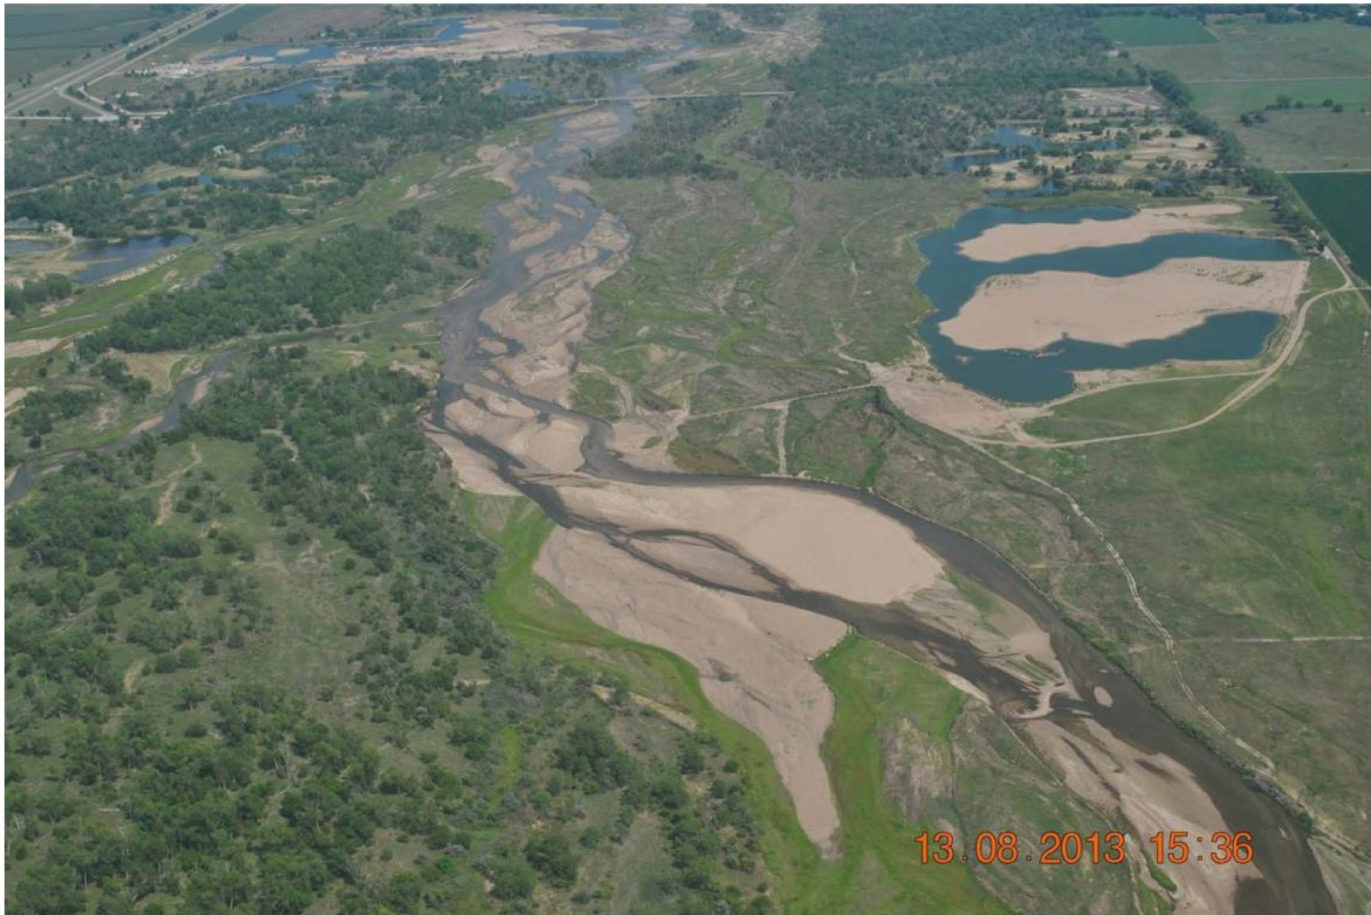
Dyer Property at the Conclusion of Phase II

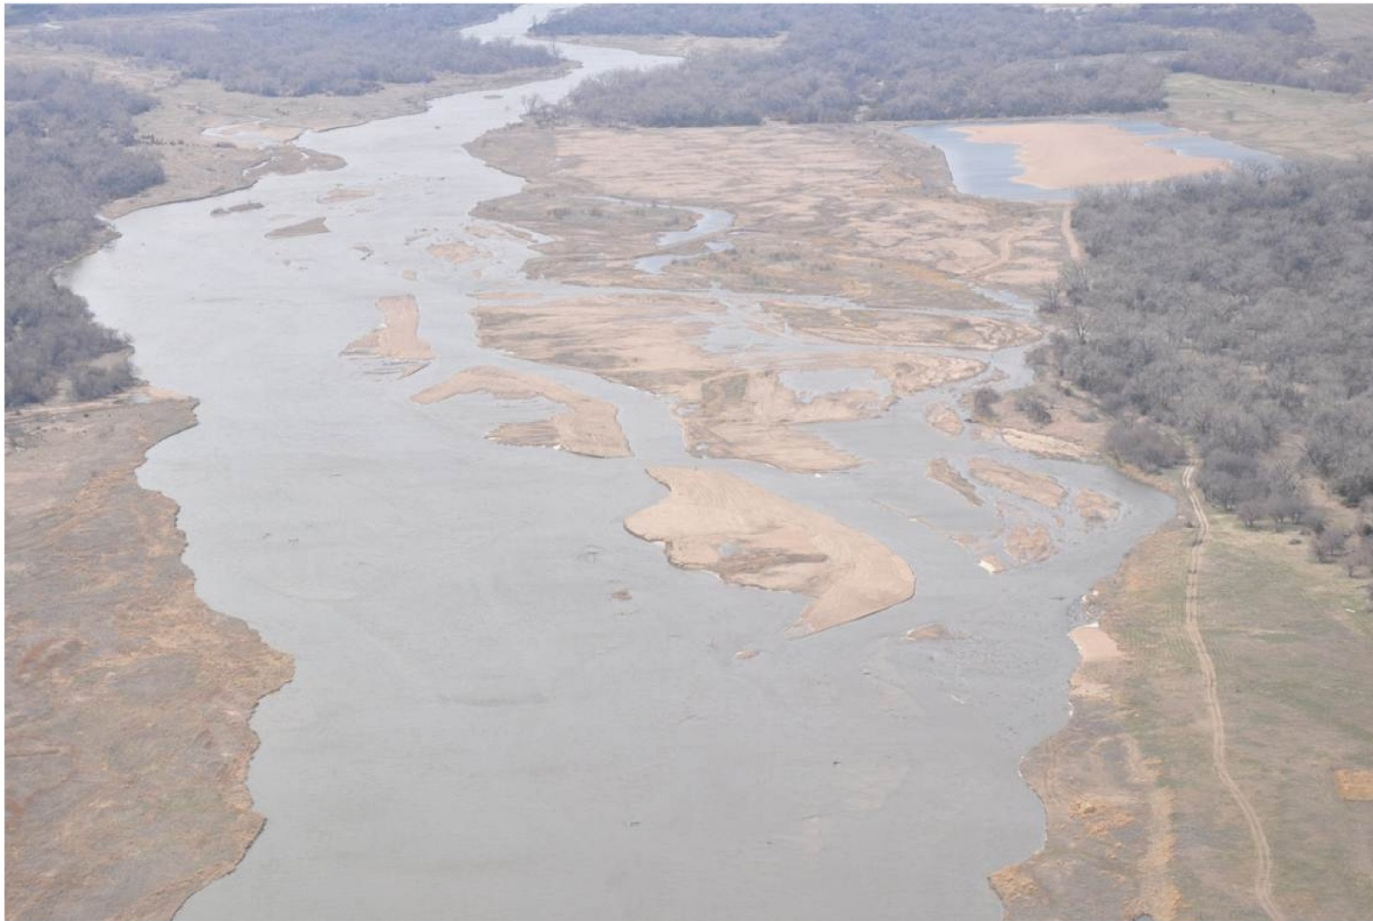
Cottonwood Ranch at the Conclusion of Phase II

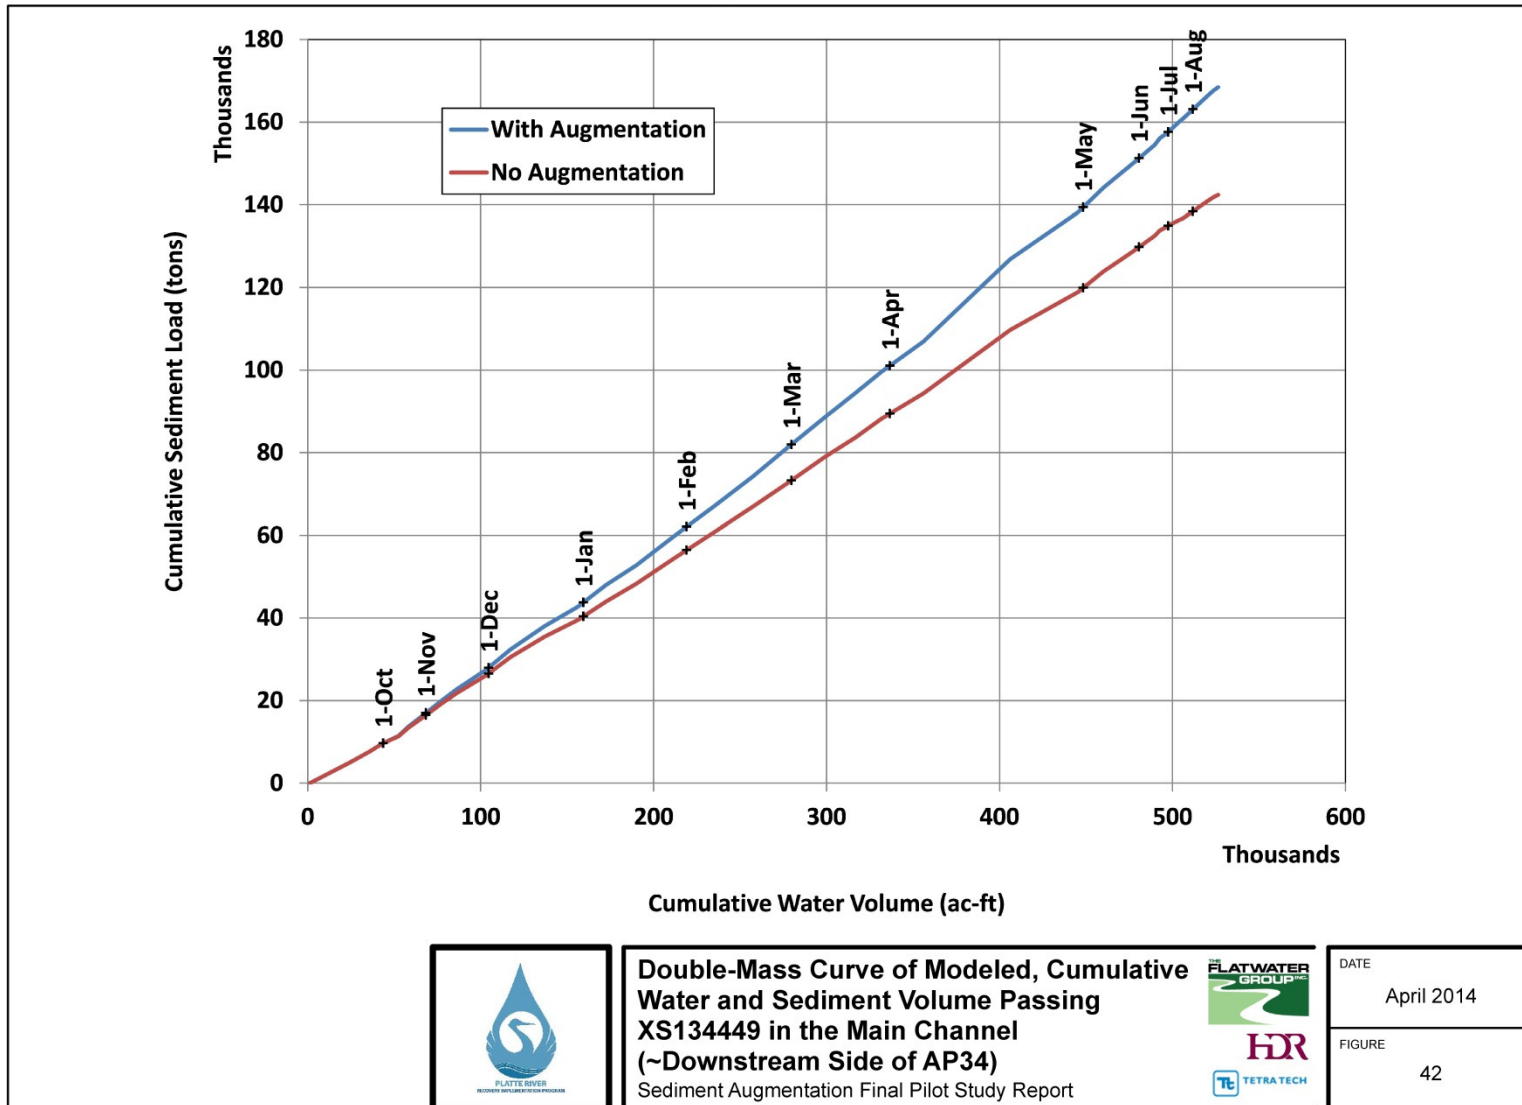
Double-Mass Curve of Modeled, Cumulative Water and Sediment Volume Passing XS13449 in the Main Channel (~Downstream Side of AP34)
Sediment Augmentation Final Pilot Study Report

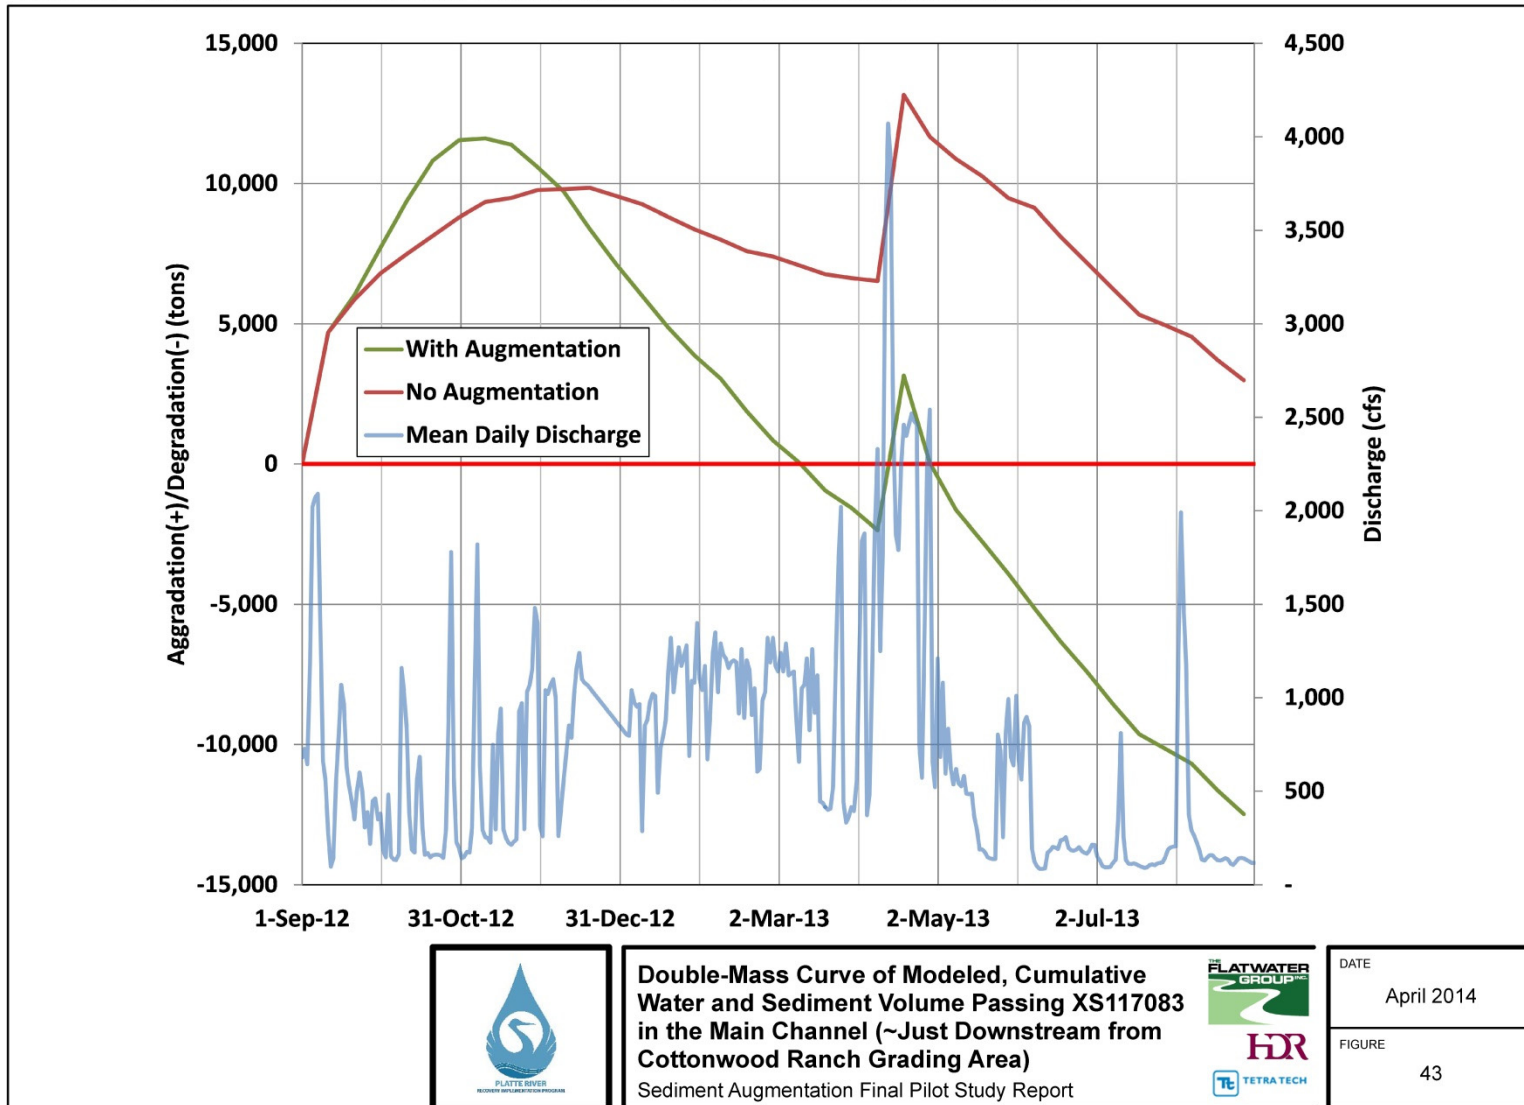
Double-Mass Curve of Modeled, Cumulative Water and Sediment Volume Passing XS117083 in the Main Channel (~Just Downstream from Cottonwood Ranch Grading Area)
Sediment Augmentation Final Pilot Study Report

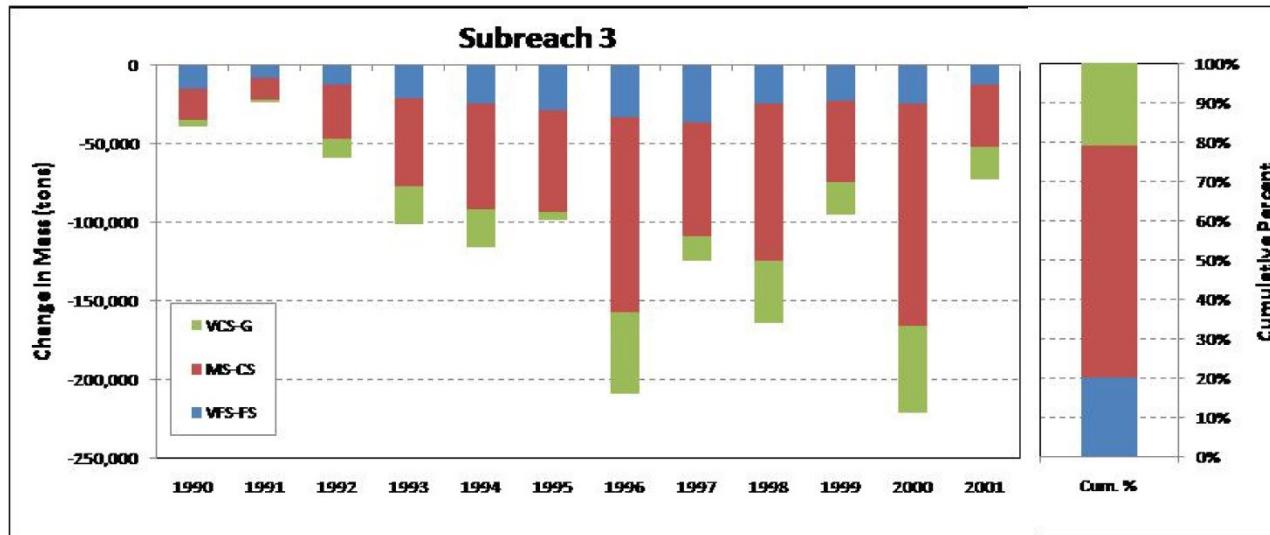
Annual Mass Eroded or Deposited Between the Overton and Elm Creek Bridges by Size Fraction, and the Cumulative Percentage Deposited Under No-Augmentation Condition
Sediment Augmentation Final Pilot Study Report

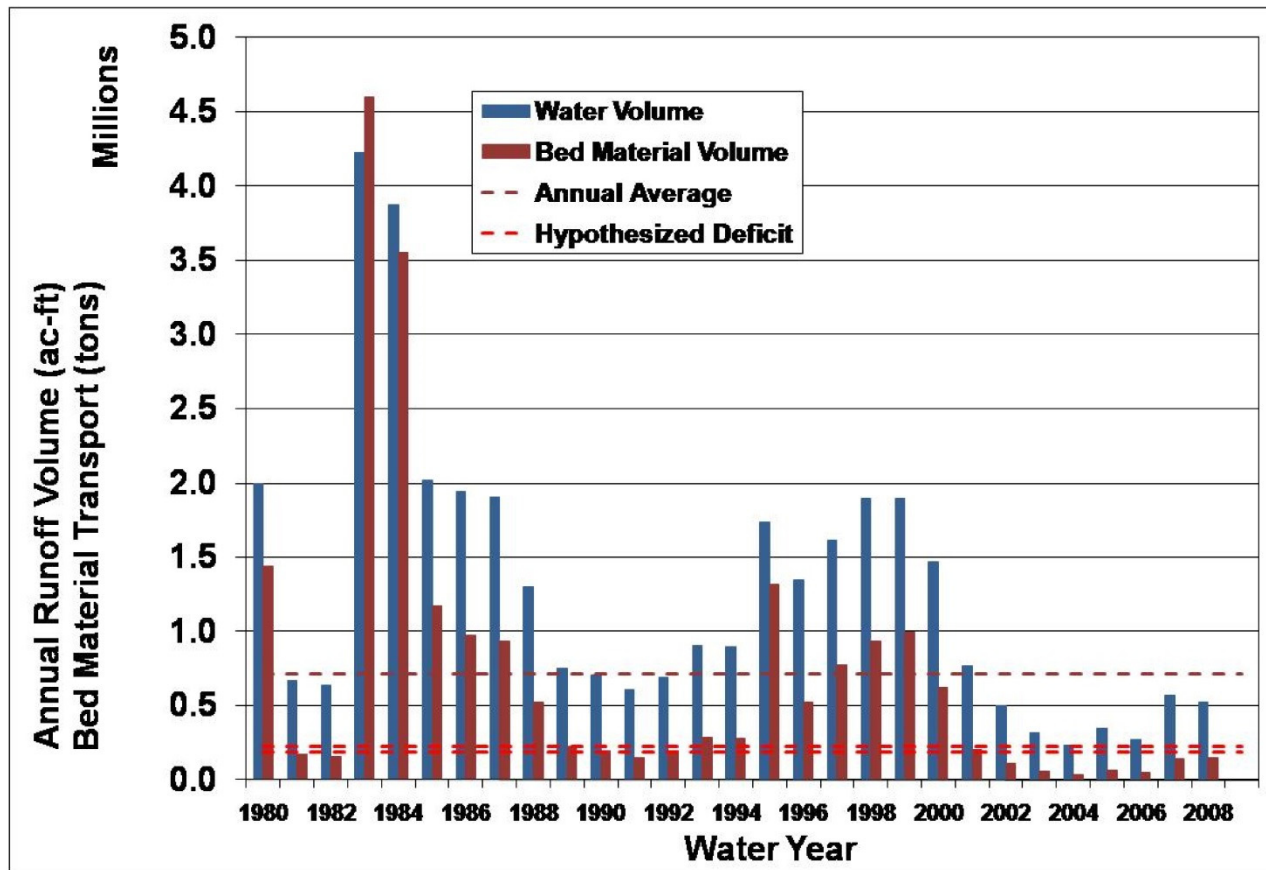
Estimated Annual Bed Material Sediment Load Passing the Overton Gage for WY1980 through 2008

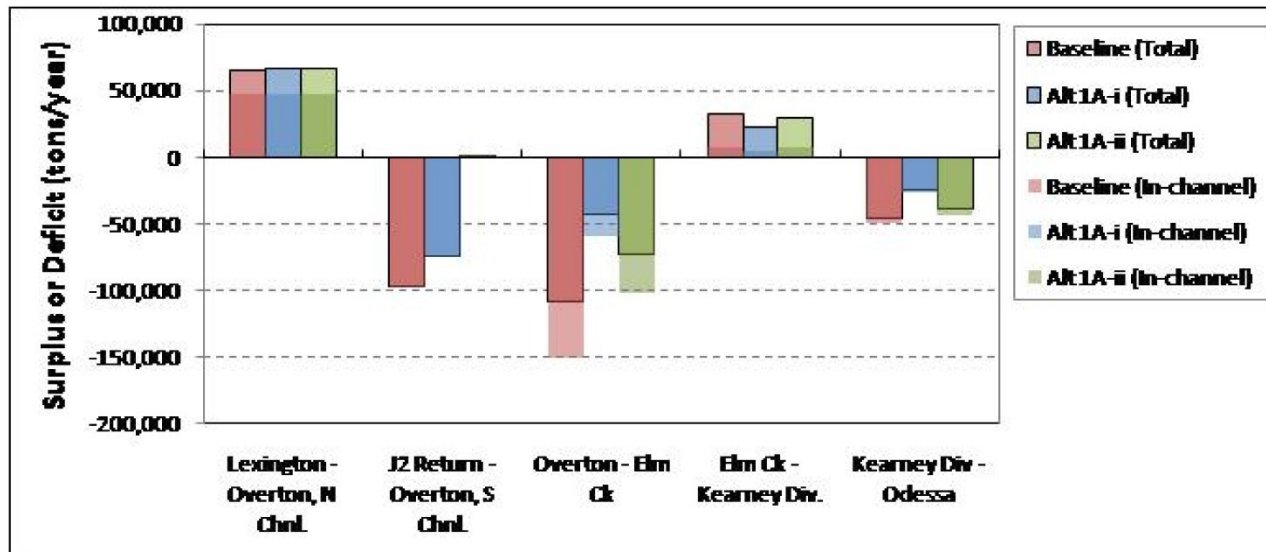
Comparison of Total and In-Channel Surplus or Deficit by Subreach Under Baseline, Alternative 1A-i and Alternative 1A-ii
Sediment Augmentation Final Pilot Study Report

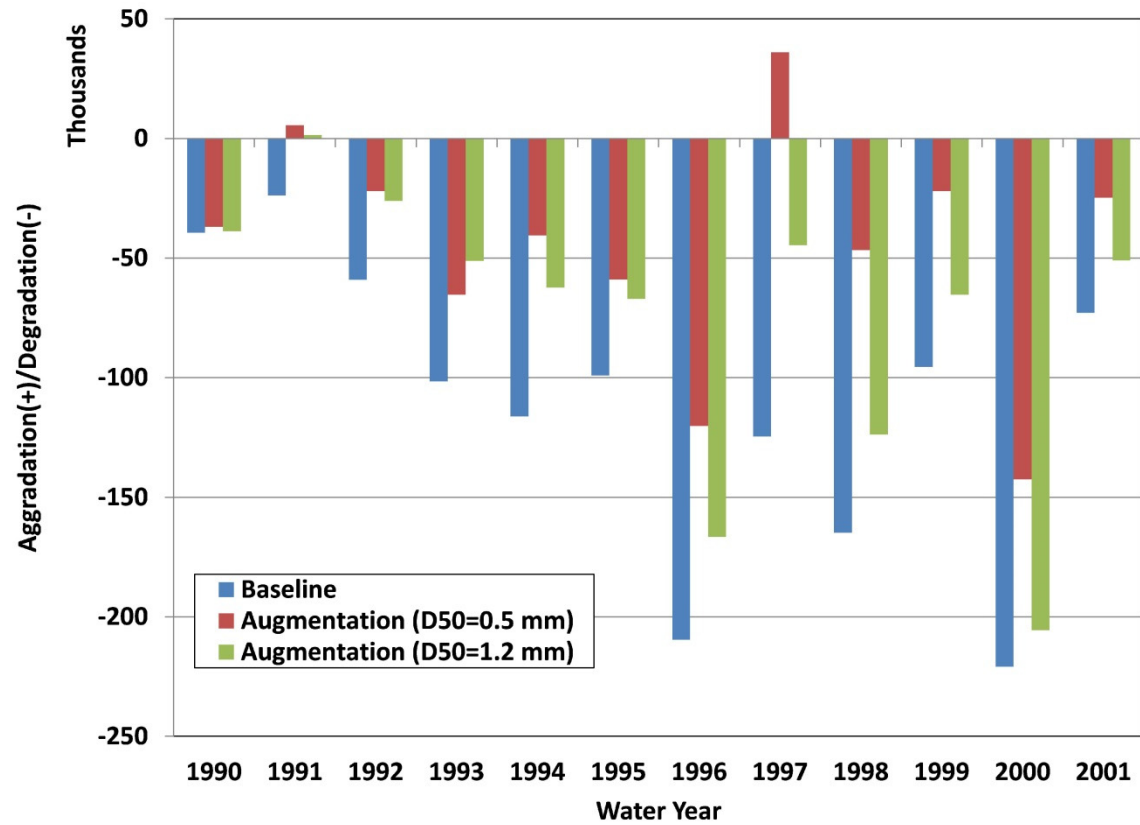
Year-to-Year Sediment Balance in Reach 3 (Overton to Elm Creek Bridge)

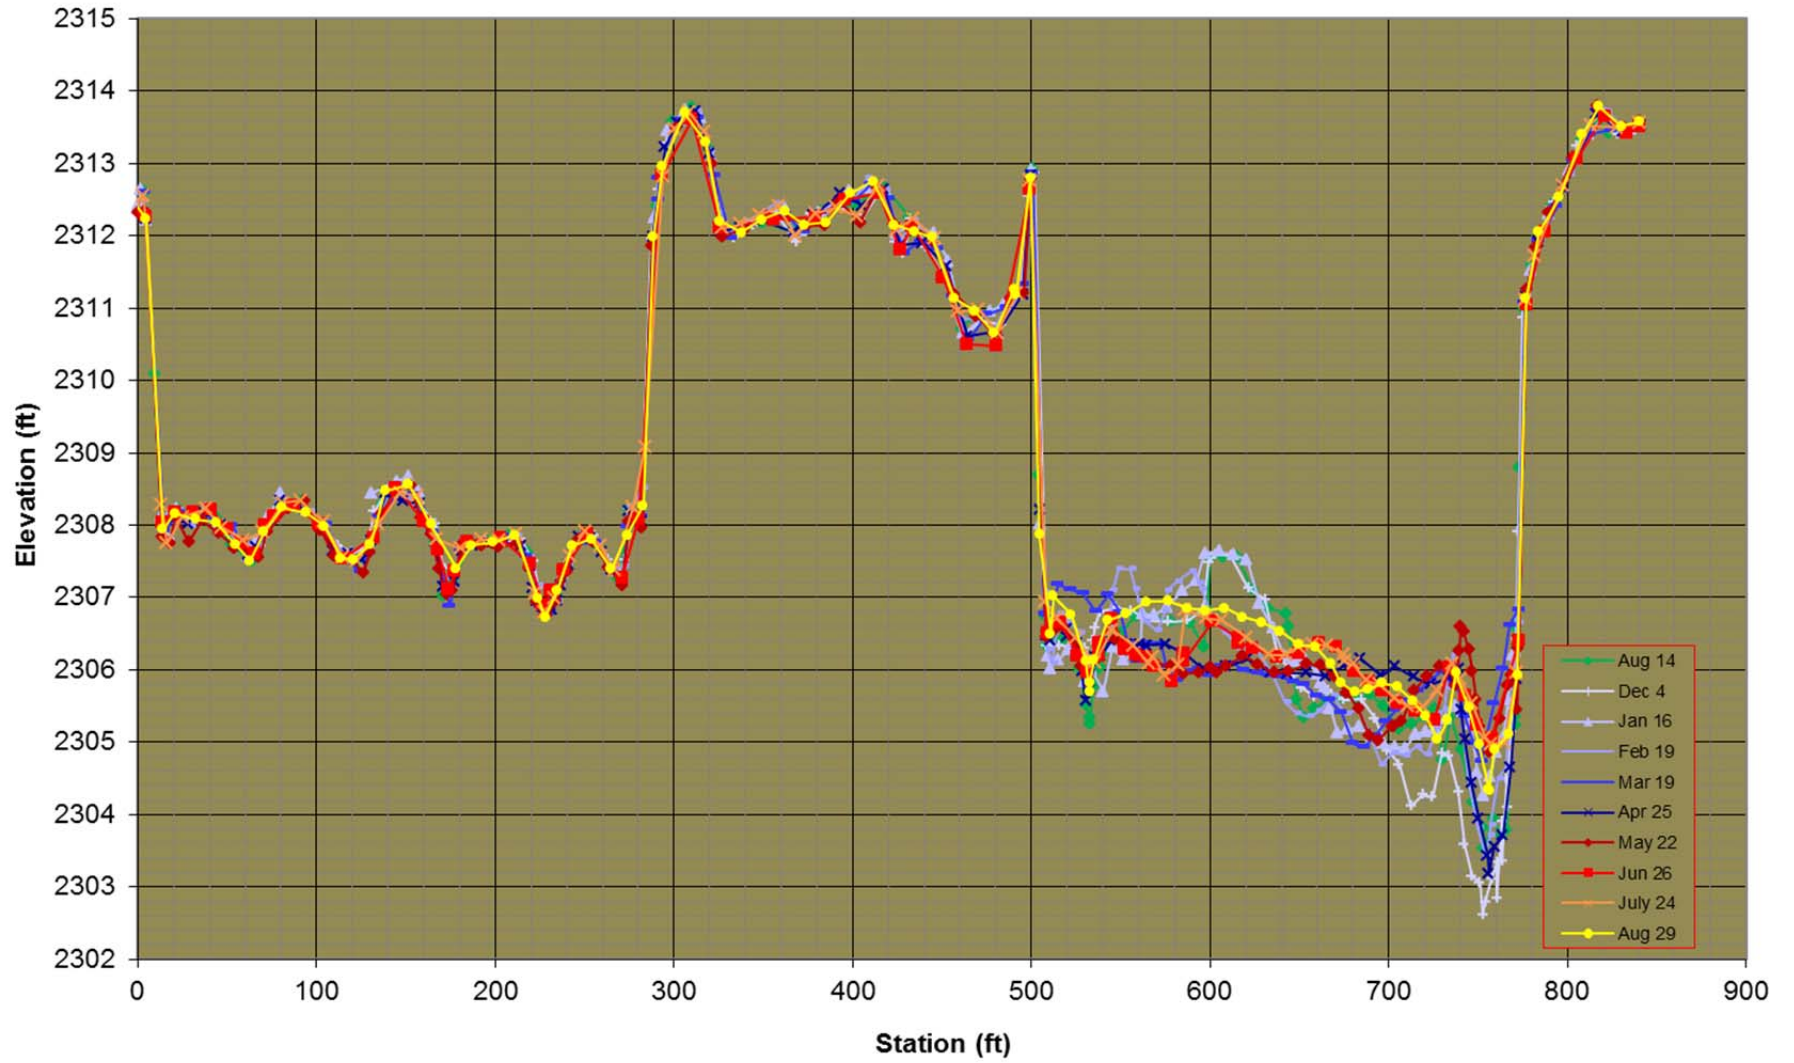
Dyer XS-1 Monitoring Cross-Section Comparison

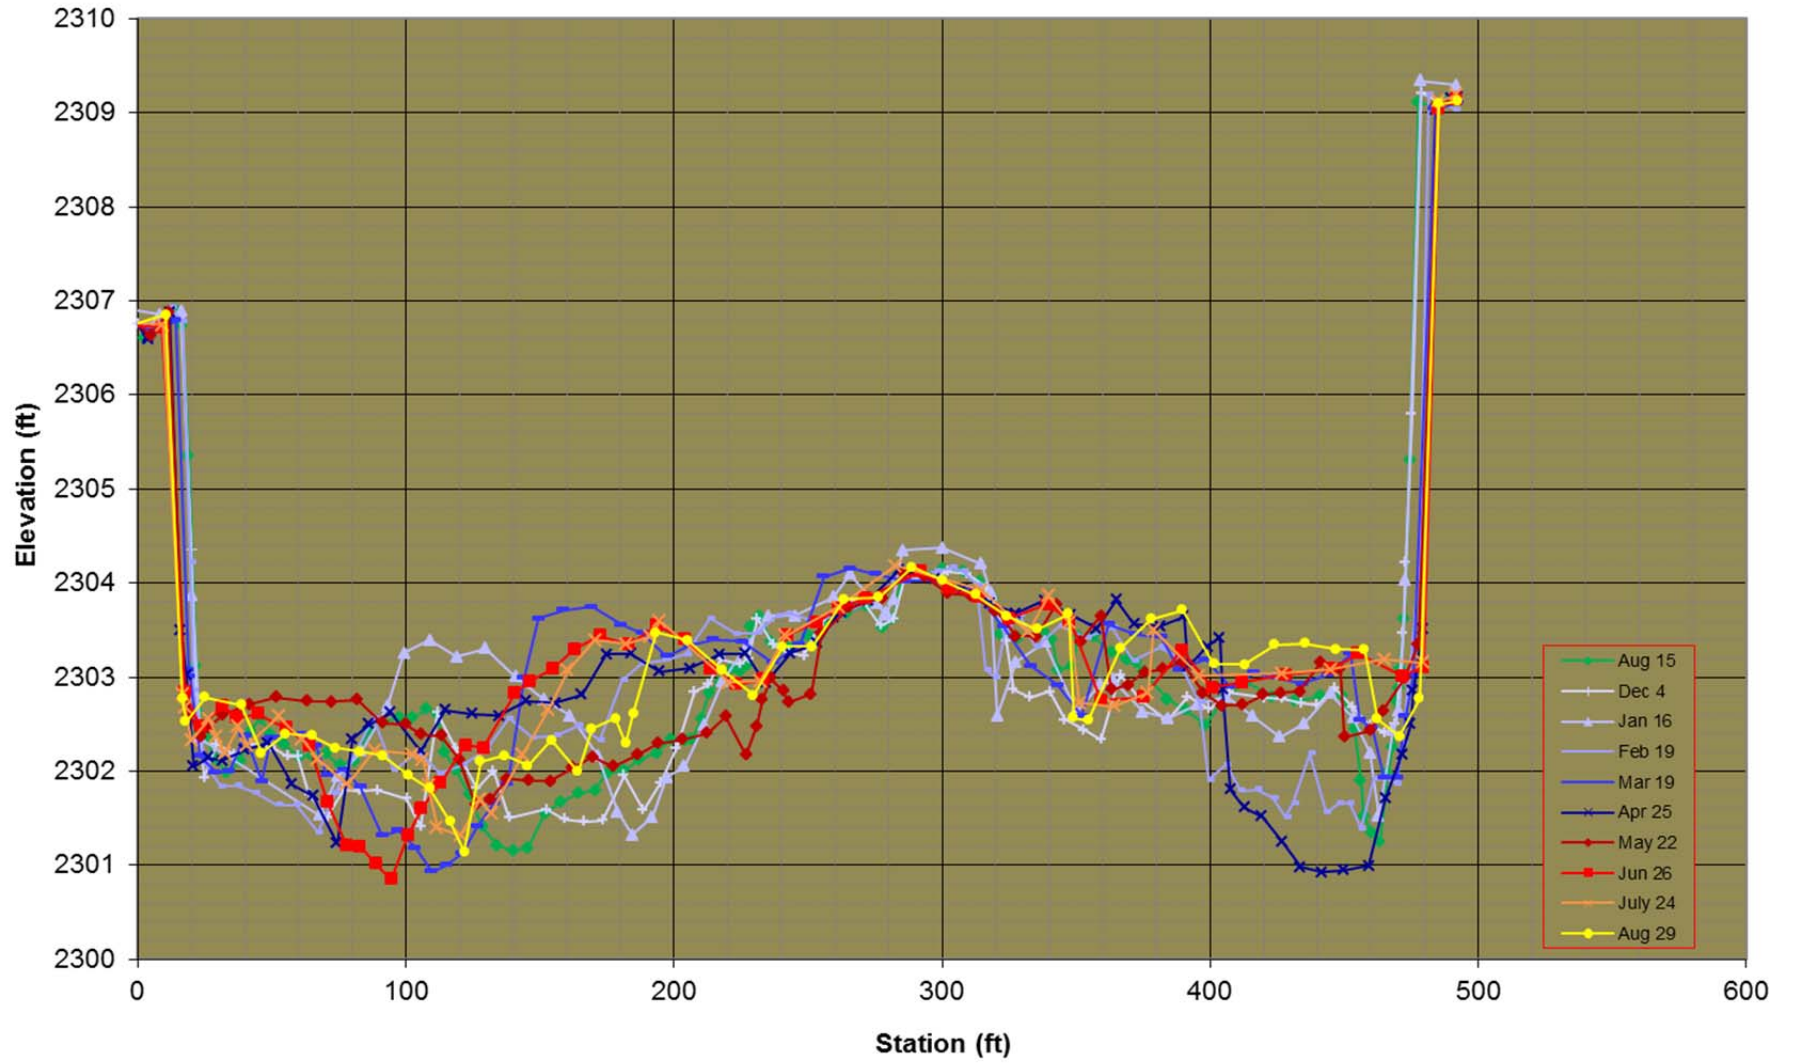
Dyer XS-3 Monitoring Cross-Section Comparison

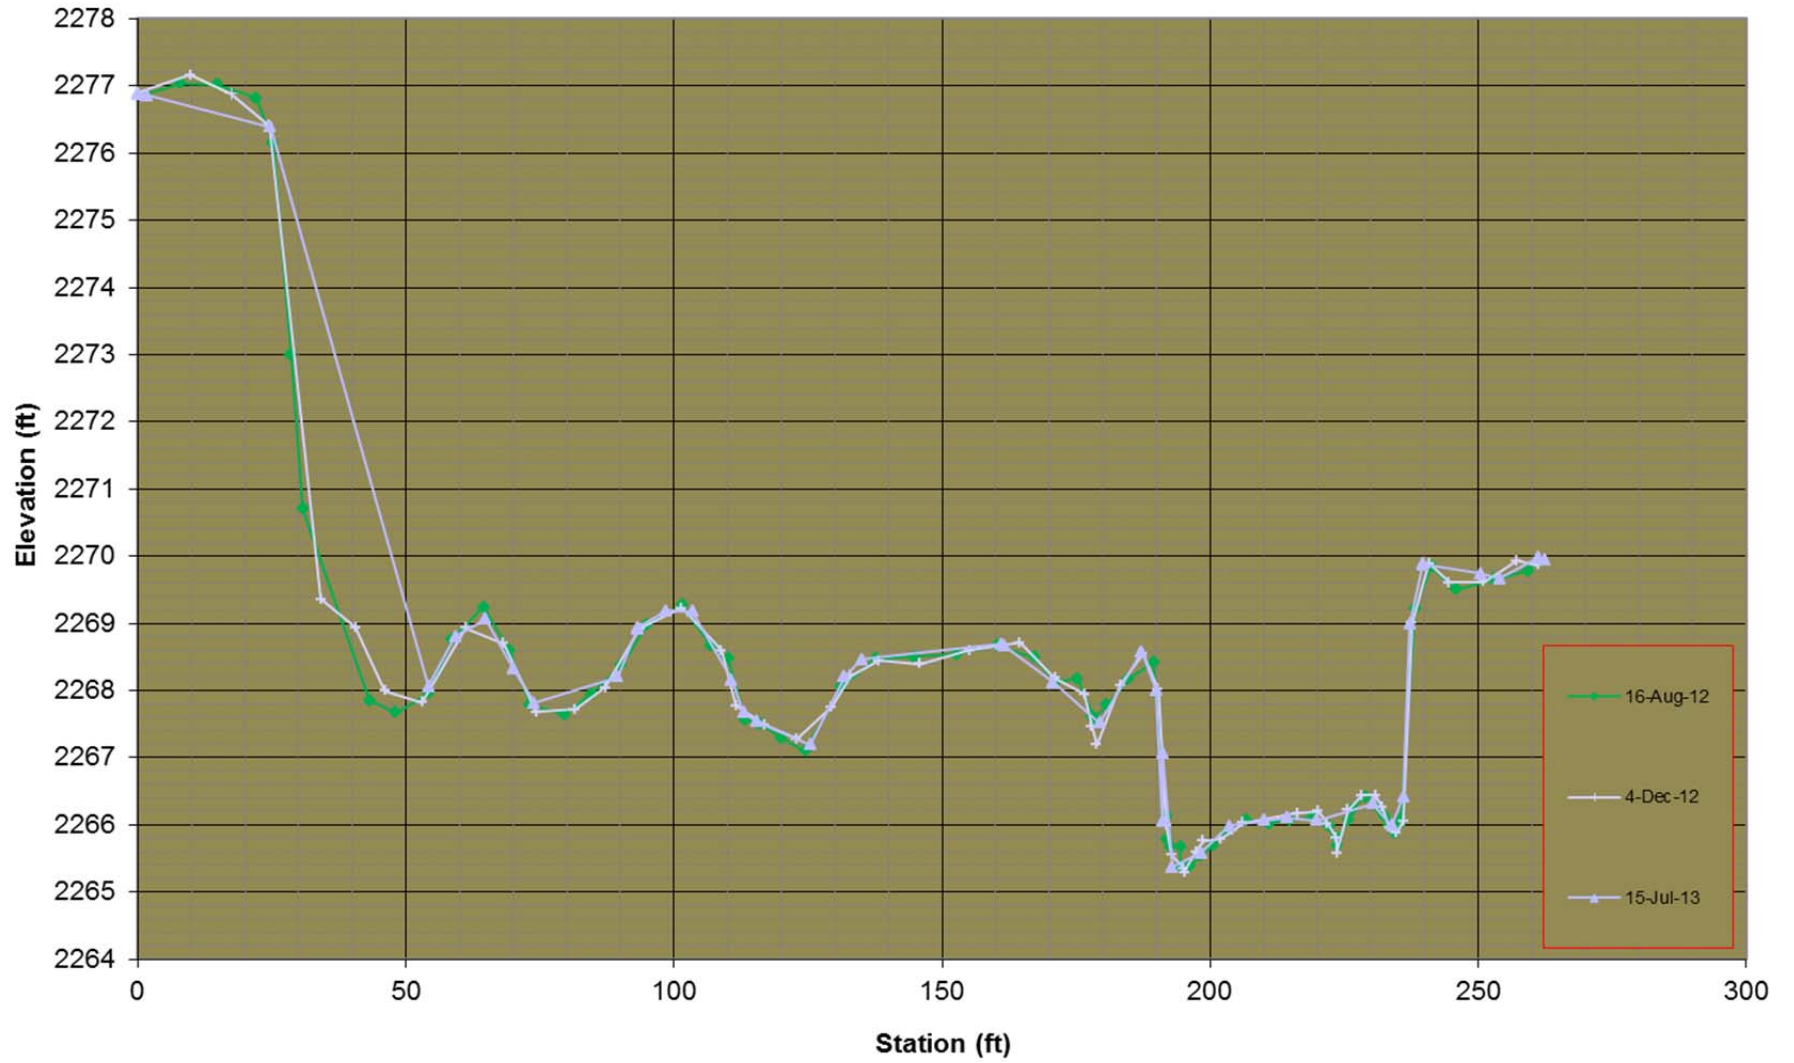
AP32B1 Monitoring Cross-Section Comparison

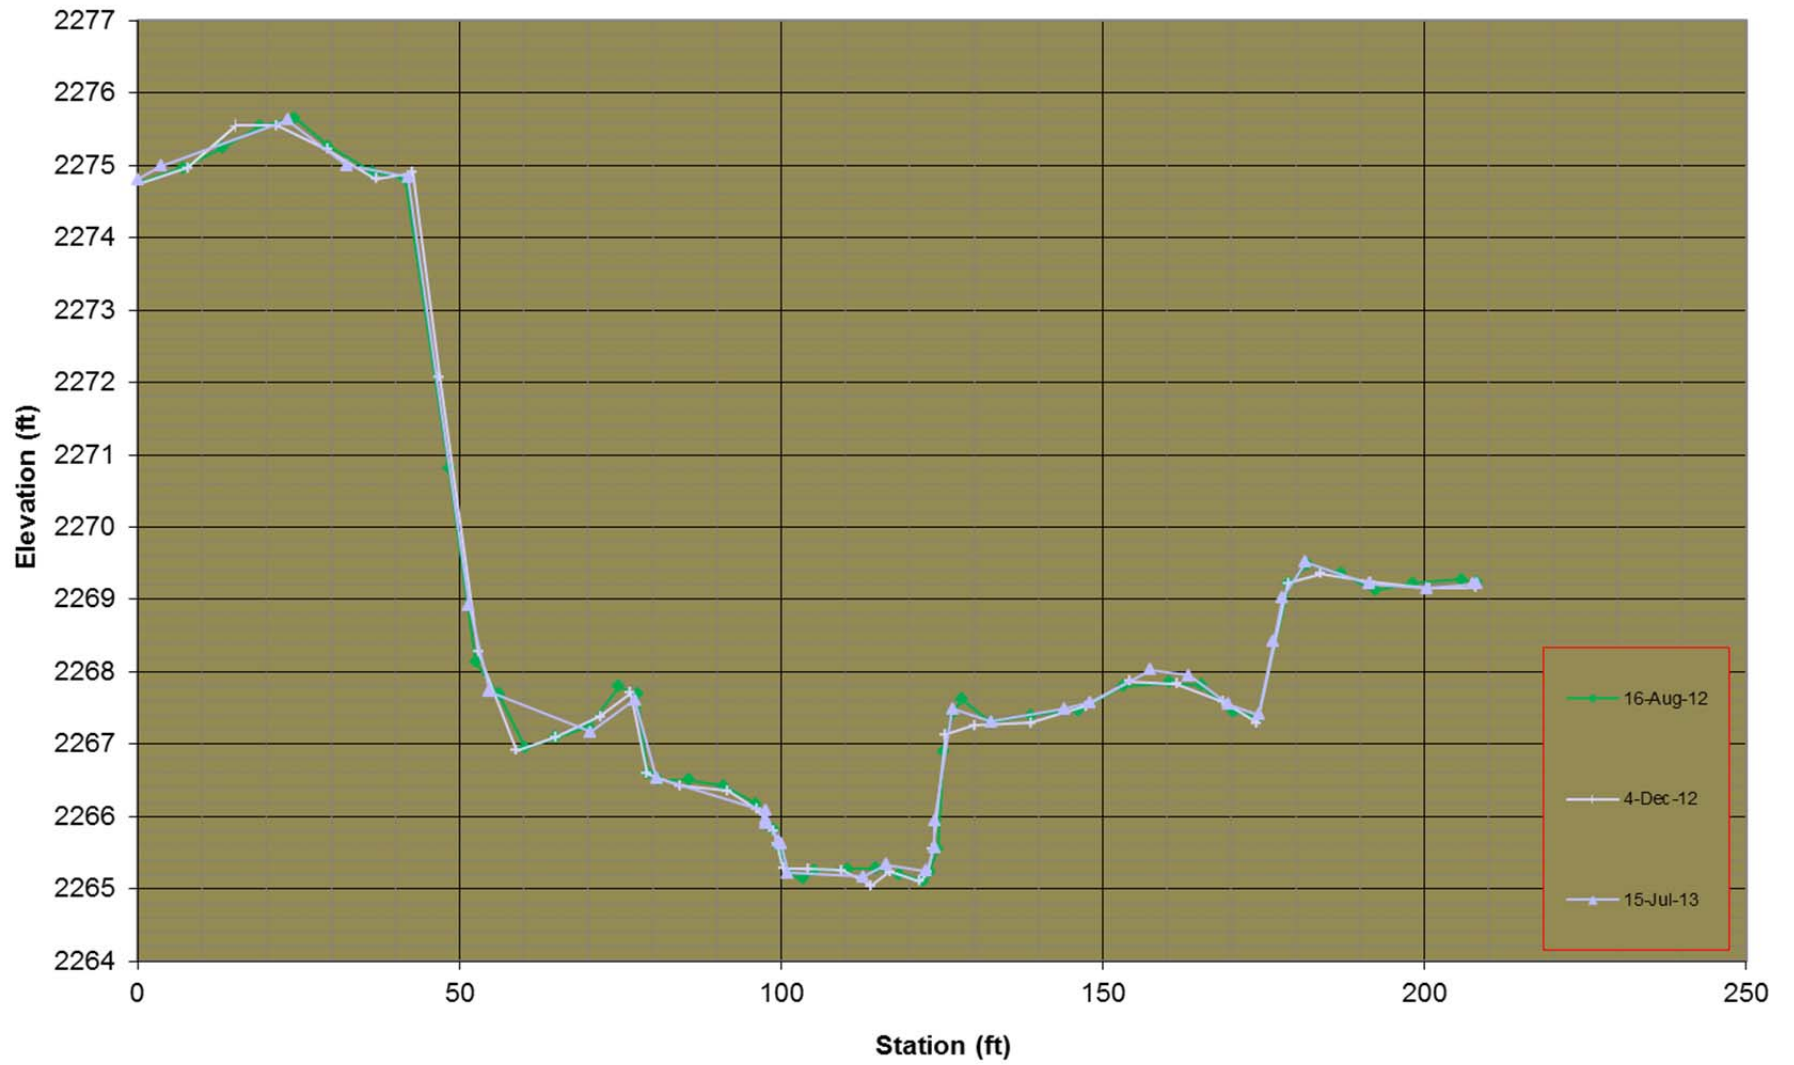
AP32B4 Monitoring Cross-Section Comparison

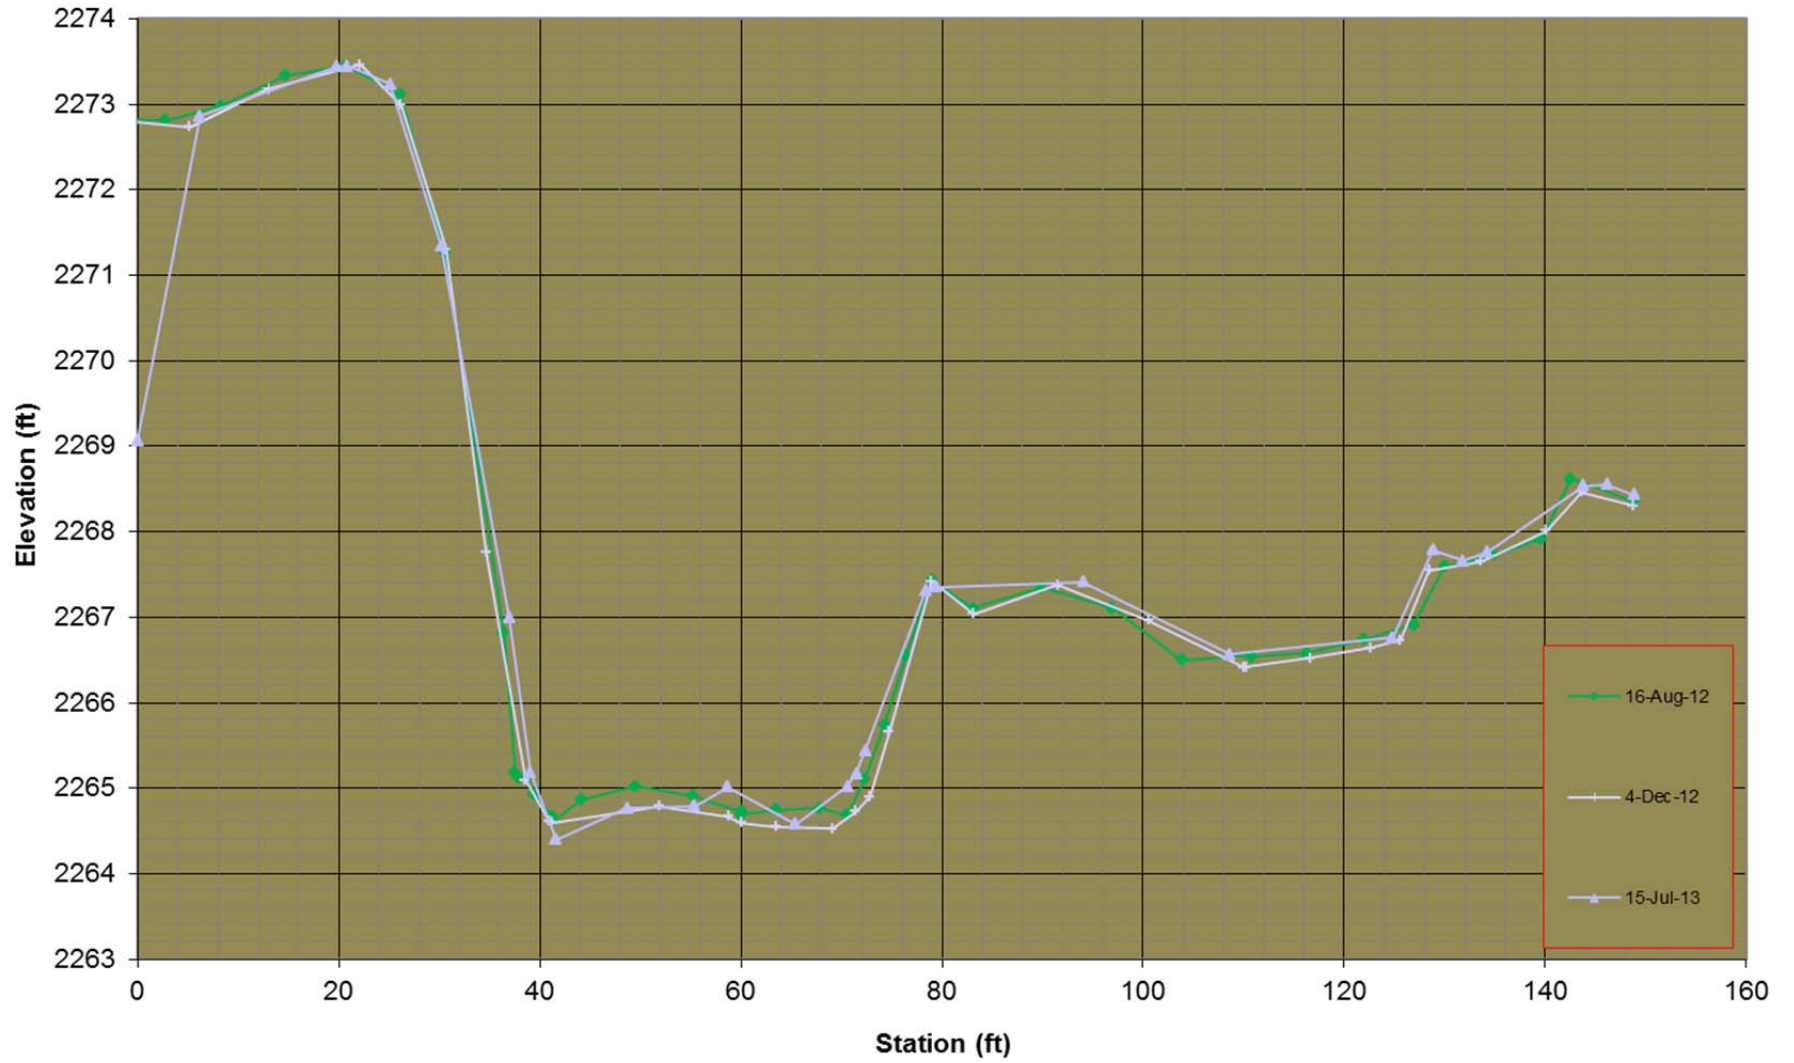
AP32B7 Monitoring Cross-Section Comparison

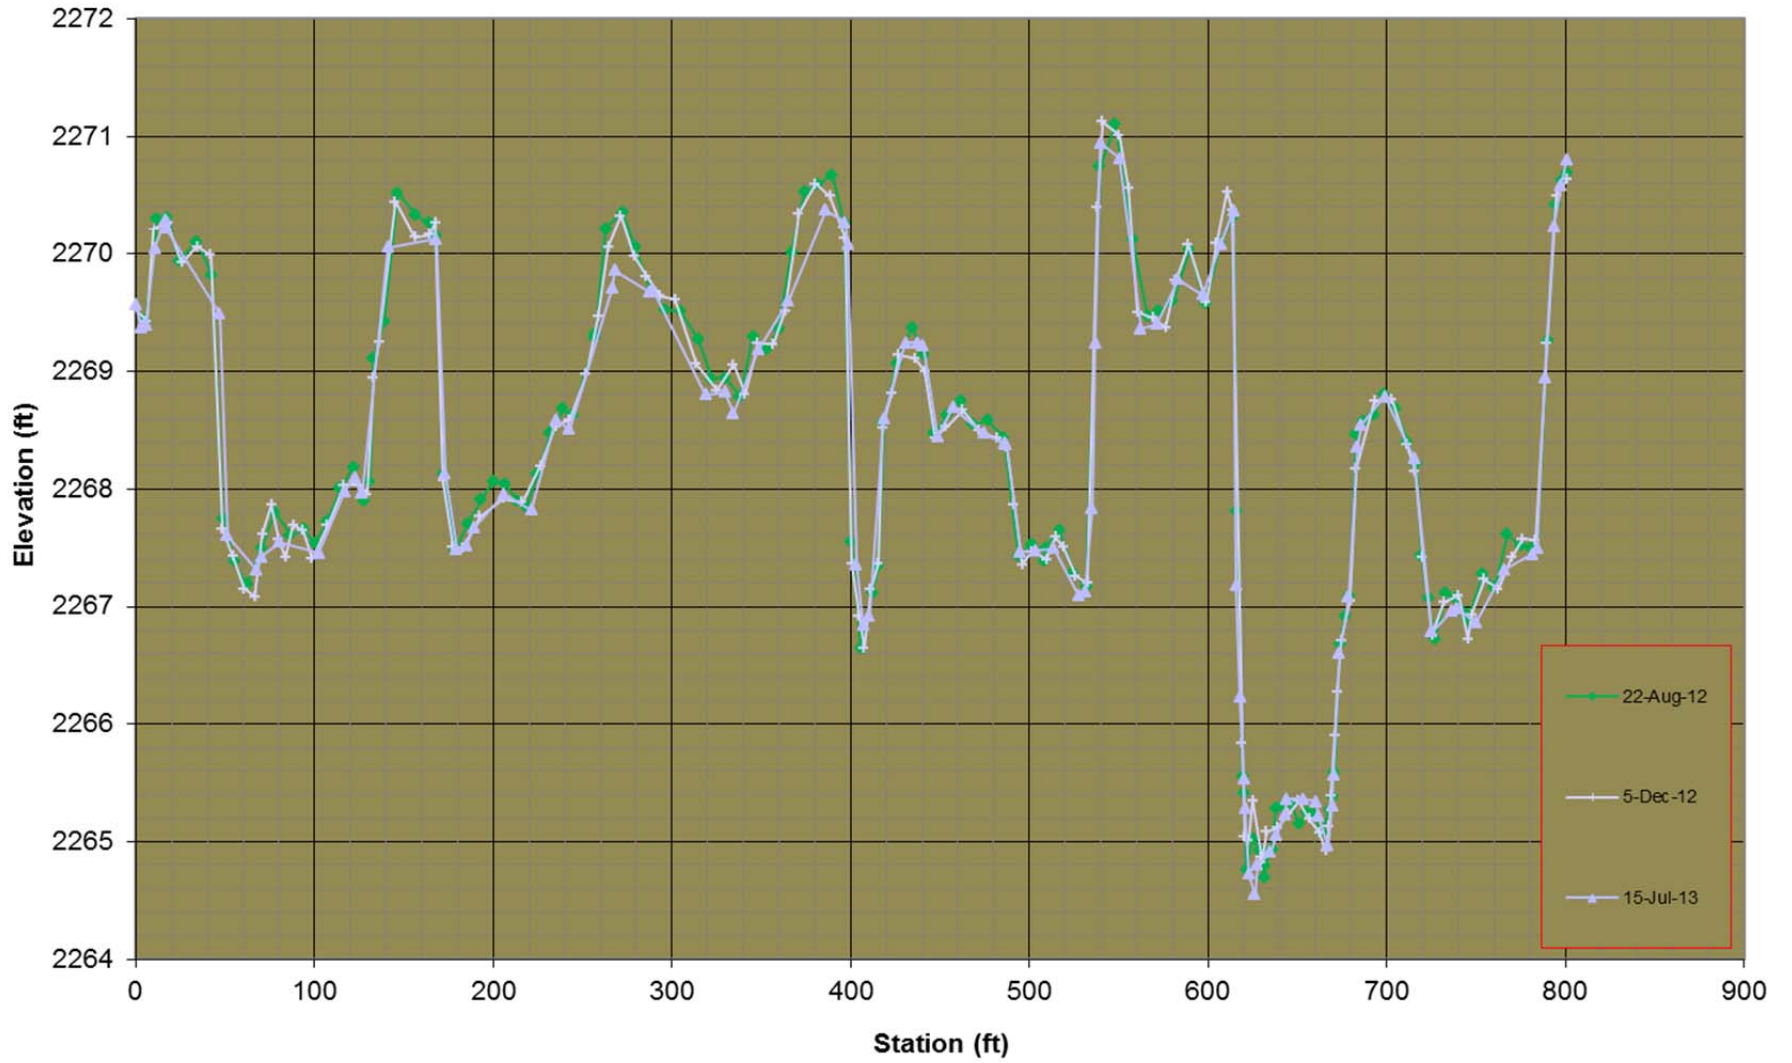
AP32C1 Monitoring Cross-Section Comparison

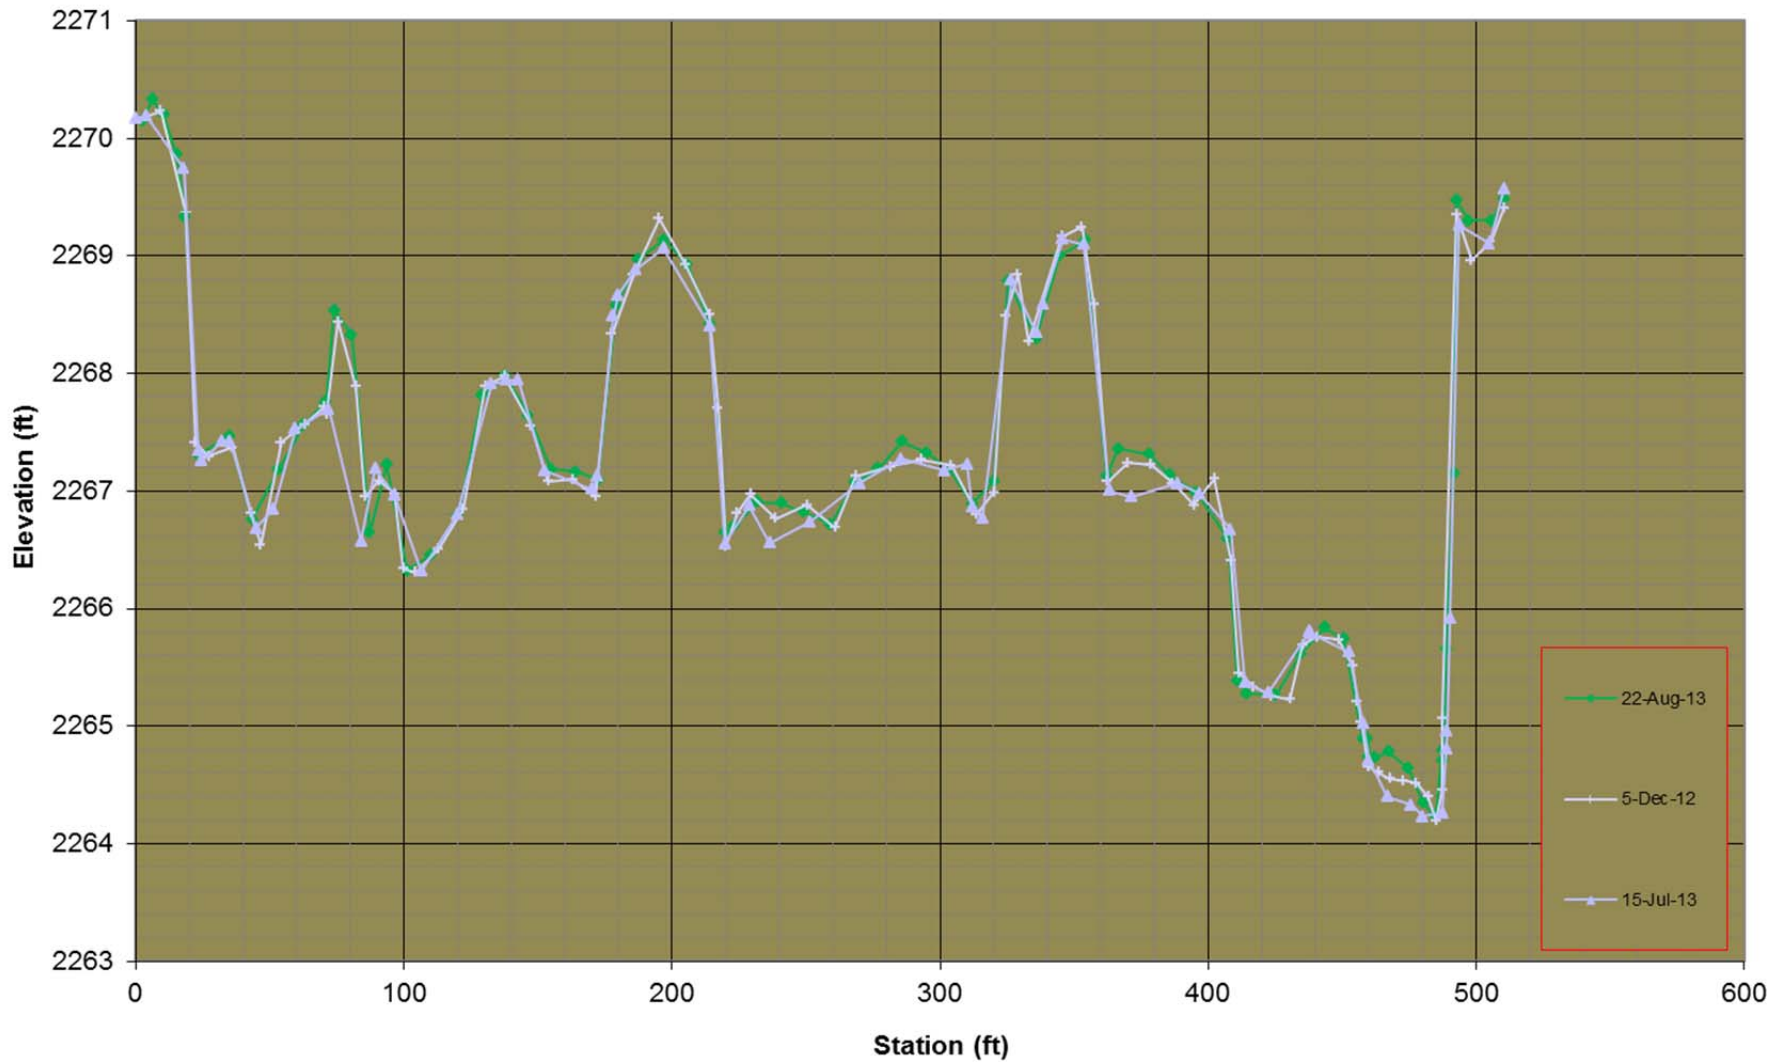
AP32C4 Monitoring Cross-Section Comparison
