SEDIMENT AUGMENTATION FINAL PILOT STUDY REPORT

PLATTE RIVER RECOVERY IMPLEMENTATION PROGRAM

April 2014

**The Flatwater Group, Inc.
In association with
HDR Engineering, Inc. and Tetra Tech, Inc.**

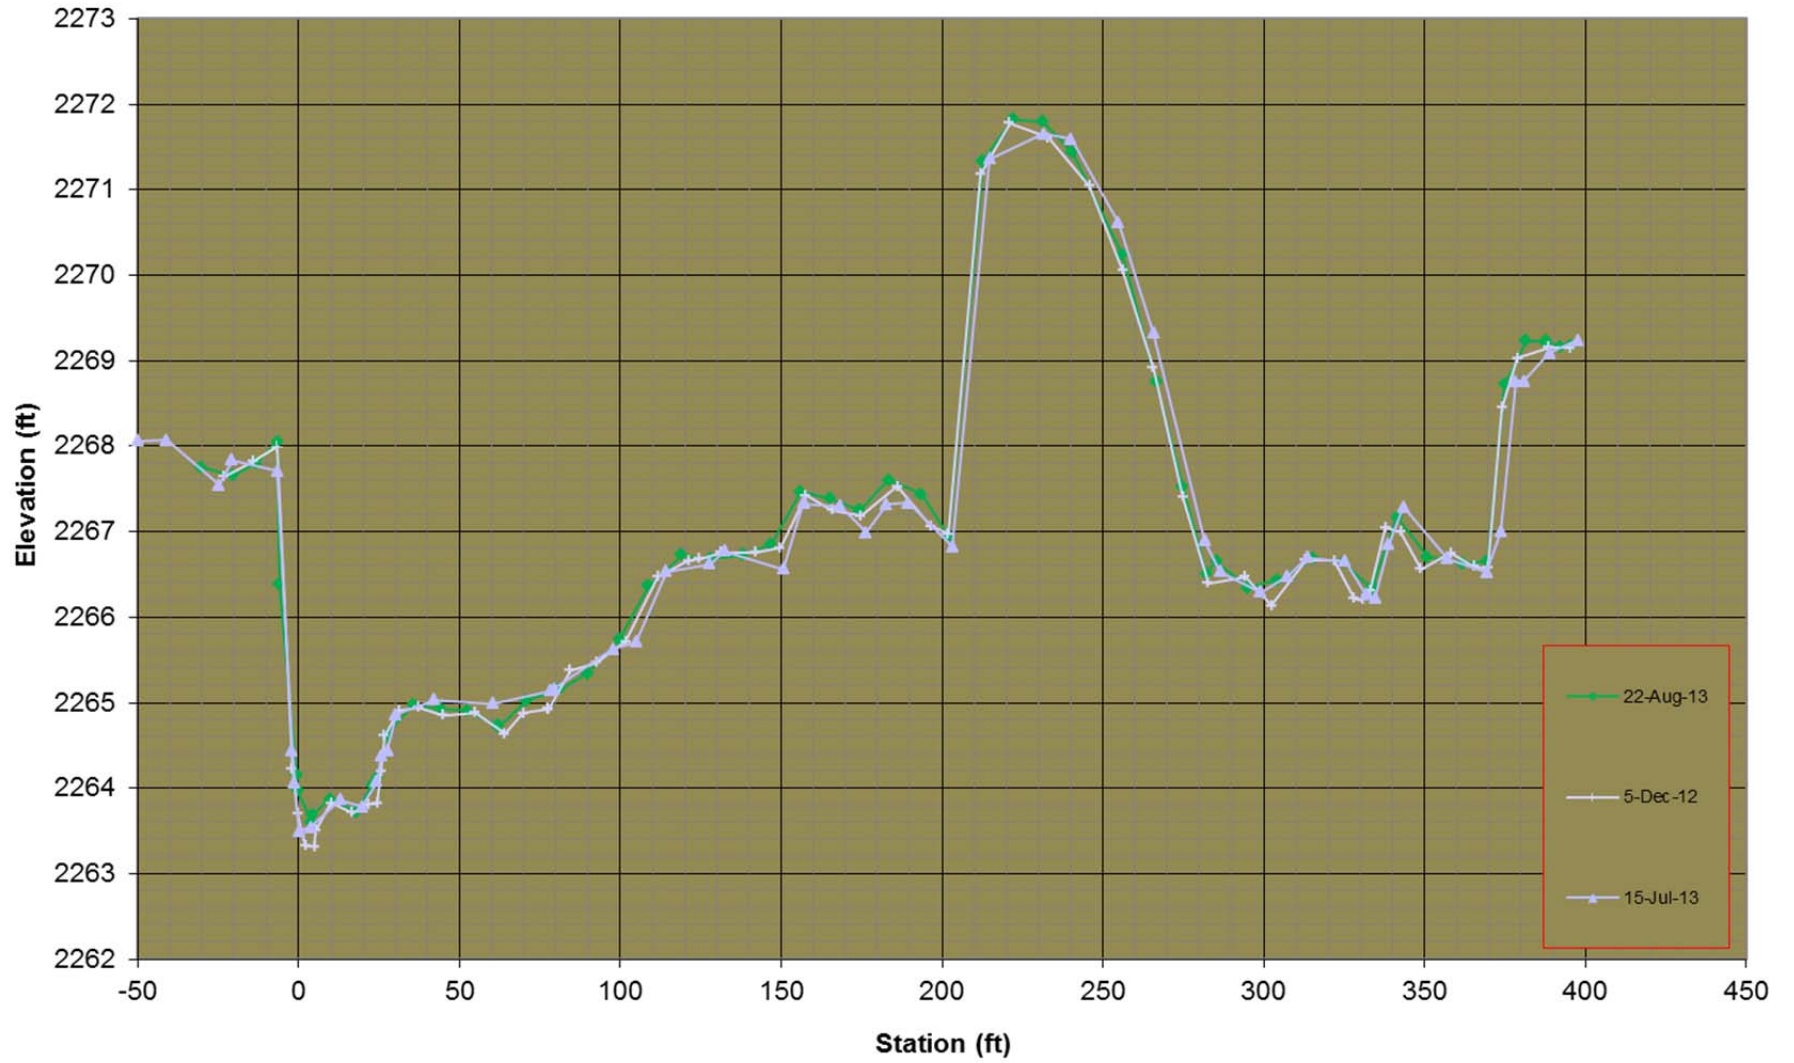
AP32C7 Monitoring Cross-Section Comparison
