NORTH PLATTE RIVER CHOKEPOINT GEOMORPHOLOGY AND SEDIMENT TRANSPORT STUDY

Prepared in Support of the Platte River Recovery Implementation Program

November 22, 2024 Final

Anderson Consulting Engineers, Inc. 375 East Horsetooth Road, Building 5 Fort Collins, CO 80525

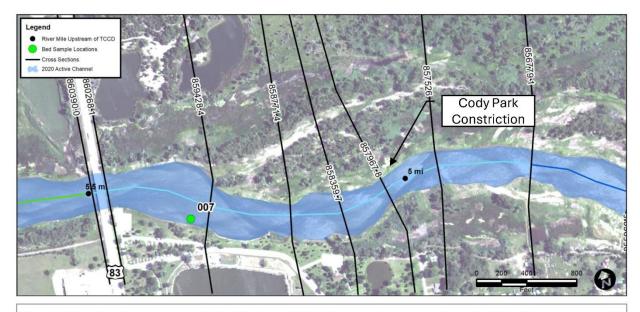
Figure 2-7 Reach 3 Upstream of HWY 83 Summary

Reach 3 is upstream of the Highway 83 Bridge, beginning approximately 6.8 miles upstream of the Tri-County Canal Diversion Structure. The 1.3-mile-long reach is slightly sinuous and includes two large vegetated islands, multiple side channels, and point (transverse) bars. The reach appears to be aggrading while bedforms (occasional riffles and dunes) are relatively stable. The channel is wider compared to other reaches and is generally laterally inactive; minimal active bank erosion was observed during the field visit. Abandoned side channels are visible in the floodplain, which likely reactivate during high flow events (i.e., greater than bankfull). The bars, primarily composed of coarse sand, are actively forming, which allows for bar migration and a mobile bed along the reach. Riparian vegetation, including woody species such as cottonwoods, and invasive phragmites are present in the floodplain and islands. Hydraulic structures of influence include the recently rehabilitated State Channel Berm, the old HWY 83 embankment and the existing Highway 83 Bridge.

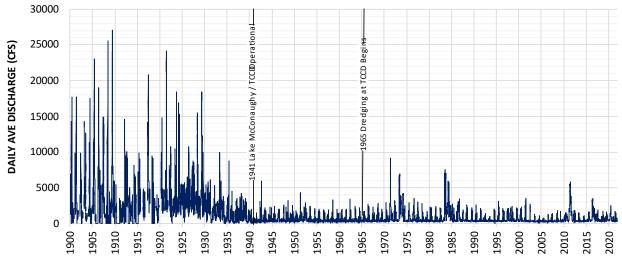
Figure 4-4 Daily Average Discharge 1900-2022 North Platte River at HWY83

Analyses were divided into five time periods occurring between 1900 and 2022. The first period (1900-1941) occurs prior to construction of Kingsley Dam and the TCCD. The following four time periods of 1942-1969, 1970-1989, 1990-1999, and 2000-2022 were divided based upon sustained trends in hydrologic periods determined by patterns in peak flows and annual flow volumes. Division of these time periods also coincide with trends in sediment aggradation or degradation estimated from specific gage analyses conducted at HWY 83 and Sutherland. Specific gage analyses are presented in a separate section of this report (see Section 5.4).

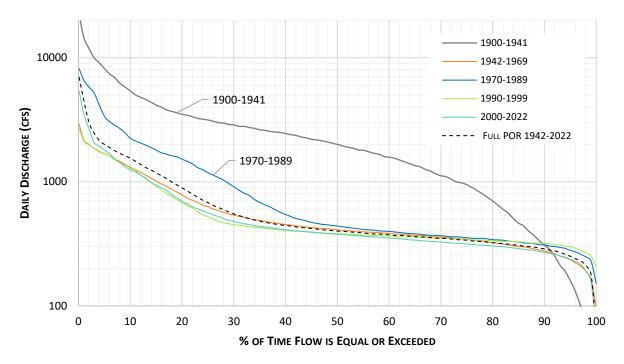
Figure 4-6 Daily Flow Duration Curves North Platte River at HWY 83

Daily flow duration curves developed for each time period are shown graphically in Figure 4-6. The flow duration curves further illustrate differences in flows before and after 1942. Compared to other periods after 1942, the curve for 1970-1989 is a clear outlier because of high flow events in the early 1970s and mid-1980s. The flow exceeded 10% of the time between 1970-1989 is roughly 2,200 cfs as compared to 1,300 cfs for the other three time periods after 1942. An even larger deviation is noted at the 2% exceedance flow where during 1970-1989 it is approximately 5,800 cfs as compared to 2,000 cfs for 1942-1969, 1,980 for 1990-1999 and 2,680 for 2000-2022.

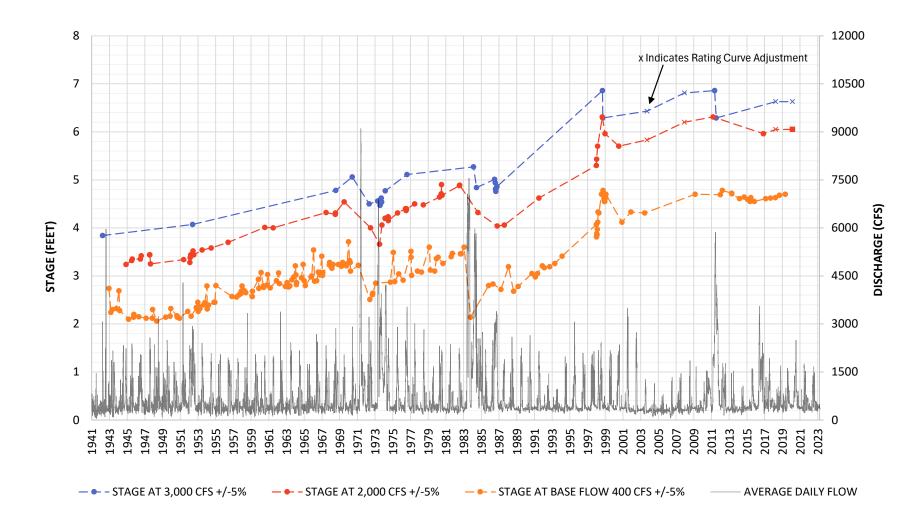
Figure 5-2 Specific Gage Analysis North Platte River at HWY 83 1942-2022

After 1999 both locations show a general stabilization of stage with some fluctuation. The stabilization of stage, especially after 2010, might suggest that the sediment "slug" has largely moved through the system. It may also indicate that the river is approaching quasi-equilibrium if hydrologic conditions remain relatively constant. This conclusion should be taken with caution, as projecting specific gage records into the future is not recommended (Biedenharn et. al. 2017).

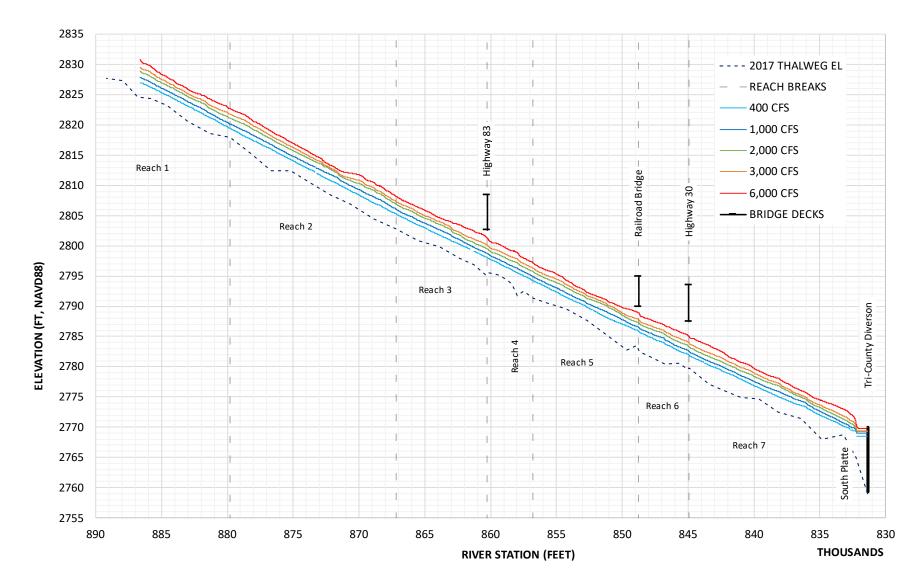
Figure 5-5 North Platte Chokepoint 2D Hydraulic Model Water Surface Profiles 400 – 6,000 cfs.

Historically, backwater from the TCCD extended approximately 2 miles upstream of the diversion, which has resulted in formation of a "sediment wedge" (see Section 7.2). The 2017 bed profiles show significant channel aggradation of 5 to 8 feet between HWY 30 and the TCCD (see Section 7.2). The 2017 bed elevation at the confluence with the South Platte River is approximately 2768.5, which is within 1.5 feet of the ogee spillway crest elevation, as shown in the water surface profile. Backwater specifically related to the TCCD no longer extends much more upstream than the confluence, due to bed aggradation. Currently, there are some backwater effects related to the constriction of flow just below the confluence. Figure 5-6 shows hydraulic model results between the confluence and TCCD. The figure includes inundation mapping, velocity vectors, and water surface elevations and indication of the constriction of flow described above.

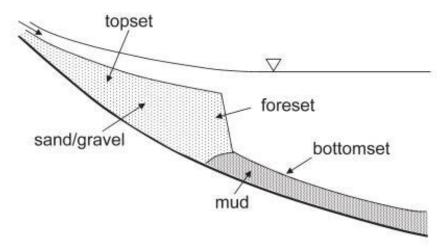
Figure 6-9 Sediment Dynamics of a River Entering a Backwater Zone.

As the North Platte flow nears the region of decreased water surface slope associated with the TCCD, larger sediment sizes will stop moving before more easily transported sediment such as silt and clay (Figure 6-9). Our evaluation of the channel profile (see Section 7.2) shows that between 1940 and 2011 up to eight feet of sediment has been deposited as a wedge from the TCCD upstream to HWY 30 (2.6 miles, about 14,000 feet) (see Figure 7-19). It is reasonable to assume that fine sediments transported as wash load do not settle out due to water PPNID continuously pushing water through the TCCD, but the deposition of sand and larger sized sediment fits the conceptual diagram.

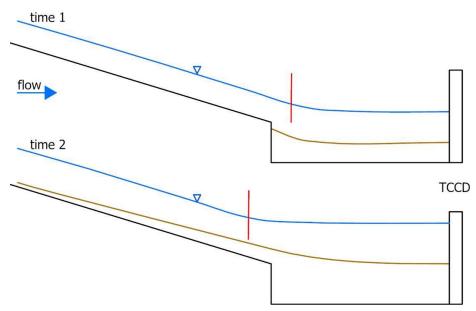
The 1D model calculates the bed variation in streamwise dimension. This simplification assumes bedload sediment transport that moves along a uniform, rectangular channel. Thus, all depositional or erosional triggers such as changes in base level can only move sediment longitudinally and ignore the ability of a river to adjust its width by eroding or depositing sediment laterally. In addition, capacity-limited channels like the Chokepoint segment are better conceptualized as a tank or bathtub at the end of a flume (Figure 6-10).

Figure 6-10 Conceptual Diagram of the Side-View of a Flume Entering a Tank that Fills with Sediment. The downstream end of the tank is analogous to the TCCD. The black lines are the tank and flume bed, the brown line is the sediment that has filled the tank and flume, the blue line is the water surface, and the red vertical line is the trigger point of the backwater effect where flow begins to lose sufficient energy to transport sediment.

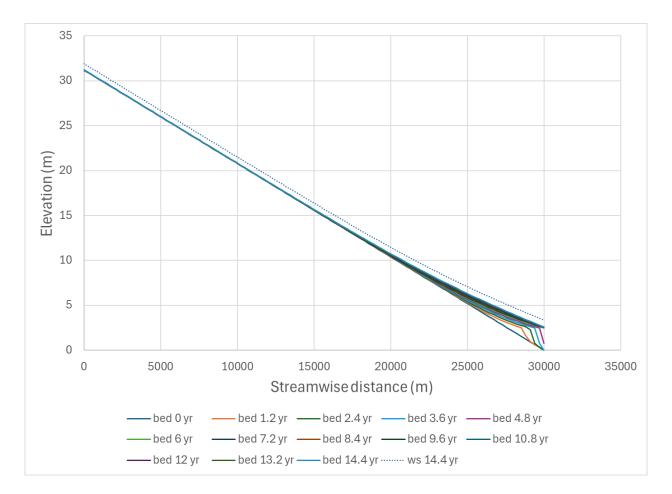
Figure 6-11 Results from 1D morphodynamic modeling of TCCD backwater.

The results also indicate that the "trigger point" will only move once the accommodation space is filled in. This is an important consideration for the longevity of sediment removal/dredging and its effects on backwater at Hwy 83. Note the accommodation space in the "tank" does not need to be filled in completely to have upstream impacts.

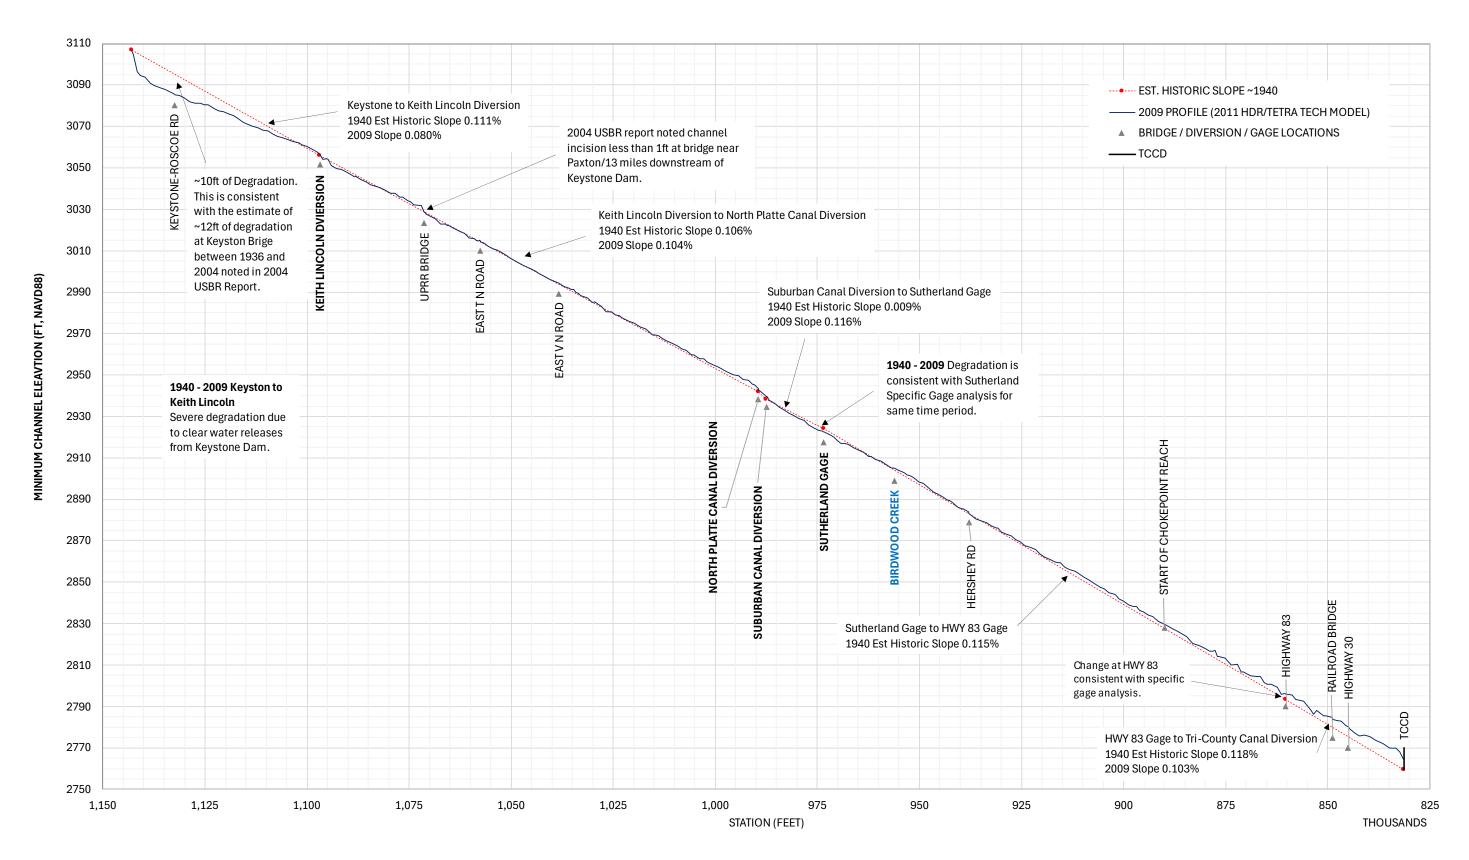
Figure 7-17 North Platte Bed Profile Keystone to Tri-County Canal Diversion 1940 - 2011

Within the current study reach additional bed profile information was obtained from the FEMA Flood Insurance Study (FIS) dated May of 1979. The 1979 FIS included bed profile information from a hydraulic study conducted in 1972. The FIS profile references NGVD29 and was converted to NAVD88 so that comparison to other data sets could be made. Flood Insurance Rate Maps (FIRMs) included in the FIS provided cross section location mapping that was utilized to correlate the FIS profile stationing with the current study. Figure 7-19 shows a comparison of the 1940, 1972, and 2009 bed profiles for the current study reach. Table 7-1 provides a summary and comparison of slope information for the years 1940, 1972, and 2009.

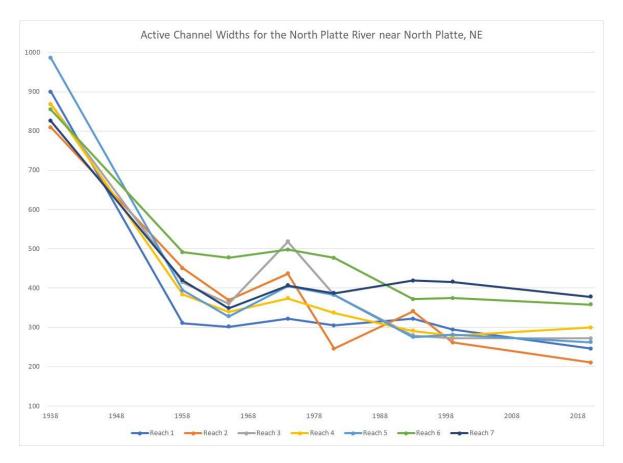
Figure 7-23 Active channel widths between 1938 and 2020

These results collectively document a system that has consolidated into fewer channels over the last century, which has in turn resulted in a narrowing of the active stream corridor and reduction in hydraulic conveyance. These results also demonstrate the relatively wide and shallow nature of the channel geometry of the North Platte River, indicated by bankfull width to depth ratios ranging between 100 and 180. For context, historical bankfull width to depth ratios prior to water development were likely 5 to 10 times higher, which reinforces the observed trend in reduction of the active channel width over the past sixty to eighty years.

Figure 7-23 shows the reduction in the percentage of active channel over time as mature vegetation progressively expanded into the active channel. The complement to the percentage reduction in active channel width is the expansion of vegetation. This analysis highlights that for the locations analyzed in the Chokepoint segment, woody vegetation has expanded onto approximately 70 to 90 percent of the total channel width (leaving only about 10 to 30 percent of the former total channel width as active, non-vegetated width). The development of vegetation on sandbars within the old channel and establishment of woody vegetation on the floodplain coincides with the decrease in hydraulic conveyance through the Chokepoint segment. As noted in USBR (2004), changes in vegetation and channel form are highly dependent and complex, so drawing direct cause-and-effect relationship is difficult. However, the trends summarized above indicate vegetation encroachment is a variable in the stabilization of channel widths as the channel evolved from braided to single-thread. The vegetation changes, particular the increase in mature woody species, have also contributed to the decrease in hydraulic conveyance, primarily through an increase in hydraulic roughness.

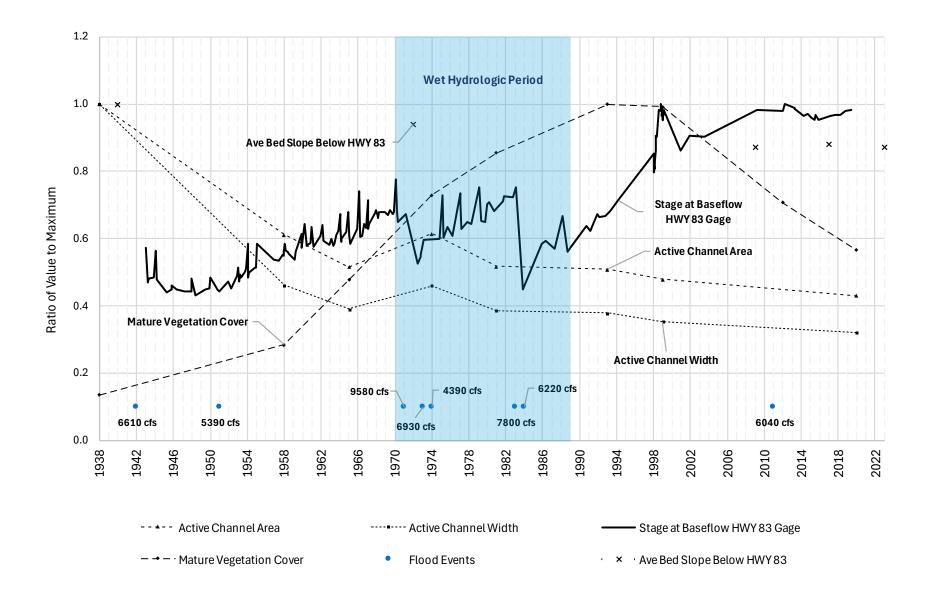
Figure 10-1 Comparison of temporal change in geomorphic analyses.

The various analyses, summarized in Figure 10-1, suggest the evolution of the North Platte River through the Chokepoint over the past approximately 20 years has reached a state of quasi-equilibrium, or dynamic equilibrium. Dynamic equilibrium on the Platte River was defined by Simons & Associates (1990), "This condition of relatively steady widths with minor fluctuations in narrowing and widening." The conclusion that the Chokepoint segment has reached a general state of dynamic equilibrium is supported by the balance between active channel area and vegetated cover area, which for most reaches, has changed little since the 1980s. Further, the bankfull hydraulic capacity, which tends to correlate with the minor flood stage, appears to have settled into a range between approximately 1,200 and 1,700 cfs upstream of Highway 83 and 1,700 cfs downstream to the TCCD structure. Also, a large, sustained flow event, probably greater than the peak flow and duration of the most recent flood event in 2011, would likely disrupt the quasi-equilibrium state
