PLATTE RIVER RECOVERY IMPLEMENTATION PROGRAM

Data Synthesis Compilation

Sediment Augmentation

December 10, 2024

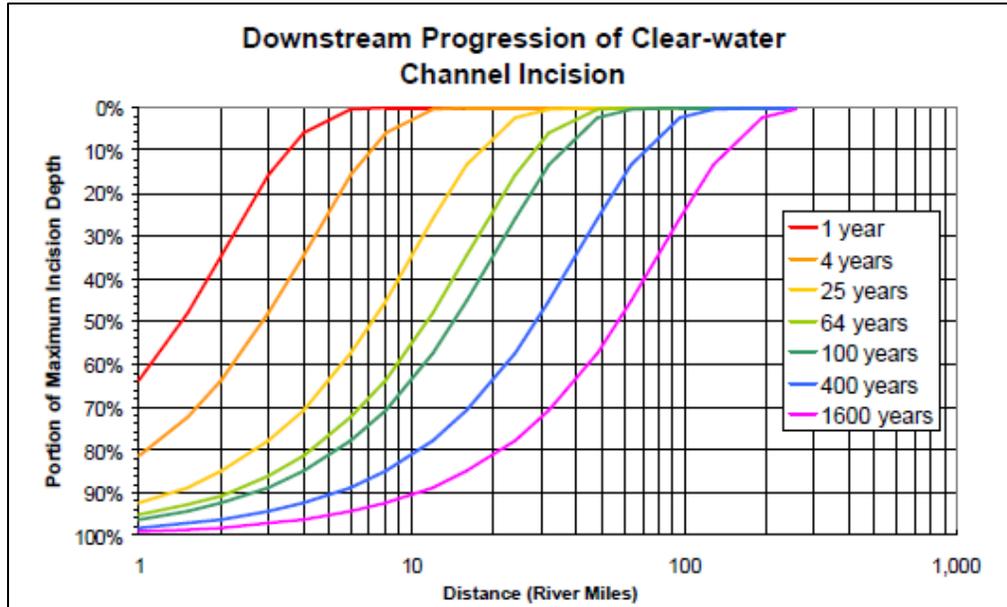
Figure 1.2. Reproduction of Figure 4.16 from Murphy et al (2004). Figure shows estimated progression of incision over time below the J2 Return.

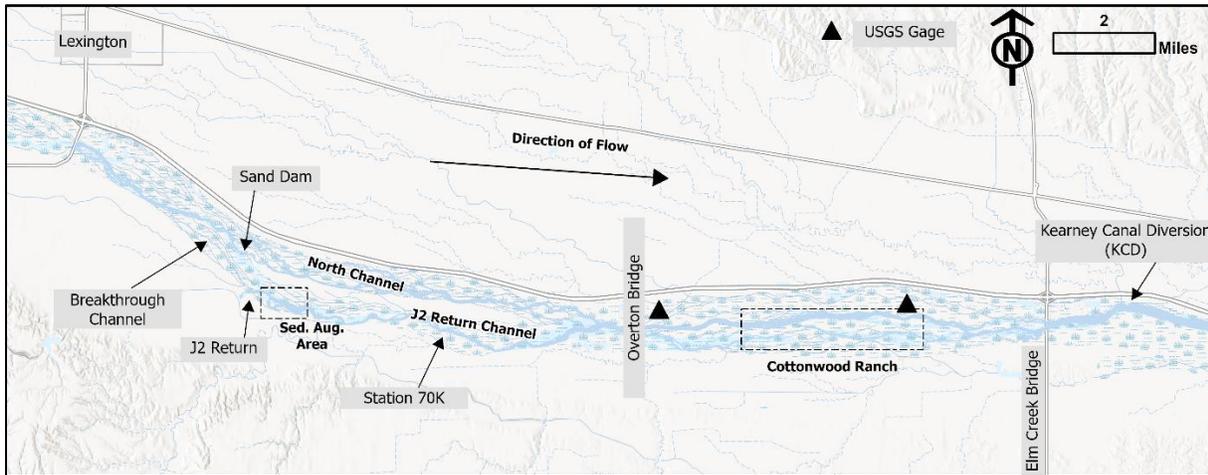
Figure 2.1. Map of the sediment augmentation study area including stream gage locations and landmarks of interest.

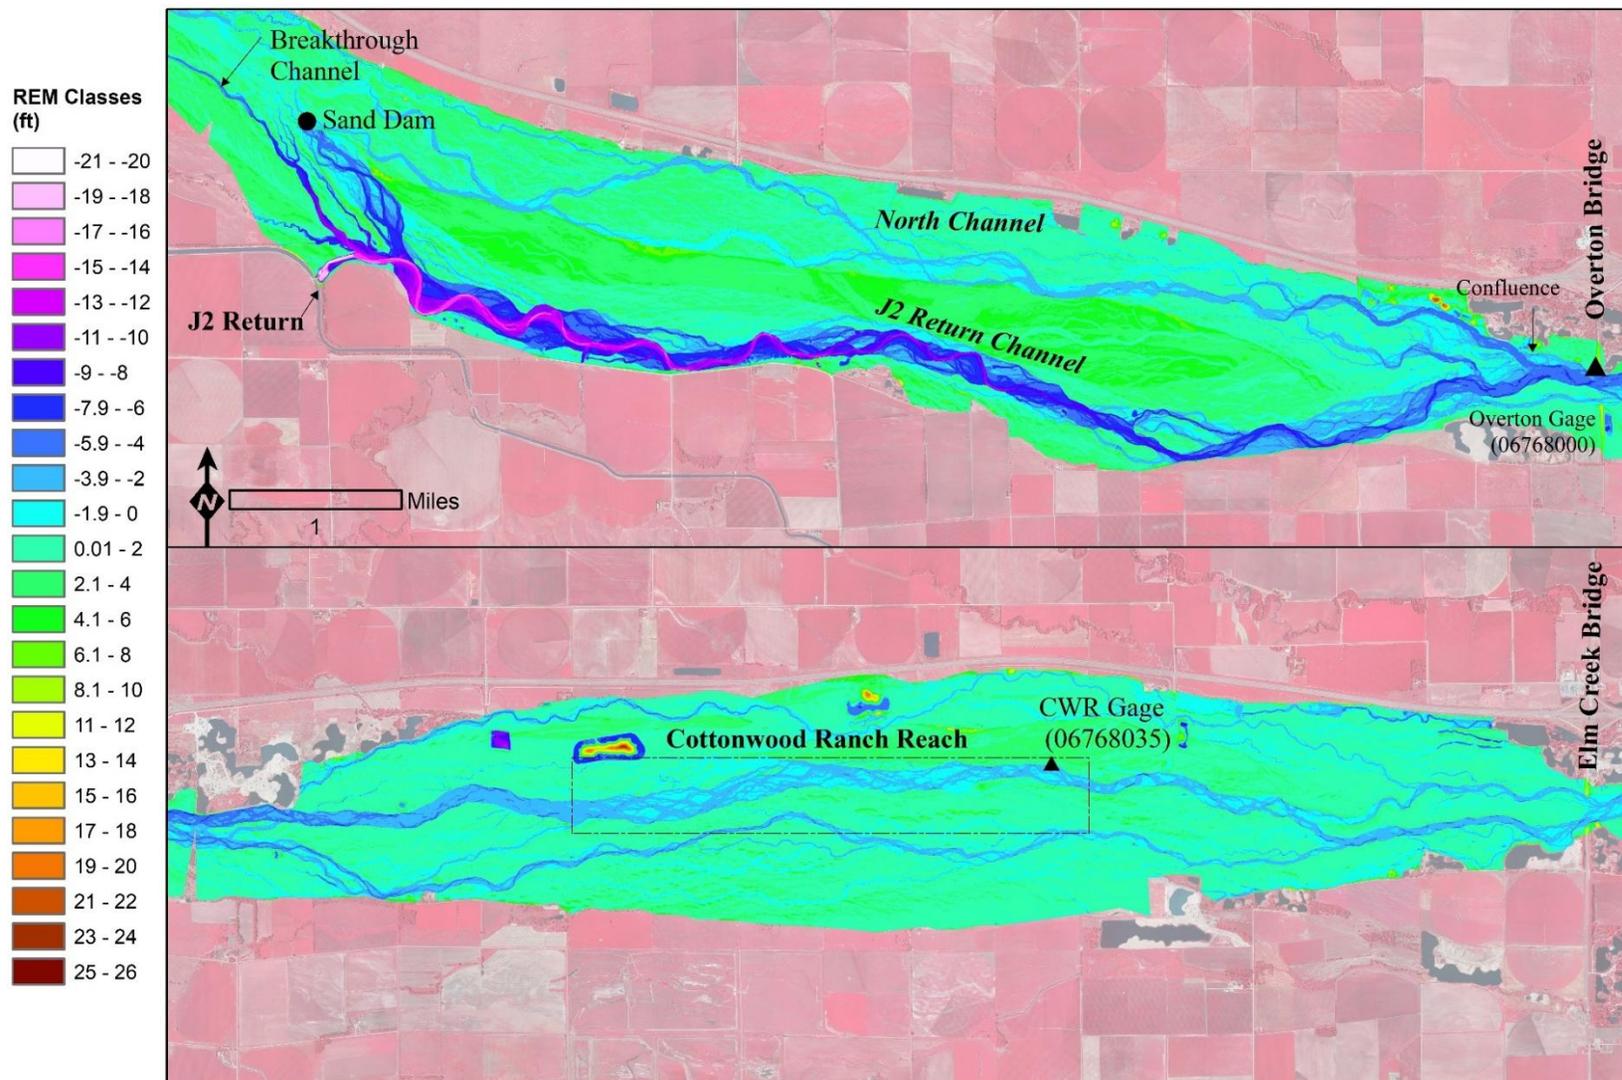
Figure 2.5. Relative elevation model (REM) of 2016 topo-bathymetry compared to the average elevation of the historical channel (GGL). The figure is split into J2 Return to Overton Bridge (top) and Overton Bridge to Elm Creek Bridge (bottom). Edges appear irregular due to clipping of ponds and other human-manipulated surfaces. Deviations from the GGL are much larger (10-20 ft below the floodplain) near the J2 Return and decrease to 1-6 ft below the floodplain toward the downstream extent of the study area.

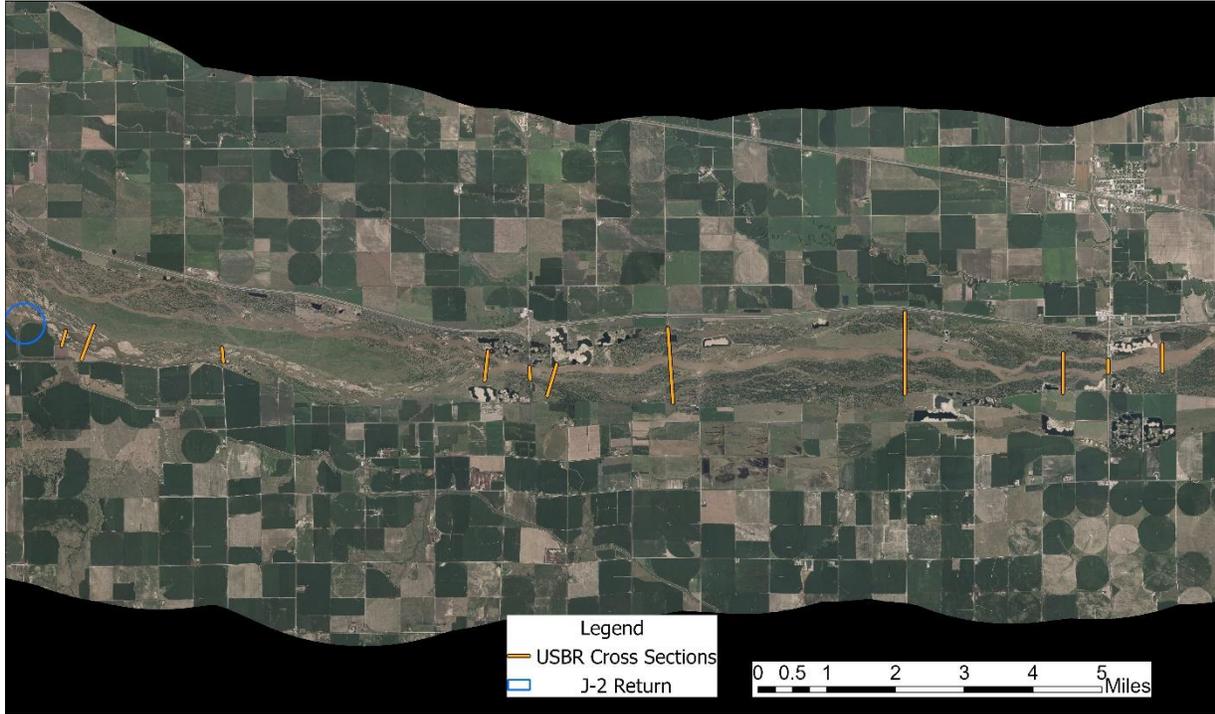
Figure 2.7. Locations of USBR 1989 and 2002 survey cross-sections.

Repeat cross section data were collected by the United States Bureau of Reclamation (USBR) in 1989 and DJ&A consultants in 2002 (Holburn et al. 2006). These entities surveyed a total of 11 cross sections in 1989 between the J2 Return and KCD. Ten were repeated in 2002. A map of these cross section locations can be found in Chapter 2, Figure 2.7.

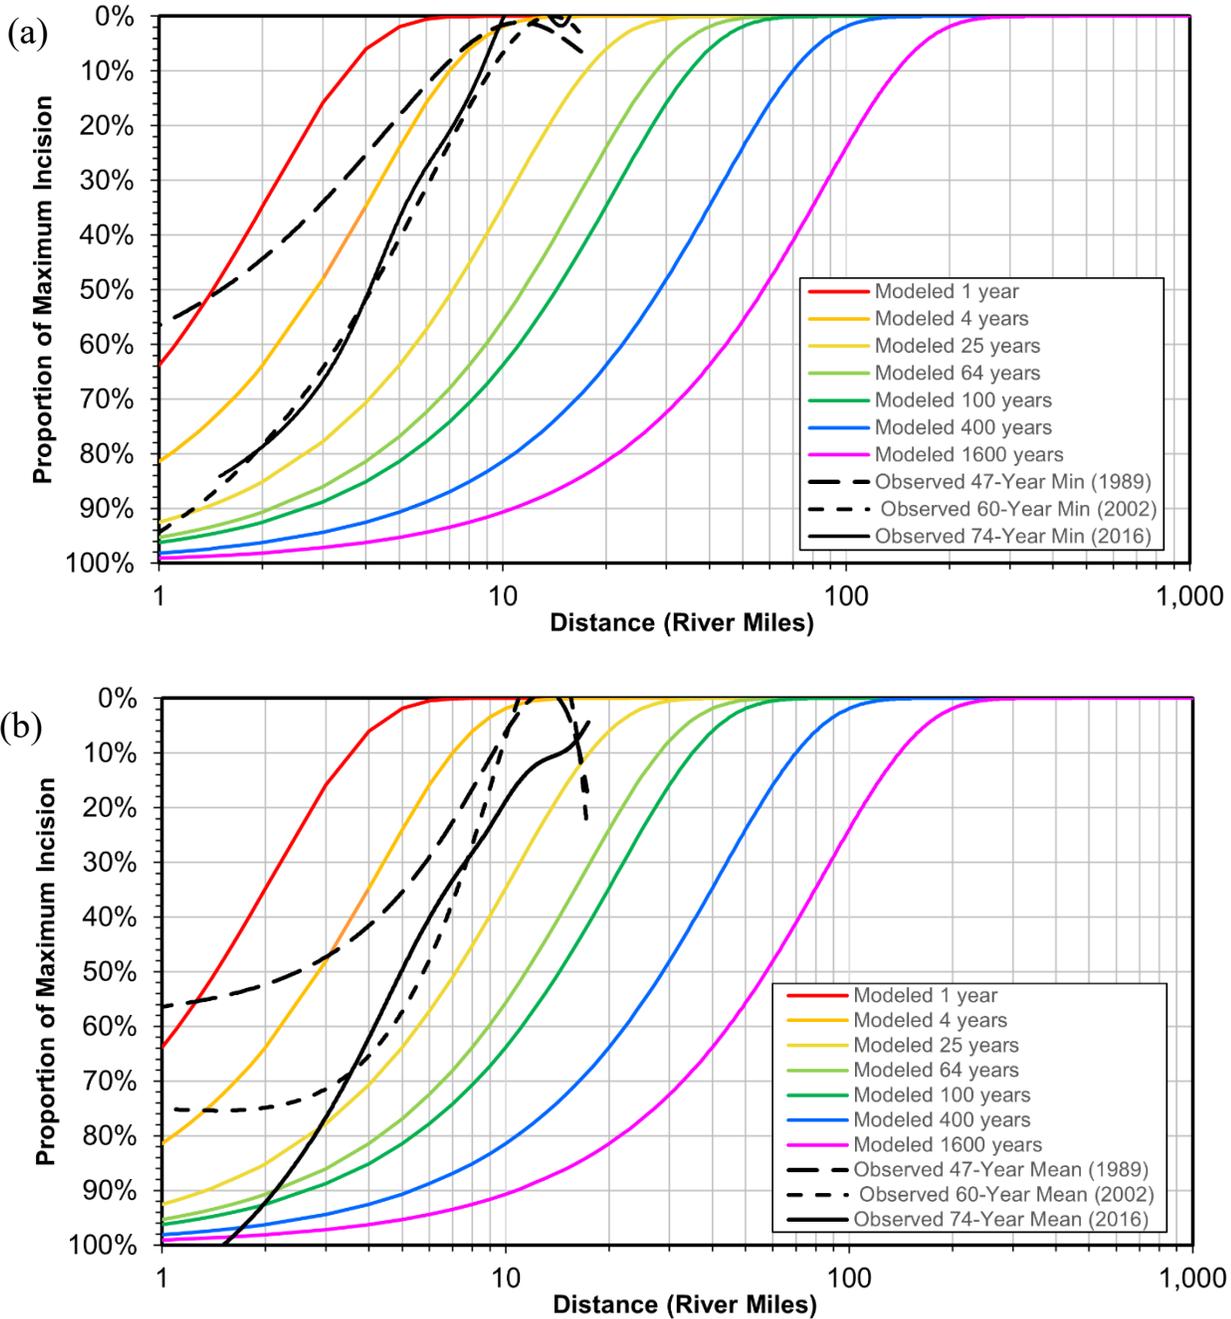
Figure 2.9. Channel incision estimates below J2 Return plotted on top of incision propagation estimates from Murphy et al. (2004). Minimum cross section elevation (thalweg) incision is shown in (a) and the mean channel elevation incision is shown in (b). Number of years represents years since operation started at J2 Return. Observed values from 1989 and 2002 were estimated with a 3rd order polynomial model through 10 transect locations, while 2016 observed

Comparisons of observed incision relative to Murphy et al. (2004) predictions are provided in Figure 2.9. The top panel (panel a) presents thalweg (minimum channel elevation) incision relative to Murphy et al.'s predictions. The bottom panel (panel b) presents mean channel incision relative to predictions. Both panels begin one mile downstream of the J2 Return and end at the KCD. The number of years in both plots reference years since J2 Return was constructed.

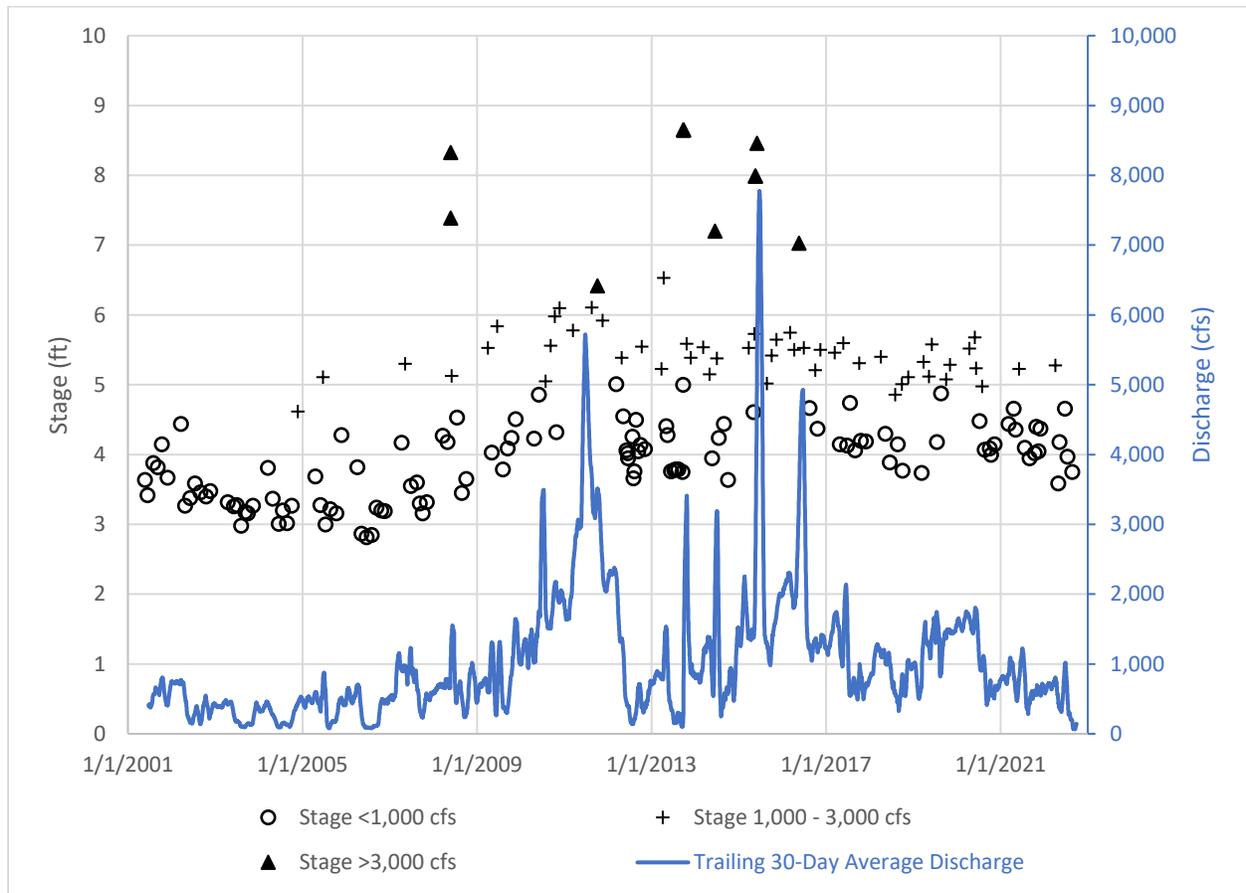
Figure 2.18. Physical measurement stage data at Cottonwood Ranch Mid-Channel gage (06768035) and trailing 30-day average discharge.

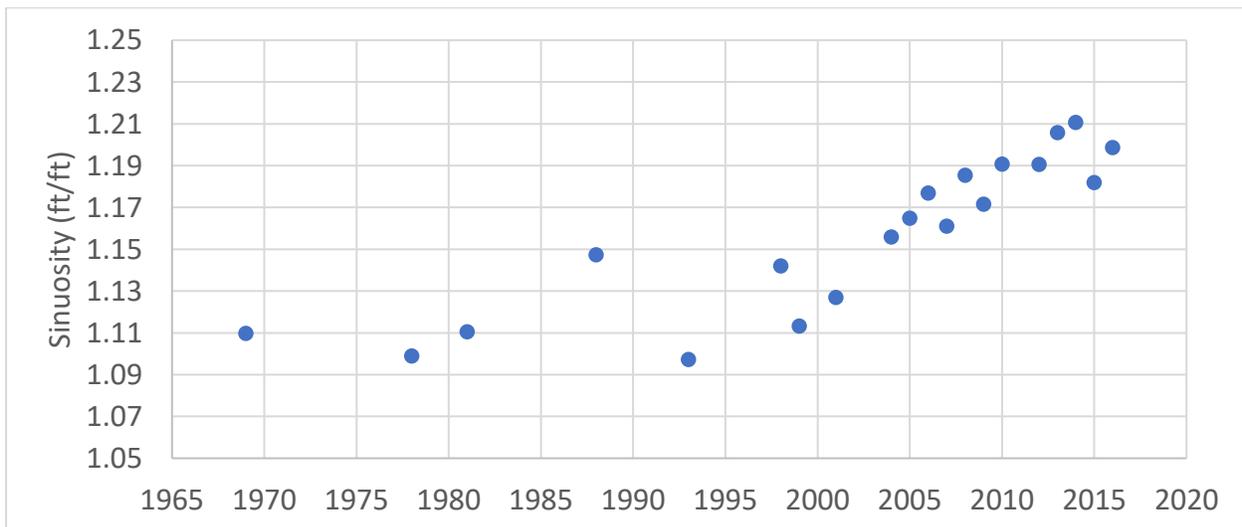
Figure 2.20. Ratio of total channel length to straight-line length (sinuosity) between the J2

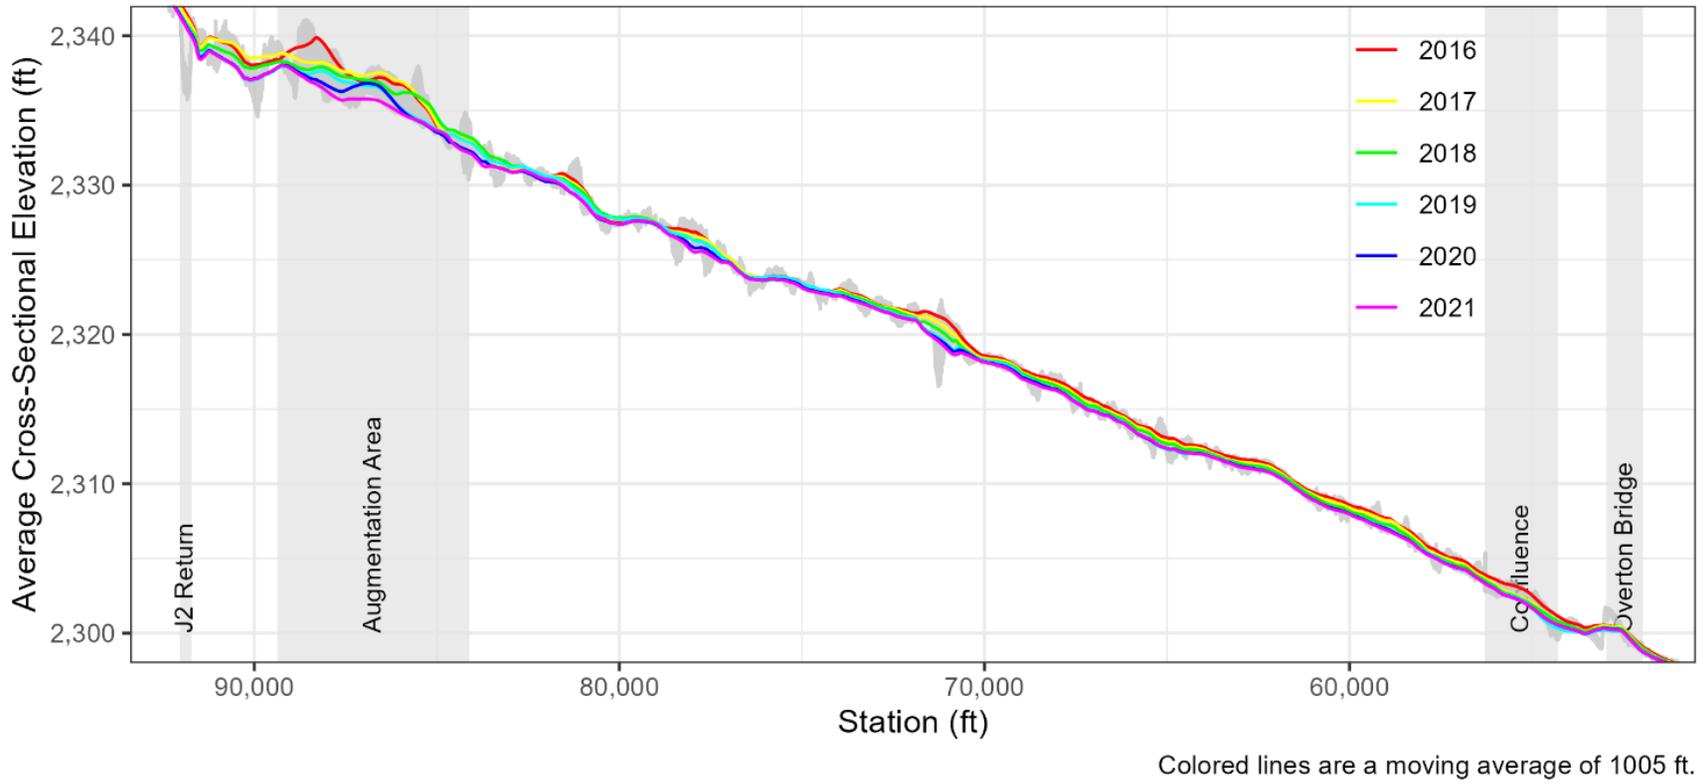
Figure 3.11. Average cross-sectional elevation longitudinal profile in the J2 Return channel. Colored lines are a moving average of 1005 ft and grey lines show the range of values for 2016–2021.

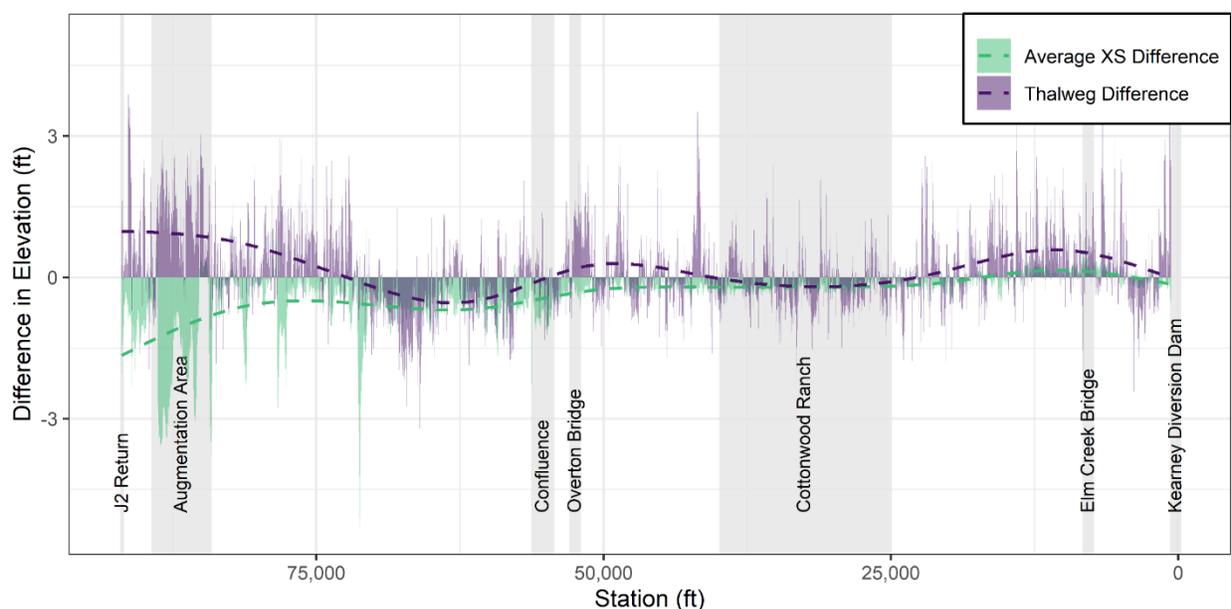
Figure 3.12. Differences in thalweg and average cross-sectional elevation from 2016 to 2021. A line depicting general trends was estimated with a generalized additive model.

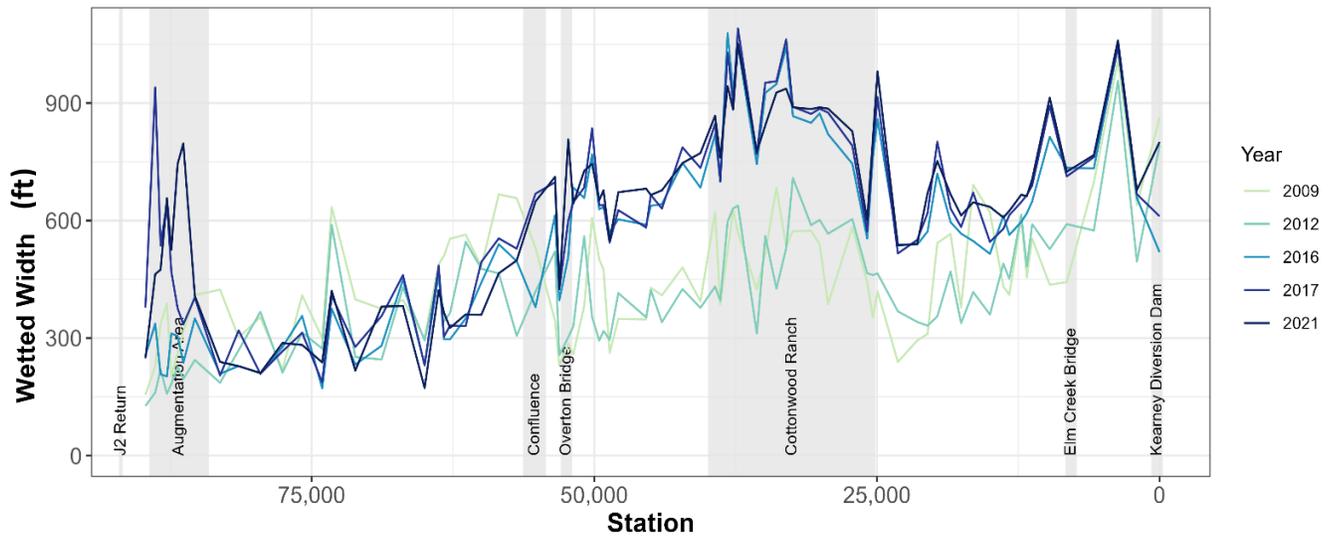
Figure 3.13 Wetted width at HEC-RAS cross-sections in 2009–2021 at a flow of 2,000 cfs. Widening due to augmentation (2017, 2021) is visible upstream of the Augmentation Boundary and widening due to the 2015 flood visible downstream of Overton Bridge.

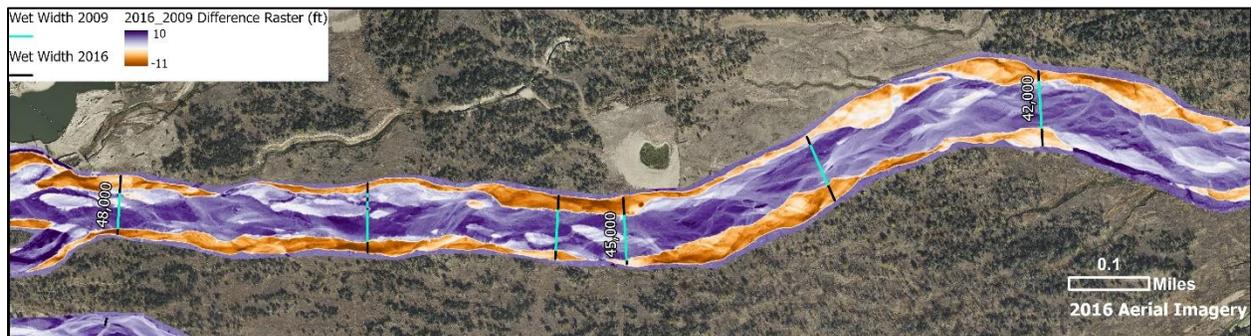
Figure 3.14 Significant channel widening is evidenced in the 2016 to 2009 difference raster by the regular pattern of erosion (orange) along channel banks between stations 48,000 and 42,000. This pattern begins at the confluence of the J2 Return and North Channels and continues to Elm Creek Bridge. Year by year comparison of LiDAR data indicates that the majority of the widening occurred in 2015.

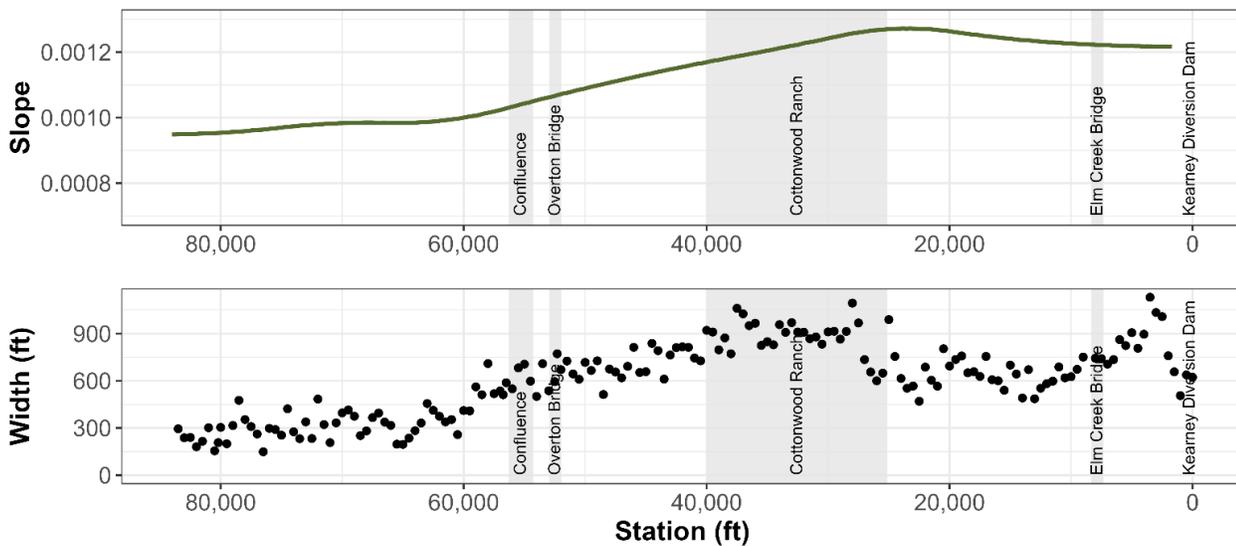
Figure 3.15. 2021 channel slope of the GAMM-modeled thalweg (top) and wetted width at 2,000 cfs (bottom). Width and slope increase together between Station 60,000 and 30,000.

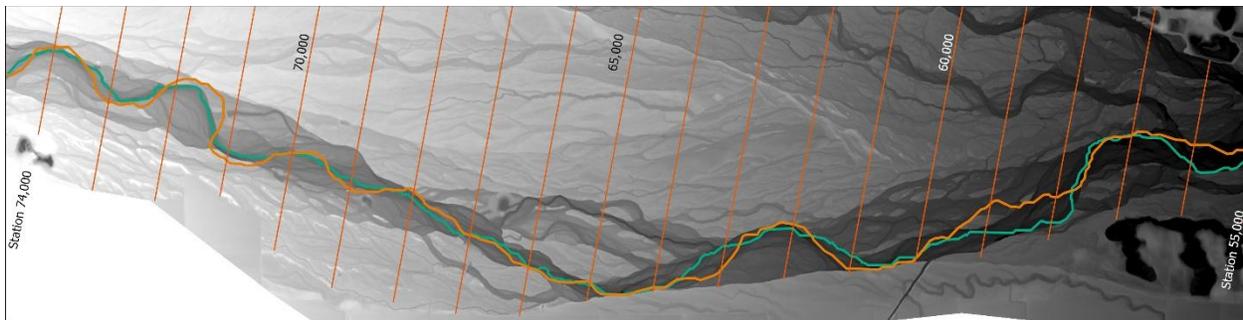
Figure 3.18. Planview of thalweg alignments in 2016 (green) and 2021 (orange) between station 74,000 and 55,000.

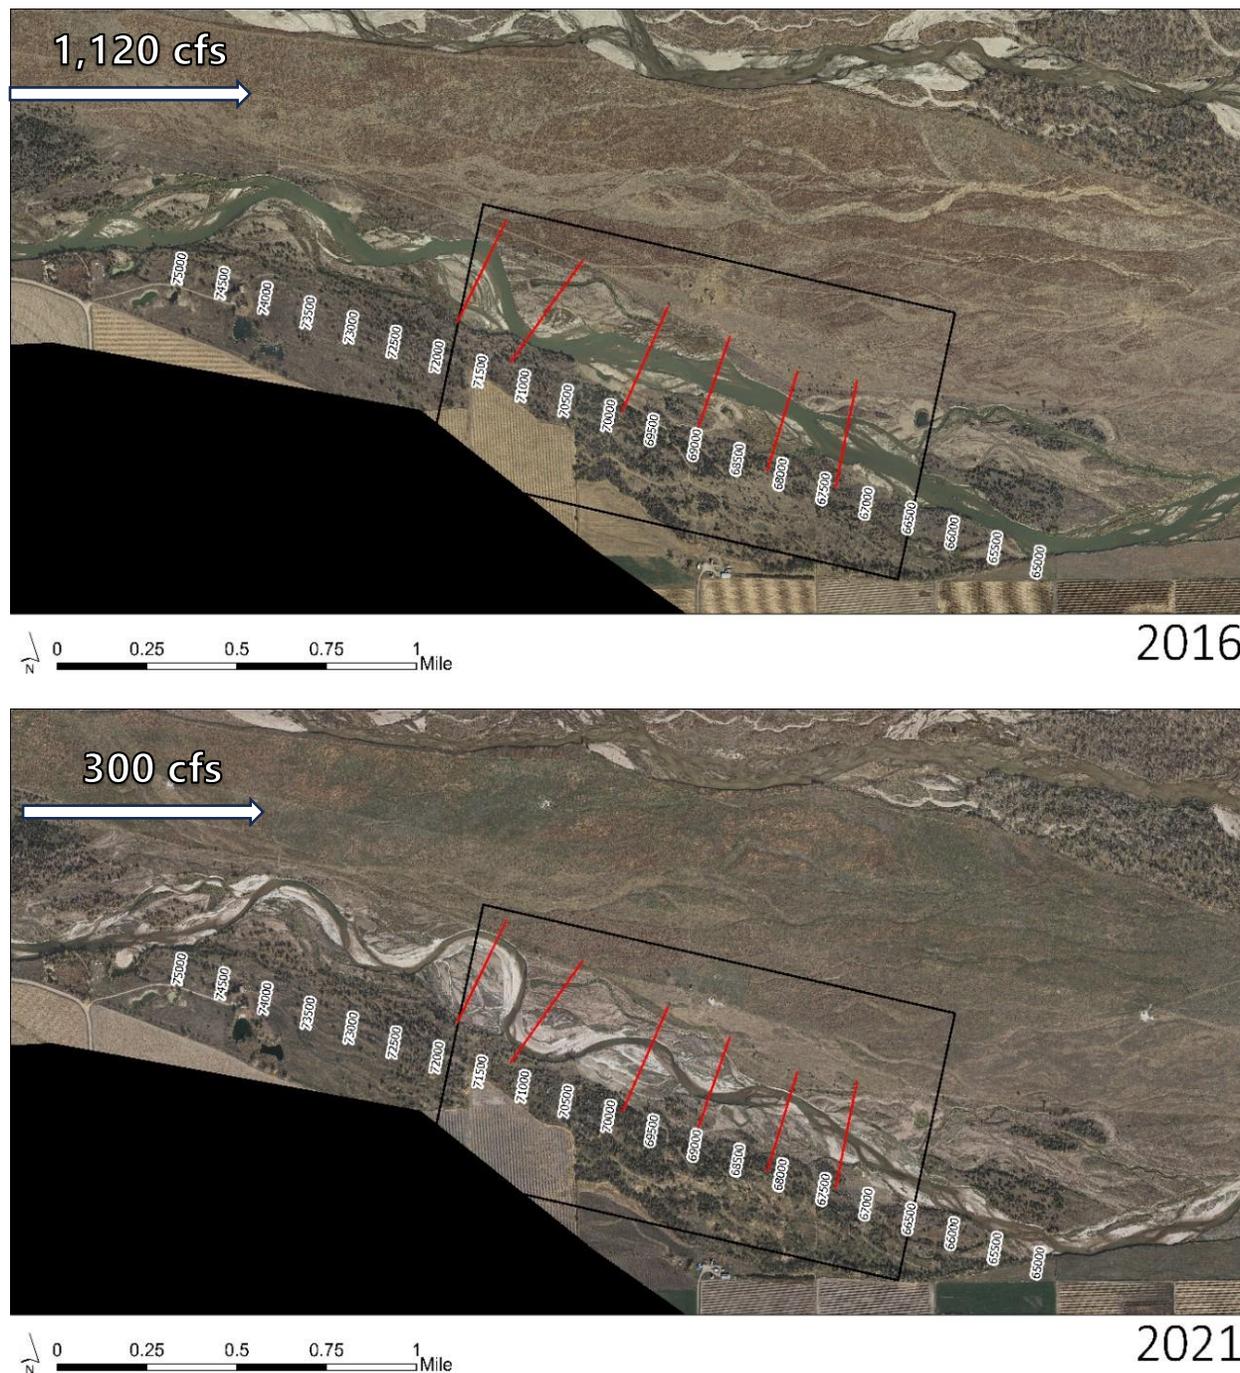
Figure 3.20. Aerial imagery of Reach 70,000 in 2016 (top) and 2021 (bottom). A black rectangle extends from Station 71,835 to Station 66,435 and delineates the reach with the most change. Cross section locations are noted in red.

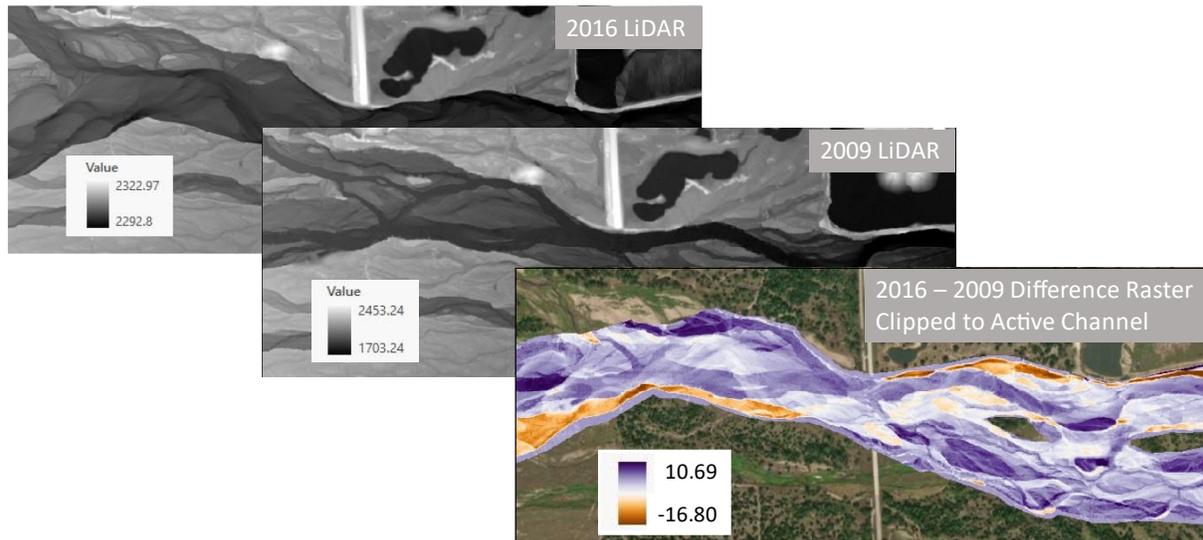
Figure 4.2. Example of raster differencing and clipping to the active channel at the Overton Bridge. 2009 elevations were subtracted from the 2016 elevations, resulting in a raster ranging from 10.69 ft of aggradation (purple) to 16.80 ft of erosion (orange).

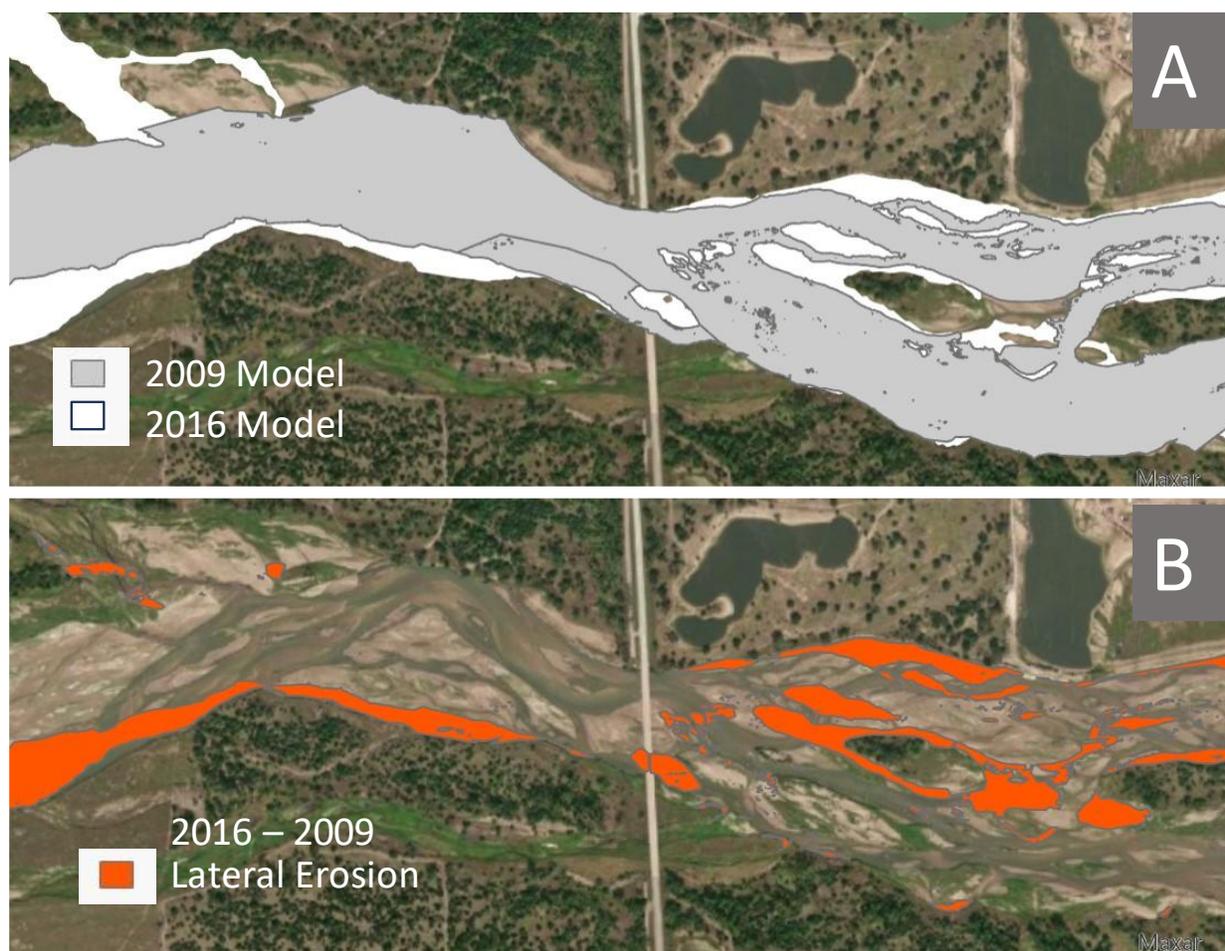
Figure 4.3. Lateral erosion was delineated by differencing hydraulic model results (A) and isolating newly wet areas (B).

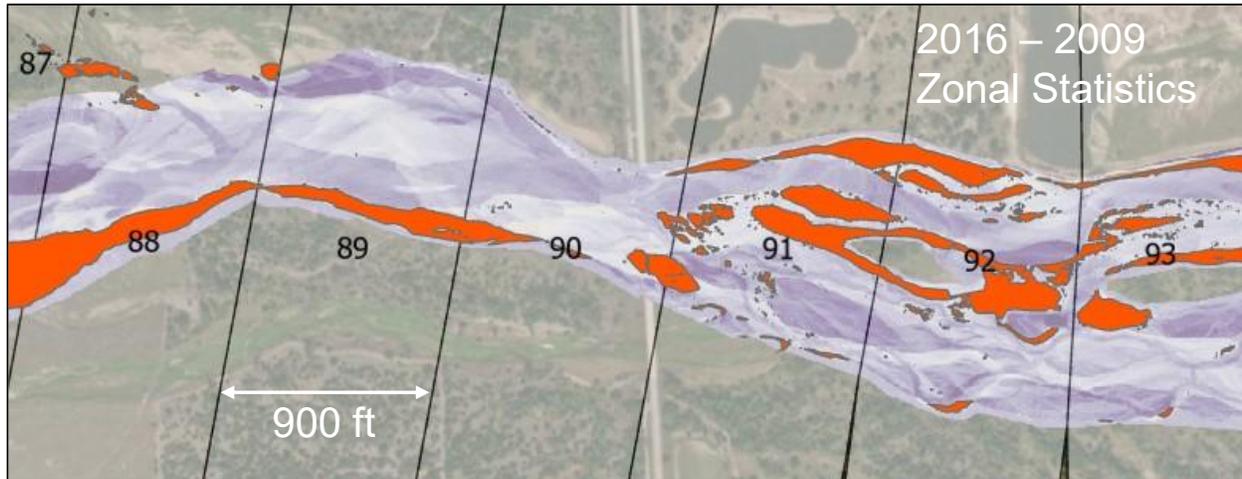
Figure 4.4. Using the zonal statistics tool, elevation differences in each 900-ft wide zone were summed. Zones are bounded in black and numbered 87-93 in this figure. The sums were then converted from ft to ft³ by multiplying the elevation difference by the raster cell area (9 ft²). The process was repeated to look only within the lateral erosion mask, shown in orange, to obtain the volume of lateral erosion in each zone.

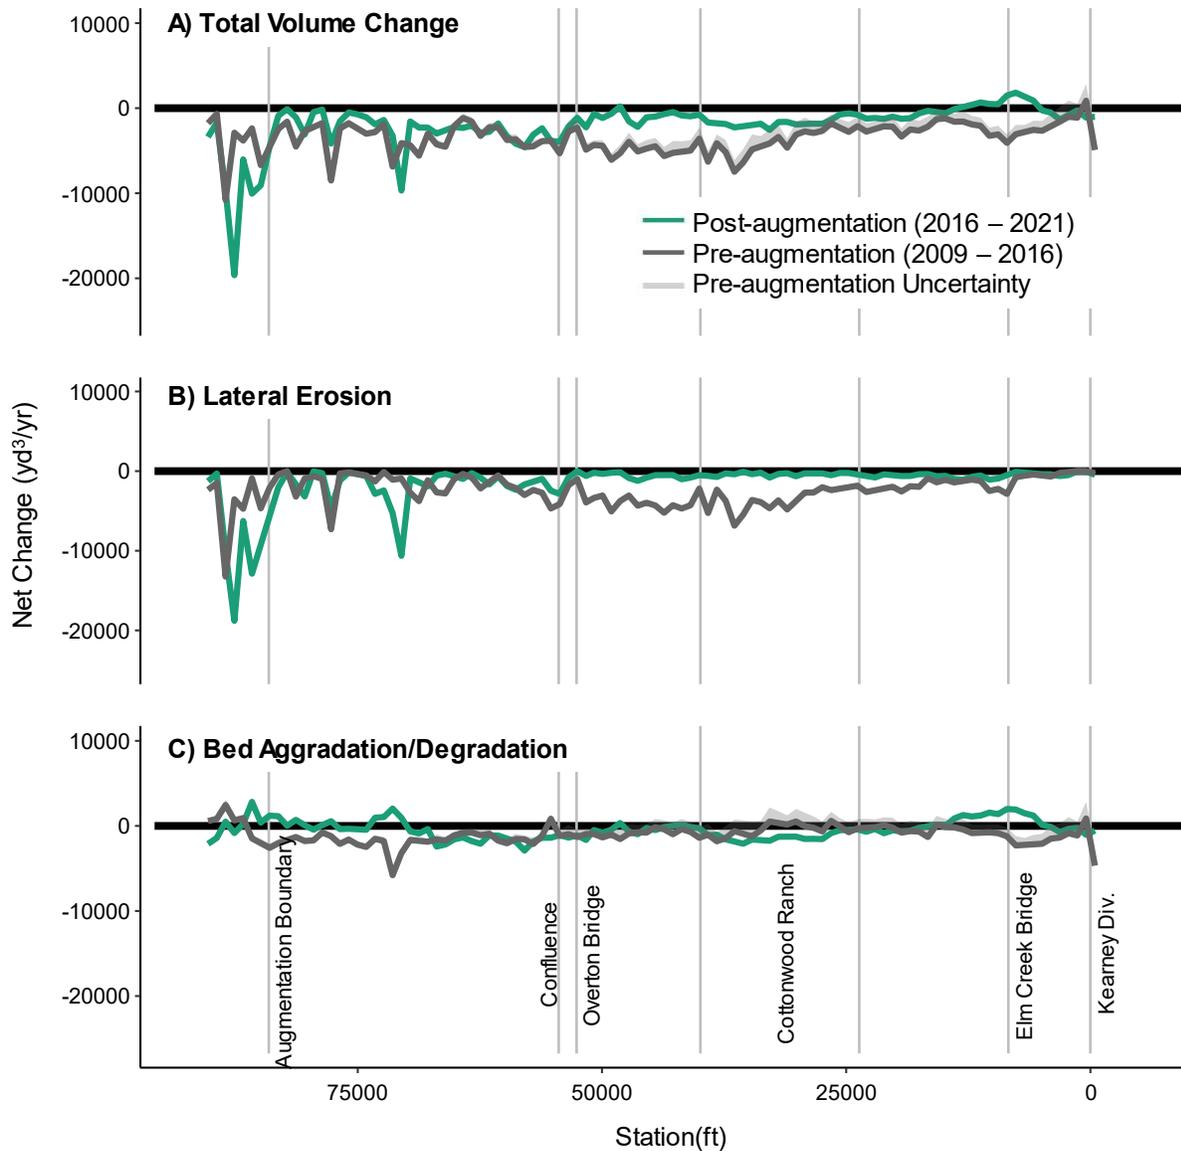
Figure 4.5. Net volume change per year by station. The figure shows the total volume change (A), which is the sum of the lateral erosion (B) and the bed aggradation/degradation (C). Upstream of Overton Bridge lateral erosion was high both pre- and post-augmentation while bed degradation reduced. Downstream of Overton Bridge much less lateral erosion occurred post-augmentation while bed volume change fluctuated around zero during both periods.

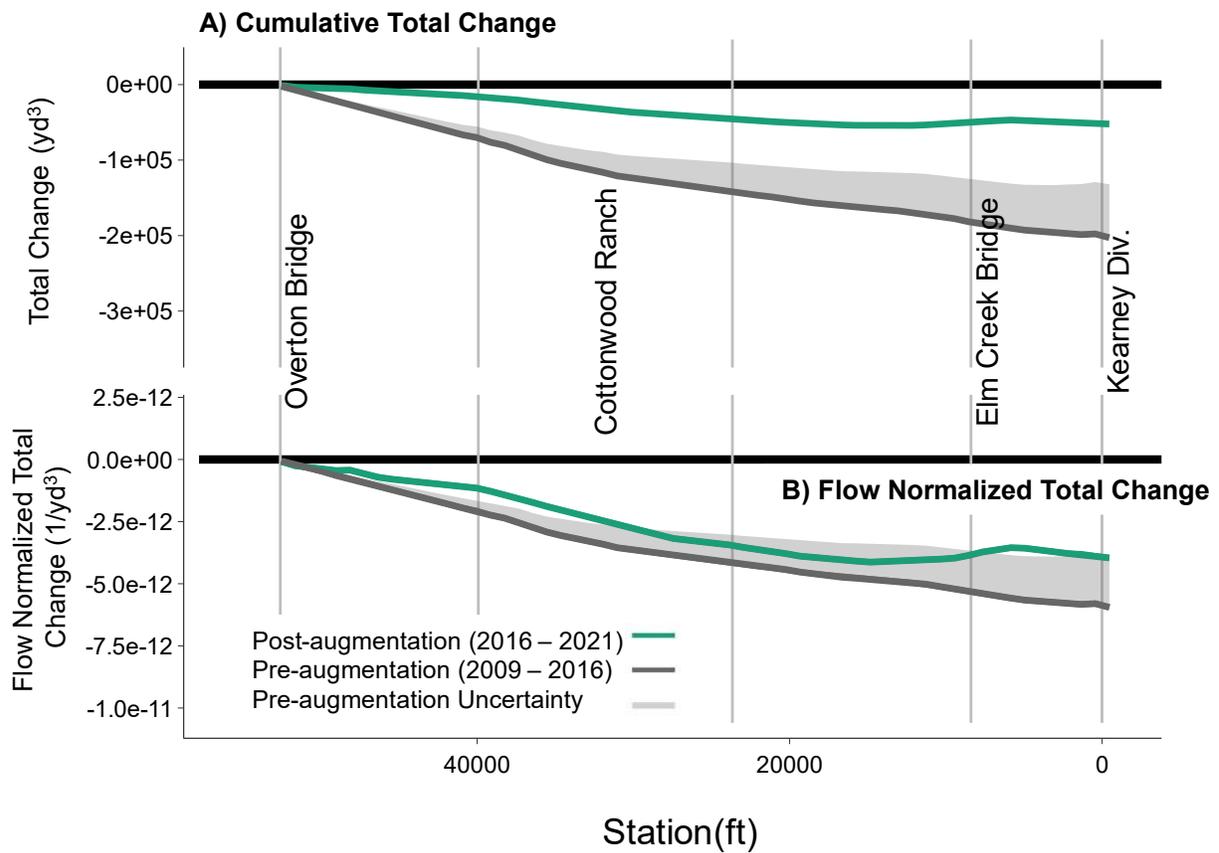
Figure 4.7. Cumulative total volume change downstream of the Overton Bridge. Values in panel B are normalized by flow at the Overton USGS gage, while values in A are not. Normalizing by flow reduces the difference between pre- and post-augmentation volume change.
