# **PLATTE RIVER RECOVERY IMPLEMENTATION PROGRAM**

## **Data Synthesis Compilation**

### **Sediment Augmentation**

December 10, 2024

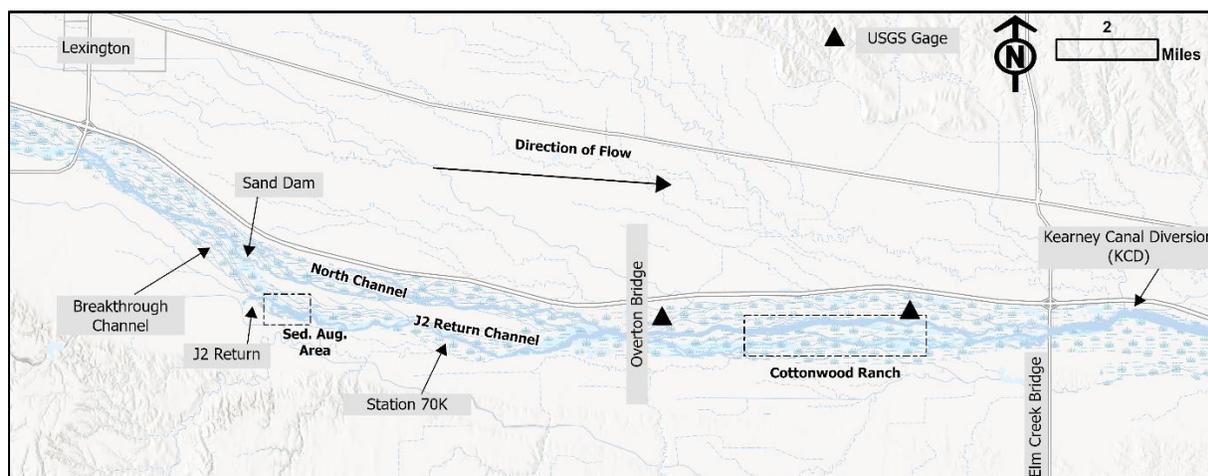
**Figure E.1** Overview map of sediment augmentation evaluation reach and features. There is no permanent surface flow connection between the north channel and the upstream end of the J2 Return Channel.

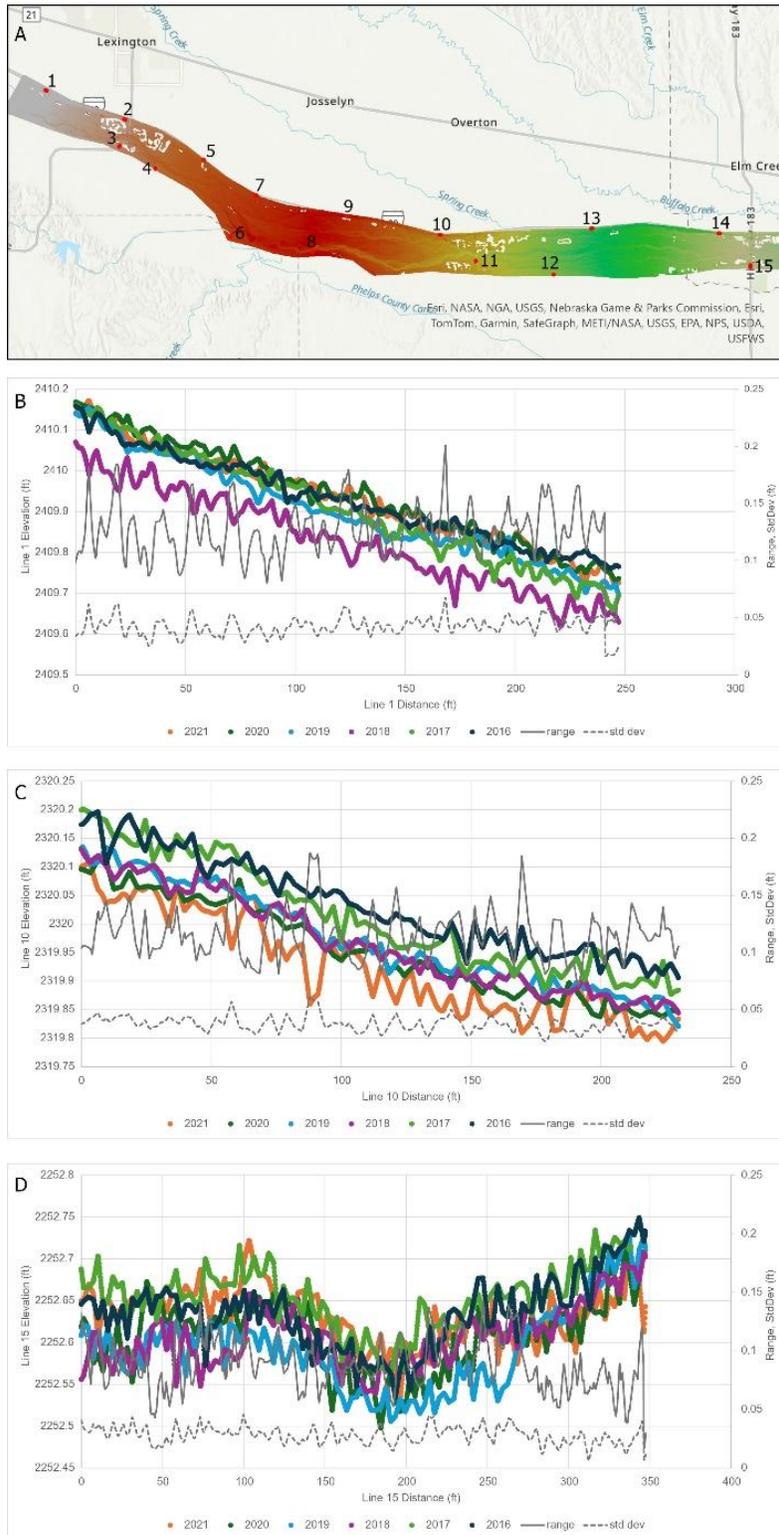
**Figure D.1.** Linear elevation extractions from three example paved surfaces (Location 1, Panel B; Location 10; Panel C, and Location 15, Panel D) in the study area (Panel A).

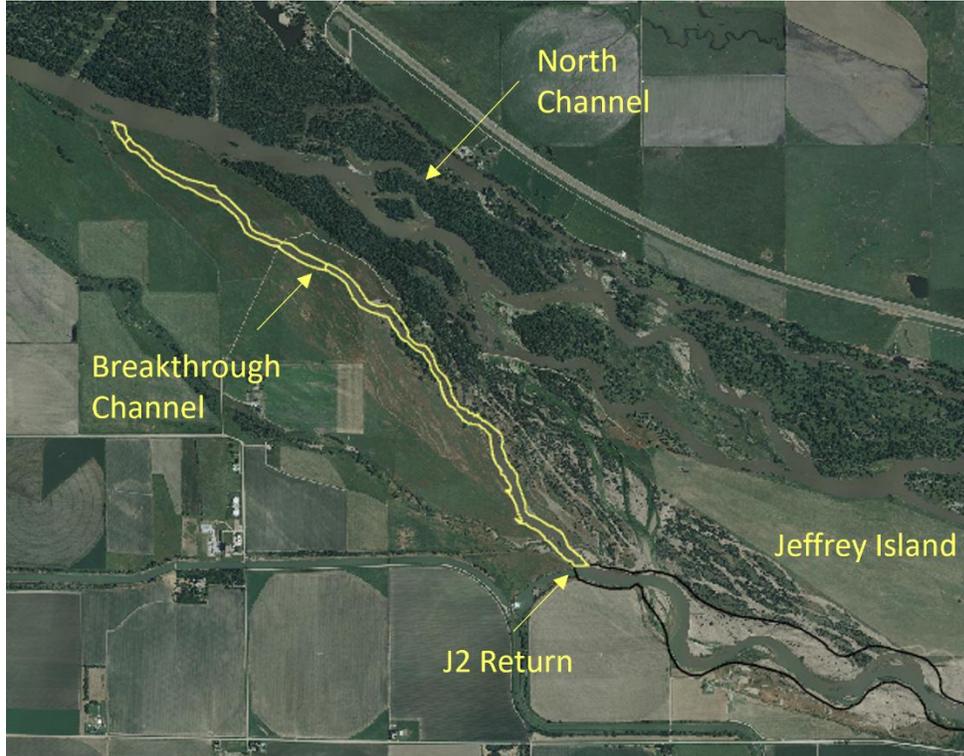
**Figure D.2** Breakthrough channel connecting the North Channel to the J2 Return Channel during high flow conditions.

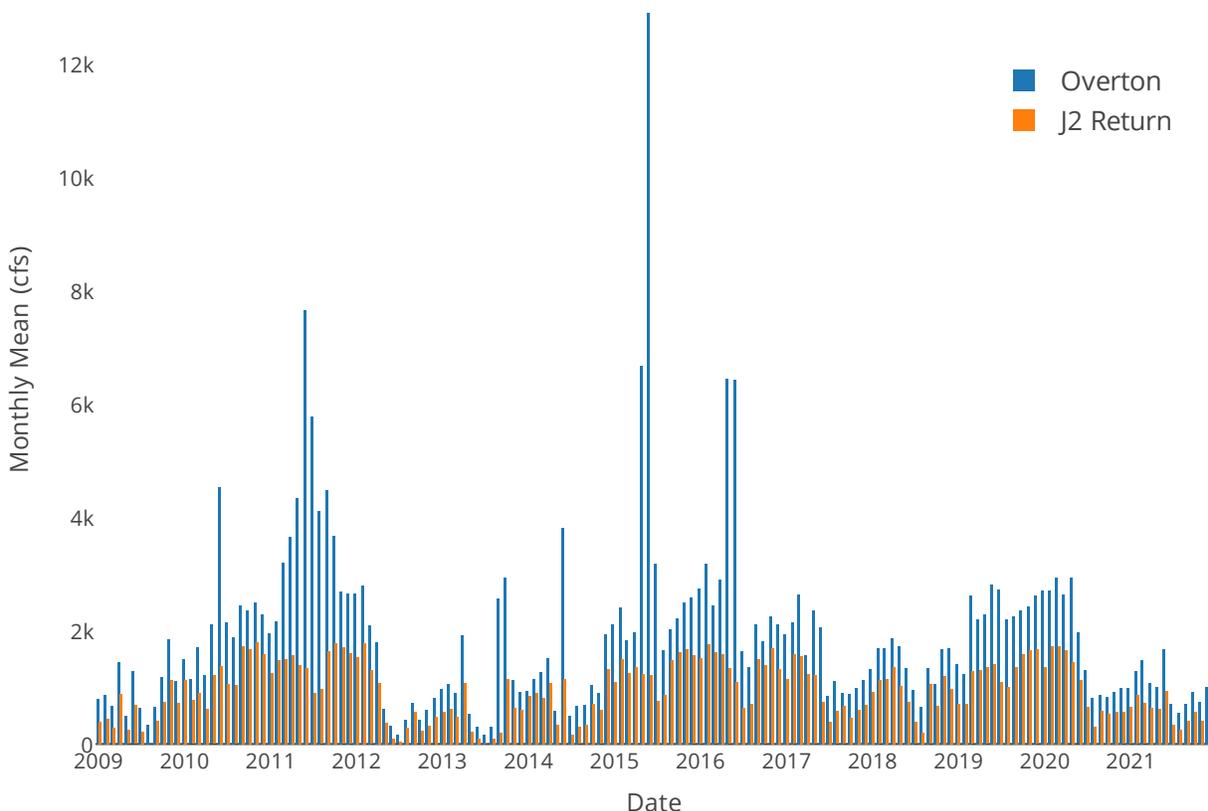
Figure D.3 Monthly mean discharge from CNPPID to the J2 Return Channel and at the USGS Overton gage from 2009 to 2021.

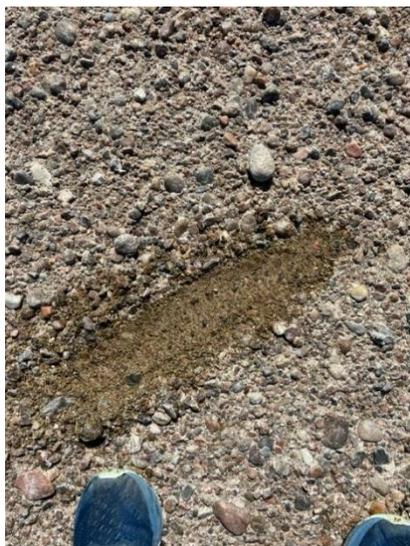
**Figure D.4.** Visual comparison of coarse armor layer overlaying finer sand on the channel bed approximately 500 feet downstream from the J2 Return

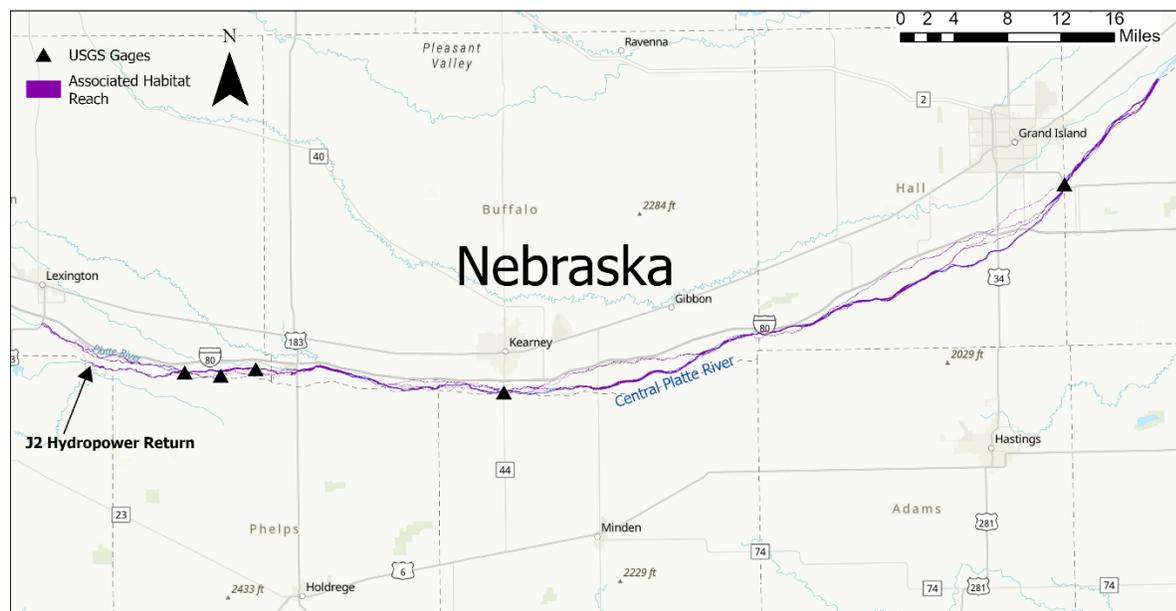
**Figure 1.1.** Associated Habitat Reach (AHR) of the central Platte River in Nebraska extending from Lexington downstream to Chapman.

The Platte River Recovery Implementation Program (Program or PRRIP) is responsible for implementing certain aspects of the recovery plans for three threatened and endangered species including the highly endangered whooping crane (*Grus americana*). More specifically, the Program has a management objective to improve survival of whooping cranes during migration through increased use of the Associated Habitat Reach (AHR) of the Platte River in central Nebraska (PRRIP 2006a). This ninety-mile reach extends from Lexington, NE downstream to Chapman, NE and includes the Platte River channel and off-channel habitats within three and a half miles of the river (Figure 1.1).

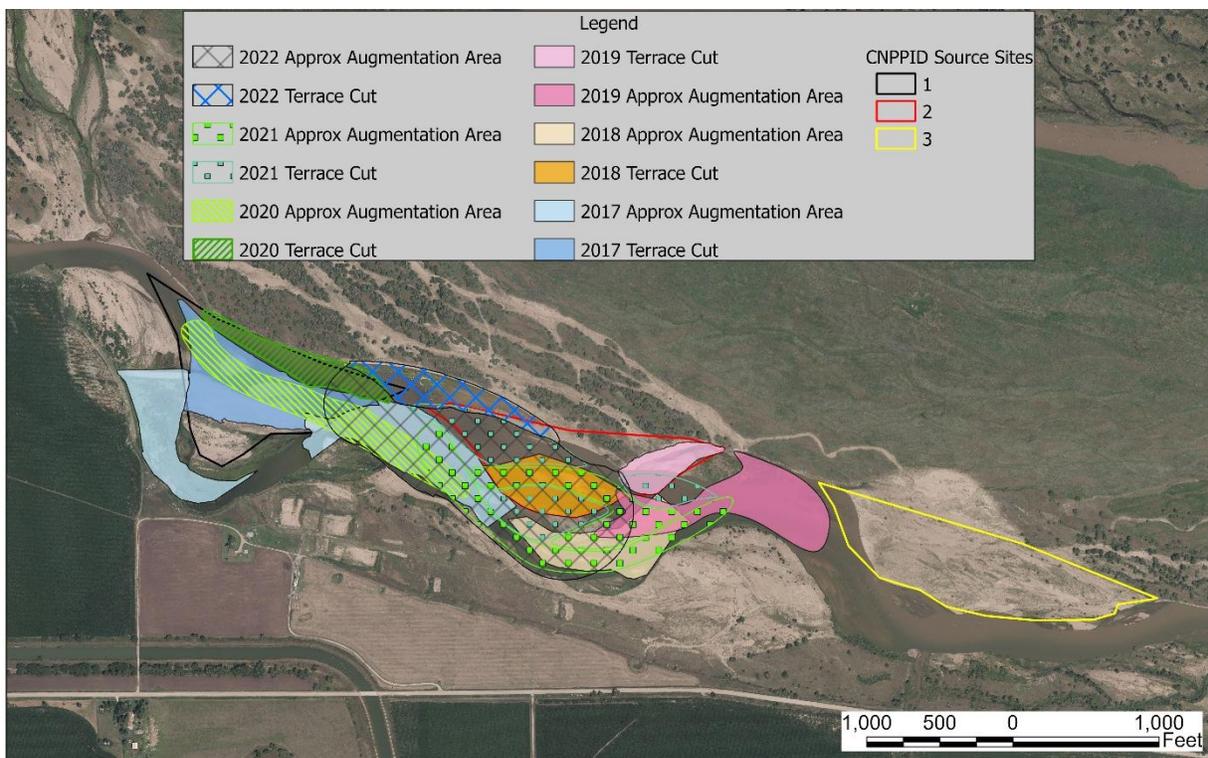
**Figure 1.5** 2017-2022 Augmentation Project Boundaries.

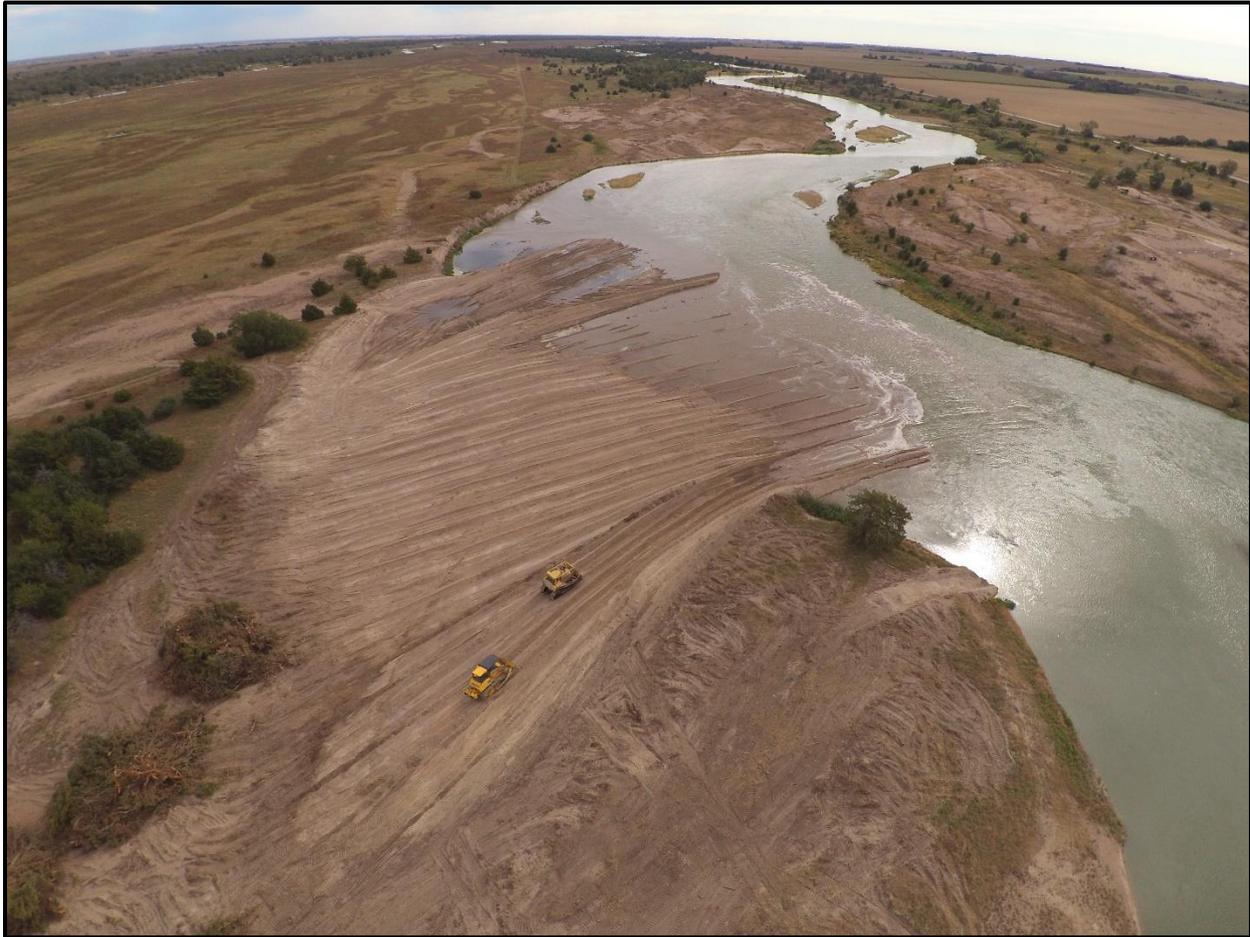
**Figure 1.6** Construction of 2019 Sediment Augmentation Project (42,300 yd<sup>3</sup> ).

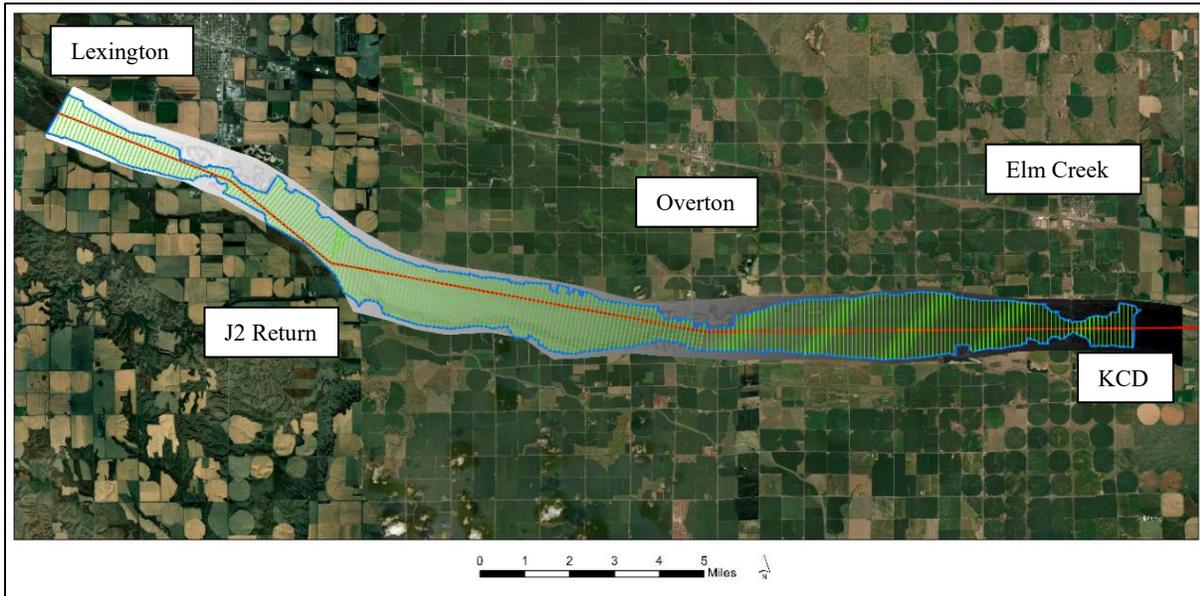
**Figure 2.2.** Floodplain centerline (red) and transects (green) through study area. Transects were generated perpendicular to centerline at five-foot intervals with example transects plotted at 500 ft spacing in this figure.

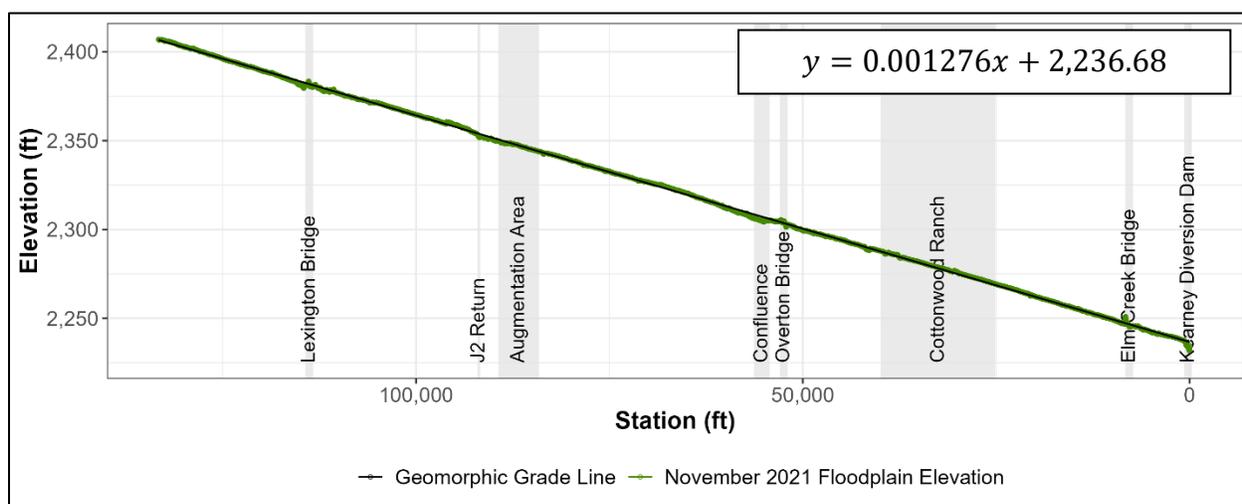
**Figure 2.3.** Geomorphologic Grade Line (GGL) (black) of historical channel footprint in study area sensu Powers et al. (2019). Equation of the GGL presented in top right. Average elevation data sampled from 2021 LiDAR data (green).

The regression of average elevation versus river station (numbered downstream to upstream), or GGL, can be found in Figure 2.3. The slope of the GGL in the study area is 0.001276. Because stationing is from downstream to upstream, slope appears positive in the equation. The slope of the GGL is consistent with previous analyses of channel slope in the AHR (Murphy et al., 2004).

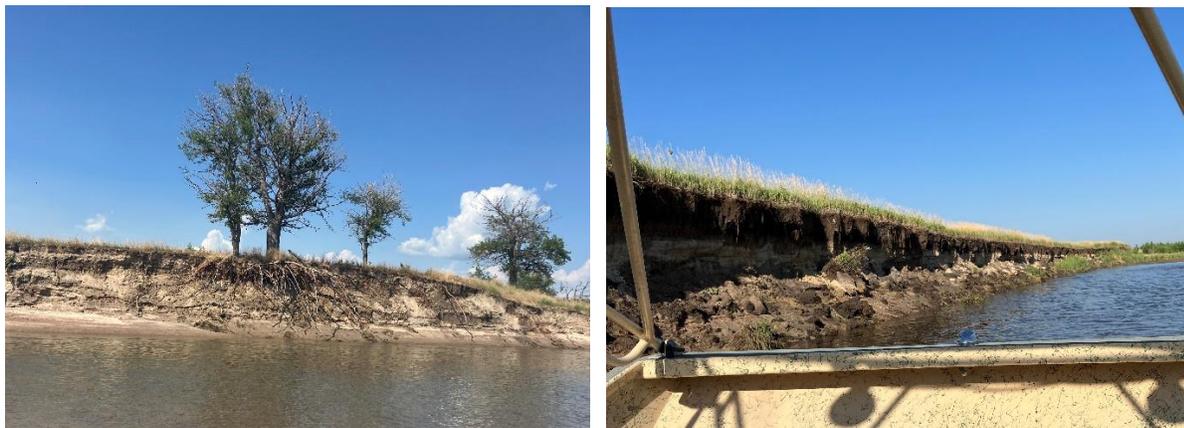
**Figure 2.4.** Field photos from July, 2024 depicting high eroding banks in the J2 Return Channel.

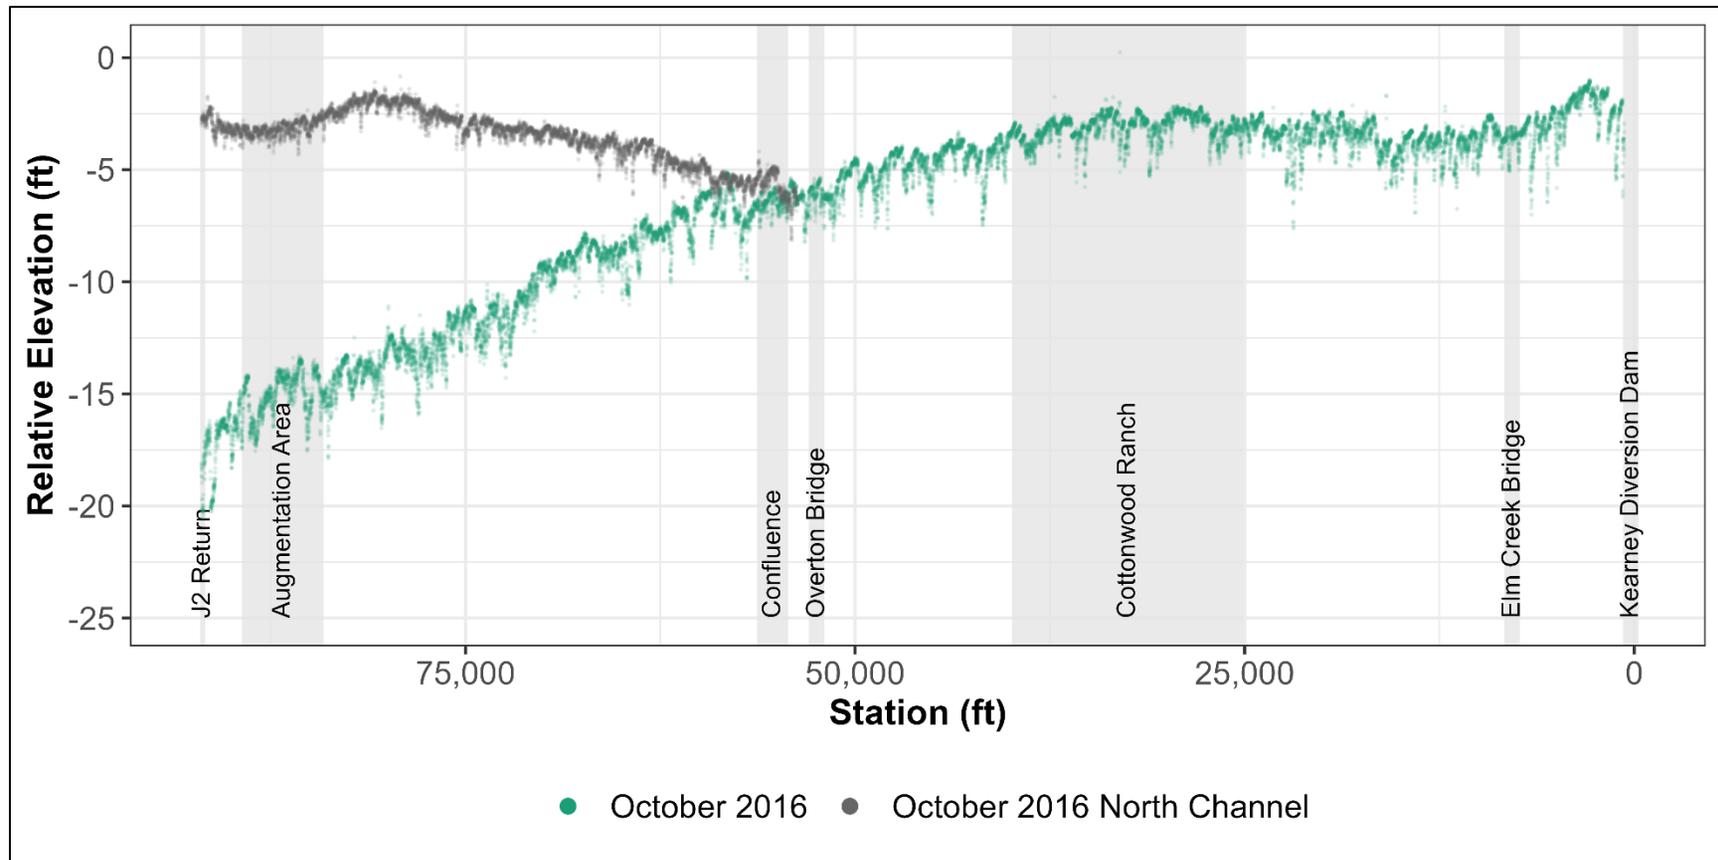
**Figure 2.6.** Elevation of deepest point (thalweg) in the North Channel (gray) and J2 Return/Main Channel (green) relative to Geomorphic Grade Line (GGL). The segment of channel immediately downstream of the J2 Return is incised on the order of 15–20 feet lower than the North Channel at the same station. Magnitude of incision decreases in a downstream direction with the thalweg becoming roughly parallel to GGL (GGL has a value of 0) near the upper end of the Cottonwood Ranch habitat complex. North Channel incision is also apparent upstream of the confluence of the North and J2 Return Channels.

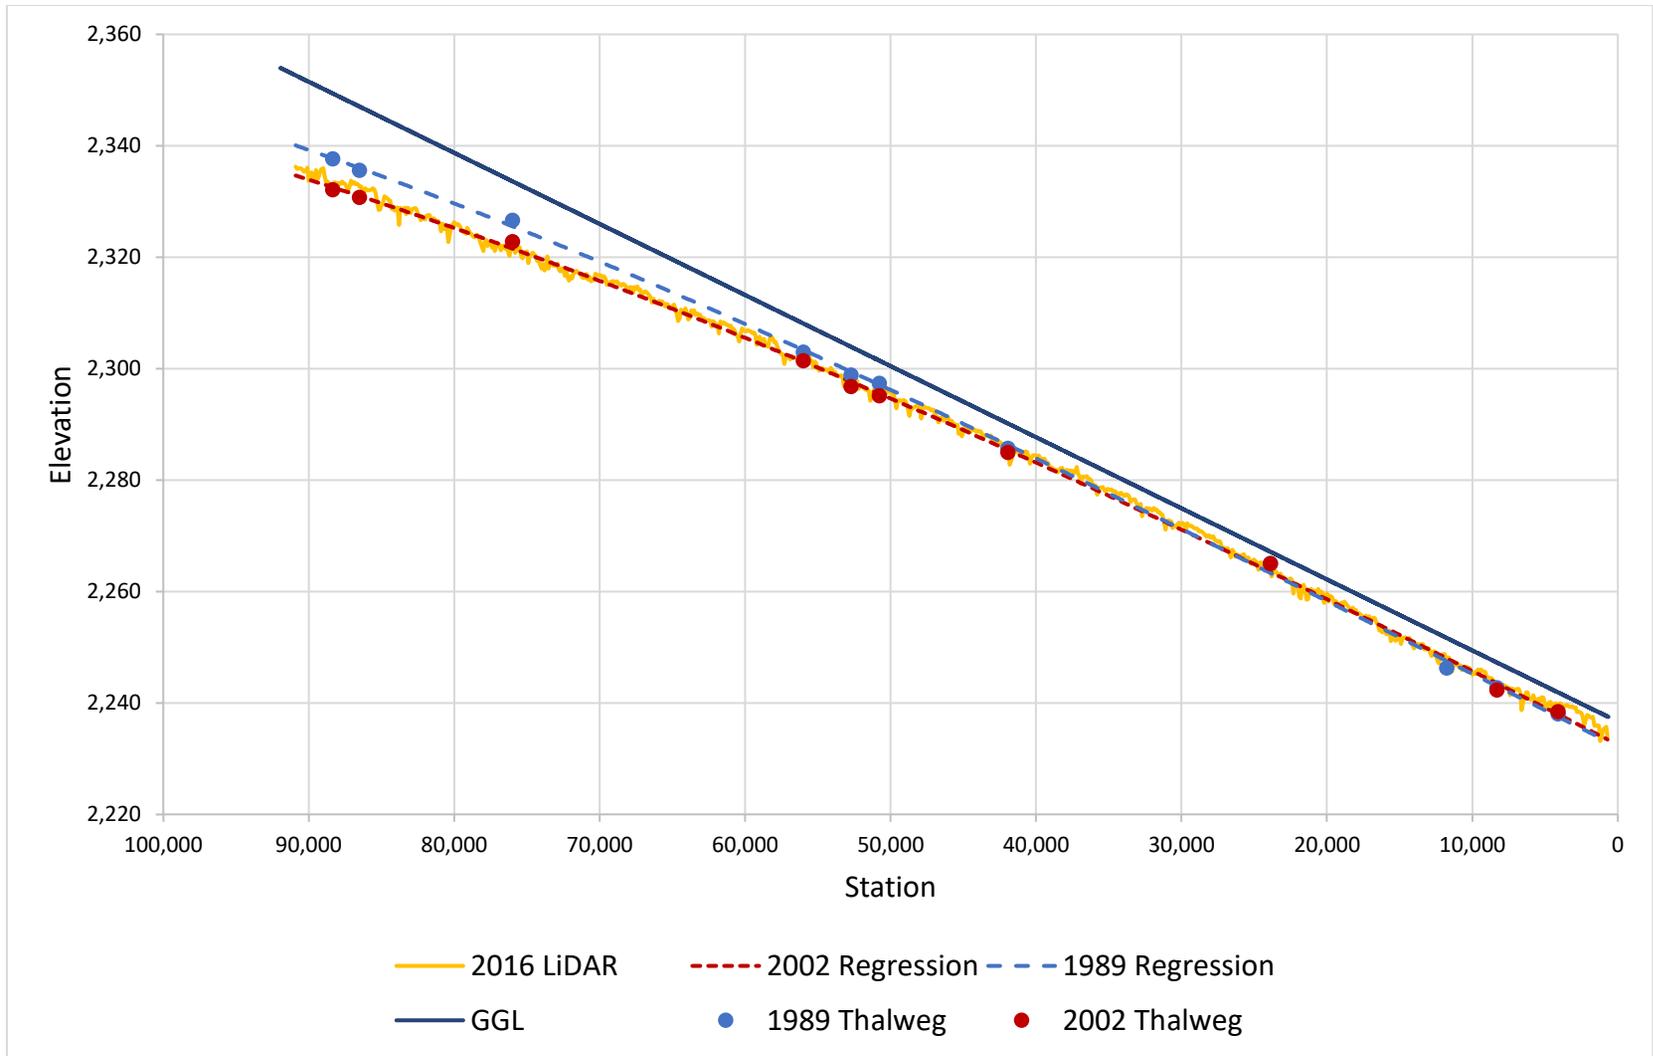
**Figure 2.8.** Modeled longitudinal profiles (cubic regression) of thalweg from 1989, 2002 cross section data. Profiles plotted with Geomorphic Grade Line (GGL) and thalweg profile from 2016 LiDAR data. Deviation from the GGL is evident between Stations 50,000 and 90,000 and increases between 1989 and 2002. No additional increase in deviation is observed between 2002 and 2016. Note that these findings are based on limited historical data and error estimates are not available.

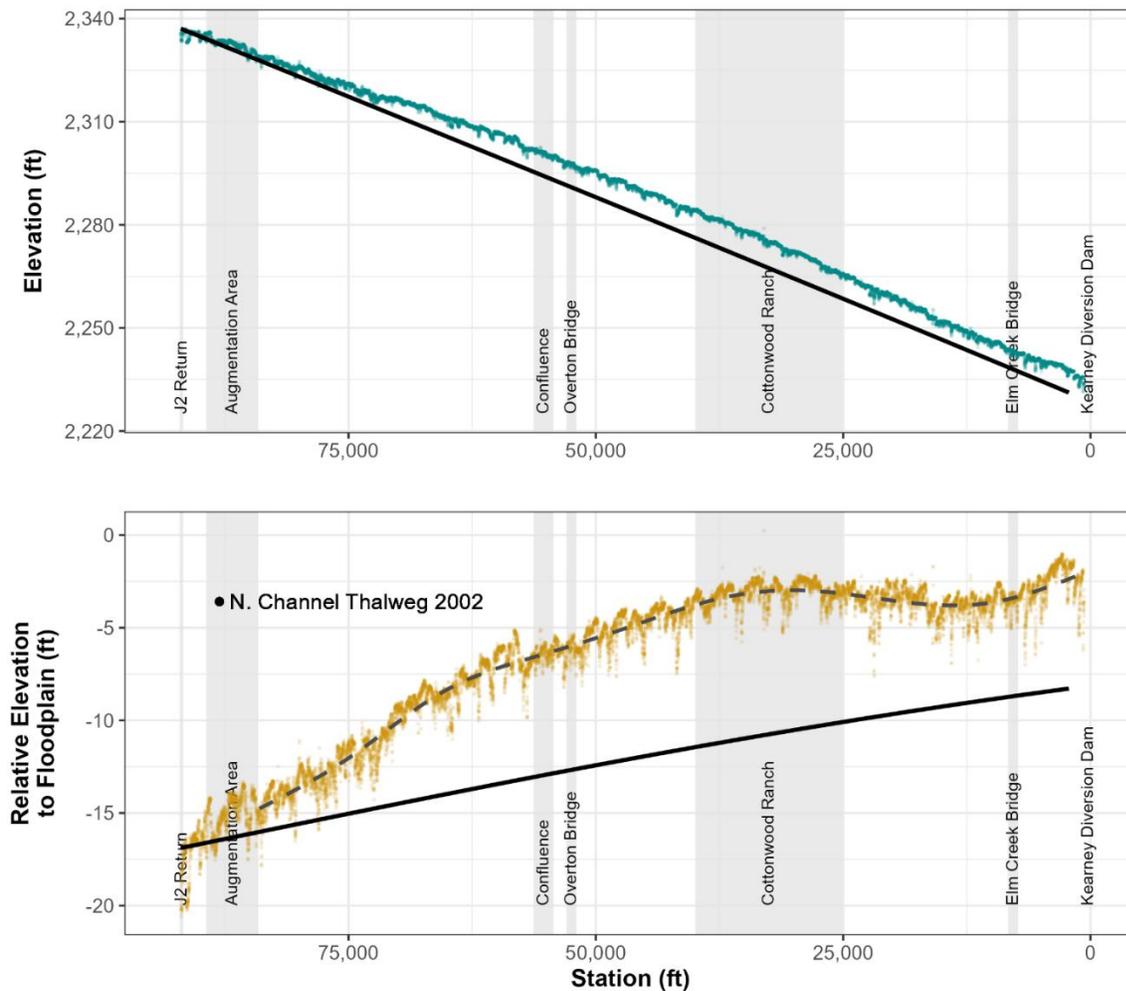
**Figure 2.10.** Observed and predicted channel thalweg elevations (a) and relative elevations to the floodplain (b) according to incision models presented in Murphy et al. (2004). The bold black lines in both plots show predicted elevations, while the dashed line in (b) is a modeled thalweg from a generalized additive mixed model (GAMM). We used a maximum potential thalweg incision value of 13.3 ft below the 2002 North Channel thalweg to be consistent with historical estimates.

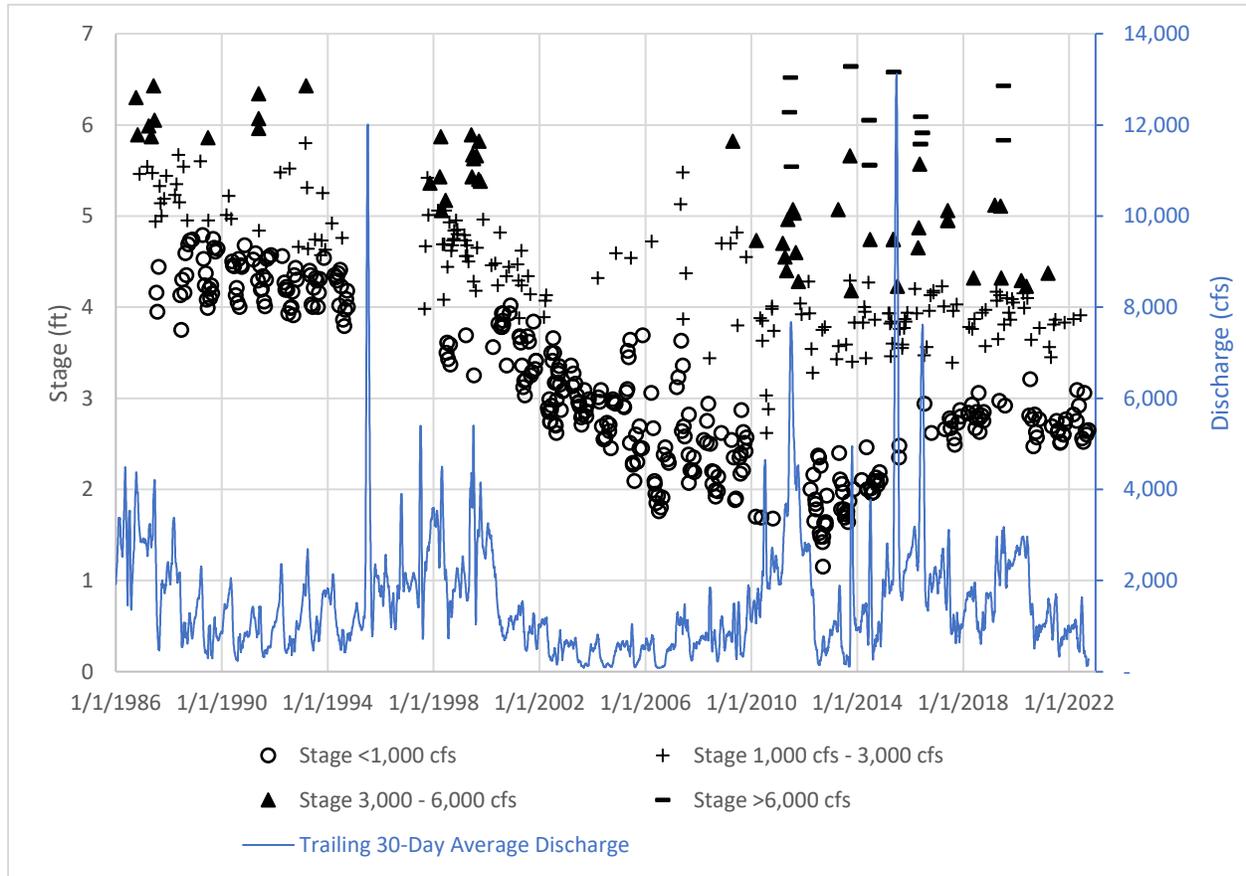
**Figure 2.14.** Physical measurement stage data at Overton Gage (USGS 06768000) and trailing 30-day average discharge. Presence of stage measurements in flow ranges above corresponding discharge on this figure reflect use of 30-day average trailing discharge.

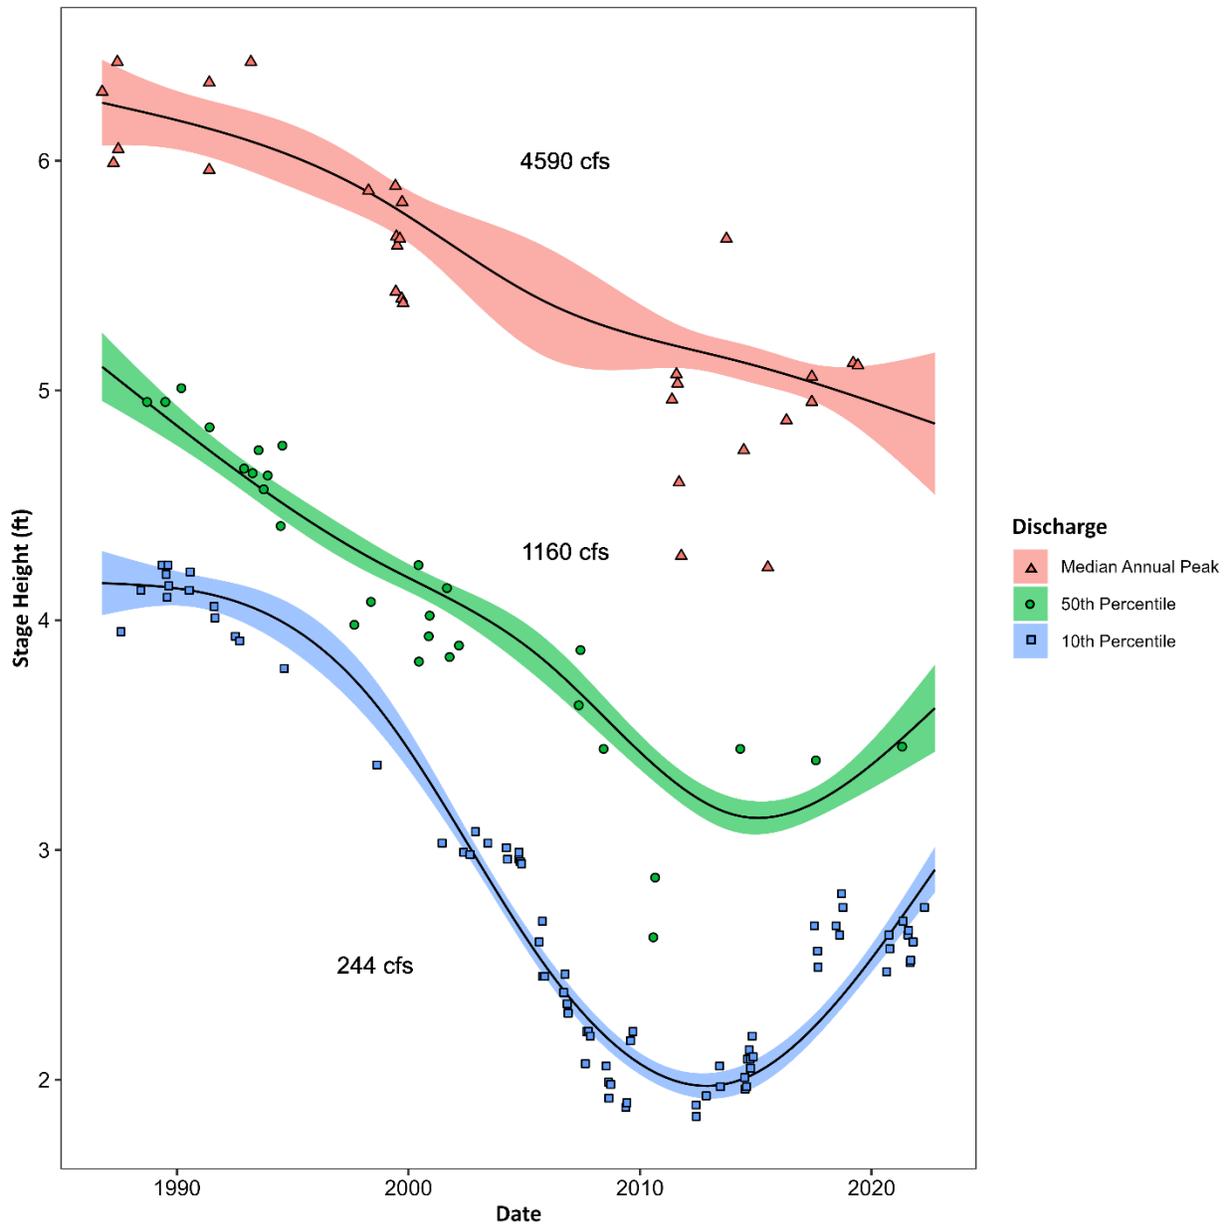
**Figure 2.15.** Specific Gage analysis for Overton Gage (USGS 06768000) at 10<sup>th</sup> percentile discharge of 244 cfs, median discharge of 1,160 cfs, and median annual peak discharge of 4,590 cfs. Shaded regions represent 95% confidence intervals for each discharge. Results indicate that elevations at this gage have decreased since 1986, though a rebound may be occurring beginning in 2013.

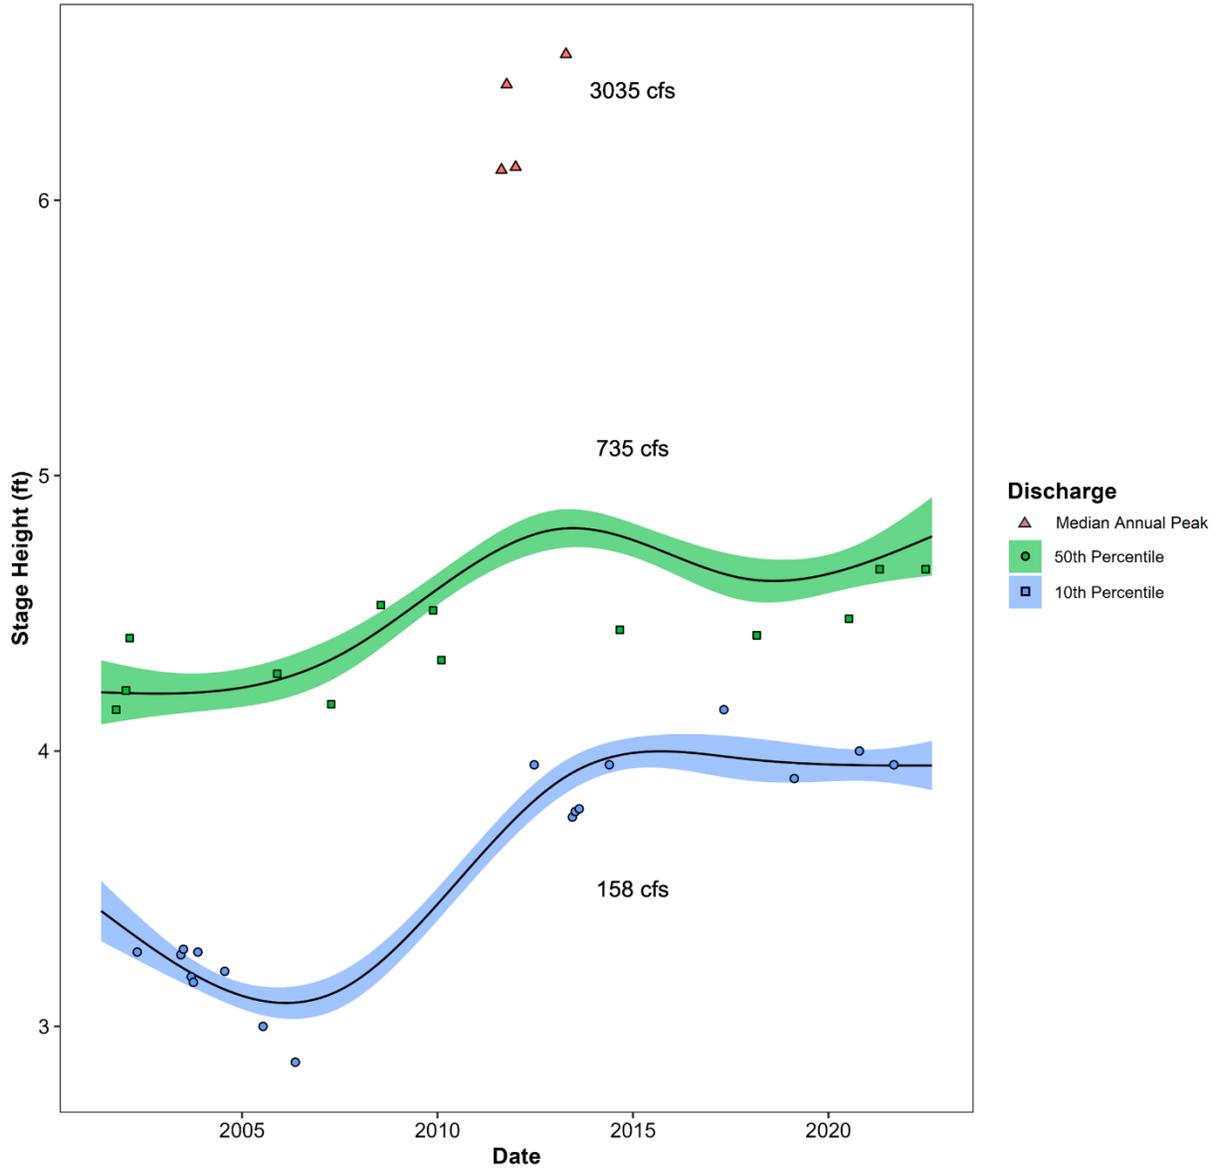
**Figure 2.19.** Specific Gage analysis for Cottonwood Ranch Mid-Channel Gage (USGS 06768035) at 10<sup>th</sup> percentile discharge of 158 cfs, median discharge of 735 cfs, and median annual peak discharge 3,035 cfs. Shaded regions represent 95% confidence intervals for each discharge. Results indicate that elevation at this gage increased slightly until approximately 2012 and 2015 for median and 10th percentile discharge, respectively, and remained relatively stable afterward.

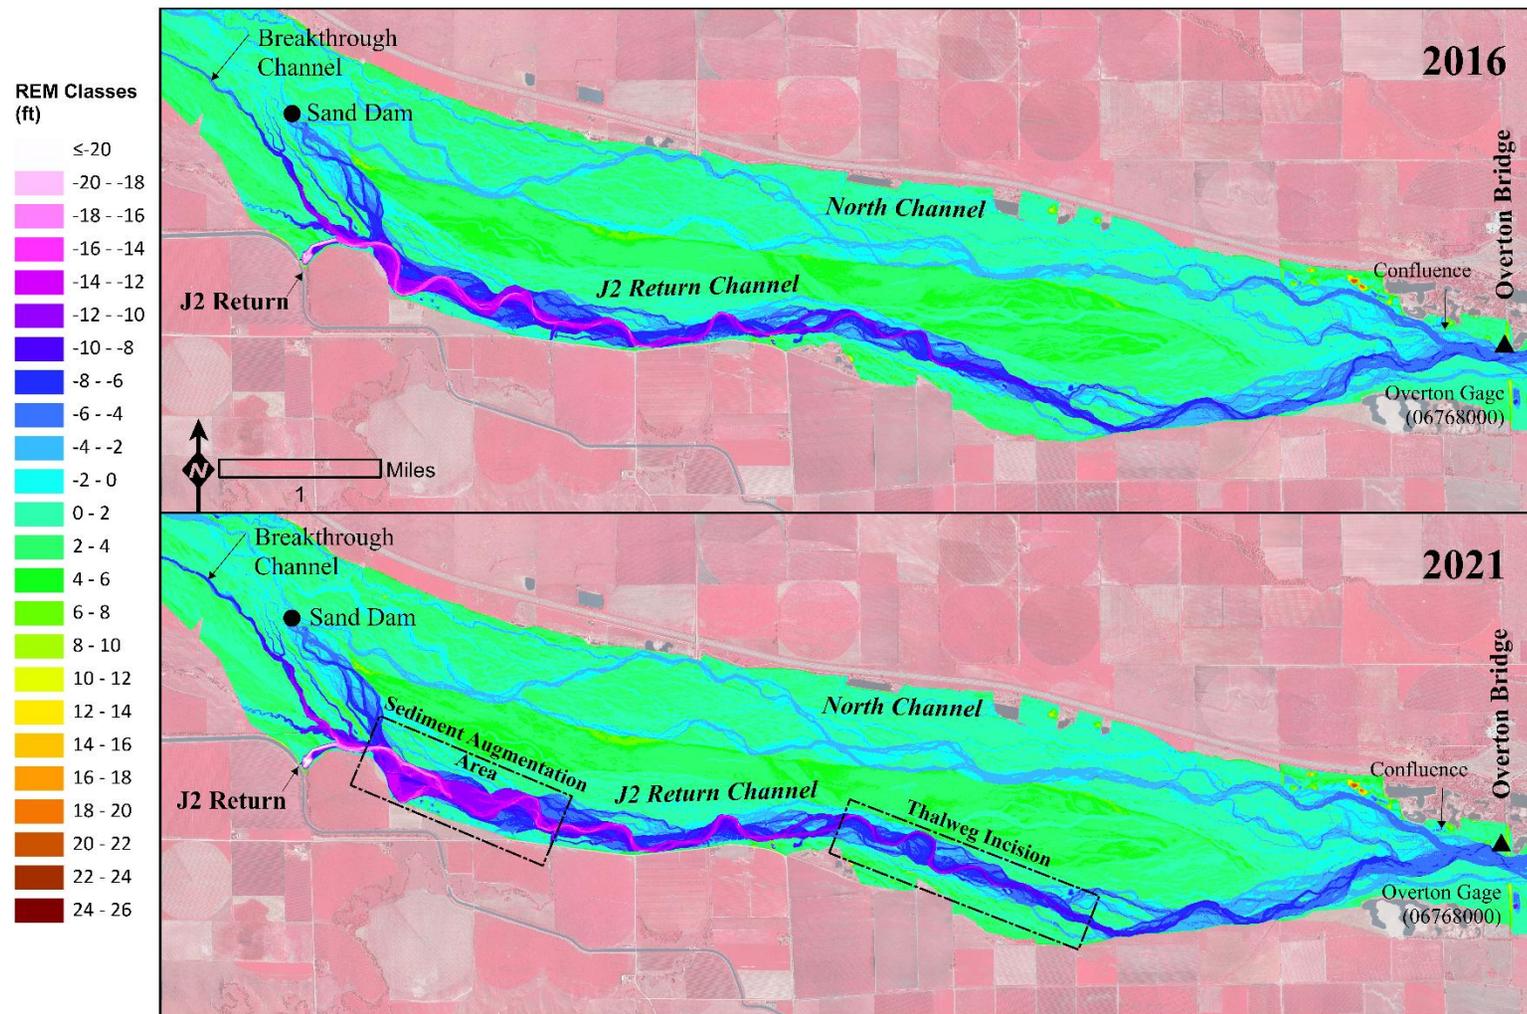
**Figure 3.1.** Relative elevation models (REMs) of the portion of the study area upstream of Overton in 2016 (top) and 2021 (bottom). The topographic signature of sediment augmentation is apparent in the 2021 REM as is a segment of thalweg incision midway between the J2 Return and Overton Bridge. More change occurred from 2016-2021 upstream of Overton Bridge than downstream (comparing Figure 3.1 to Figure 3.2 below).

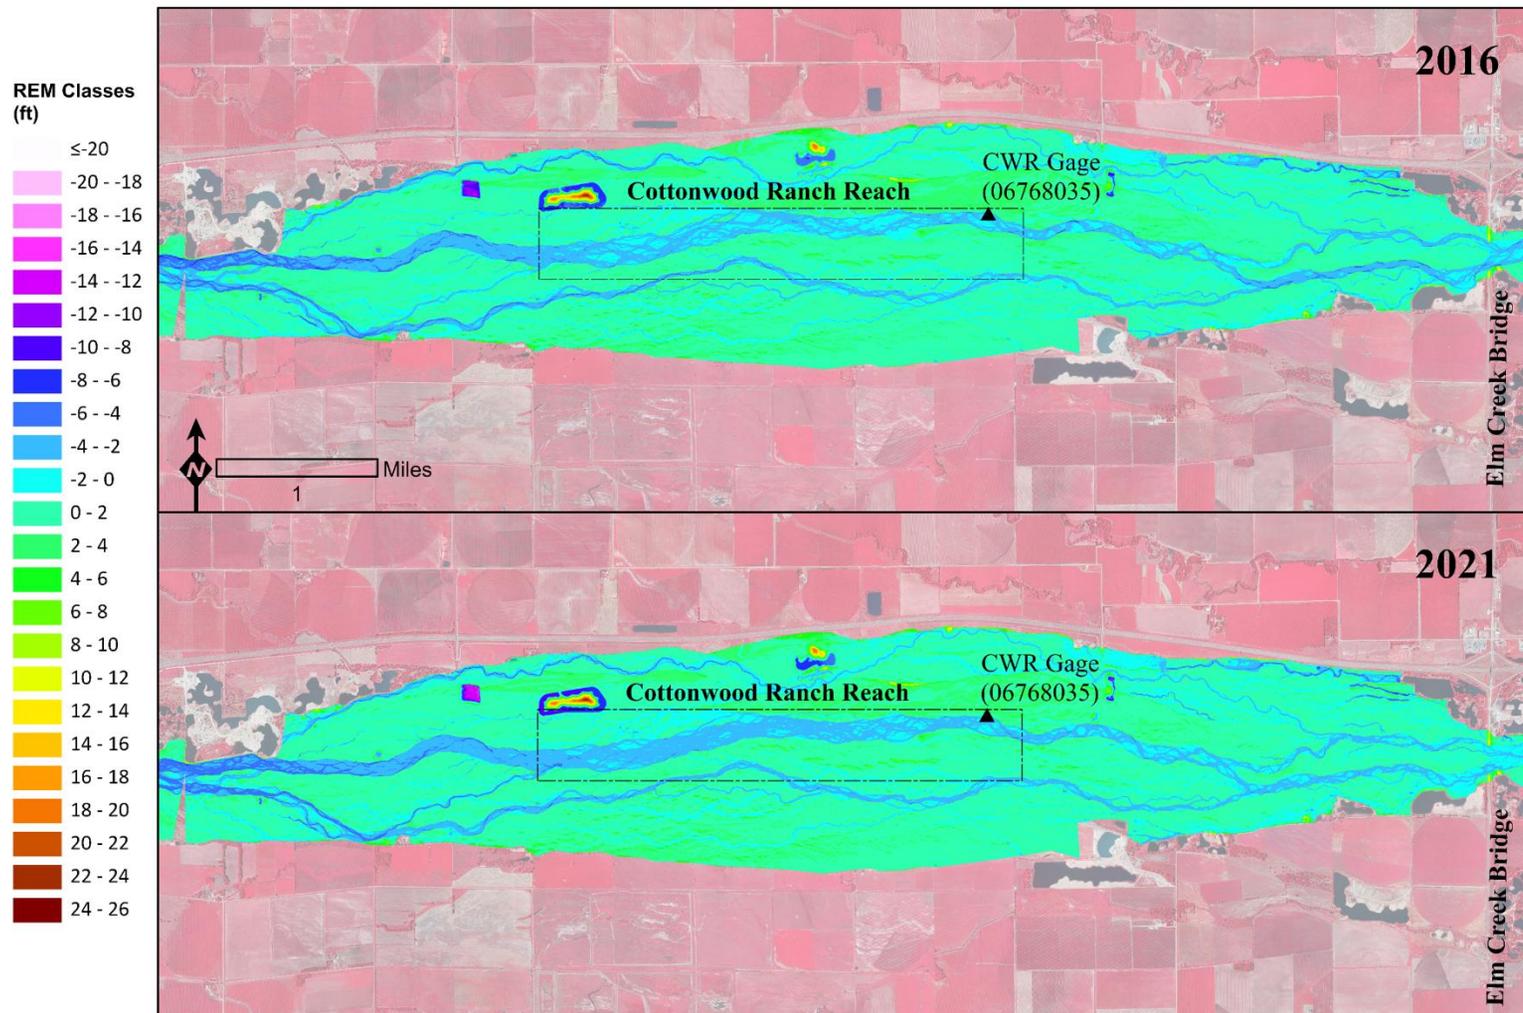
**Figure 3.2.** Relative elevation models (REMs) of the portion of the study area downstream of Overton to the Elm Creek Bridge in 2016 and 2021. Large changes to relative elevation are not apparent in this reach.

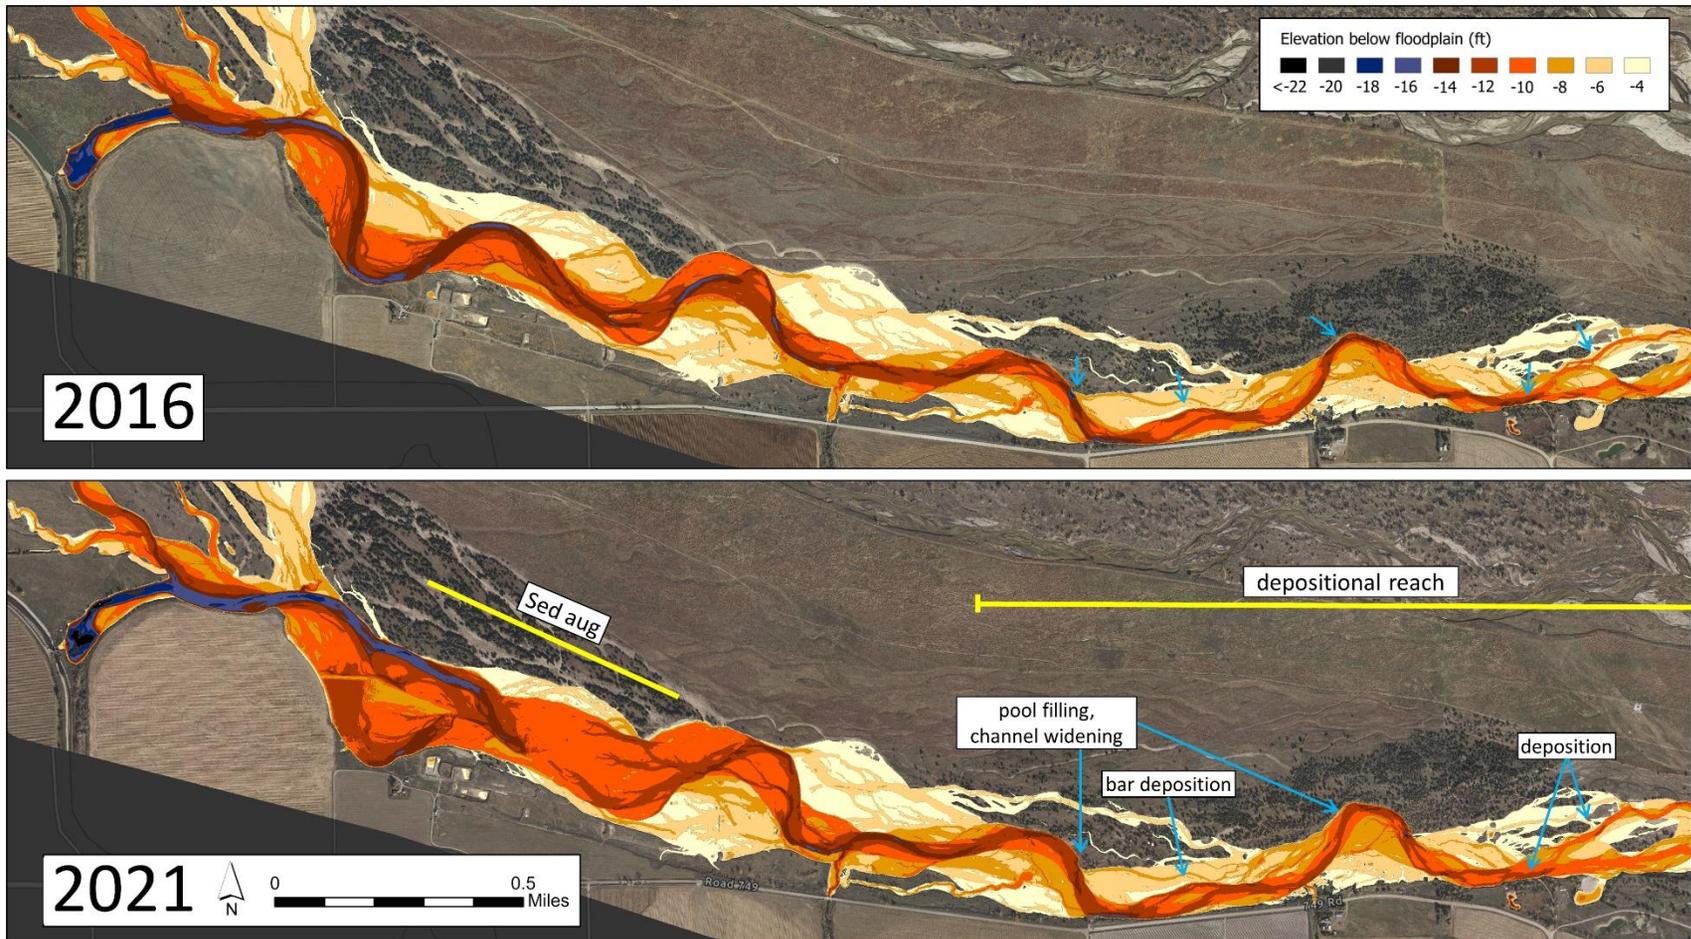
**Figure 3.3.** Annotated relative elevation model of the sediment augmentation area and downstream. The color scale illustrates four feet or more below the average floodplain and omits higher elevations. Incision occurred upstream of augmentation (blue) and deposition occurred downstream of augmentation.
