# **PLATTE RIVER RECOVERY IMPLEMENTATION PROGRAM**

## **Data Synthesis Compilation**

### **Sediment Augmentation**

December 10, 2024

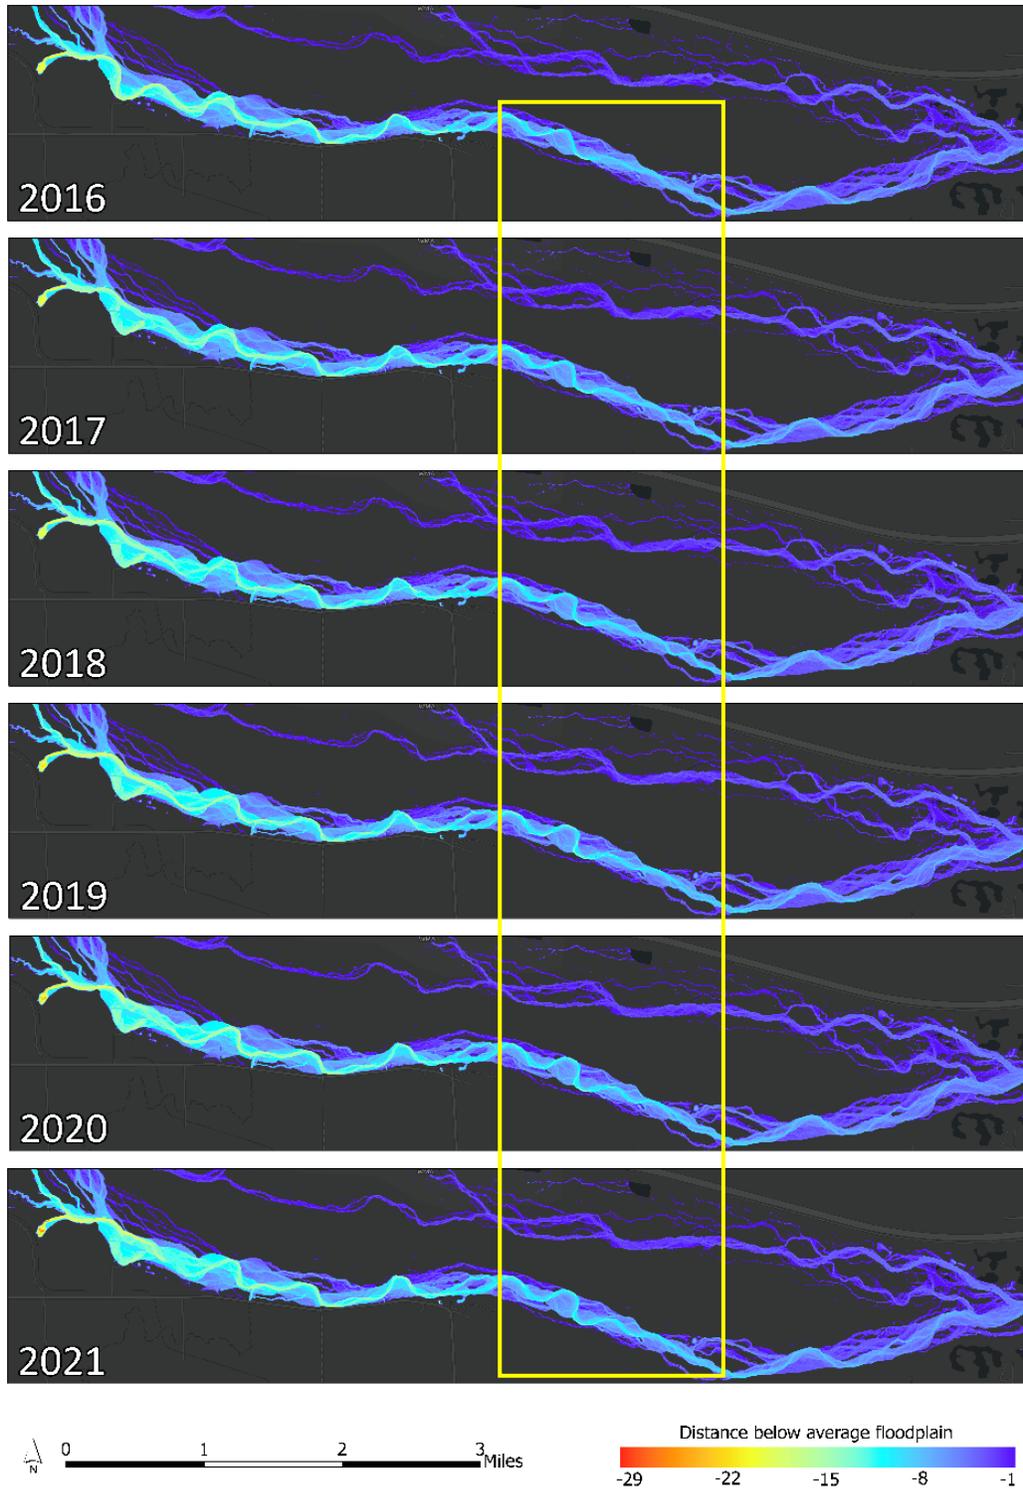
**Figure 3.4.** Annual relative elevation models (REMs) of the J2 Return Channel (2016 to 2021). Meander development and thalweg incision can be observed near Station 70,000 (yellow box).

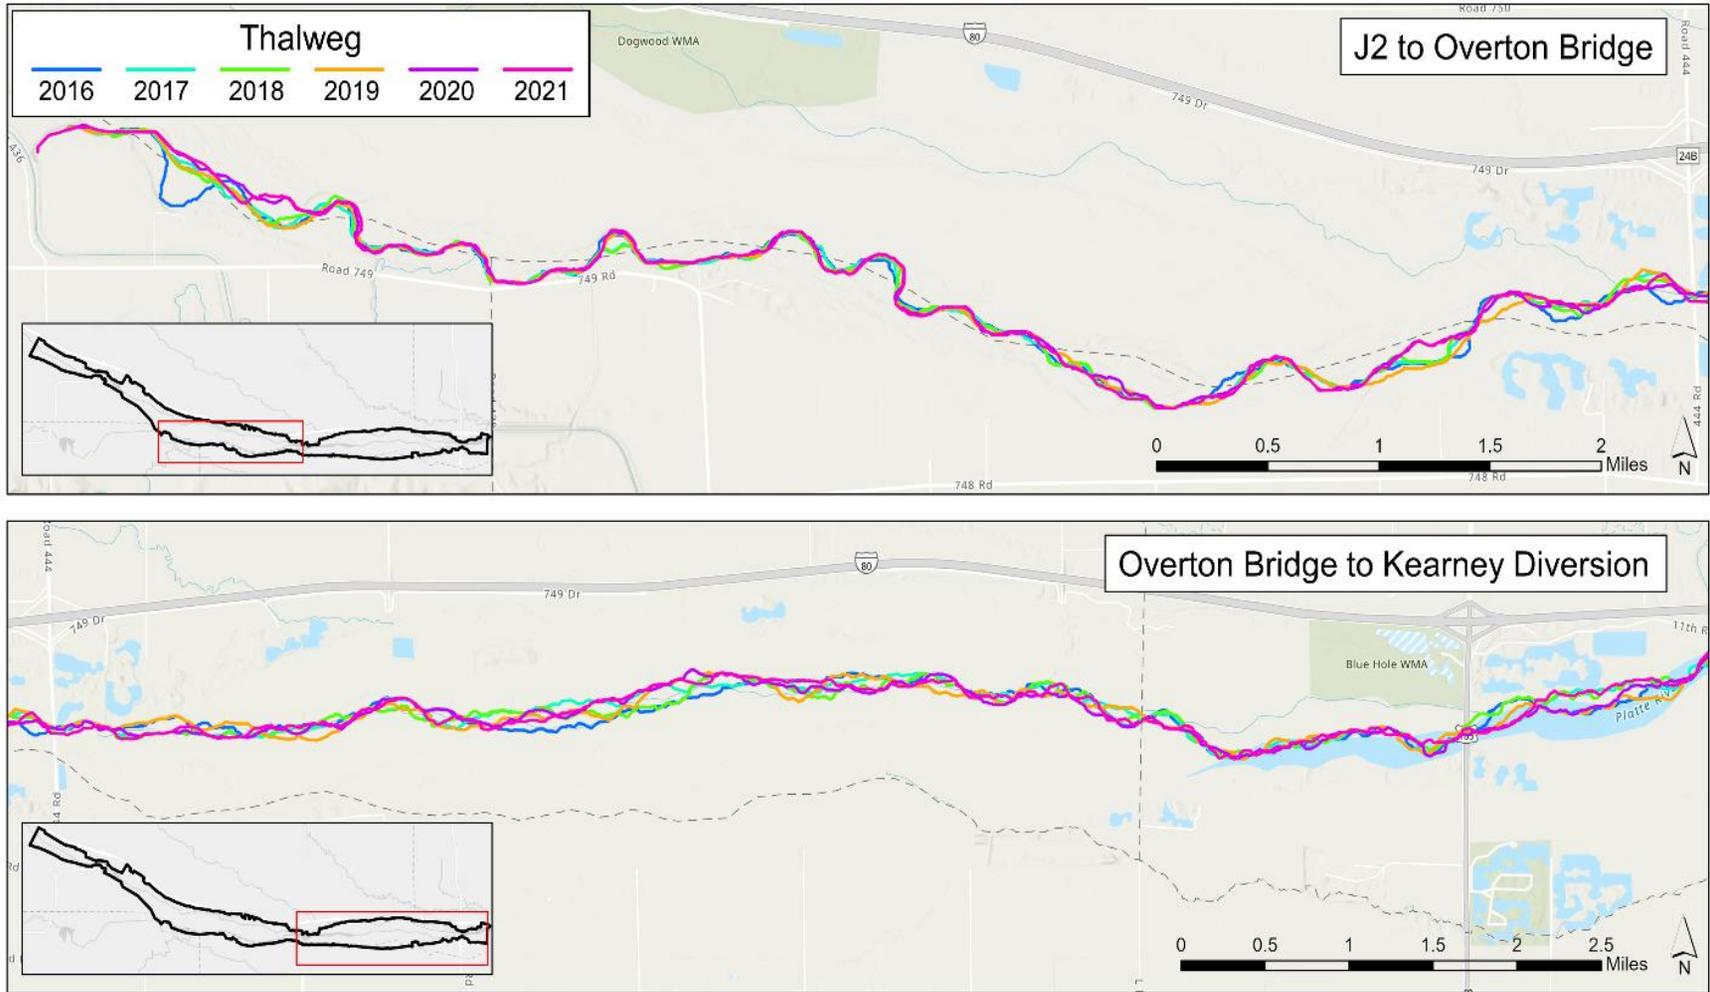
**Figure 3.5.** Annual thalweg alignments (2016–2021) derived from flow accumulation rasters. In the top panel, the transition from wandering to braided planform is present midway through the J2 Return Channel.

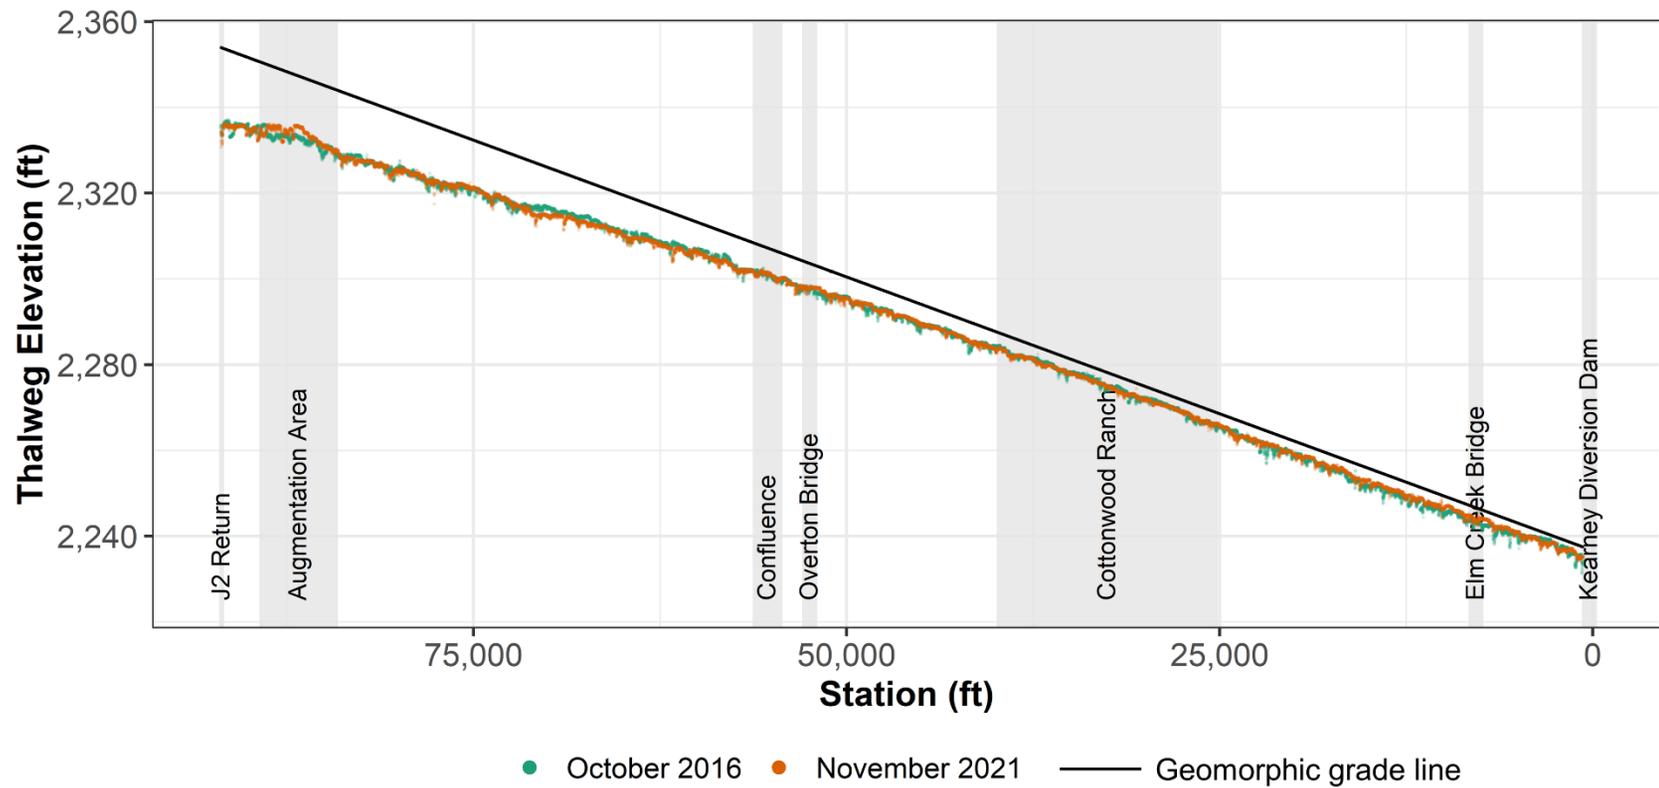
**Figure 3.6.** Longitudinal profile of thalweg elevation in 2016 (green) and 2021 (orange). The Geomorphic Grade Line (GGL) is shown in black as a reference for the magnitude of channel incision.

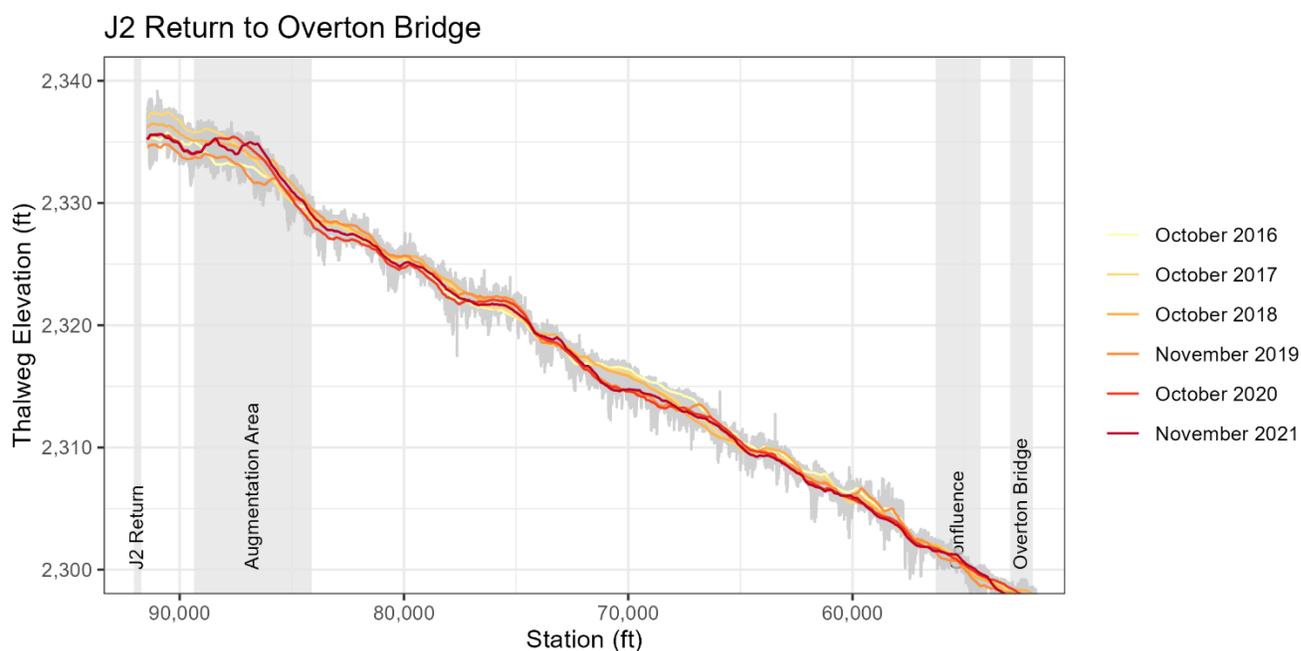
**Figure 3.7.** 2016–2021 annual moving average (1,005 ft) longitudinal profiles between J2 Return and Overton Bridge. Grey area behind profiles indicates the range of values for 2016–2021. Progressive thalweg aggradation is apparent in the sediment augmentation area and progressive degradation is apparent downstream in the vicinity of Station 70,000.

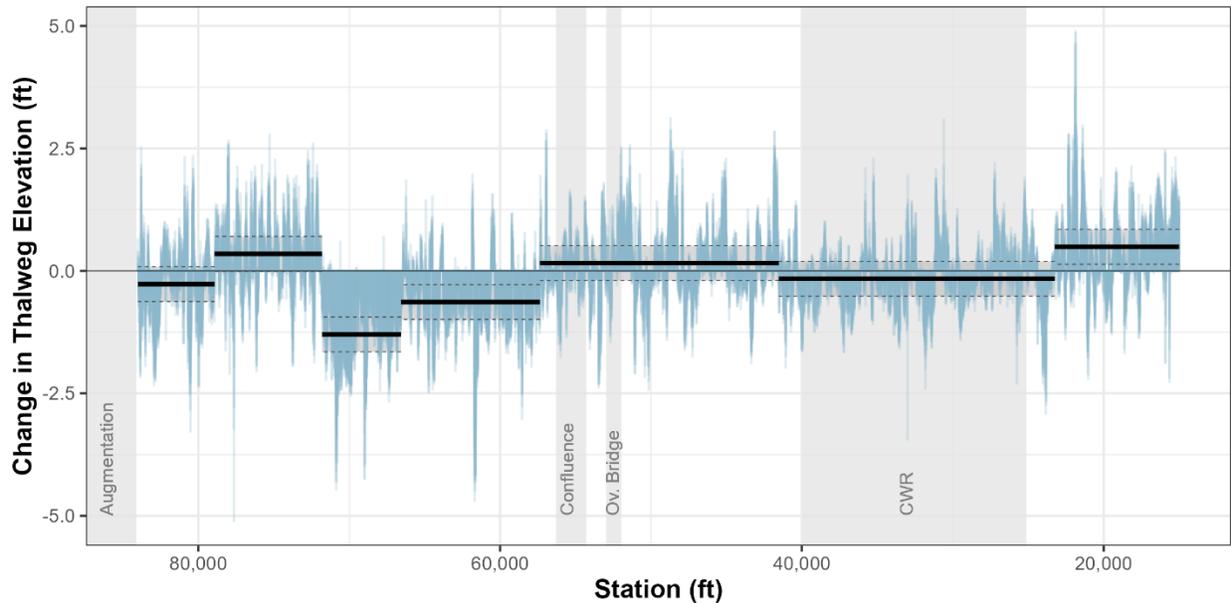
**Figure 3.8** 2016–2021 thalweg change point analysis results. Differences in thalweg elevations shown in blue. Mean segment change values shown in black. Negative numbers indicate thalweg incision and positive indicate thalweg aggradation. Shaded areas with bounding dotted lines represent the propagated error from LiDAR collection for 2016 and 2021 (0.356 ft).

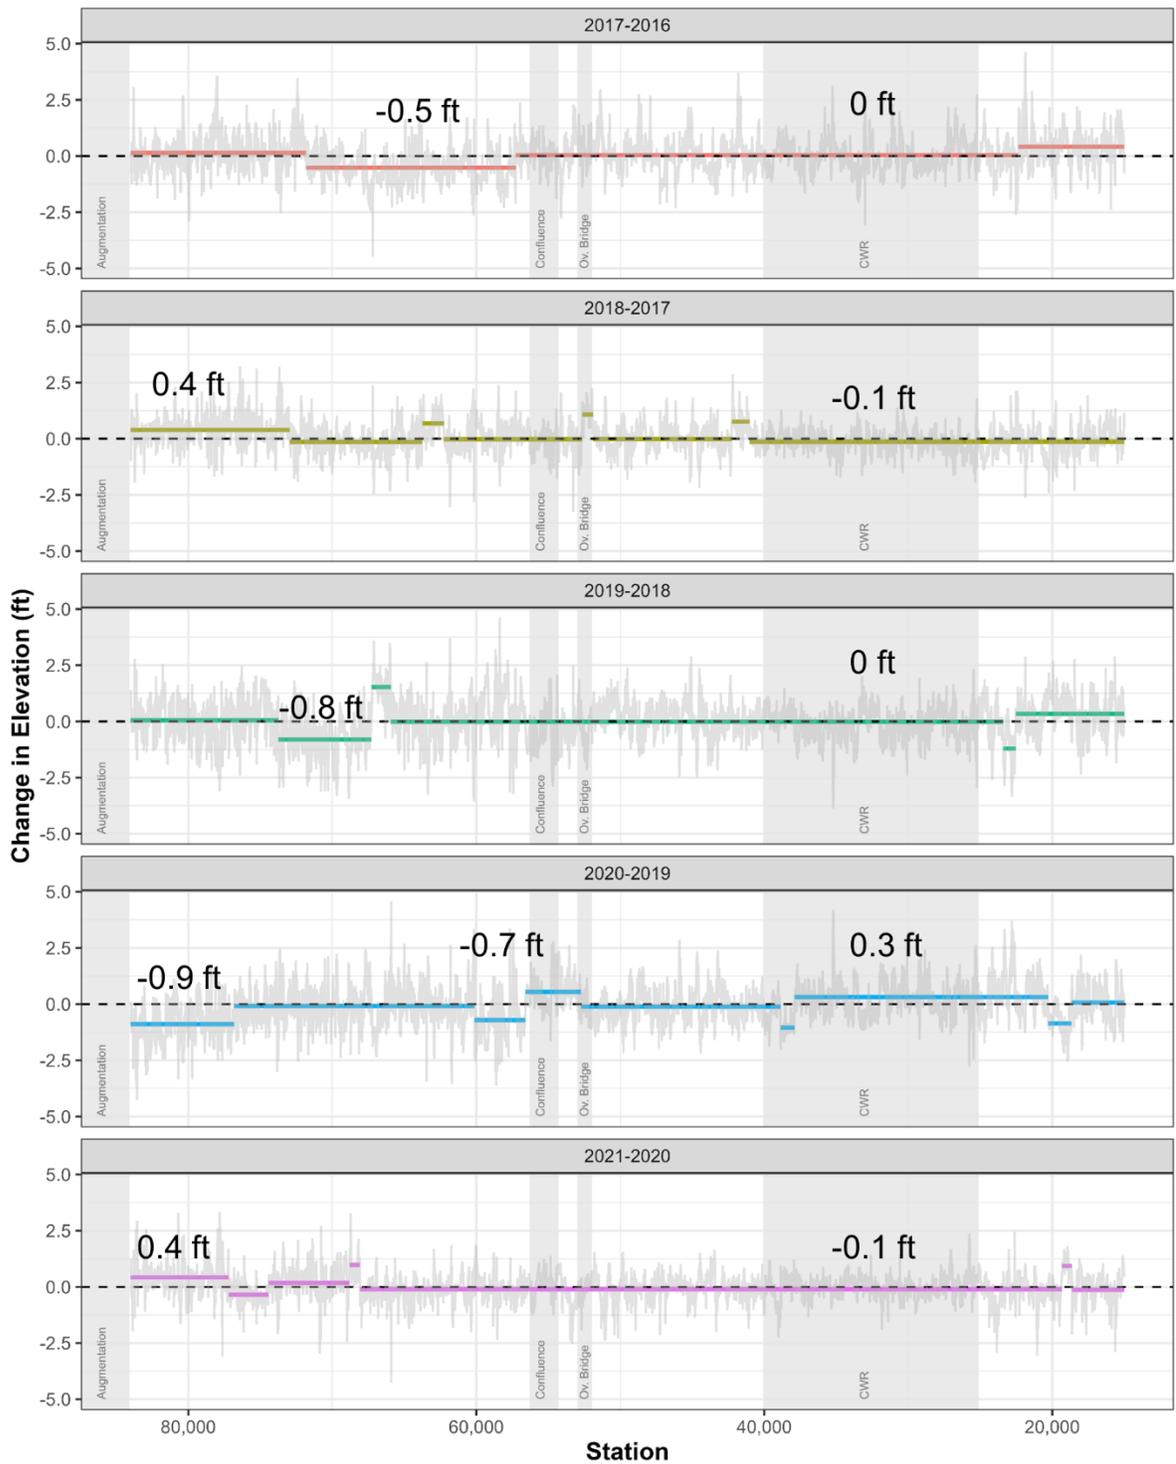
**Figure 3.9.** Annual changepoint analysis results of change in thalweg elevation between years. Colored lines show mean change values of changepoint segments. Light grey lines show at-a-station thalweg elevation difference.

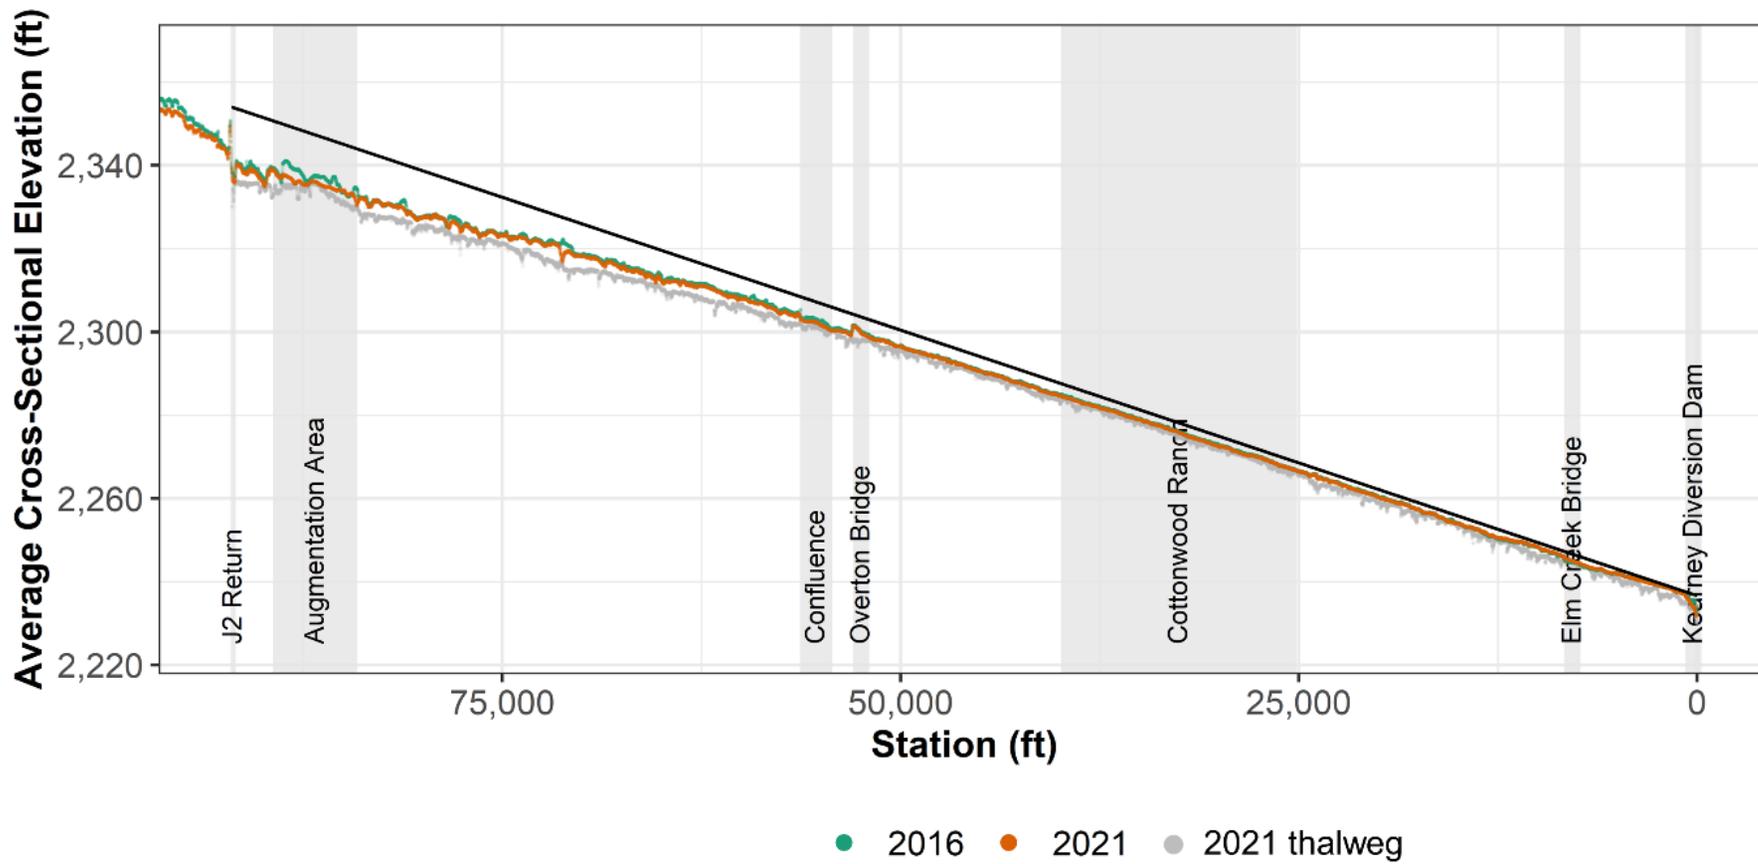
**Figure 3.10.** Average cross-sectional elevation longitudinal profile. The geomorphic grade line and 2021 thalweg are shown for reference.

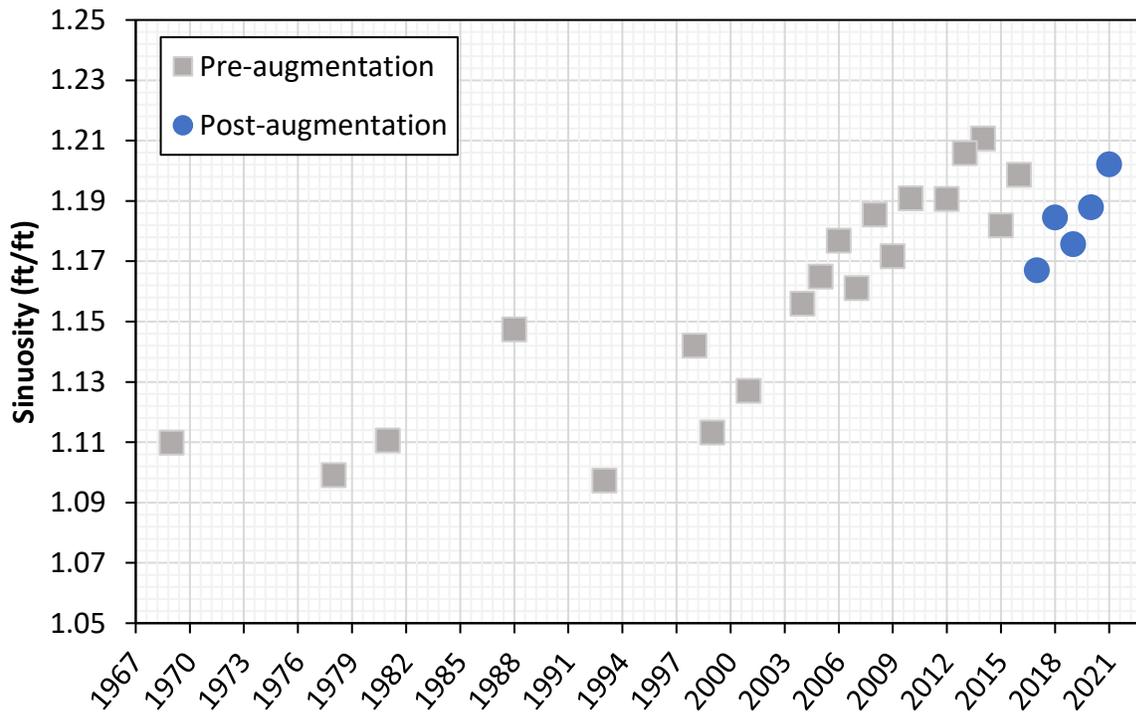
**Figure 3.16** Ratio of thalweg to straight-line length (sinuosity) in the J2 Return Channel between 1969 and 2021. Figure shows a trend in increasing sinuosity beginning in the early 2000s. Sinuosity declined in 2017 due to the construction of a meander cutoff as part of augmentation operations. Despite the cutoff, the trend of increasing sinuosity continued during the augmentation experiment.

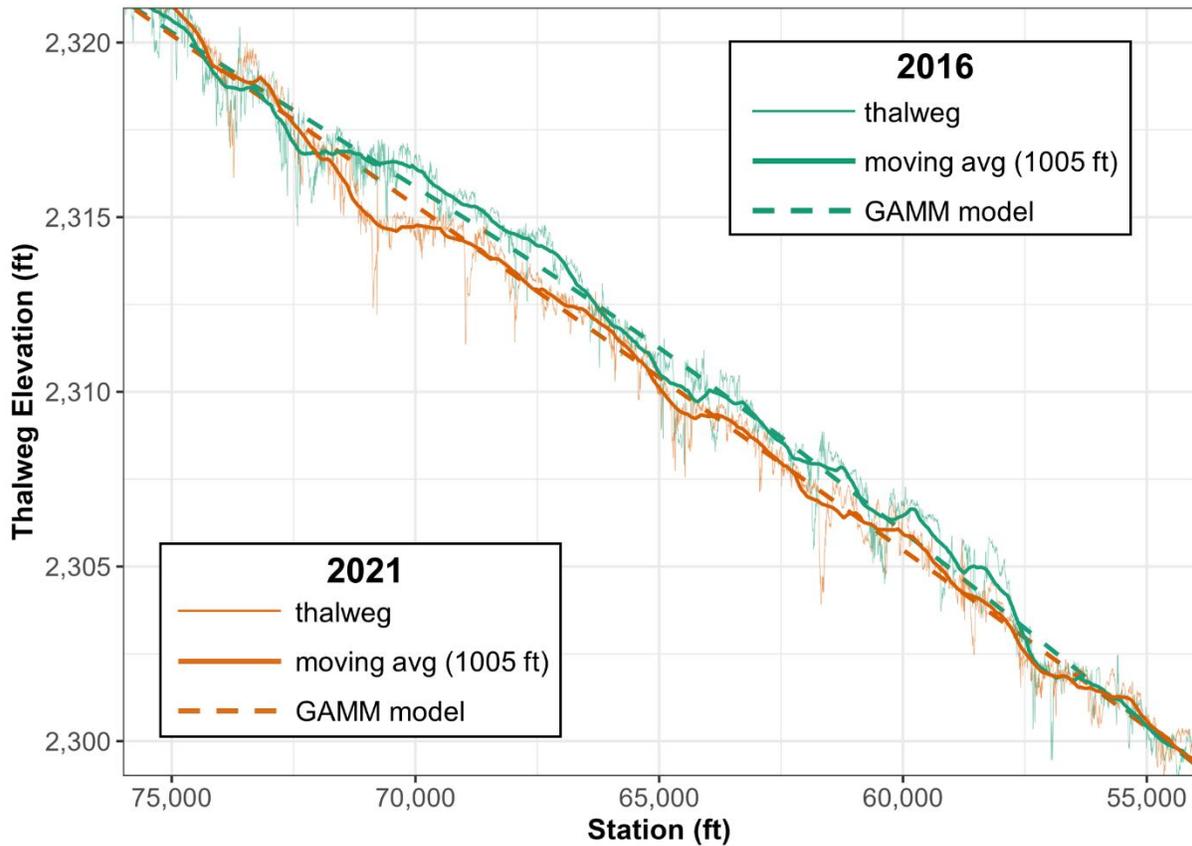
**Figure 3.17.** Longitudinal thalweg profiles and thalweg models (GAMMs) for 2016 and 2021 between Station 75,000 and 55,000.

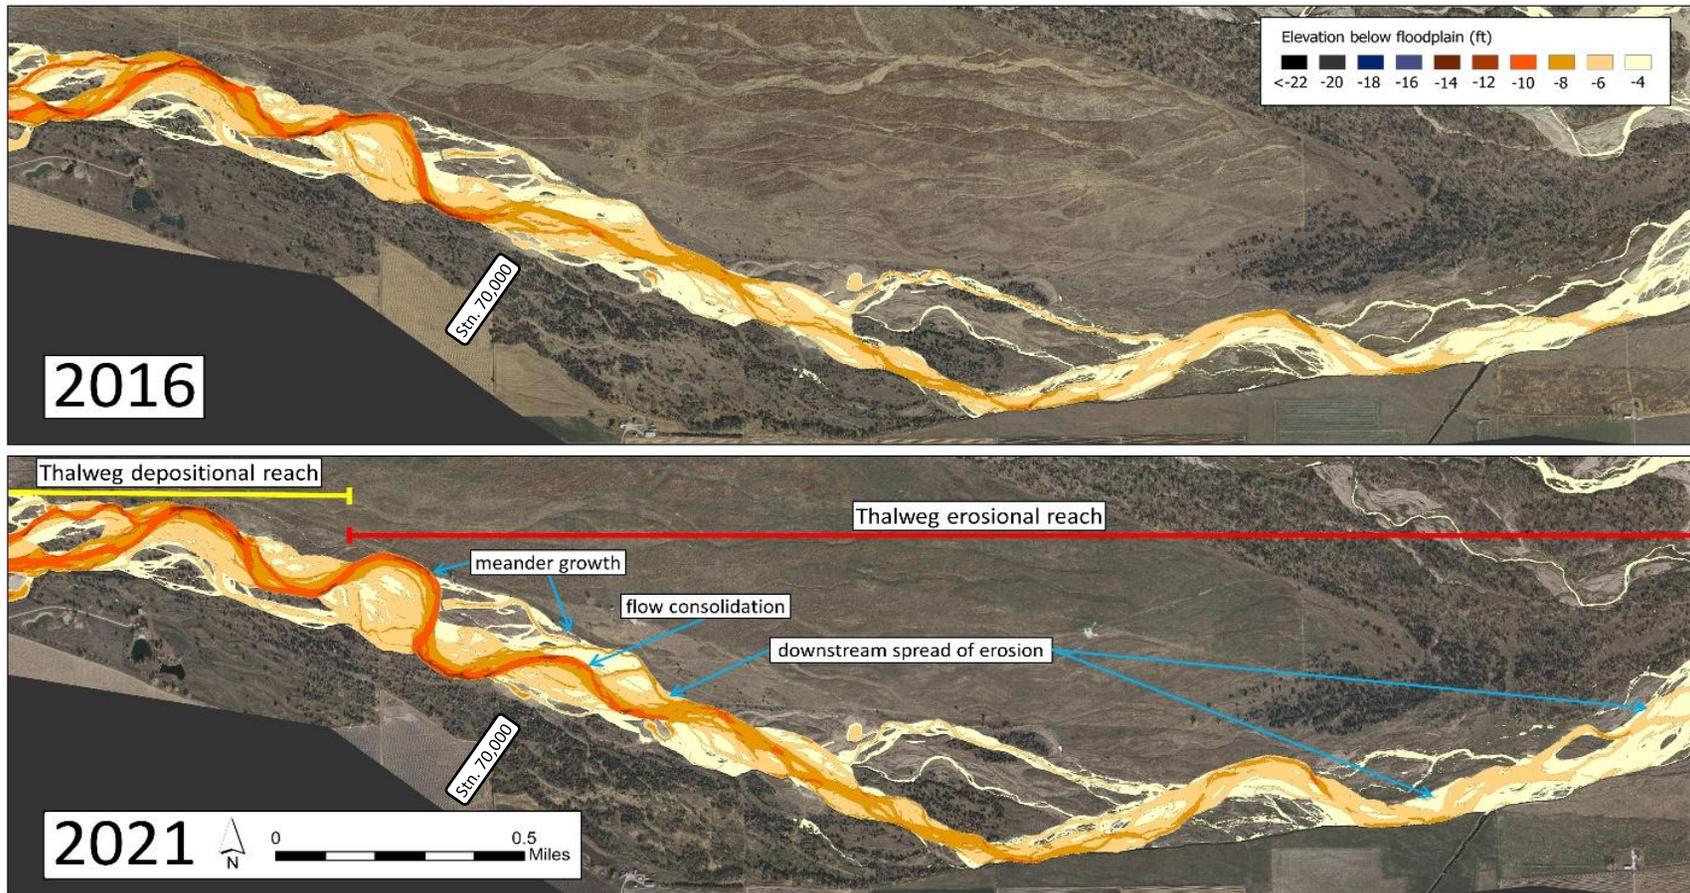
**Figure 3.19.** Annotated relative elevation models (REMs) of the downstream section of J2 Return Channel ending at Station 58,000. The relative elevation model is contoured into 2 ft intervals below -4 ft relative to the floodplain. Blue arrows in the bottom panel highlight changes since sediment augmentation. Yellow and red lines indicate regions of erosion and deposition detected by changepoint analysis.

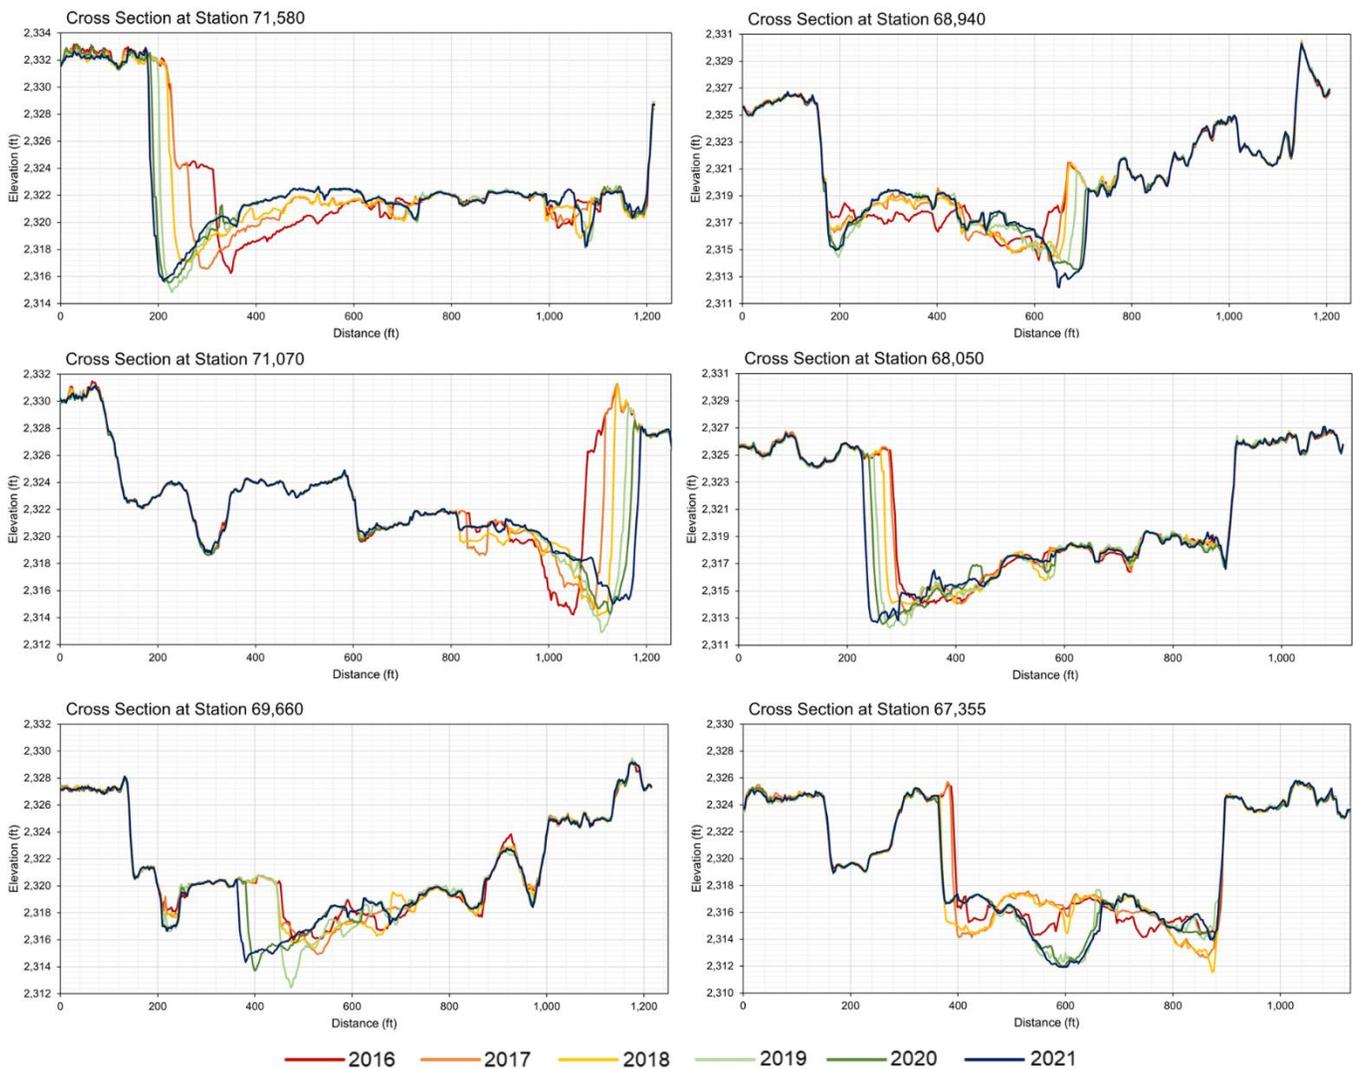
**Figure 3.21.** Cross sections viewed from river left to right, looking in the downstream direction at 6 locations in Reach 70,000 of the J2 Return Channel.

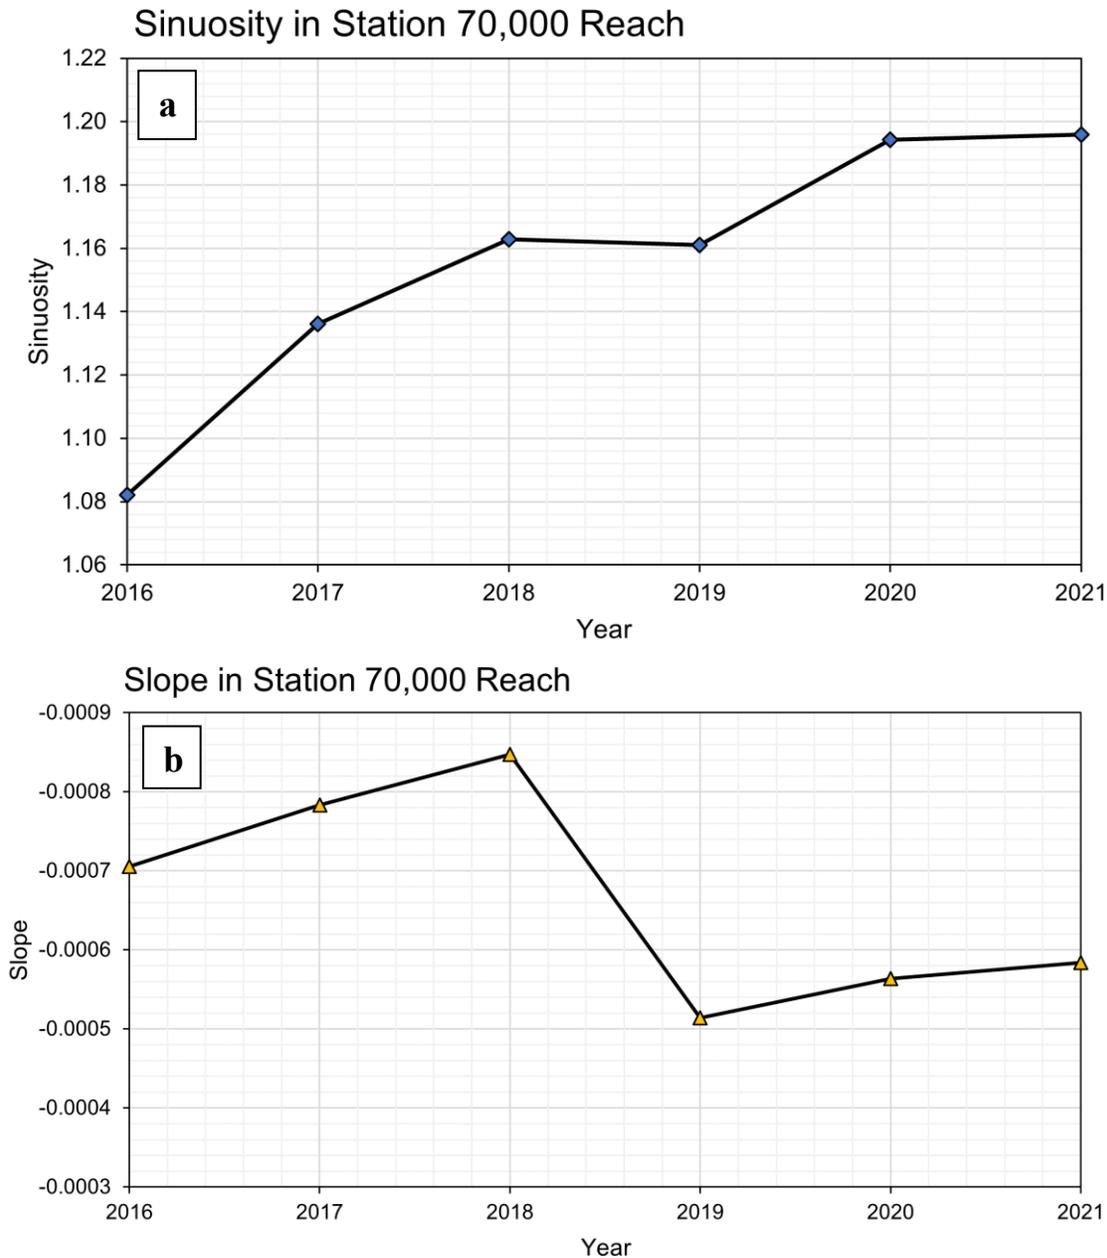
**Figure 3.22.** (a) Sinuosity of Reach 70,000, measured in the area delineated by the black rectangle in Figure 3.20. Sinuosity is the ratio of along-channel distance to straight line distance. (b) Slope of reach 70,000, measured as the slope of a linear regression between elevation and along-thalweg distance within the black rectangle in Figure 3.20.

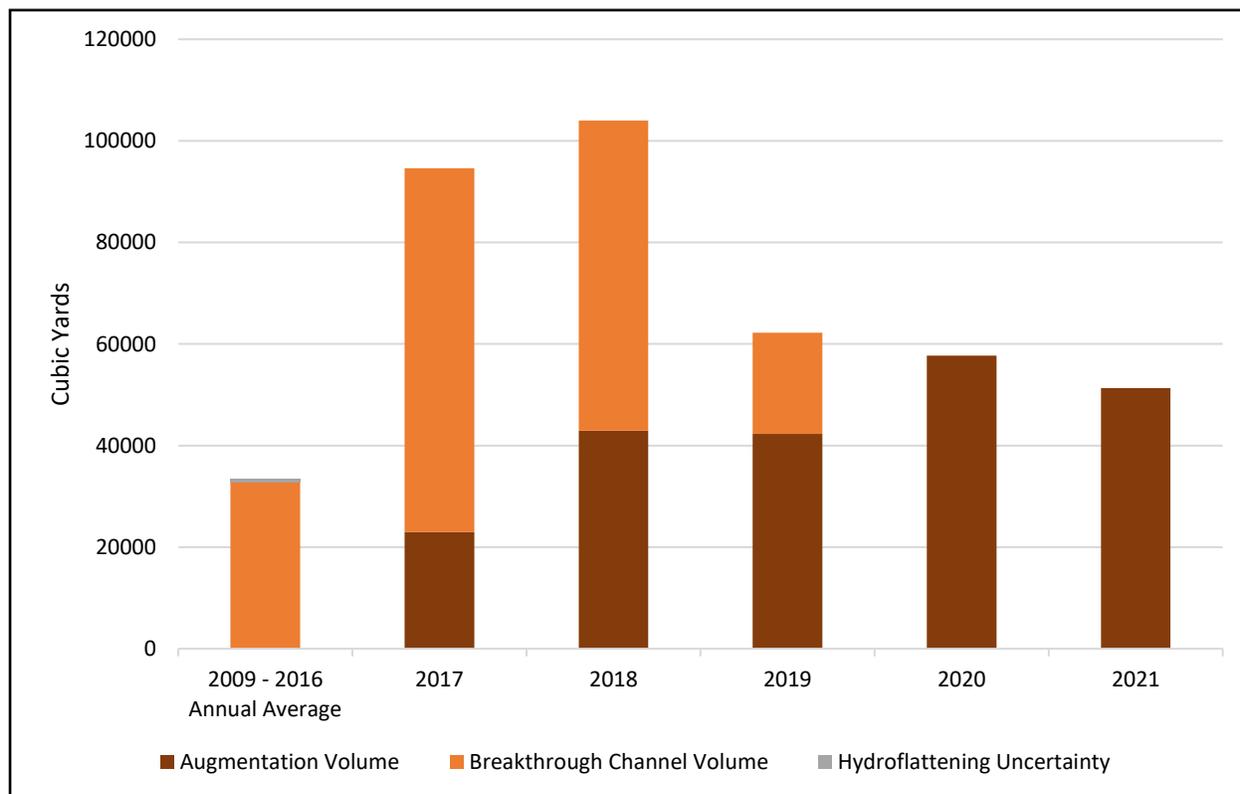
**Figure 4.1** Sediment added to the J2 Return Channel downstream of the return through erosion in the breakthrough channel (orange) and sediment augmentation (brown).

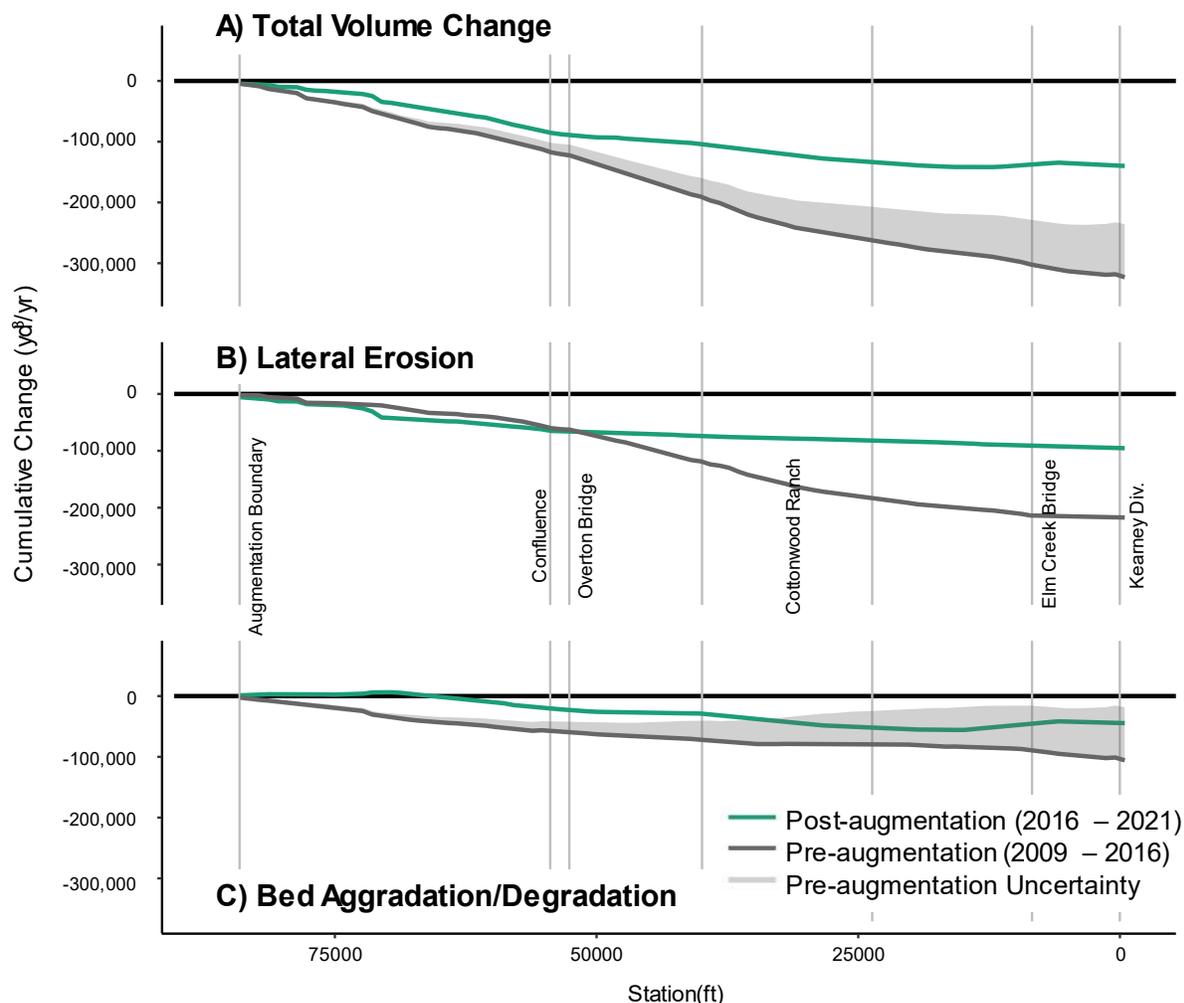
**Figure 4.6.** Cumulative volume change in the pre- and post-augmentation time periods. Lines represent the running sum of all change starting at the downstream end of augmentation projects. Gray shaded area represents the uncertainty in the pre-augmentation period due to lacking bathymetry data.

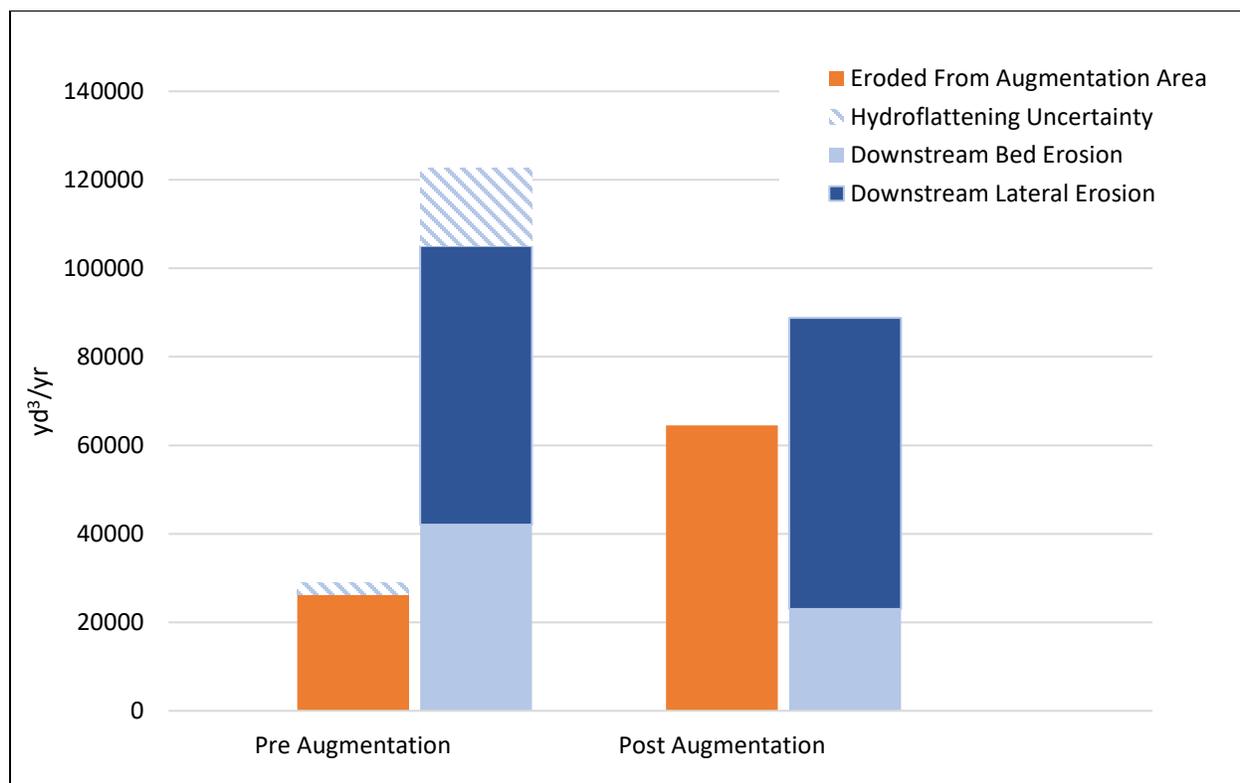
**Figure 4.8** Volumes eroded from the J2 Return Channel upstream and within the augmentation project area (orange), and downstream of augmentation projects to the Overton Bridge (blue) in pre- and post-augmentation periods. In the post augmentation period, upstream sediment supply increased and downstream bed erosion decreased. The similarity between the values of increase and decrease indicate that sediment is leaving the augmentation area and reducing bed erosion downstream.

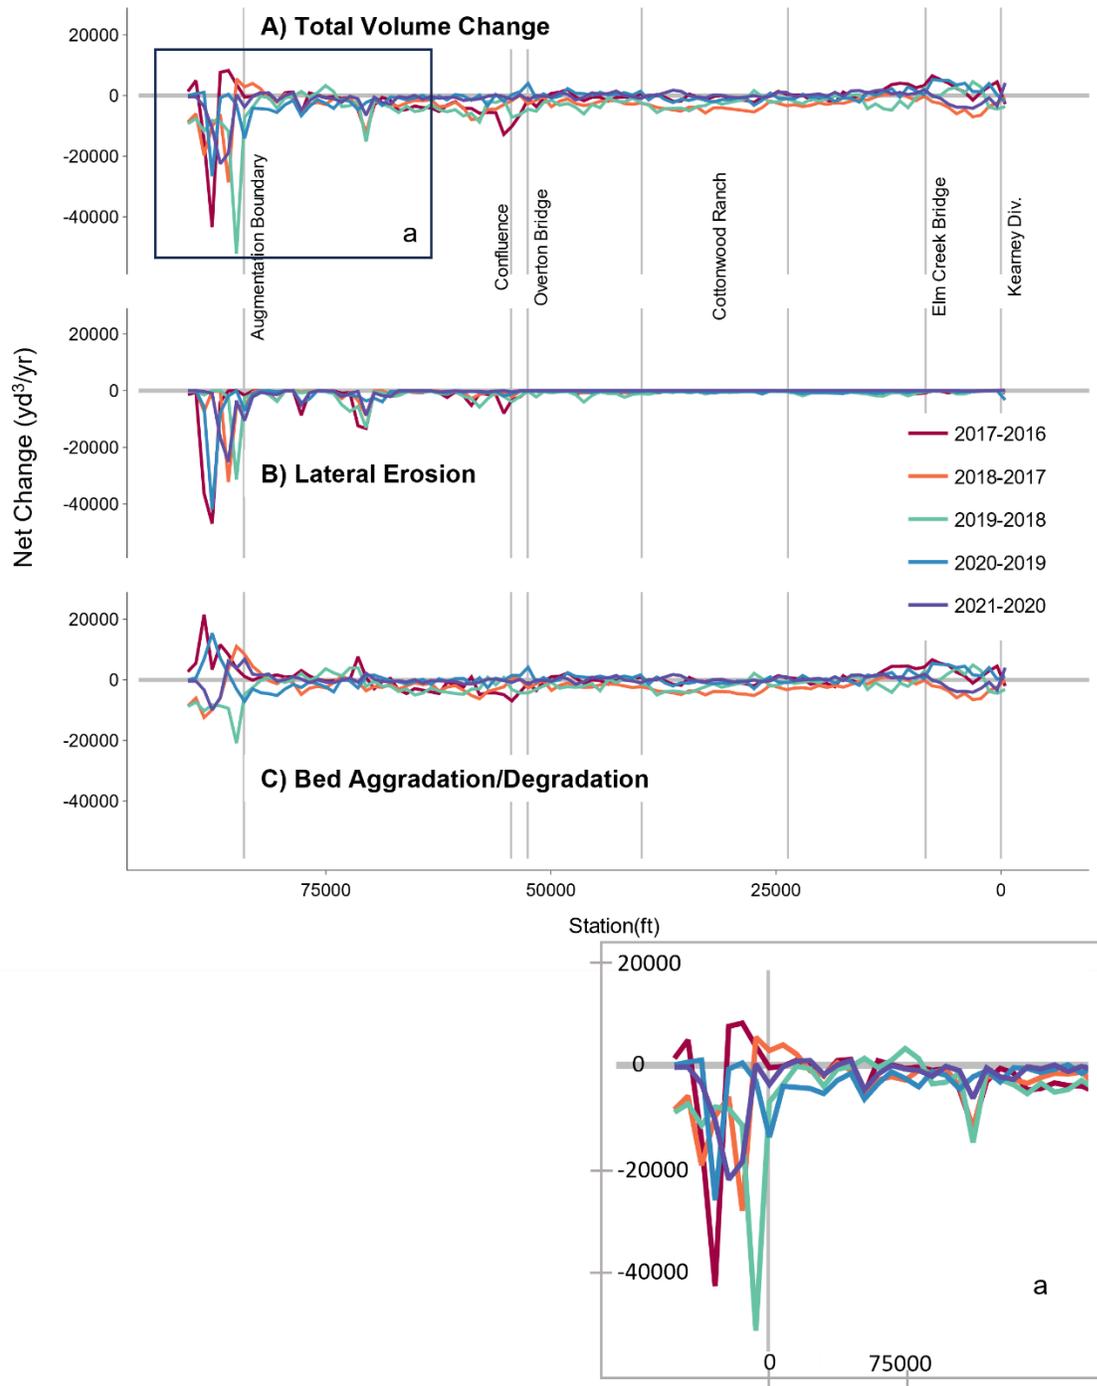
**Figure 4.9** Post-augmentation year-by-year net volume change. Inset ‘a’ depicts positive volume change that moves downstream from the augmentation zone in 2016 to 2019. This pattern is disrupted in 2019-2021, perhaps becoming more dispersed as total degradation is reduced in those years.

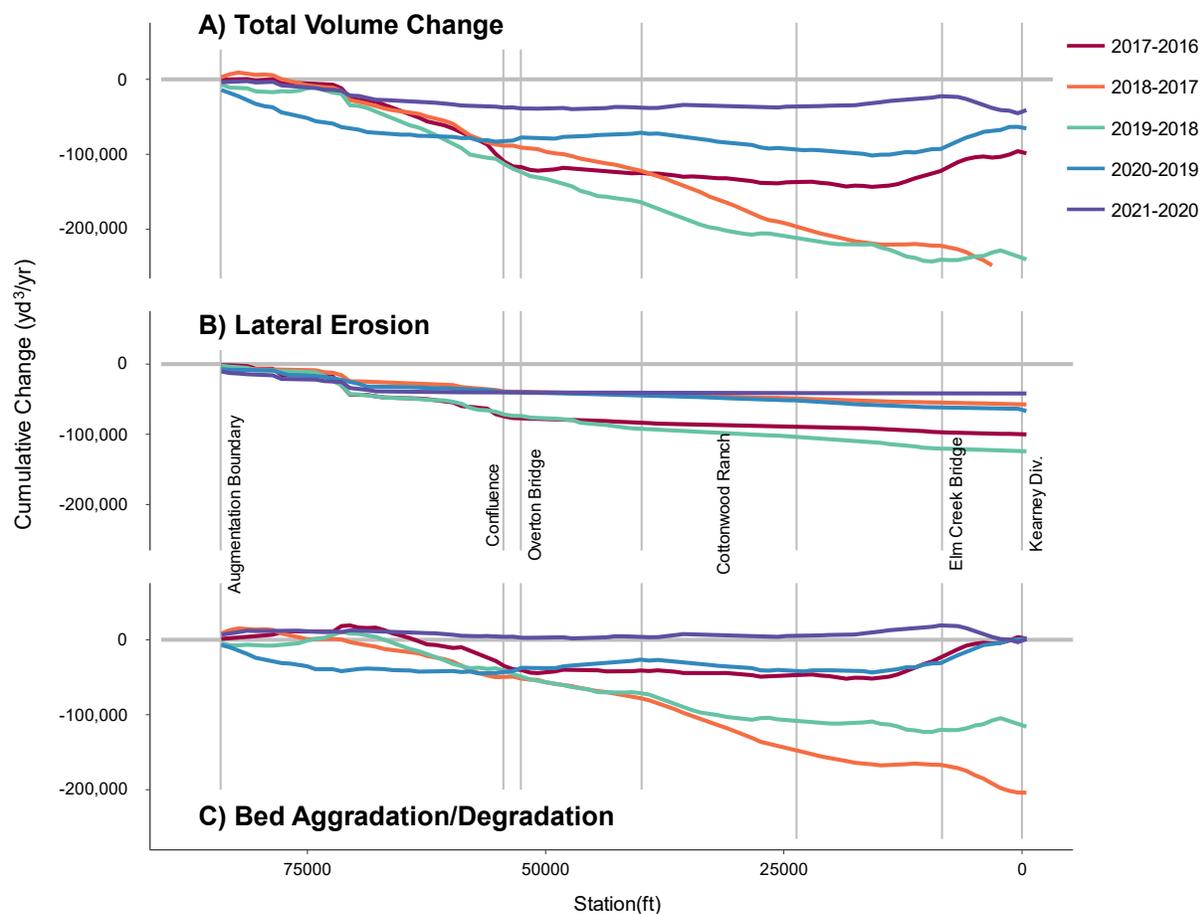
**Figure 4.10** Cumulative year-by-year volume change in the post-augmentation period. (A) Lines represent the running sum of all change starting at the downstream end of augmentation projects. The nearly flat lines downstream of Overton Bridge indicate very little lateral erosion occurred (B). Steep slopes indicate high local change, such as the high bed degradation at Cottonwood Ranch from 2017–2019 (C).
