NORTH PLATTE RIVER CHOKEPOINT TEST FLOW RELEASE

Implementation, Data Analysis, Visual
Observations, Outcomes, and Next Steps

PLATTE RIVER
RECOVERY IMPLEMENTATION PROGRAM

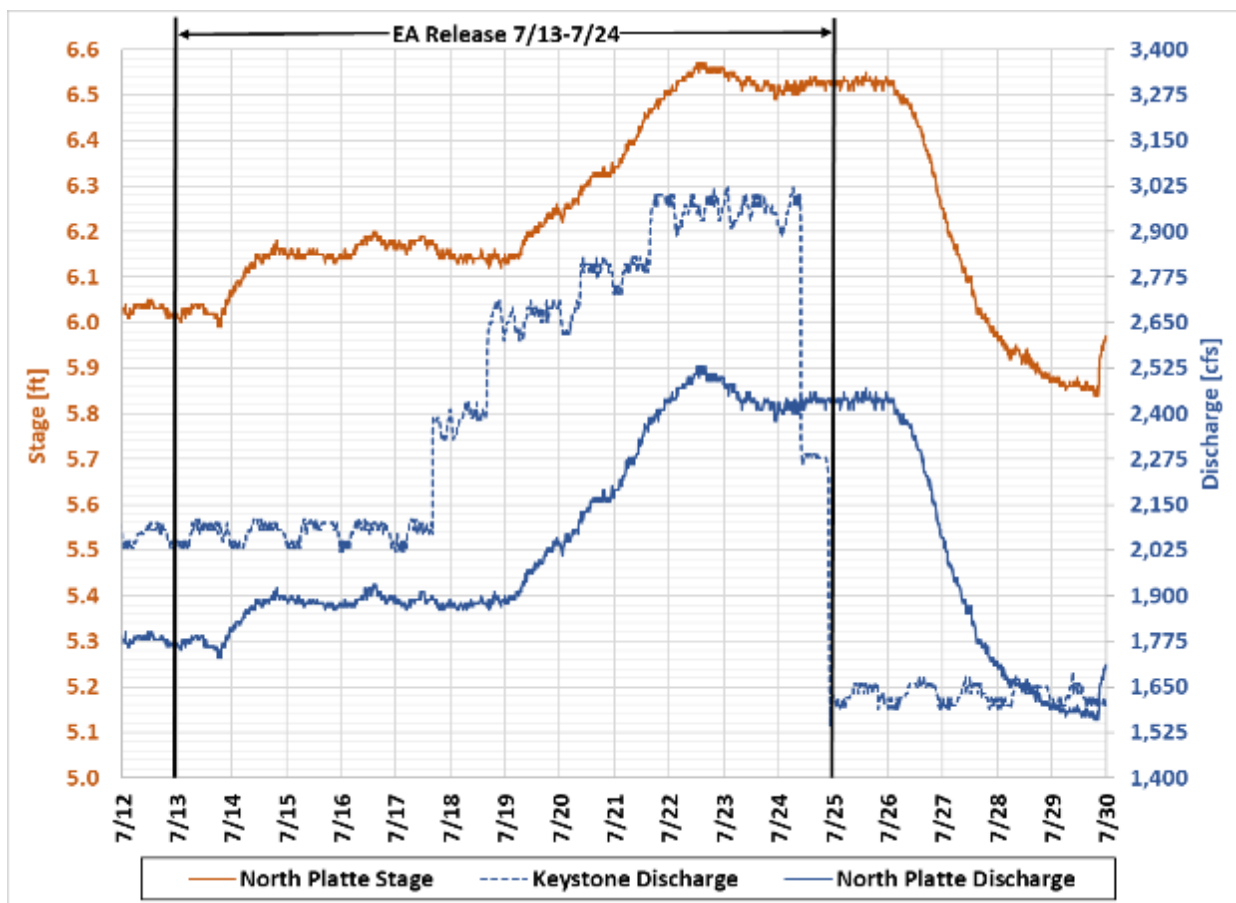
73
74 **Figure ES-1. Chokepoint Test Stage and Discharge Measurements, July 12-30, 2020**

66 At the start of the chokepoint test, river stage at North Platte was already hovering around 6.0 ft,
67 as it had been for the previous week. After a slower-than-expected climb, stage reached 6.5 ft
68 late in the evening on July 21 and peaked at 6.57 ft on July 22 before settling closer to 6.5 ft for a
69 few days. The EA release for the chokepoint test ended on July 24, stage began to drop at North
70 Platte two days later, and a steady decline was observed for several days until rainfall late on
71 July 29 abruptly reversed the downward trend and effectively erased any lingering effects of the
72 chokepoint test.

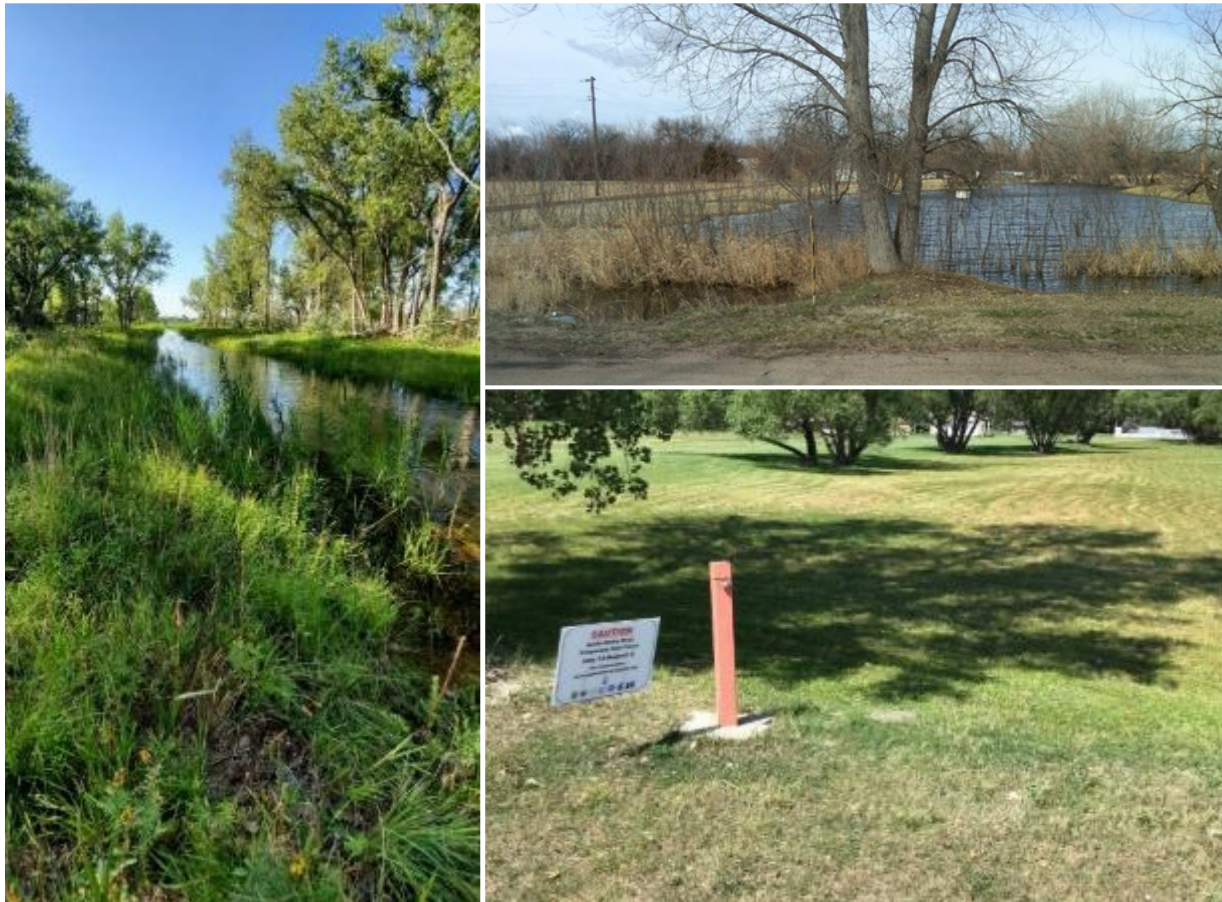
84
85 **Figure ES-2. State Channel (left), Land at N. River Rd. & N. Washboard Rd., March 31,**
86 **2011, River Stage at 6.30 ft (top right), and Land at N. River Rd. & N. Washboard Rd.,**
87 **July 20, 2020, River Stage at 6.29 ft (bottom right)**

75 The image on the left side of **Figure ES-2** shows flow in the State Channel, looking downstream
 76 with the berm on the left, on July 20 when the average stage for the North Platte River at North
 77 Platte was 6.29 ft. In contrast to prior flood events, no standing water of concern was observed
 78 anywhere in the area of North River Road and North Washboard Road. This is illustrated by the
 79 images on the right side of Figure ES-2, both of which show the same location in the southwest
 80 quadrant of that intersection when the river was at nearly identical stages during the spring 2011
 81 flood and during the summer 2020 chokepoint test. That the berm appears to have diverted river
 82 flows entirely away from an area that experienced significant flooding in the past indicates
 83 successful performance of the restored State Channel Berm under high flow conditions.

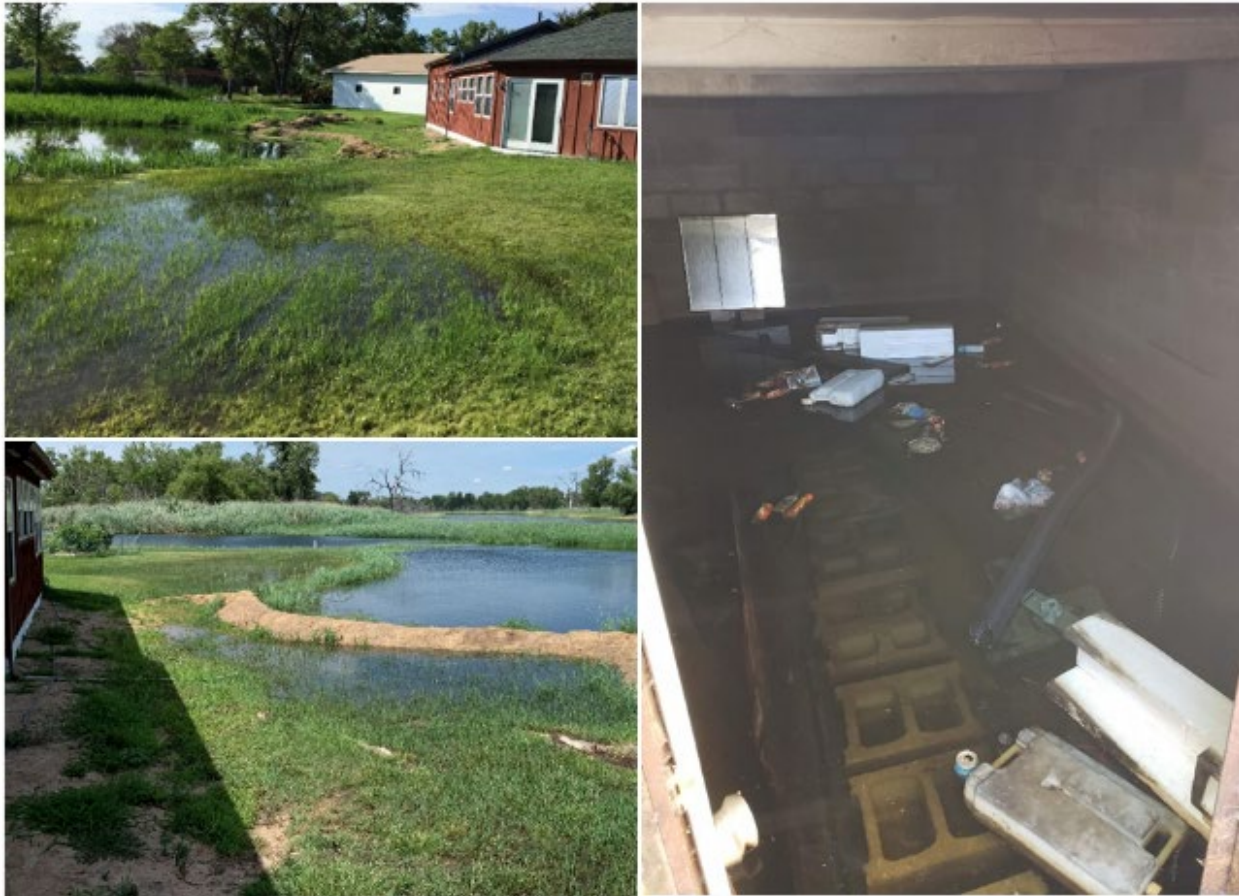
99
100 **Figure ES-3. Observed High Water Impacts at Red Fox Lane (left) and Darlene Road**
101 **(right) Properties**

88 Low-lying areas of Cody Park, especially at and near the boat ramp, flooded to an extent
89 consistent with NWS flood impacts descriptions. High water concerns were reported by owners
90 of riverfront agricultural lands (much of which was accretion ground within the bounds of the
91 historical high banks) far upstream around Sarben as well as closer to North Platte near the
92 Muskrat Run State Wildlife Management Area. Owners of residential properties along the south
93 bank of the North Platte River in the Vieyra Drive-Red Fox Lane-Darlene Road neighborhood of
94 North Platte reported issues stemming from high river (and groundwater) levels that included
95 water overtopping the banks of backyard ponds, water encroaching to within a few feet a house
96 foundation, septic system problems, inaccessible outbuildings due to soggy ground, and a
97 partially-flooded below-grade storm cellar. **Figure ES-3** shows some of these impacts in photos

109 At the peak of the chokepoint test with river stages at or above 6.5 ft, surface water crept
110 horizontally to within a few feet of the house on Red Fox Lane, but vertically remained well
111 below the foundation. Problems with underground septic systems and storm cellars are
112 groundwater impacts. After site visits to the Red Fox Lane and Darlene Road residential
113 properties on July 23-24, the NWS reported during the July 24 daily coordination call that the
114 observed impacts met the criteria for threats to property. NWS declared that there would be no
115 change to minor flood stage for the North Platte River at North Platte, a position that was

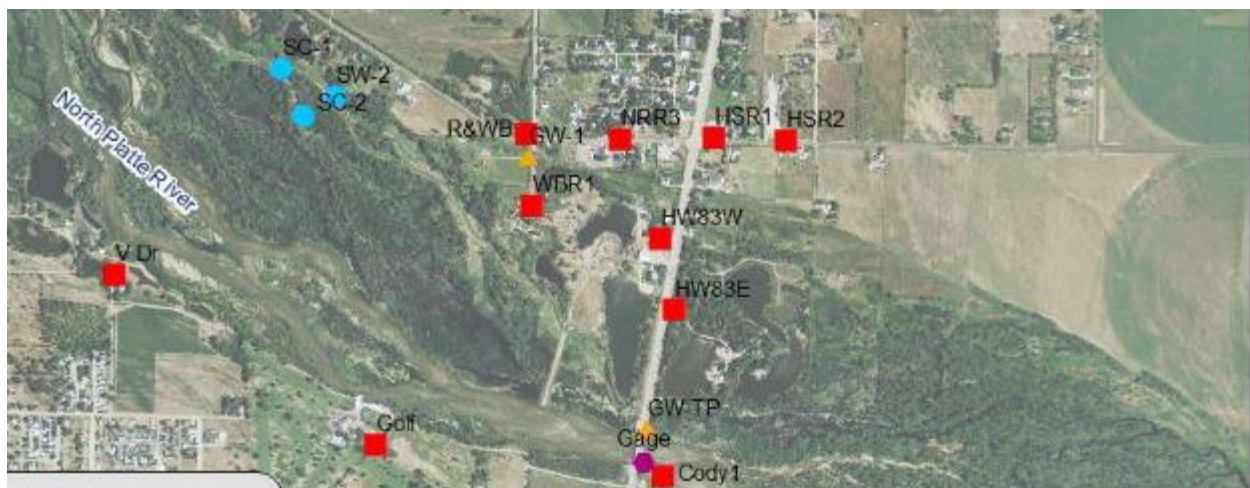
519
 520 **Figure 9. Monitoring Locations with Surface Water Measurements**

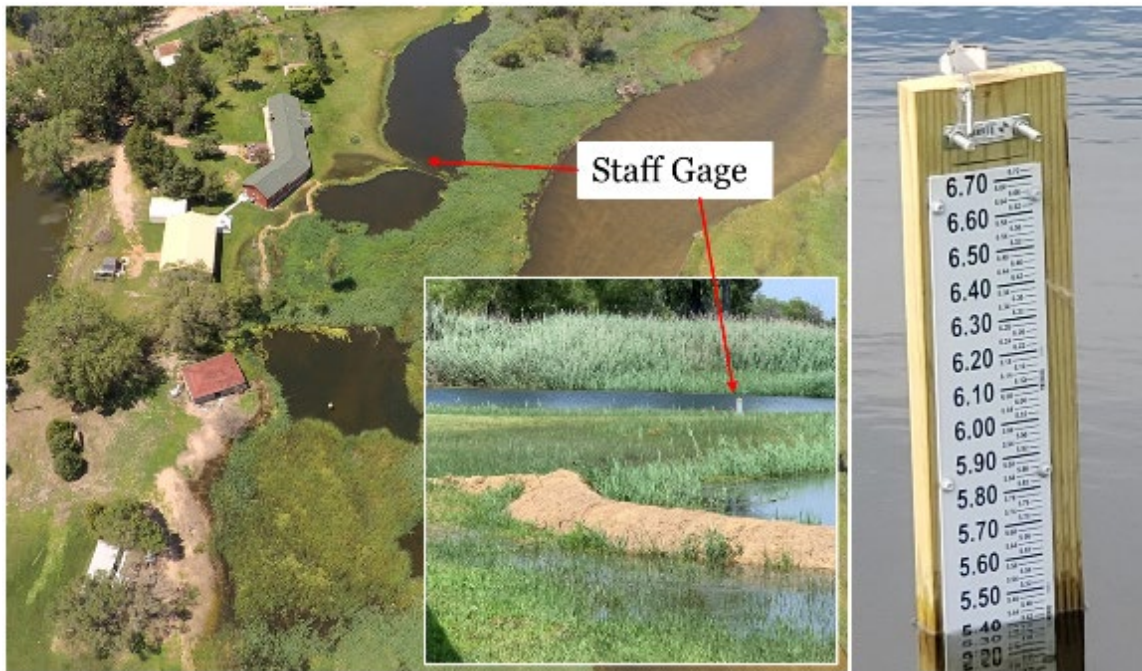
Figure 11. Location of Albrecht Staff Gage

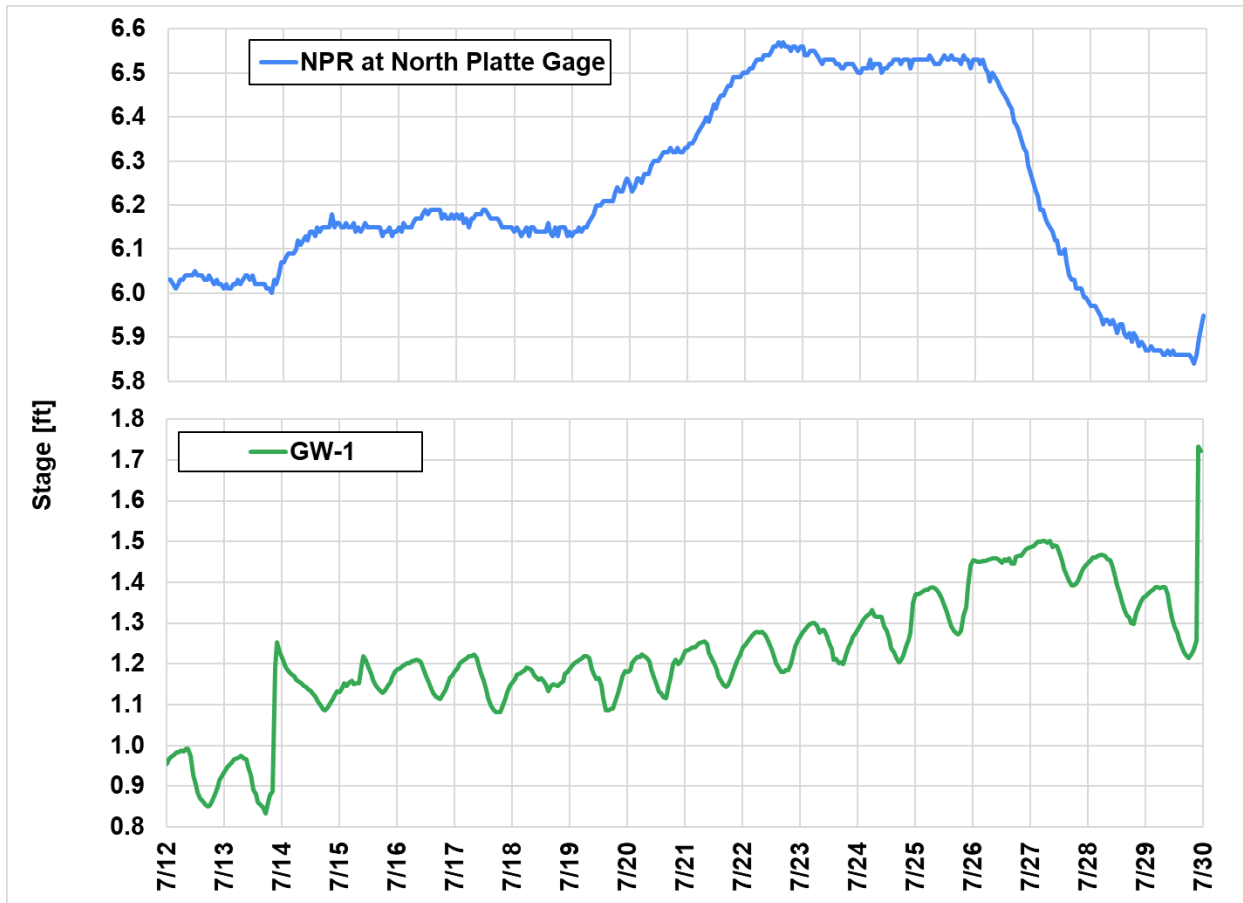
555 **Figure 13. Groundwater Levels at Monitoring Well GW-1, July 12-30, 2020**
556

553 surface water level dropped, the groundwater began to decline as well, but the trend reversed
554 sharply with the rainfall a couple days later.

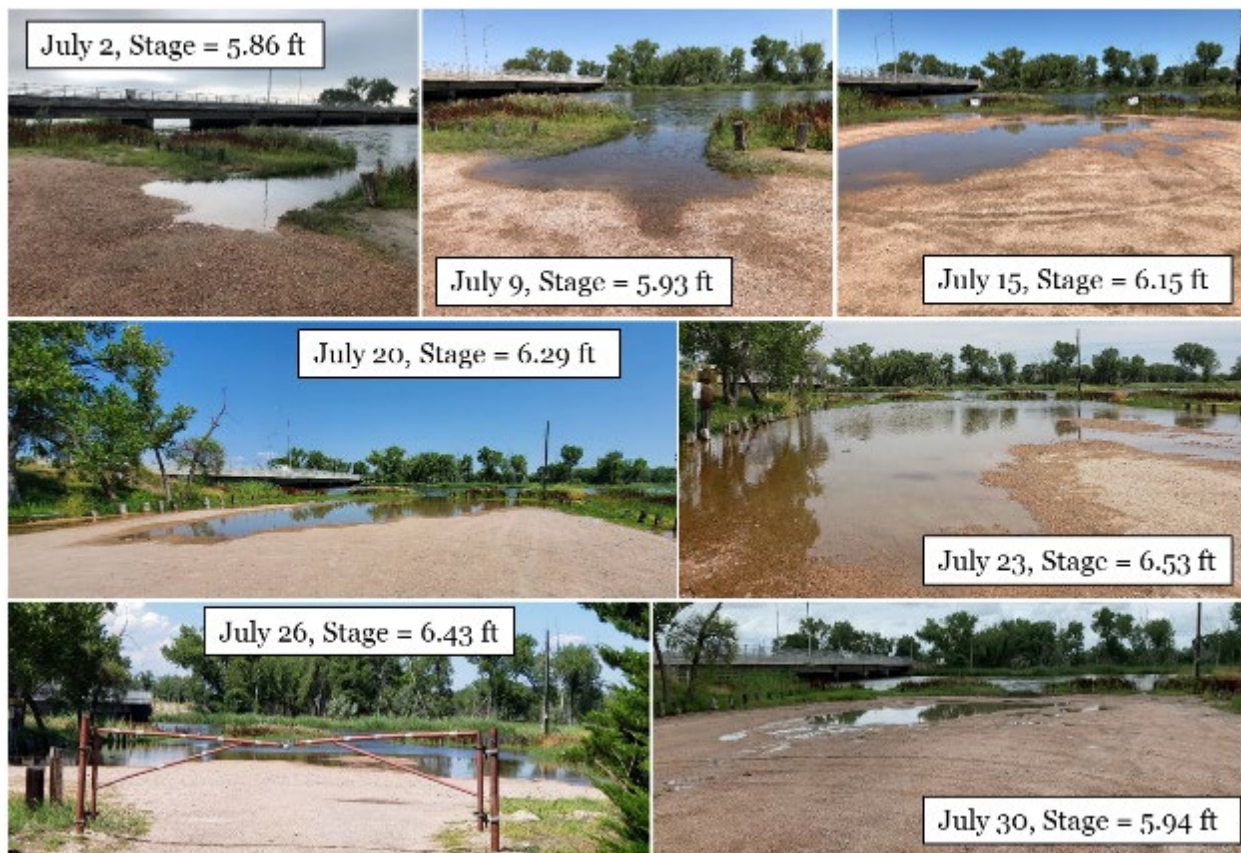
612 **Figure 14. Cody Park Boat Ramp, July 2-30, 2020**
613

598 The Cody Park boat ramp sits in the northwest corner of the park adjacent to the Highway 83
599 bridge abutment on the south bank of the North Platte River. It is the area of the park with the
600 lowest elevation and therefore the first and most likely area to be impacted by flooding. This
601 was clearly reflected in NWS minor and moderate flood stage definitions prior to the chokepoint
602 test, and the observed flooding during the chokepoint test was as expected. In the days leading
603 up to the chokepoint test, with the river already approaching 6.0 ft, the submerged area was
604 confined mostly to the boat ramp itself, which descends into the main river channel. As the river
605 continued to rise, water spread out over increasingly large areas of the adjoining parking lot.
606 Eventually the City of North Platte locked off access to the parking lot and boat ramp for safety
607 reasons. By July 30, nearly a week after the chokepoint test ended, most of the water had

608 drained out of the parking lot area (note that some of the standing water visible in the July 15 and
609 July 30 photos may be a result of recent rainfall more so than river flooding). **Figure 14** shows a
610 progression of photos at the boat ramp and its adjoining parking lot at various stages before,
611 during, and after the chokepoint test.

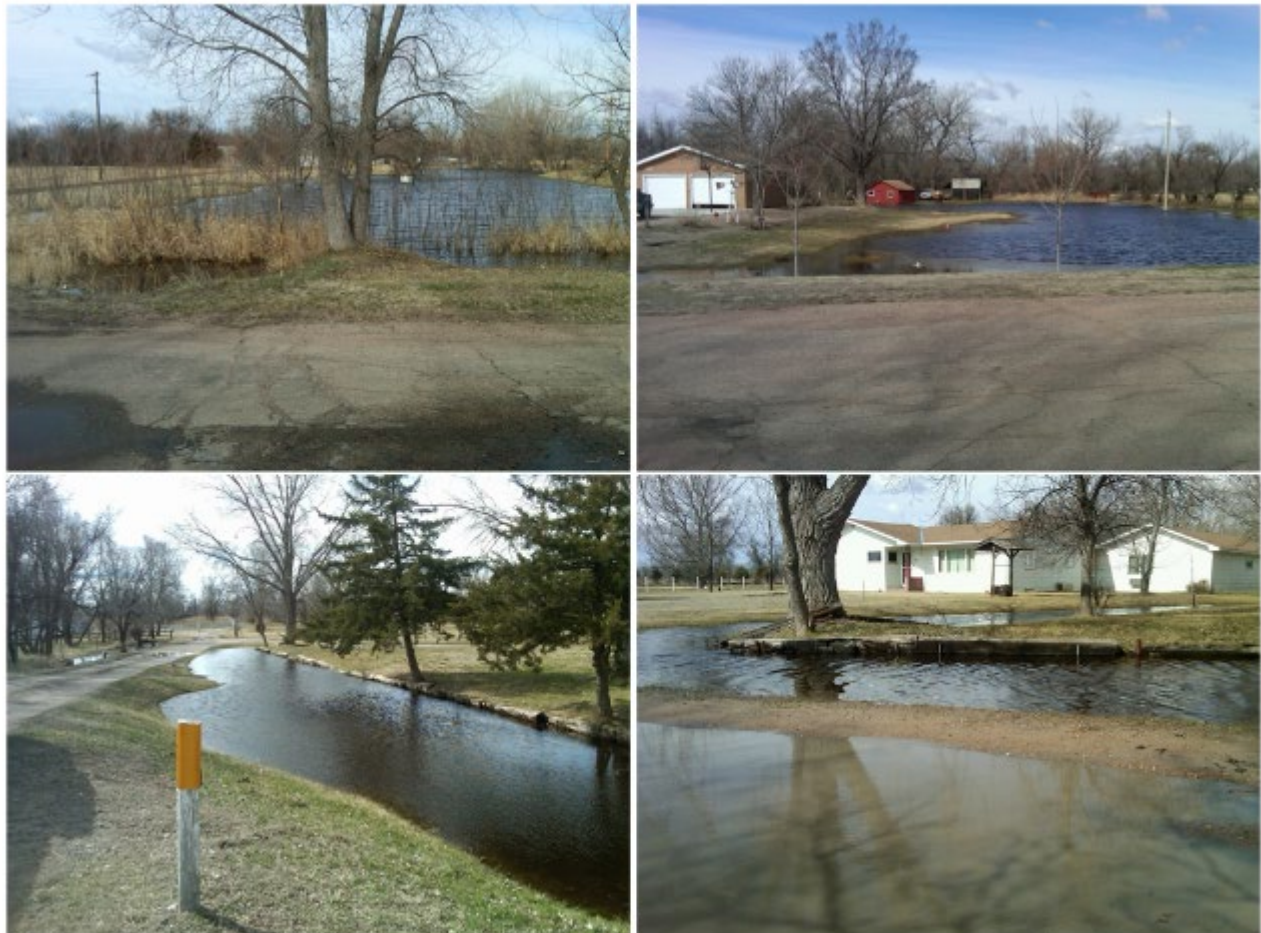
623 **Figure 15. Standing Water along North Washboard Road, March 31-April 1, 2011**
624

617 of a river channel that runs just along the edge of these properties. This was recognized in the
618 NWS flood stage definitions as written before the chokepoint test. **Figure 15** shows locations
619 along the west side of North Washboard Road, starting near the intersection with North River
620 Road and progressing south, early in the 2011 floods. These photos were taken March 31-April
621 1, 2011 when the North Platte River at North Platte gage was recording stages from 6.3 ft to 6.32
622 ft, comparable to stages observed during the July 2020 chokepoint test.

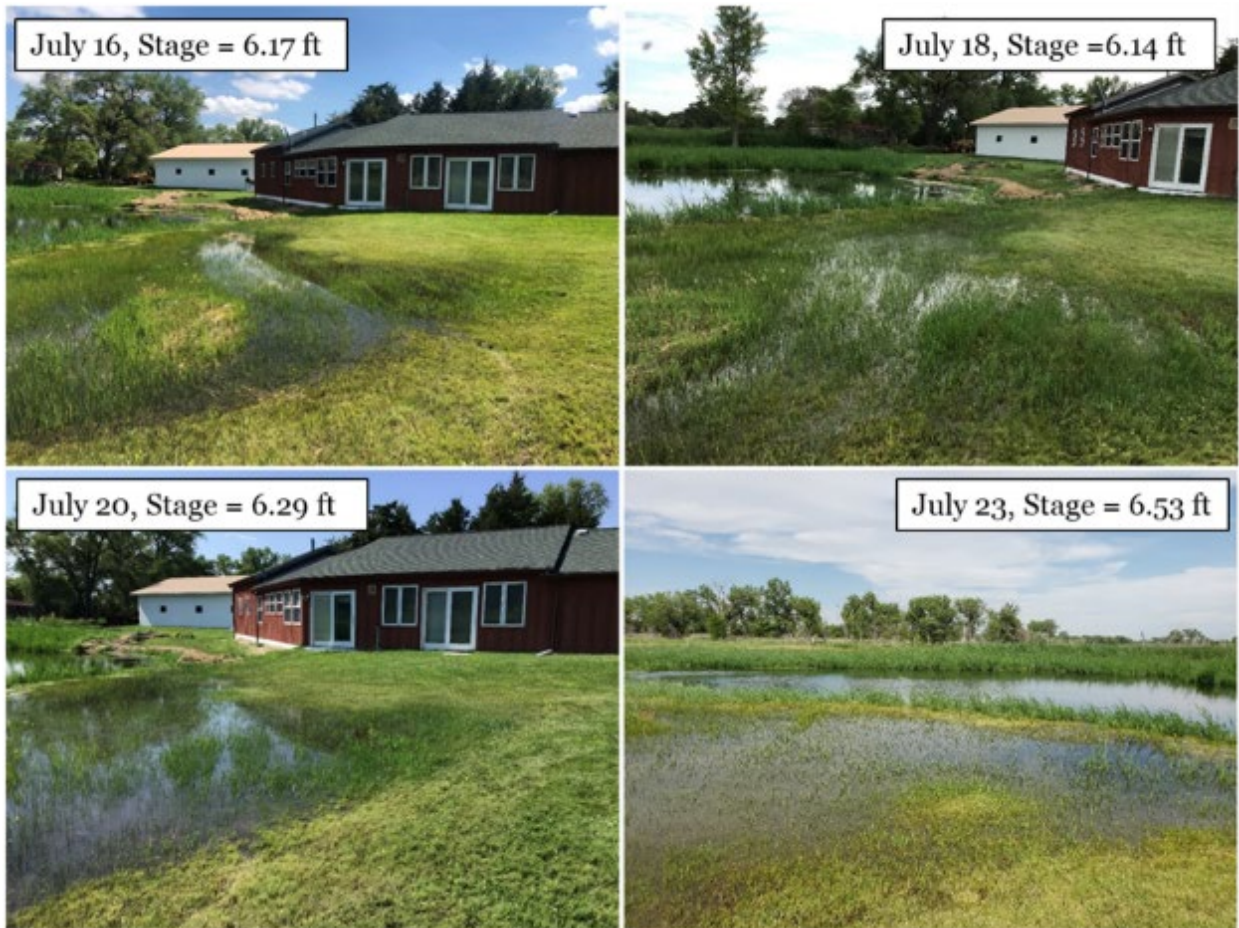
Figure 18. Albrecht Property Backyard Near Ponds

659 **Figure 18** and **Figure 19** show the encroachment of water behind the Albrecht house from
660 different angles. Rising water spread outside the banks of the backyard ponds into adjacent low
661 spots and also seeped through a low berm. The bottom photos in Figure 19 are both from July
662 24; the lower right photo shows that while water had spread laterally from the ponds to within 6
663 ft of the house, there was still a fairly significant vertical slope to reach the foundation. The
664 homeowner also reported septic system issues. **Figure 20** presents an aerial view of the Albrecht
665 property on July 24. The limits of the high water directly behind the house are the clearly visible
666 darkened areas outside the perimeters of the ponds. By the time of the NWS site visit on July 27,
667 water had receded from the low-lying areas closest to the house as the river stage was drawn
668 down.

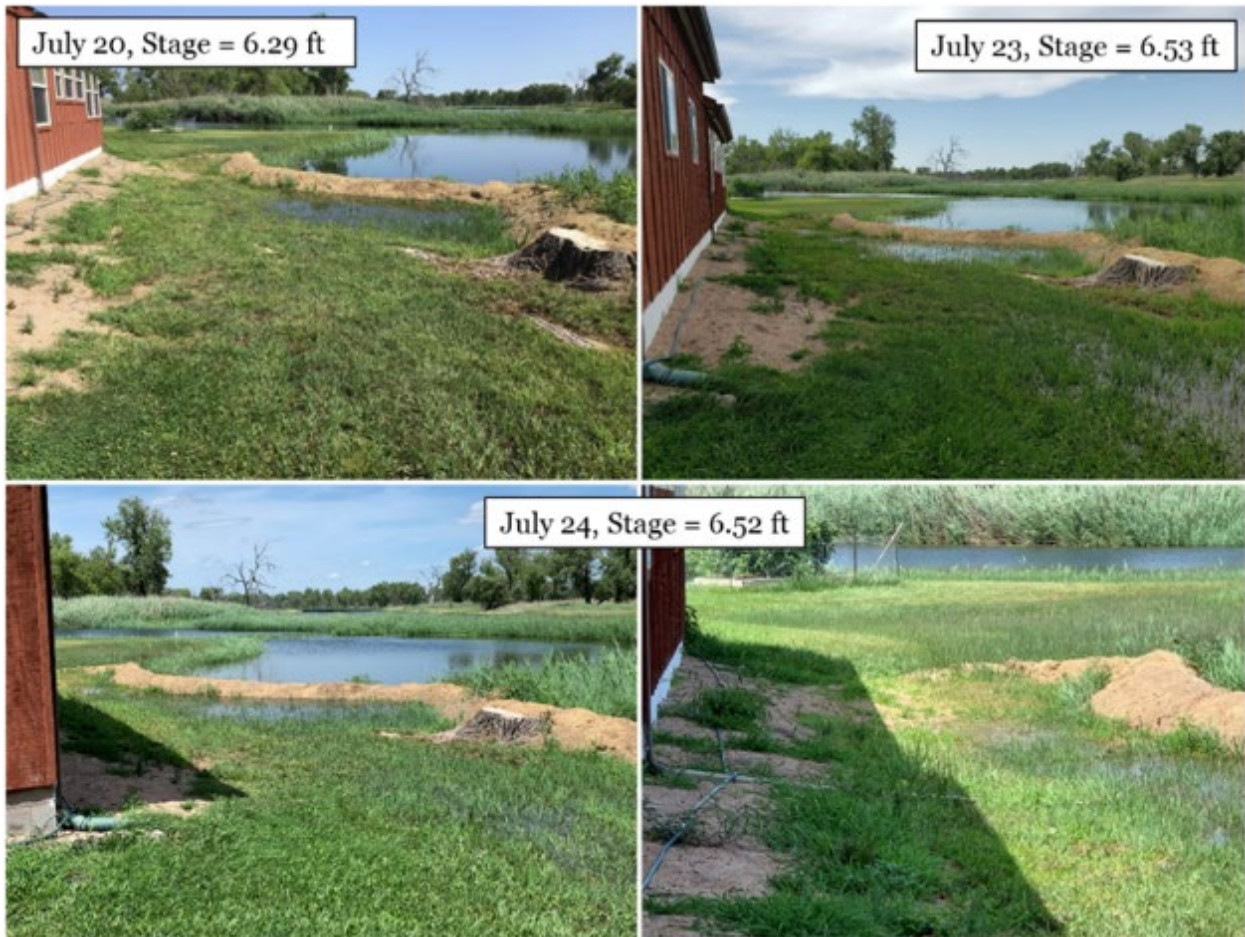
Figure 19. Albrecht Property Backyard Behind House

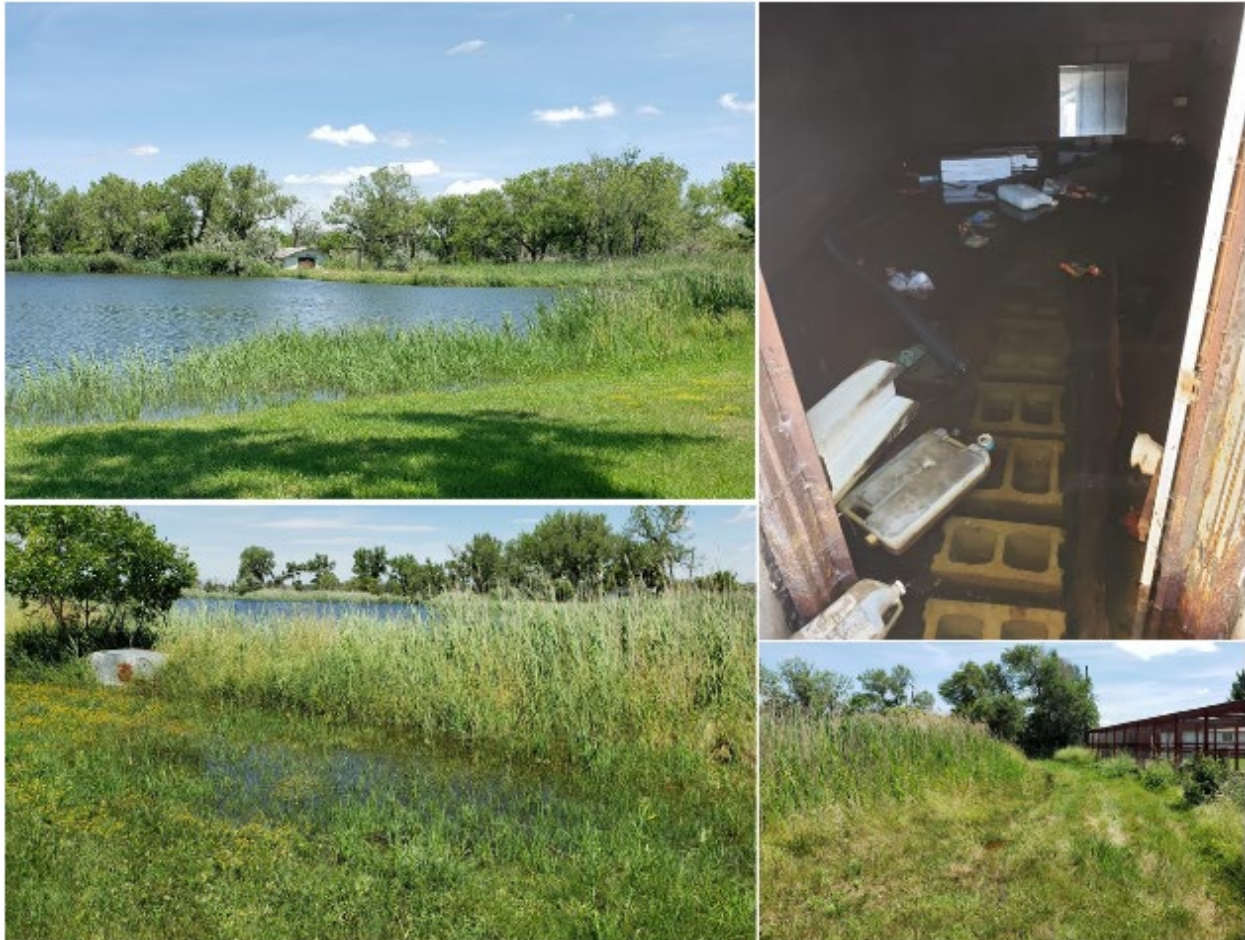
681
682 **Figure 21. Darlene Road Property, July 24, 2020**

675 NWS visited the Darlene Road property on Friday July 24. Similar to issues observed at the
676 Albrecht property, standing water was spreading beyond the edges of the backyard pond, and the

677 homeowner also reported problems with the septic system. In addition, access to an old barn
678 across the pond from the house was said to be cut off and an underground storm cellar in the
679 front yard was partially flooded. Photos from the Darlene Road property are shown in **Figure**
680 **21**.

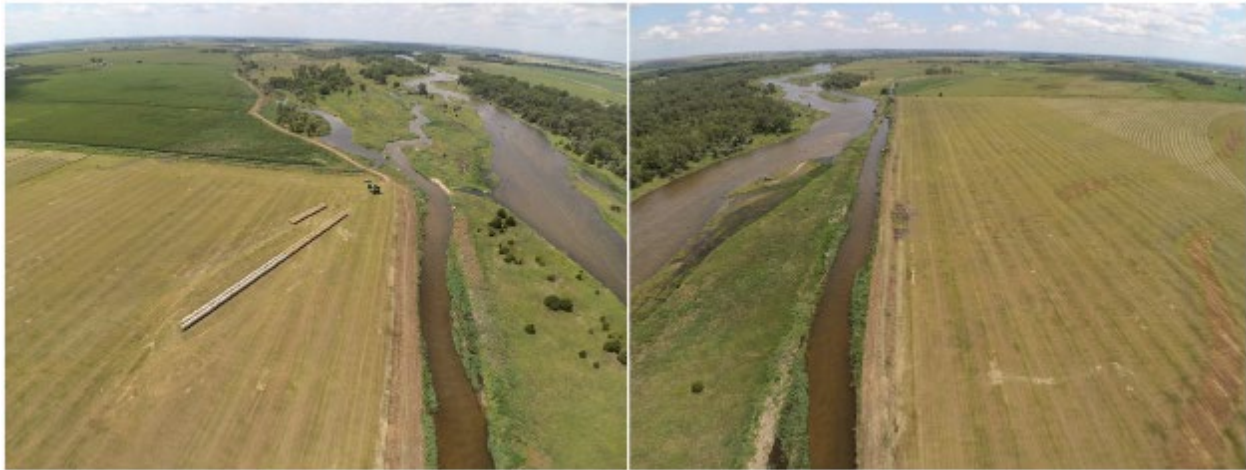
706
707 **Figure 23. North Platte River, Cody-Dillon Canal Inlet, and Agricultural Lands near**
708 **Muskrat Run, July 22, 2020, Left: Looking West, Right: Looking East**

697 Flows into the Cody-Dillon inlet channel were high and starting to cause minor bank erosion in
698 places. A drain marks the boundary between the corn field and the hay meadow; this drain was
699 backing up due to the high river flows and spilling over into a small area of the hay meadow.
700 **Figure 23** shows aerial images of the property on the day of the site visit. Nothing observed on
701 July 22 seemed to be of great concern, but the landowner called again the next day to report that
702 water backing up into the hay meadow was impeding the use of a center pivot irrigation system
703 for the corn field (a portion of the northeastern turn of the half circle center pivot tracks through
704 the hay meadow). This information was conveyed on the July 23 daily coordination call, and
705 NWS staff also visited the site that day.

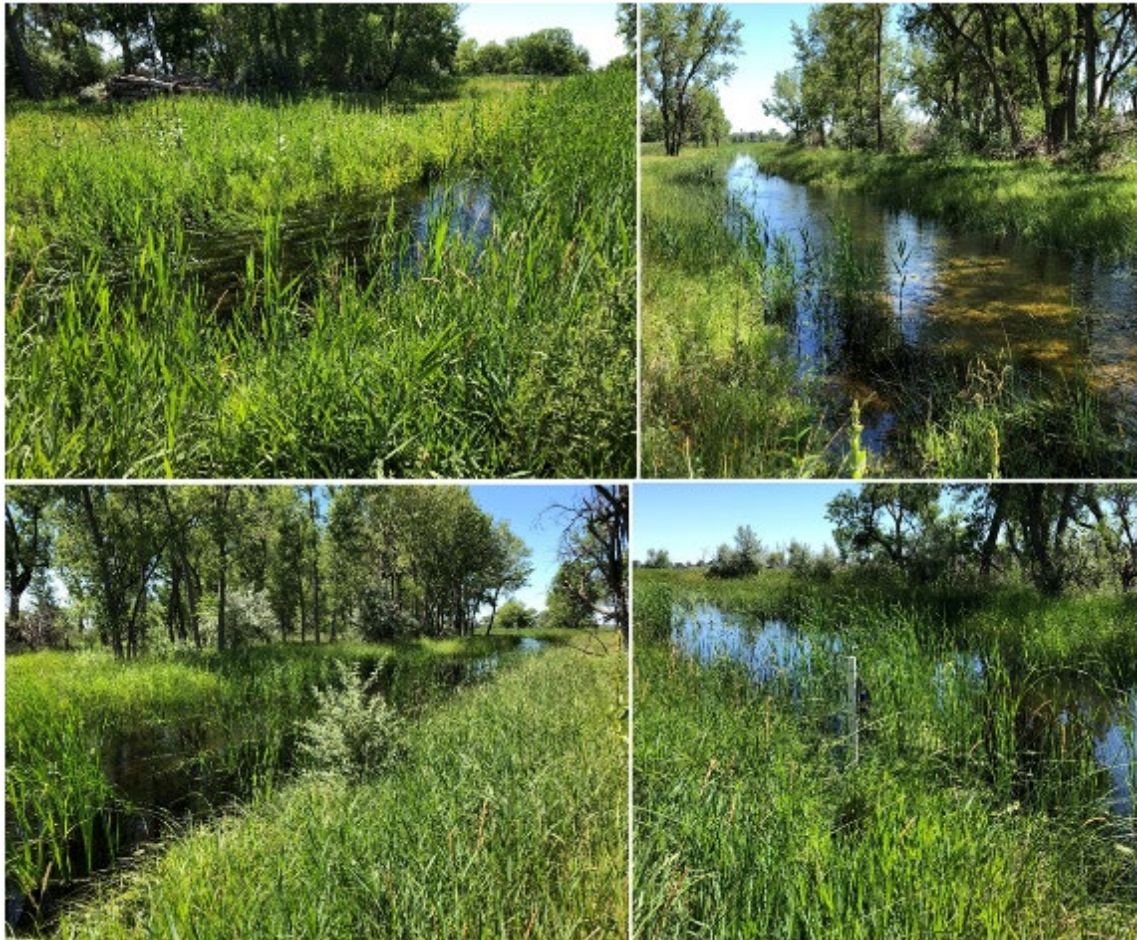
721
722 **Figure 24. State Channel, July 15 (Stage = 6.15 ft), Top: Near SC-1, Bottom: Near SC-2**

710 The performance of the restored State Channel Berm under high flows was the subject of a
711 chokepoint test objective, and no problems were observed. Repairs to the State Channel Berm
712 were described in previous sections, and Figure 16 illustrates the extent to which those
713 improvements appear to entirely divert water away from the North River Road and North
714 Washboard Road area under high flow conditions. The following series of figures shows the
715 actual flow conditions along the State Channel at or near surface water monitoring stations SC-1
716 and SC-2 on several days during the chokepoint test. **Figure 24** shows views looking upstream
717 and downstream near SC-1 and SC-2 on July 15. **Figure 25** shows three views of the State
718 Channel on July 20, and **Figure 26** shows the State Channel on July 24, near peak flow and
719 shortly after the decision was made to terminate the chokepoint test. The bottom right photo in

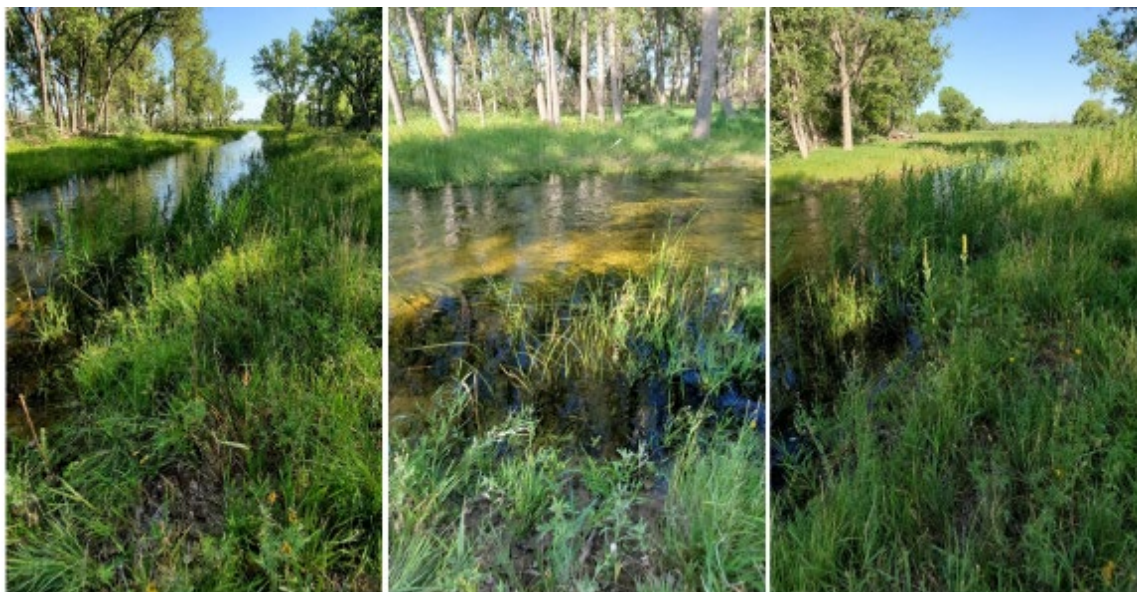
723
724 **Figure 25. State Channel, July 20 (Stage = 6.29 ft)**

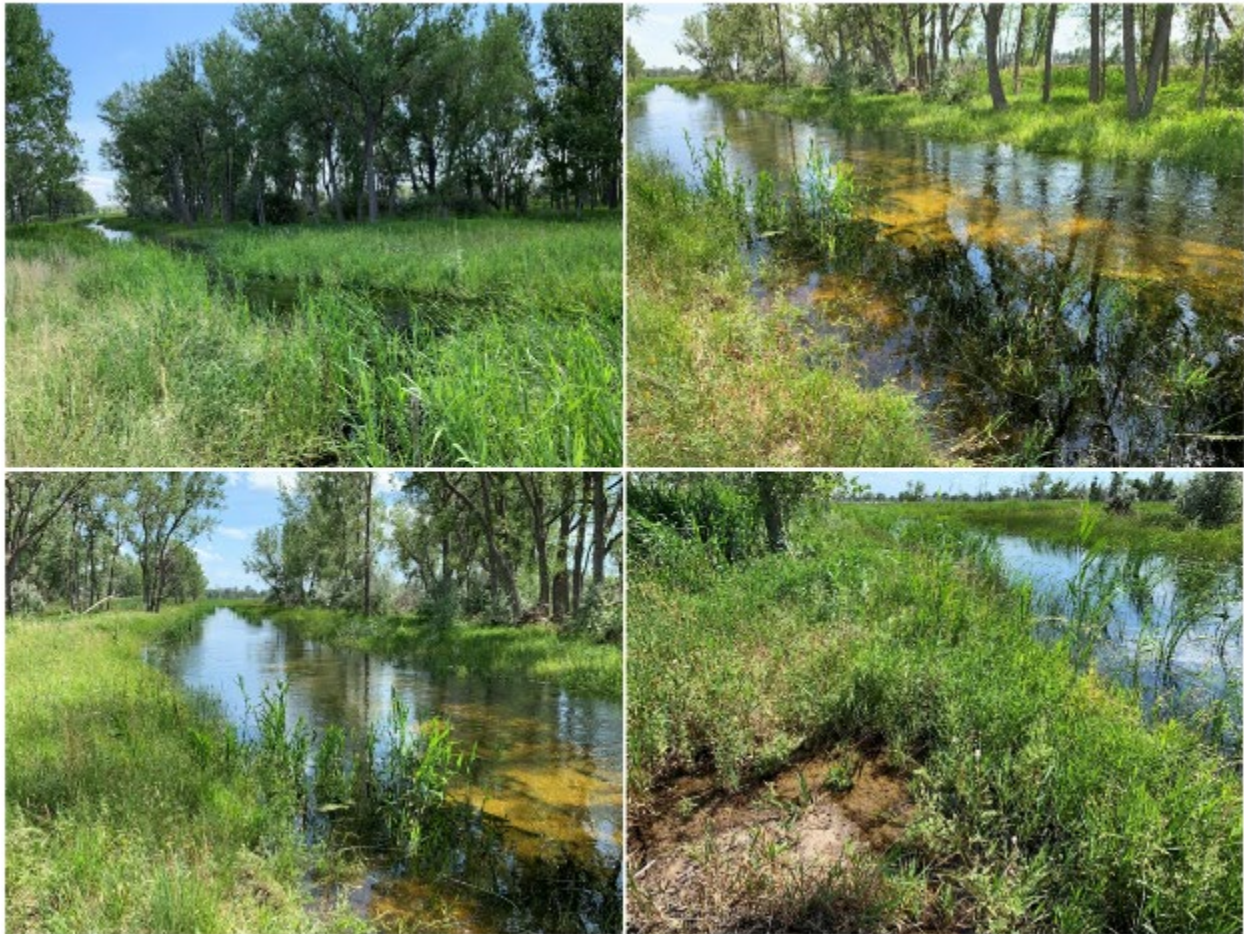
725
726 **Figure 26. State Channel, July 24 (Stage = 6.52 ft), Top: Near SC-1, Bottom: Near SC-2**

720 Figure 26 captures a low spot in the berm over which a small amount of water was flowing.

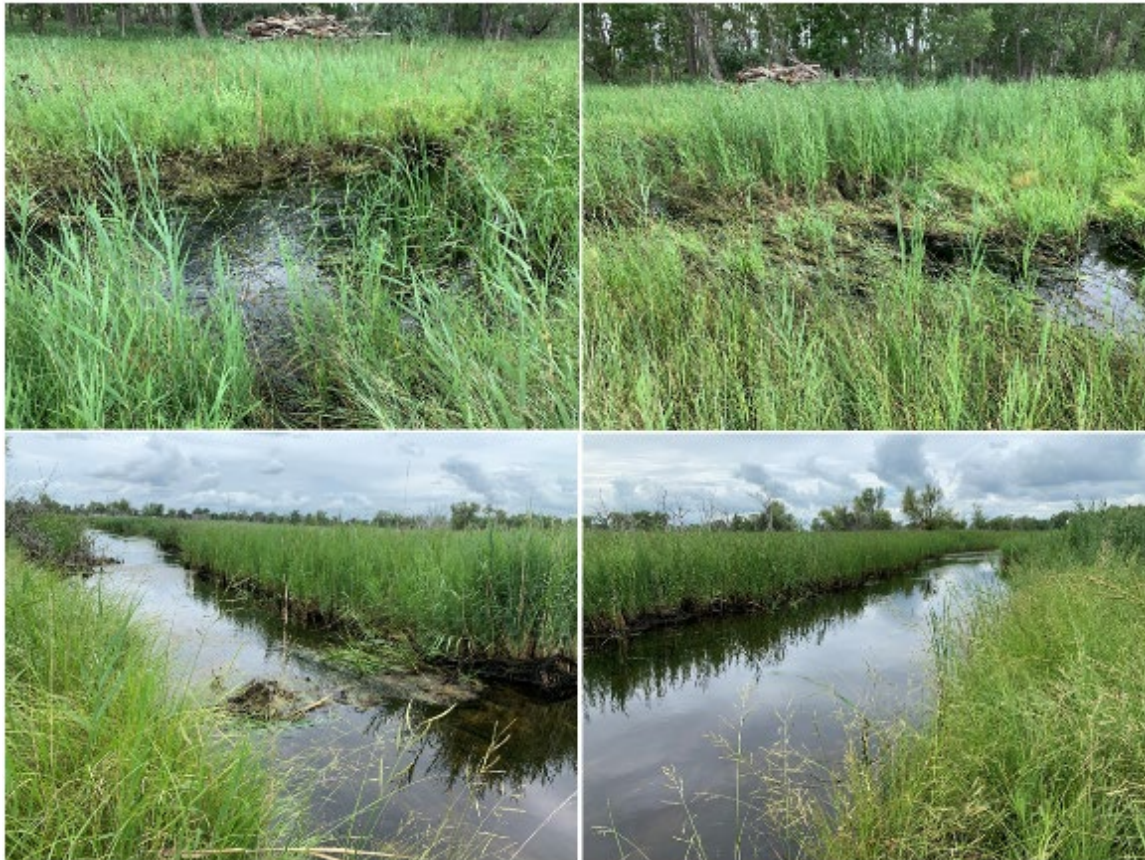
732
733 **Figure 27. State Channel, July 30 (Stage = 5.94 ft), Top: Near SC-1, Bottom: Beyond SC-2,**
734 **near Confluence of State Channel and North Platte River Main Channel**

727 Finally, **Figure 27** shows the State Channel nearly a week after the chokepoint test was ended.
728 By this time, the North Platte River at North Platte had dropped by more than half a foot to be
729 below minor flood stage again. The top photos show views near SC-1 at the upper end of the
730 State Channel, and the bottom photos were taken far downstream along the State Channel, near
731 where it meets the main channel of the North Platte River.
