***Information On NWS Flood Stage For The
North Platte River At North Platte***

***Presented By Kenny Roberg
Senior Forecaster And Hydrology Program
Leader***

***National Weather Service Forecast Office
North Platte, Nebraska***

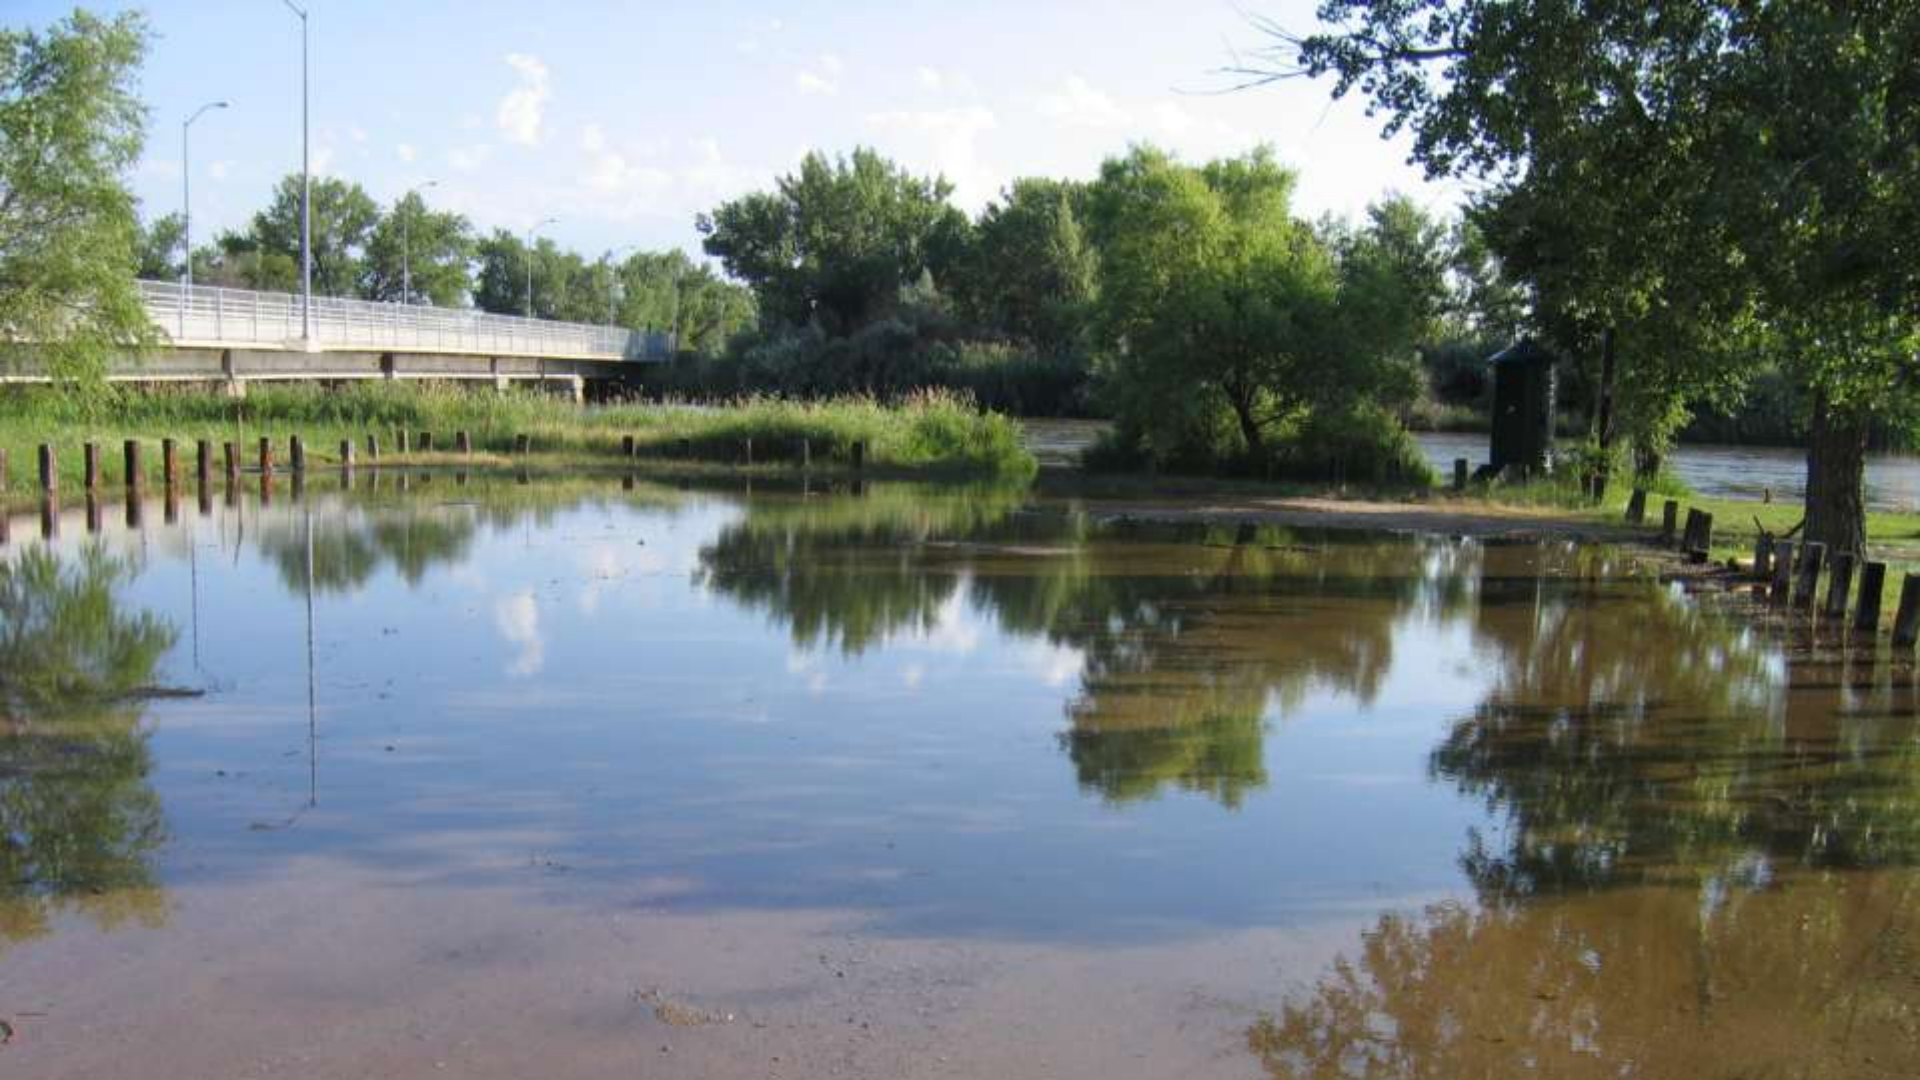
North Platte River At North Platte Stage 5.8 Feet on July 17, 2008

07/17/08 stage 5.8 ft
showing gage house

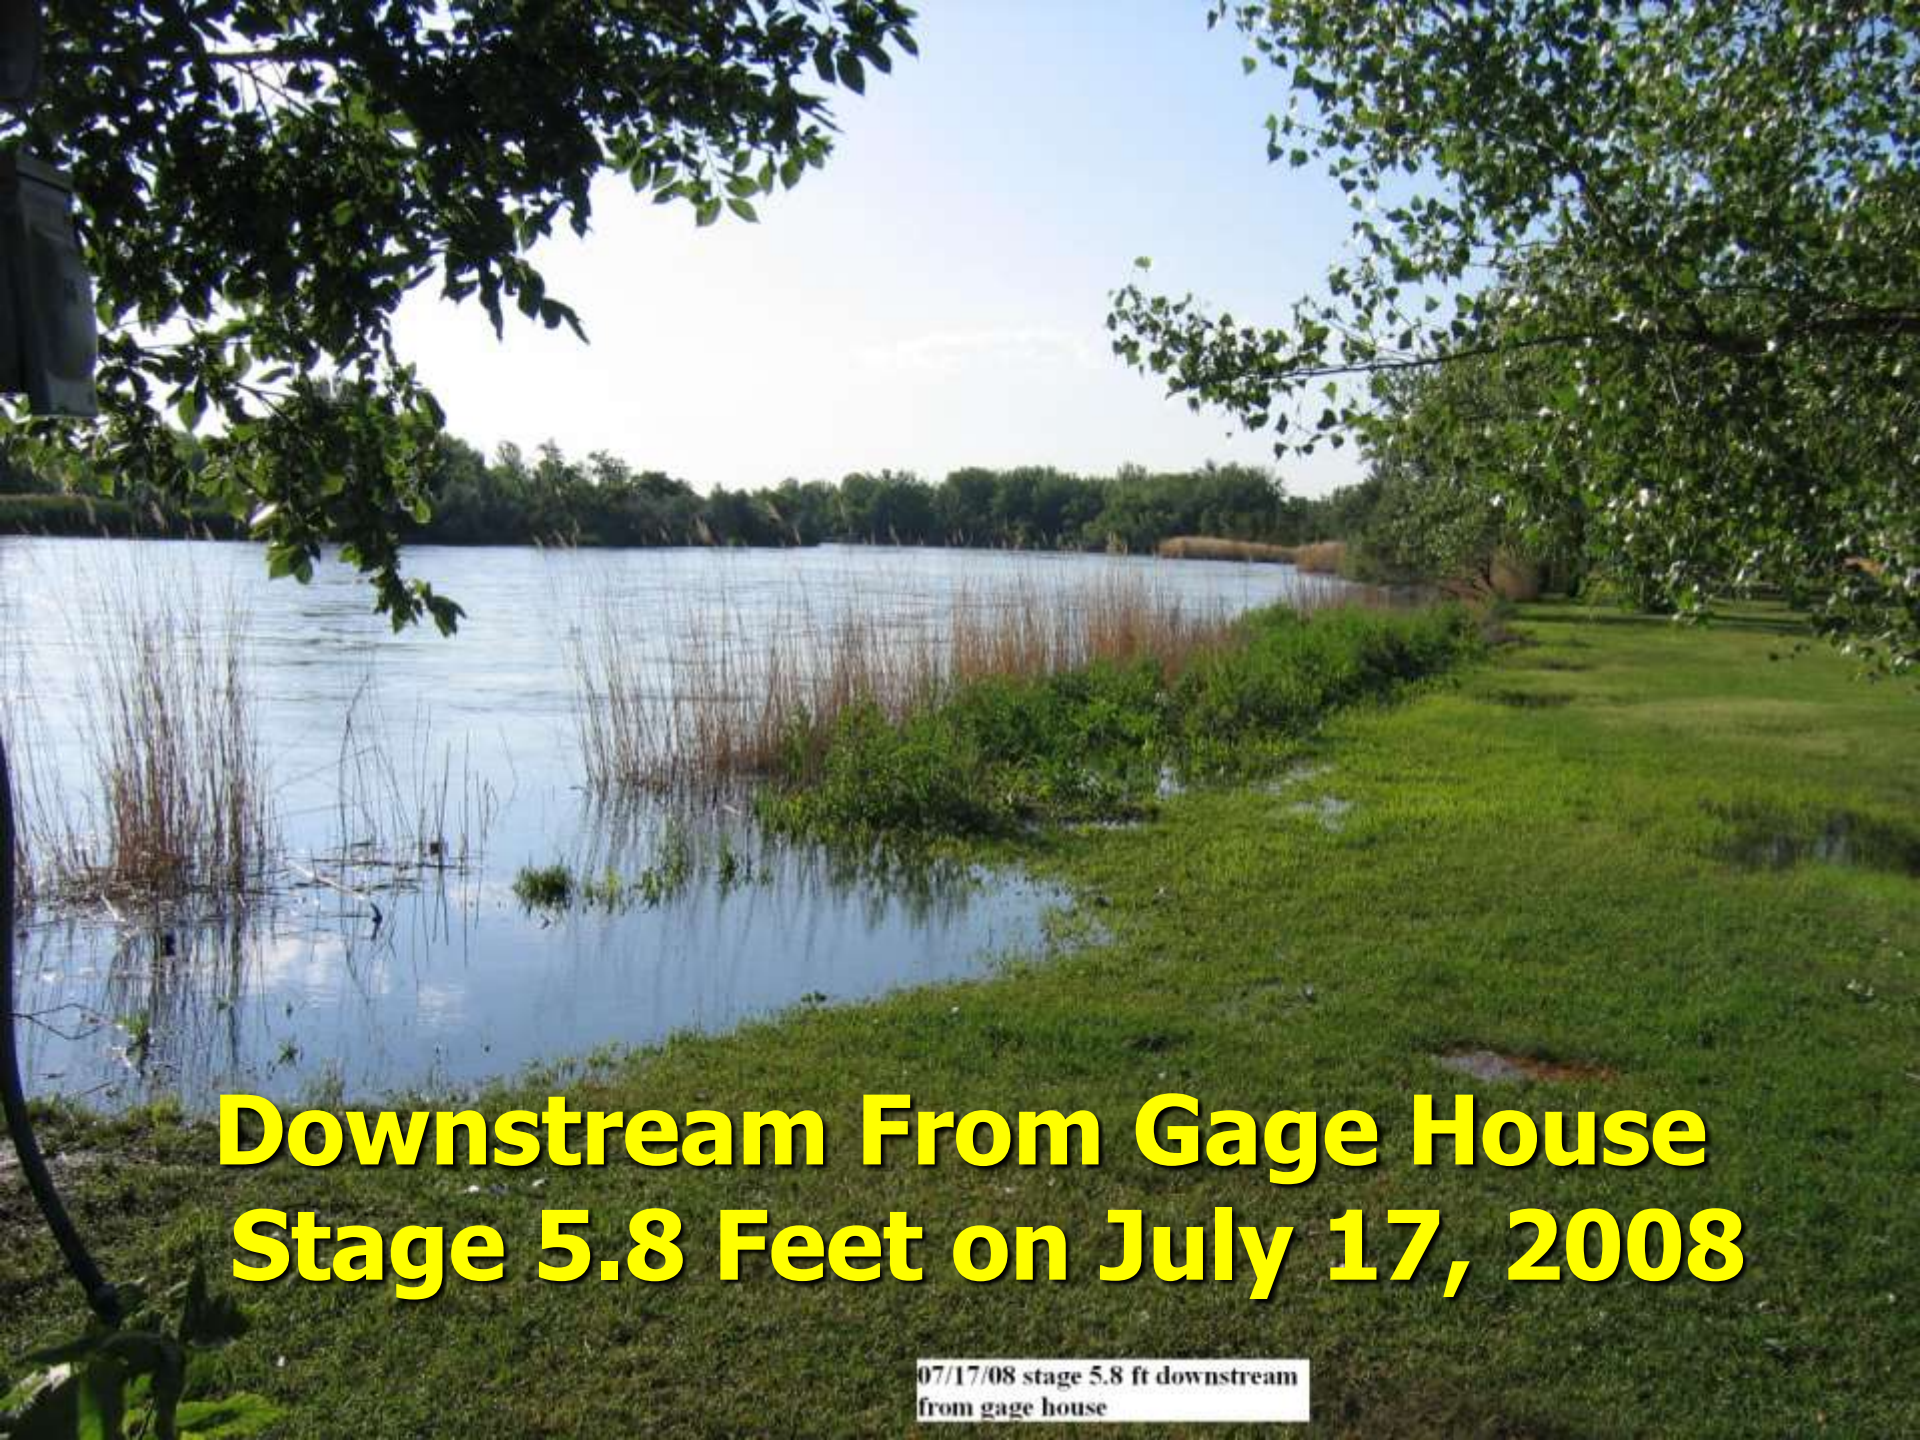
**Downstream From Gage House
Stage 5.8 Feet on July 17, 2008**

07/17/08 stage 5.8 ft downstream
from gage house

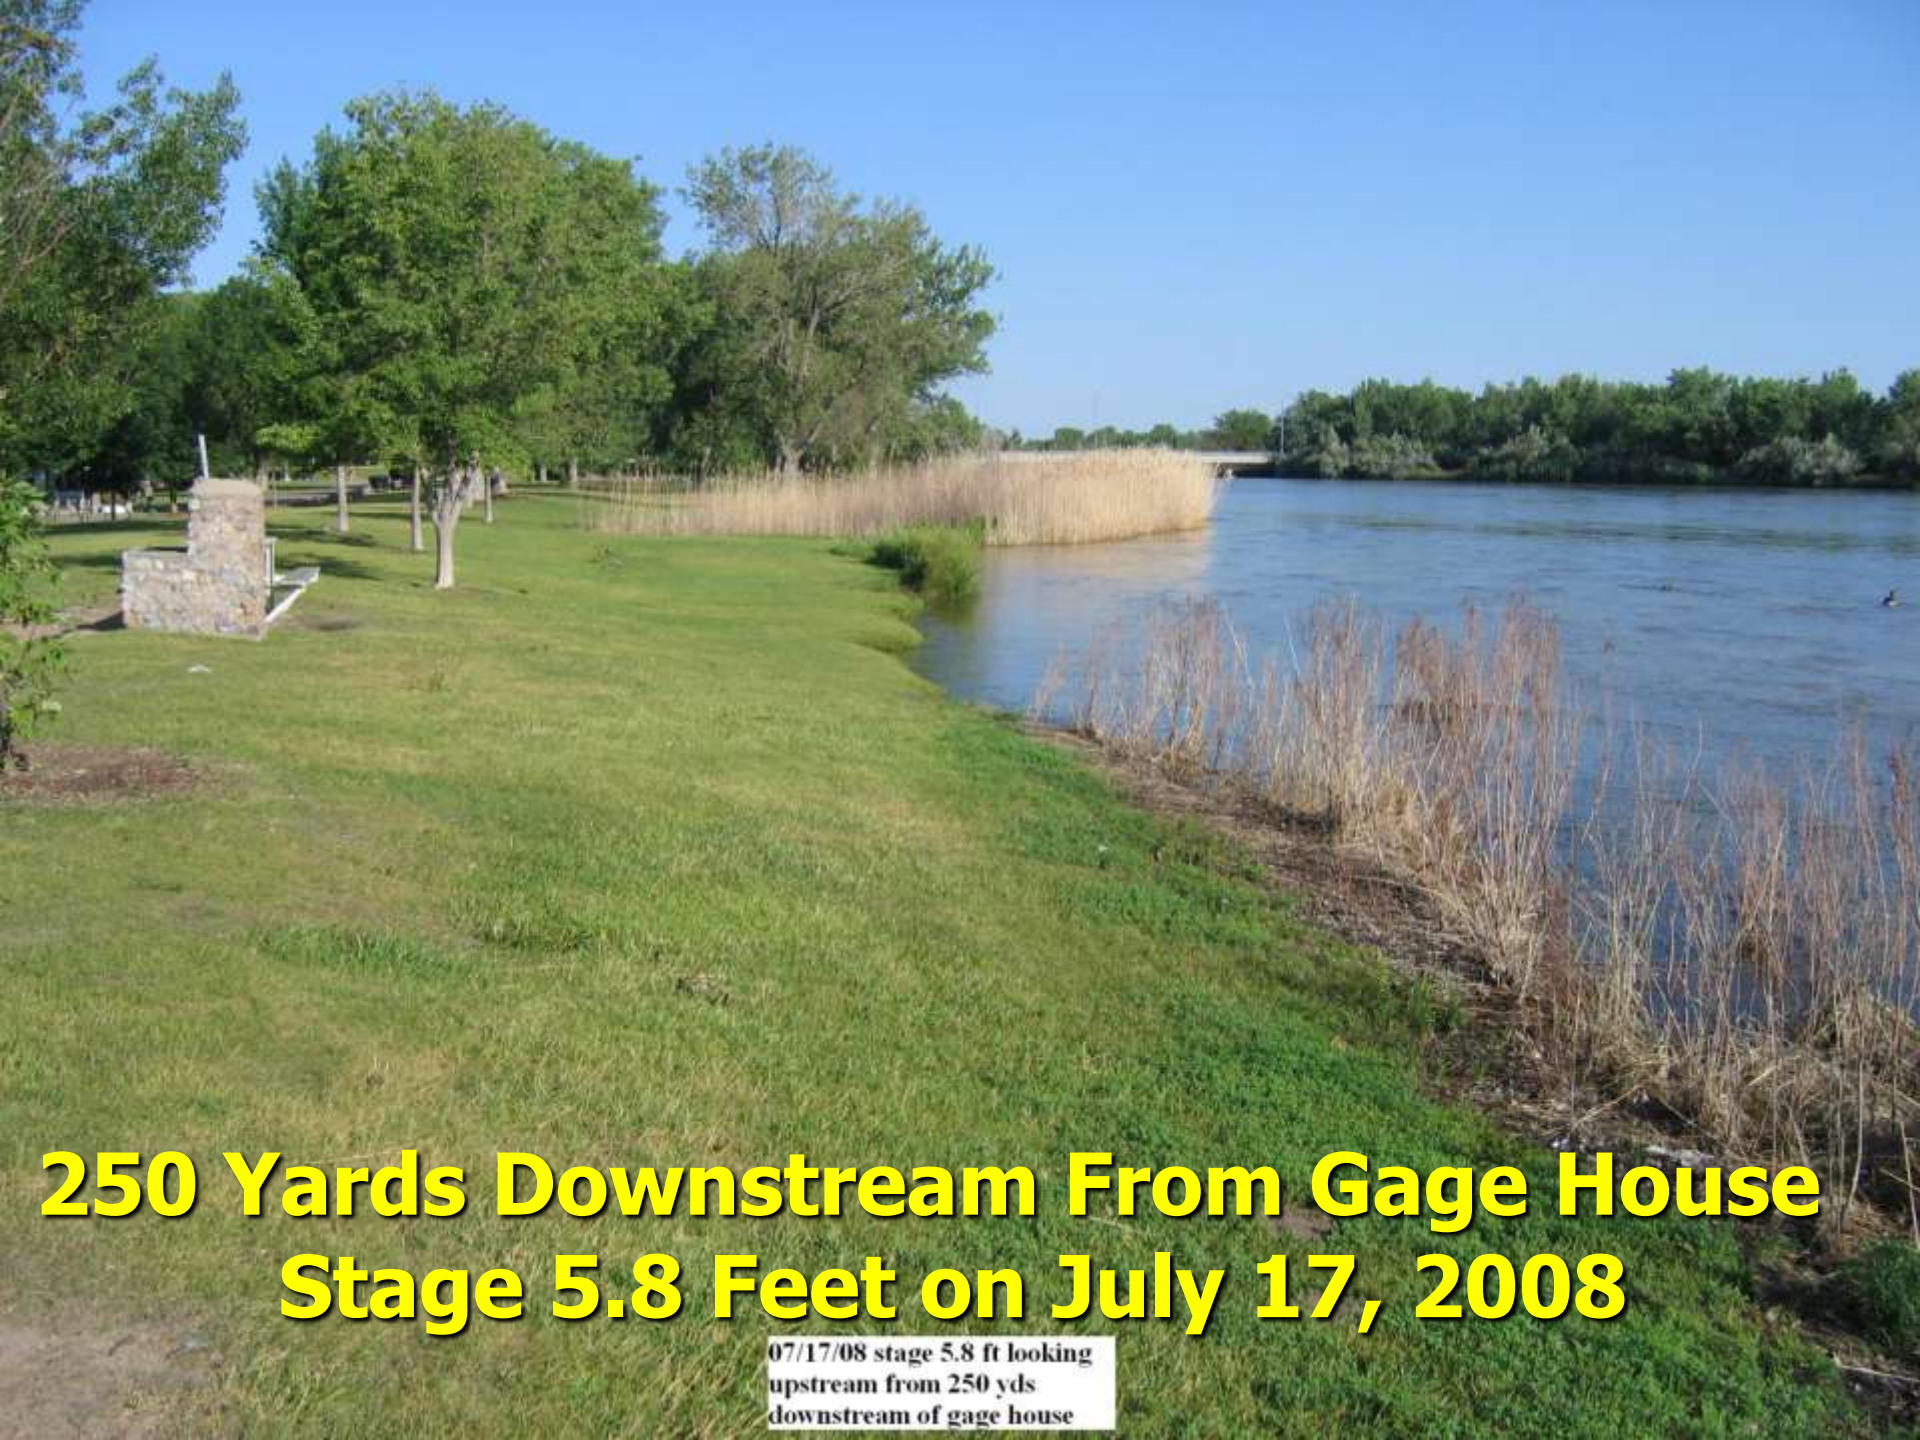
**250 Yards Downstream From Gage House
Stage 5.8 Feet on July 17, 2008**

07/17/08 stage 5.8 ft looking
upstream from 250 yds
downstream of gage house

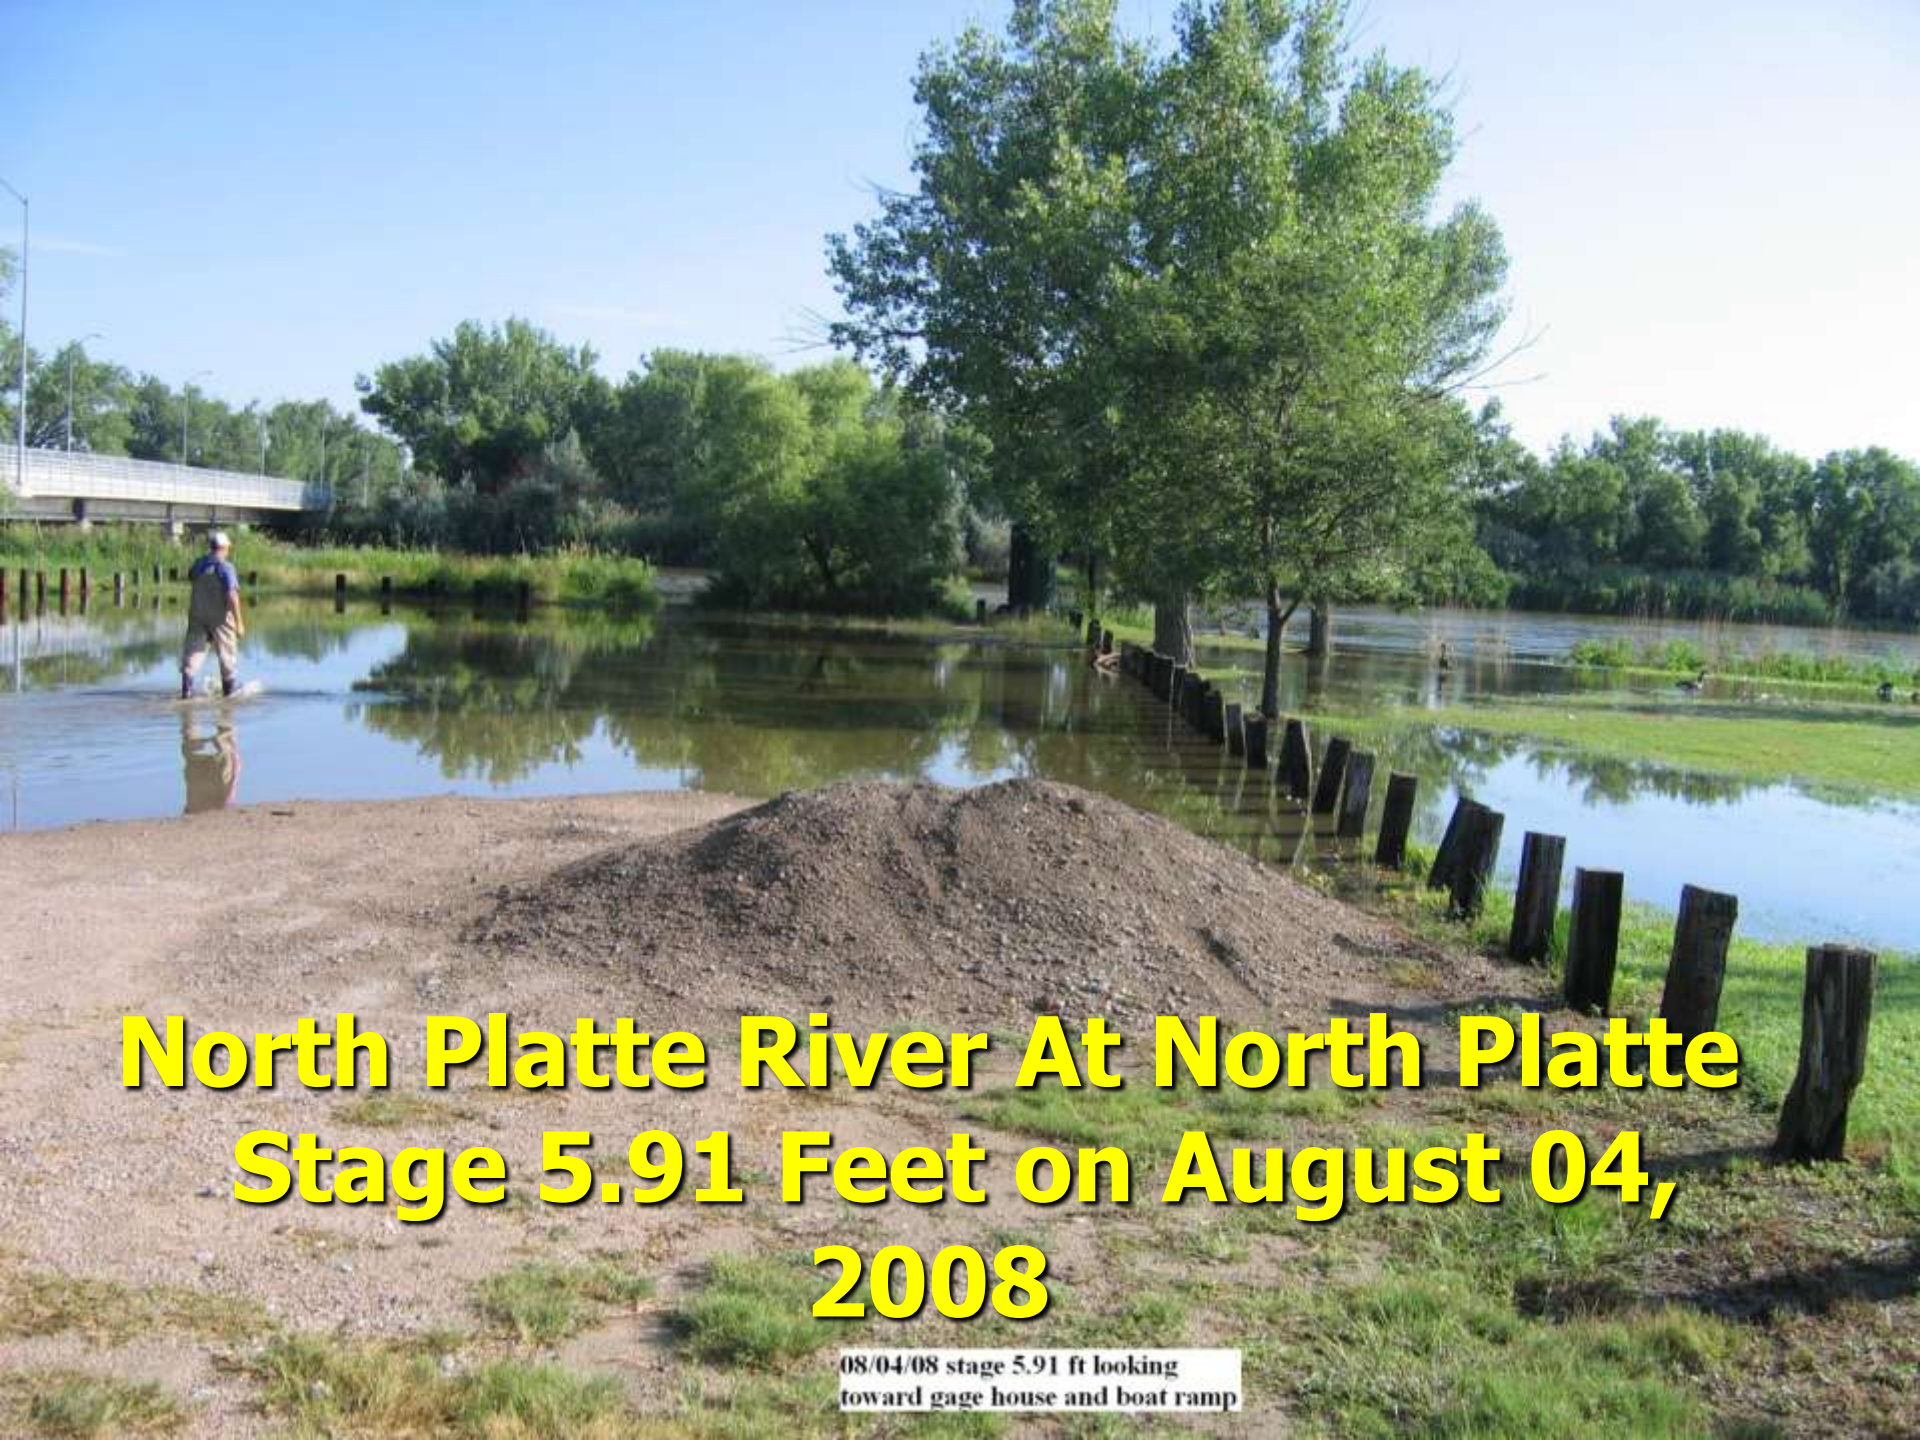
A photograph of the North Platte River. In the foreground, there is a large, conical pile of dark gravel on a sandy bank. To the right of the gravel, a line of weathered wooden posts extends into the water. A person wearing a blue shirt and light-colored pants is wading through the shallow water on the left side of the frame. In the background, a concrete bridge spans across the river, surrounded by lush green trees and vegetation under a clear blue sky.

**North Platte River At North Platte
Stage 5.91 Feet on August 04,
2008**

08/04/08 stage 5.91 ft looking
toward gage house and boat ramp

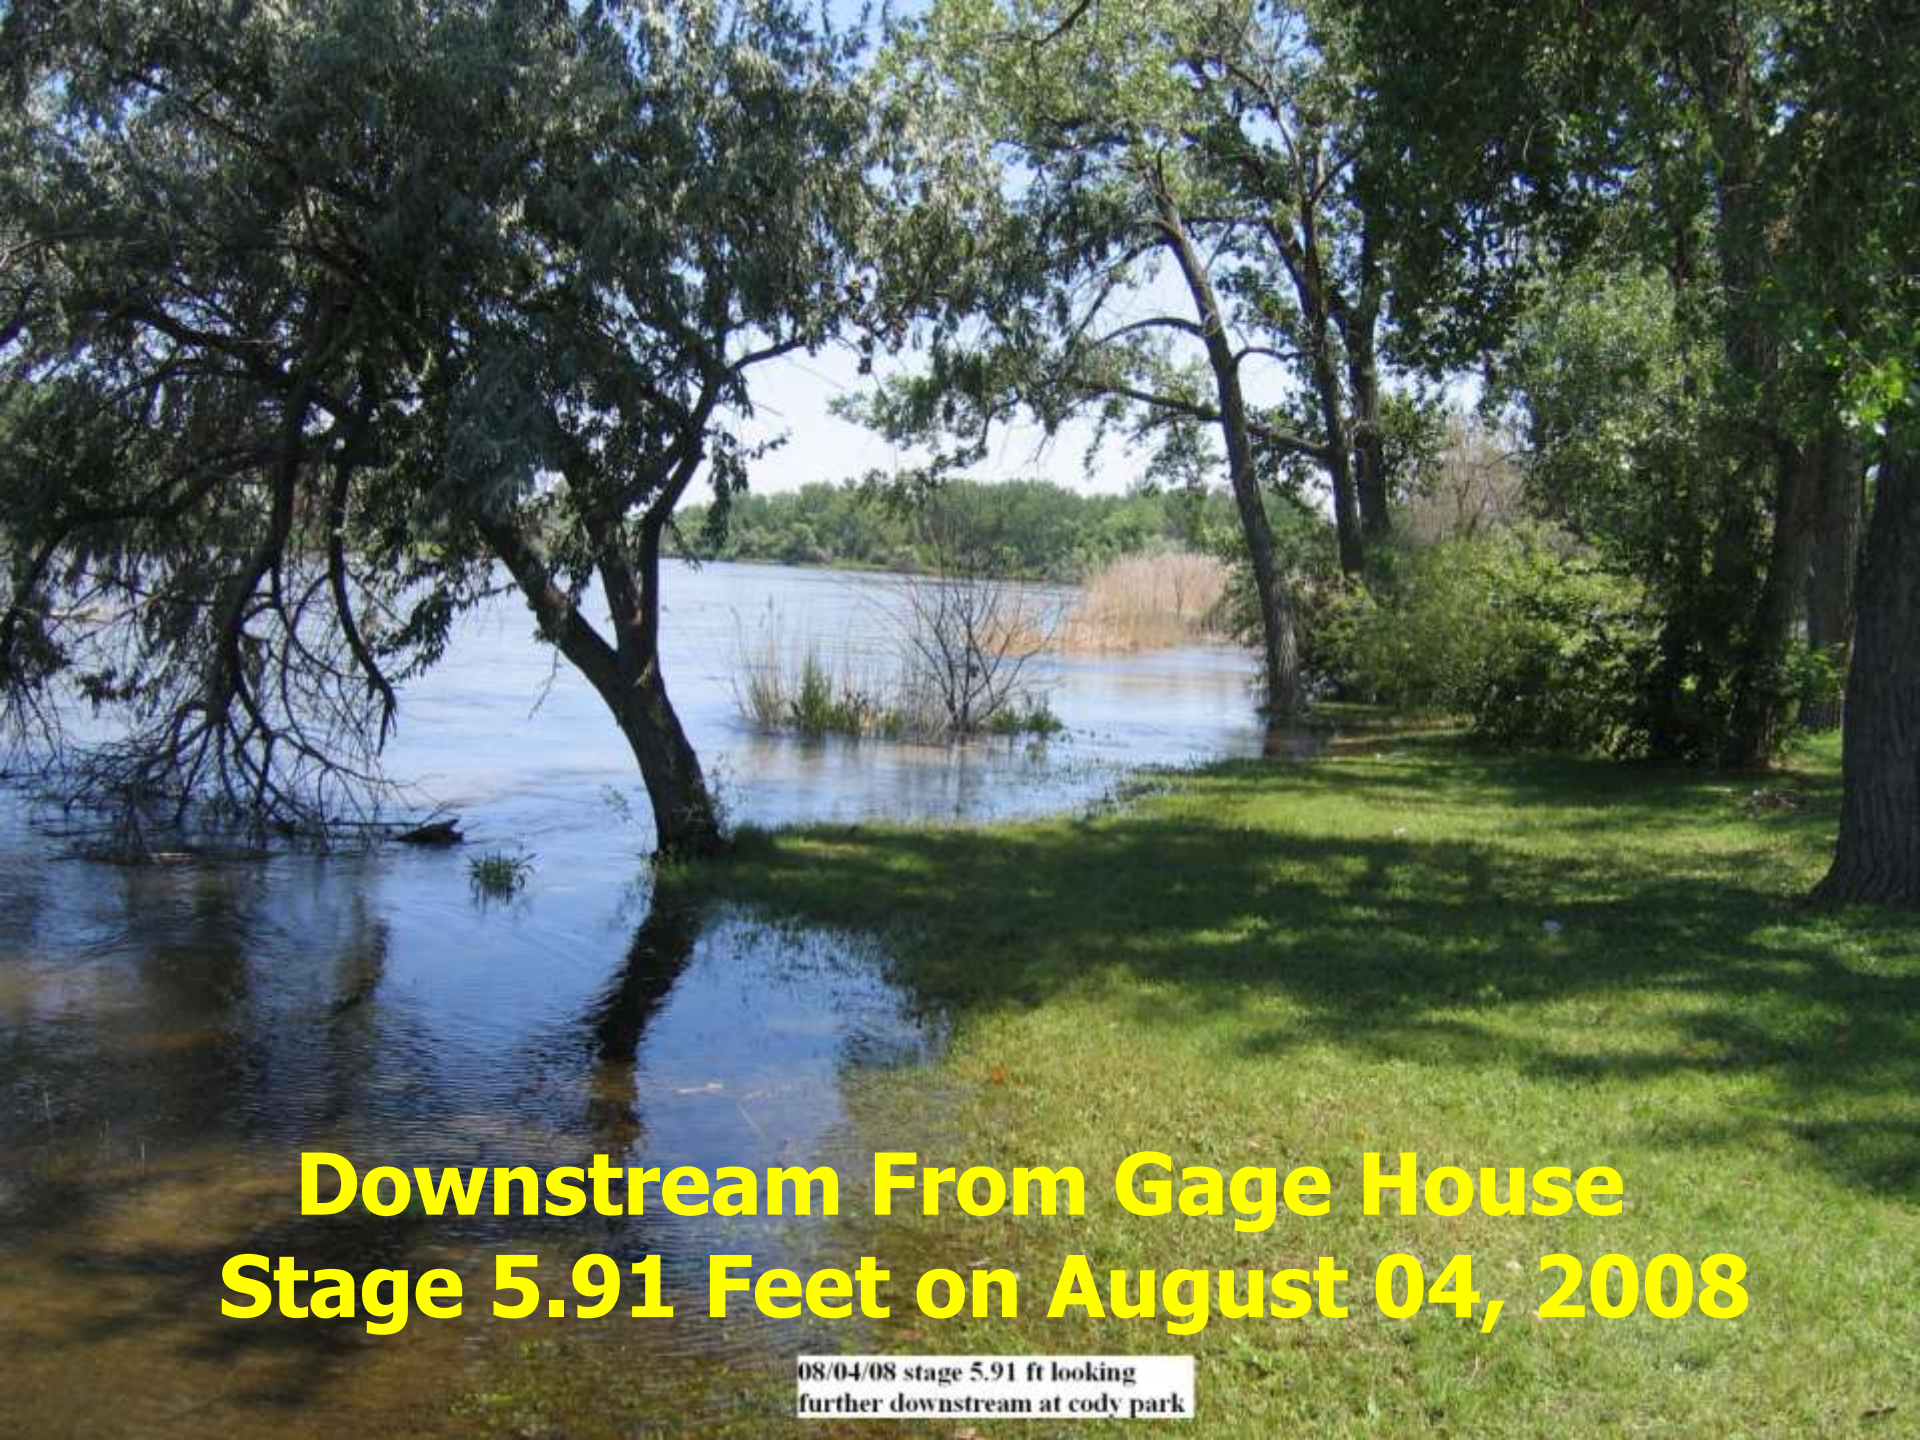
**Downstream From Gage House
Stage 5.91 Feet on August 04, 2008**

08/04/08 stage 5.91 ft looking
further downstream at cody park

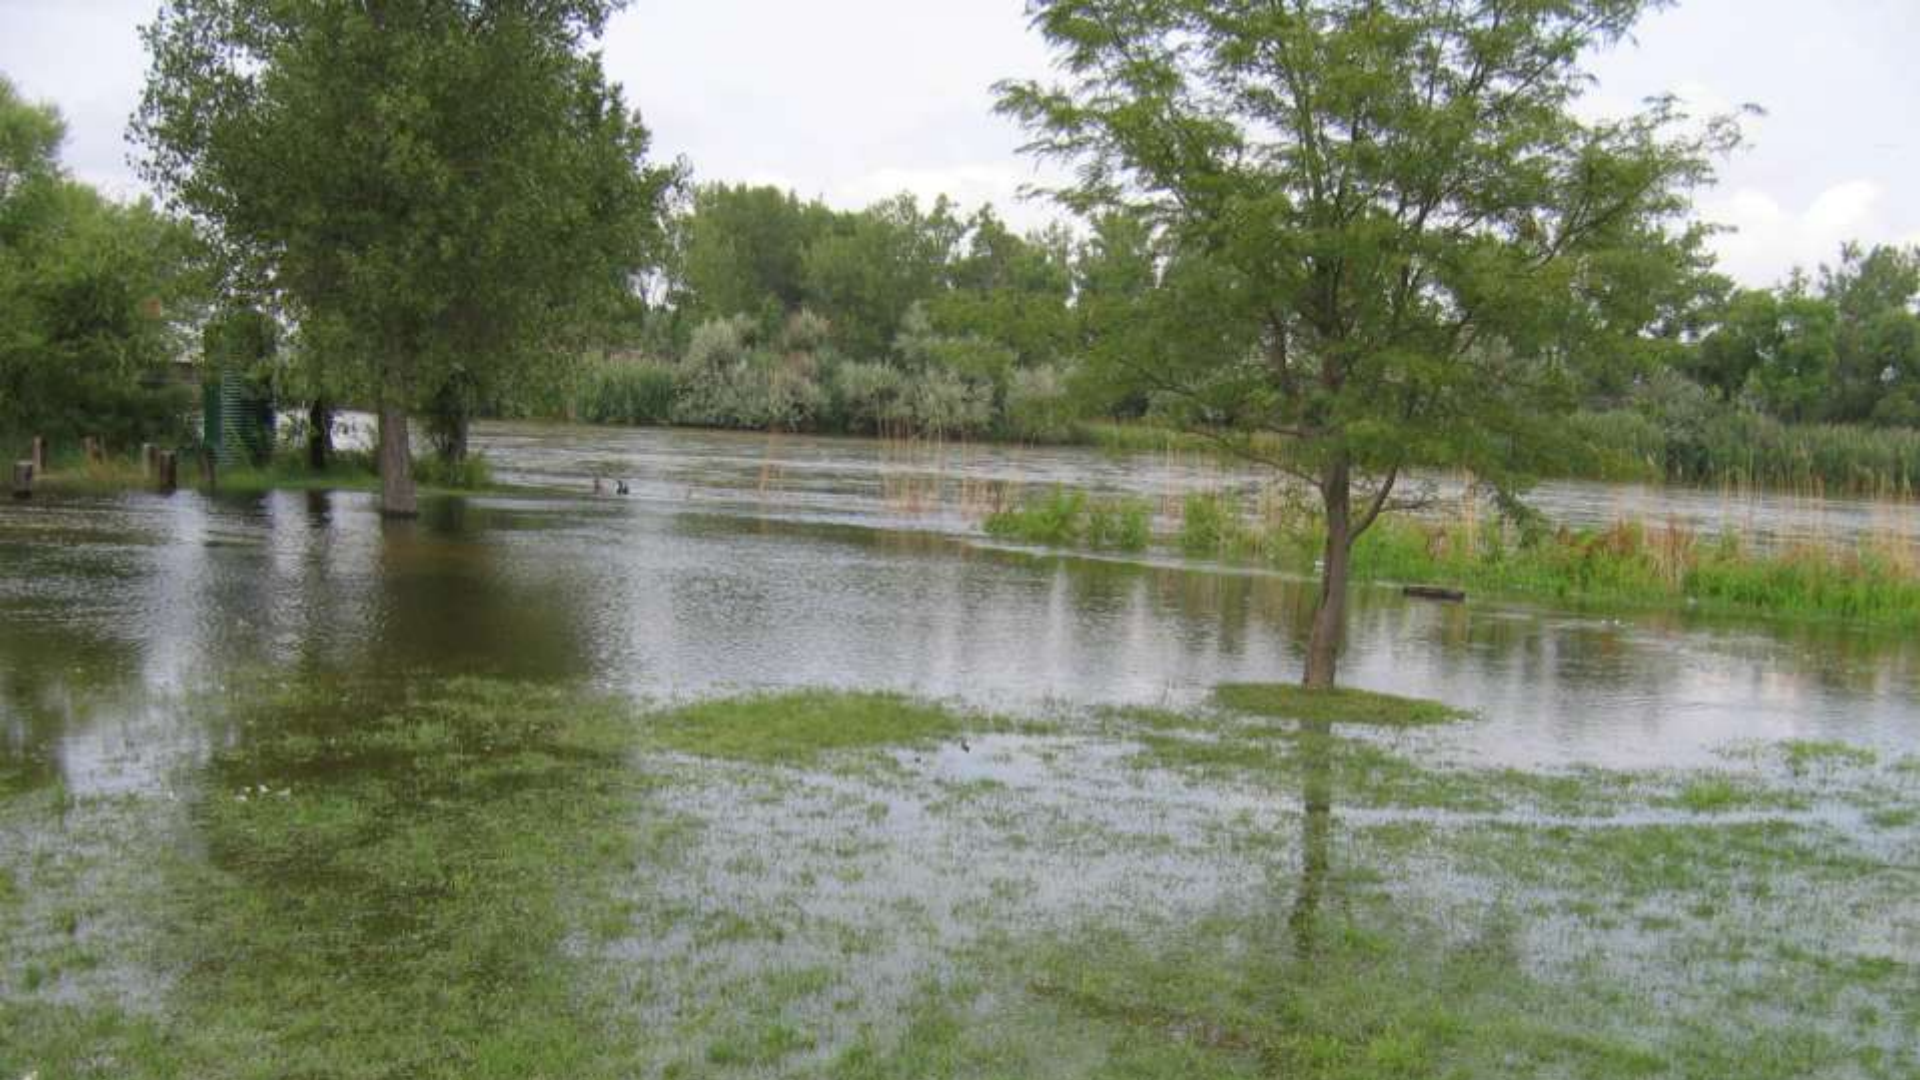
Water Visibly Flowing Into Cody Park Stage 6.15 Feet on August 06, 2008

08/06/08 stage 6.15 ft looking
toward gage house

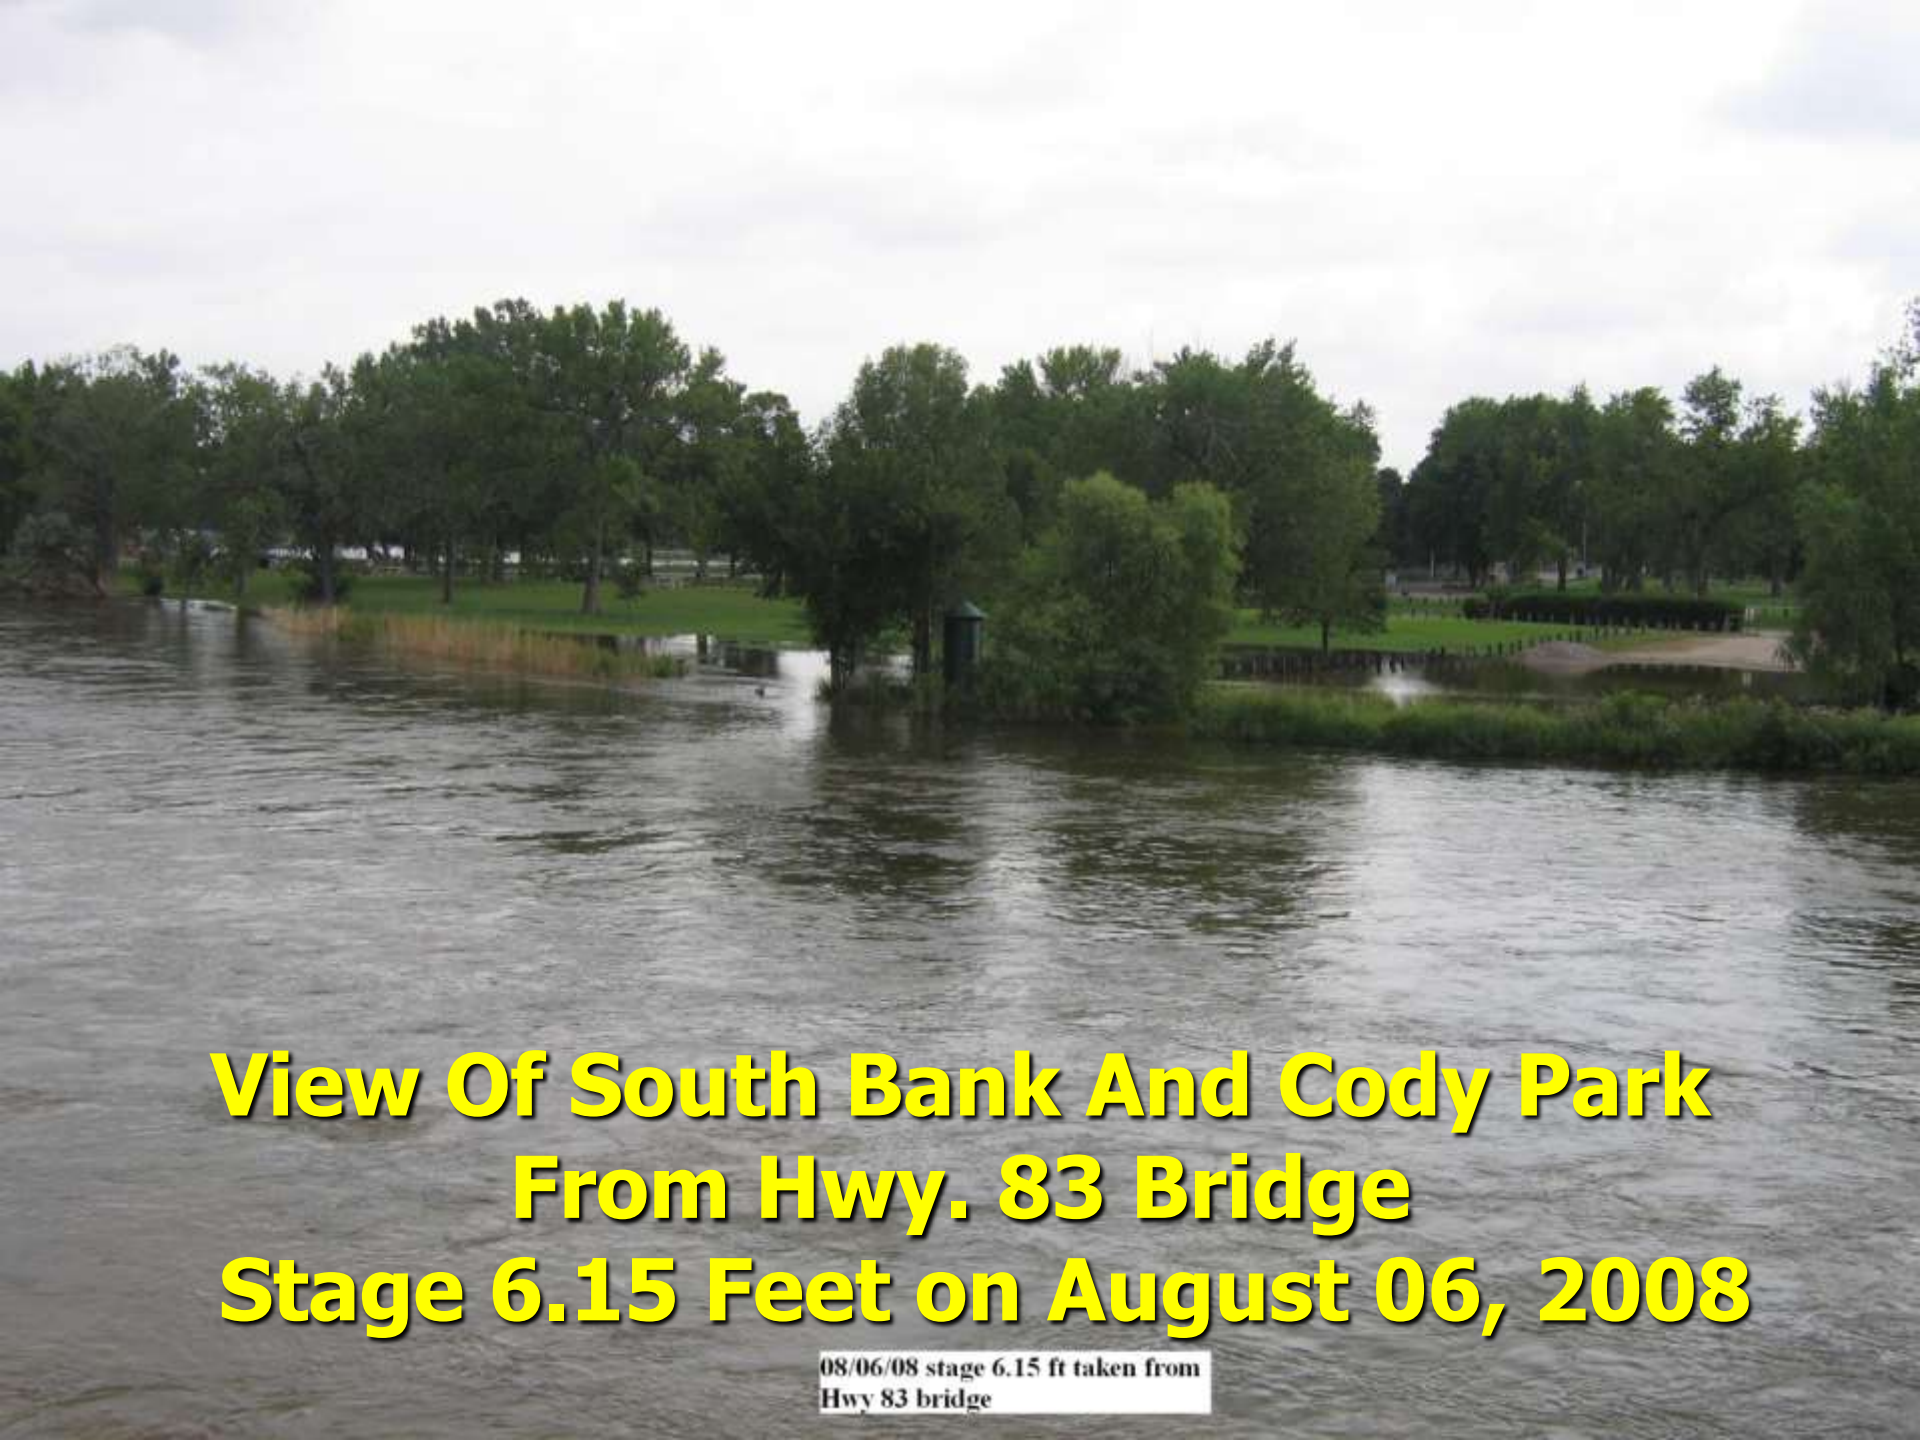
A wide river flows through a landscape. The water is a murky, greyish-brown color. The right bank is heavily flooded, with water reaching up to the trunks of several trees. In the background, a dense line of green trees stretches across the horizon under a cloudy, overcast sky. The overall scene suggests a significant flood event.

**View Of South Bank And Cody Park
From Hwy. 83 Bridge
Stage 6.15 Feet on August 06, 2008**

08/06/08 stage 6.15 ft taken from
Hwy 83 bridge

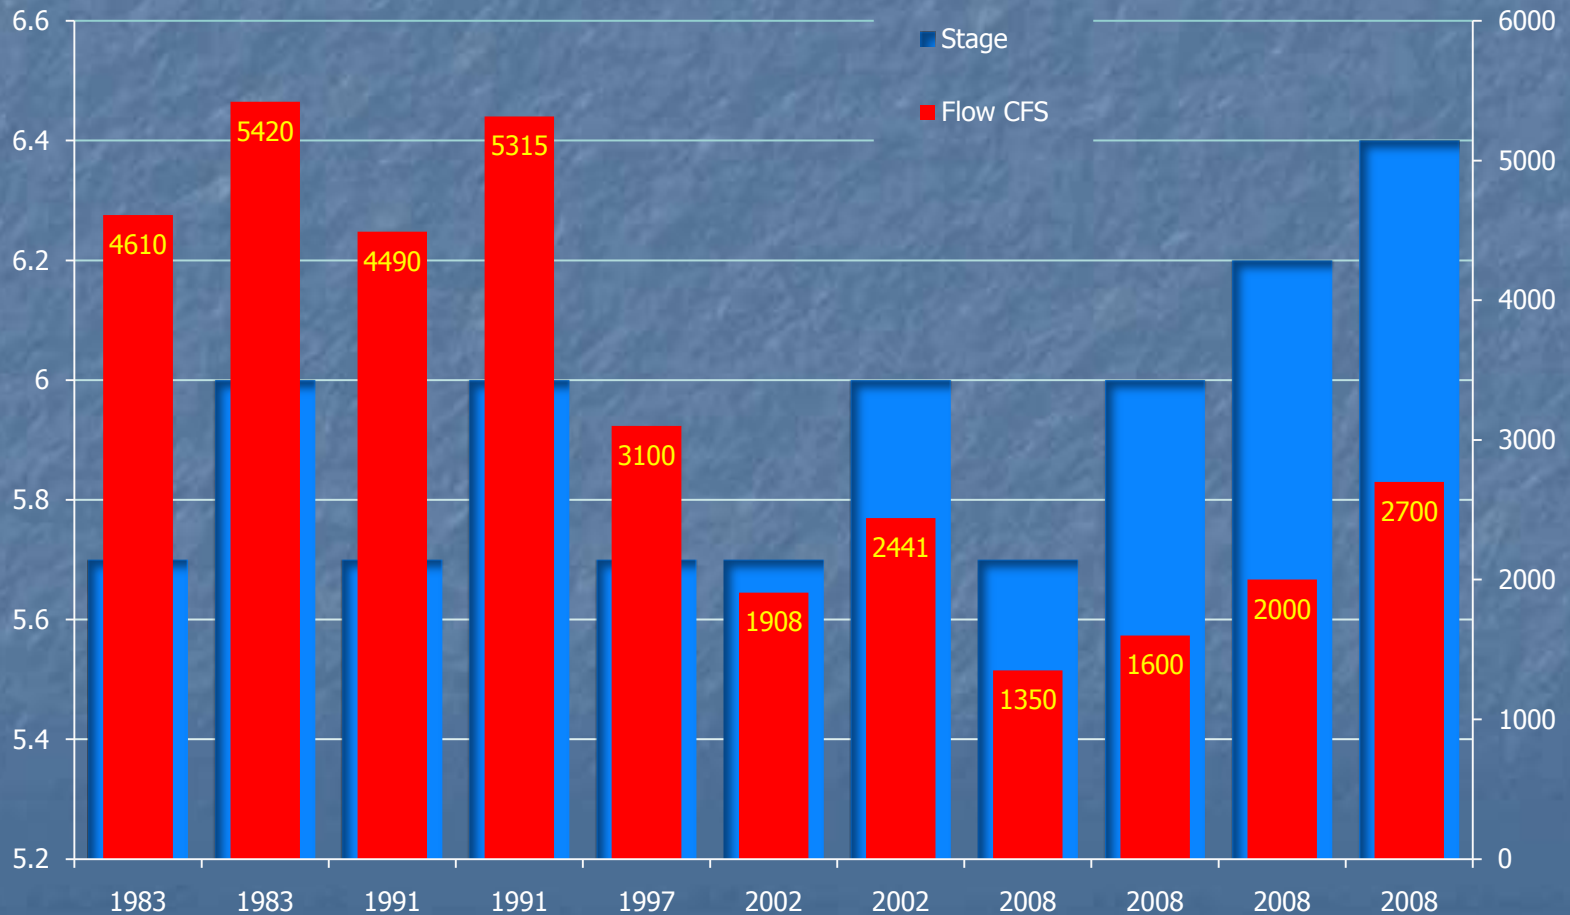
Stage and Flow 1983 to 2008

1983-1991 USGS Rating Tables

1997-2008 NDNR Rating Tables
