DATA ANALYSIS SUMMARY REPORT

MAY 2008 NATURAL HIGH FLOW EVENT

Prepared for:
**Governance Committee of the
Platte River Recovery Implementation Program**

By:
Executive Director's Office

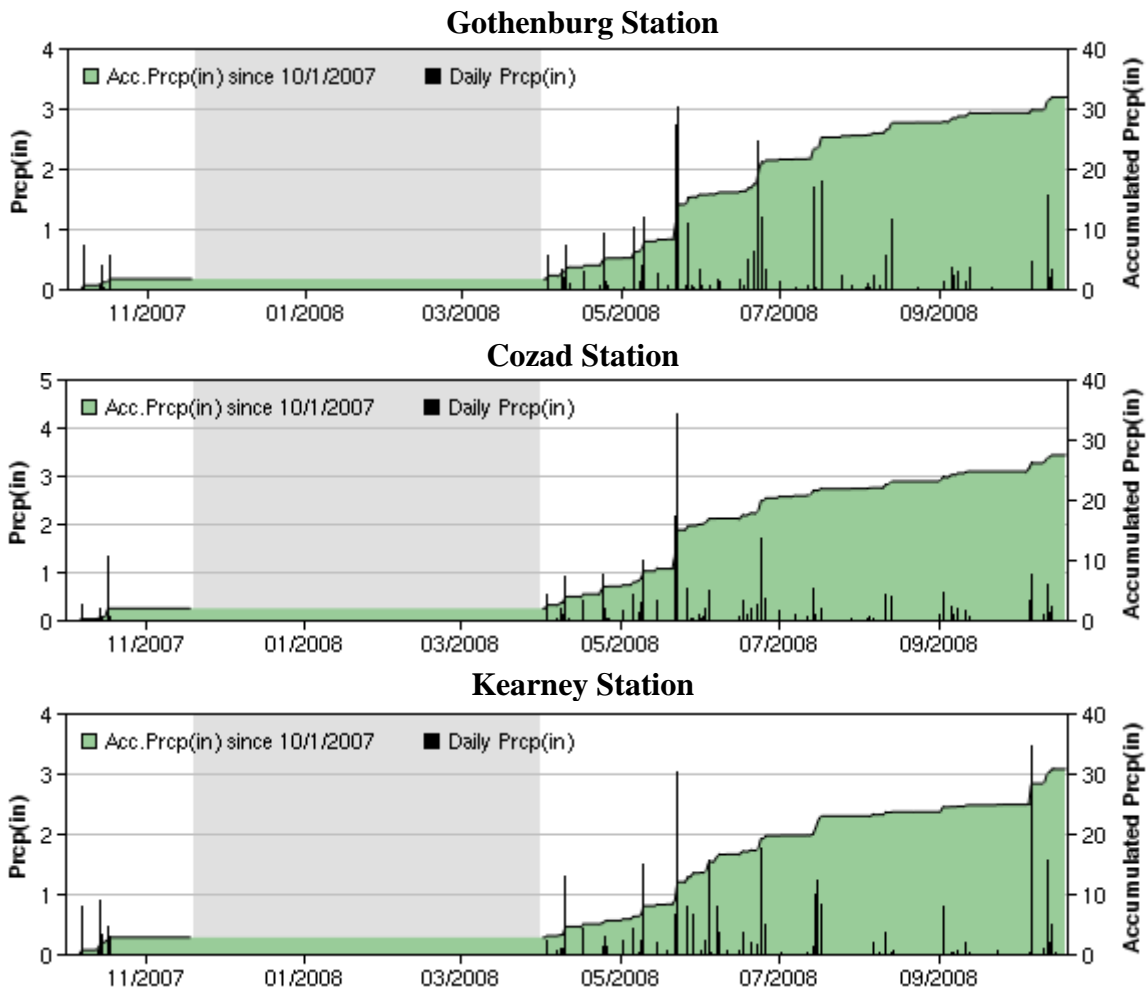
Figure 3 – Daily and Cumulative Precipitation for Gothenburg, Cozad and Kearney Weather Stations

This rainfall event was also preceded by several lesser events producing a May precipitation total on the order of ten to twelve inches at the west end of the habitat reach. Average May precipitation in this area is slightly less than four inches. Figure 2 presents total precipitation for the month of May. Figure 3 presents daily and cumulative precipitation records for the Gothenburg, Cozad, and Kearney automated weather stations.

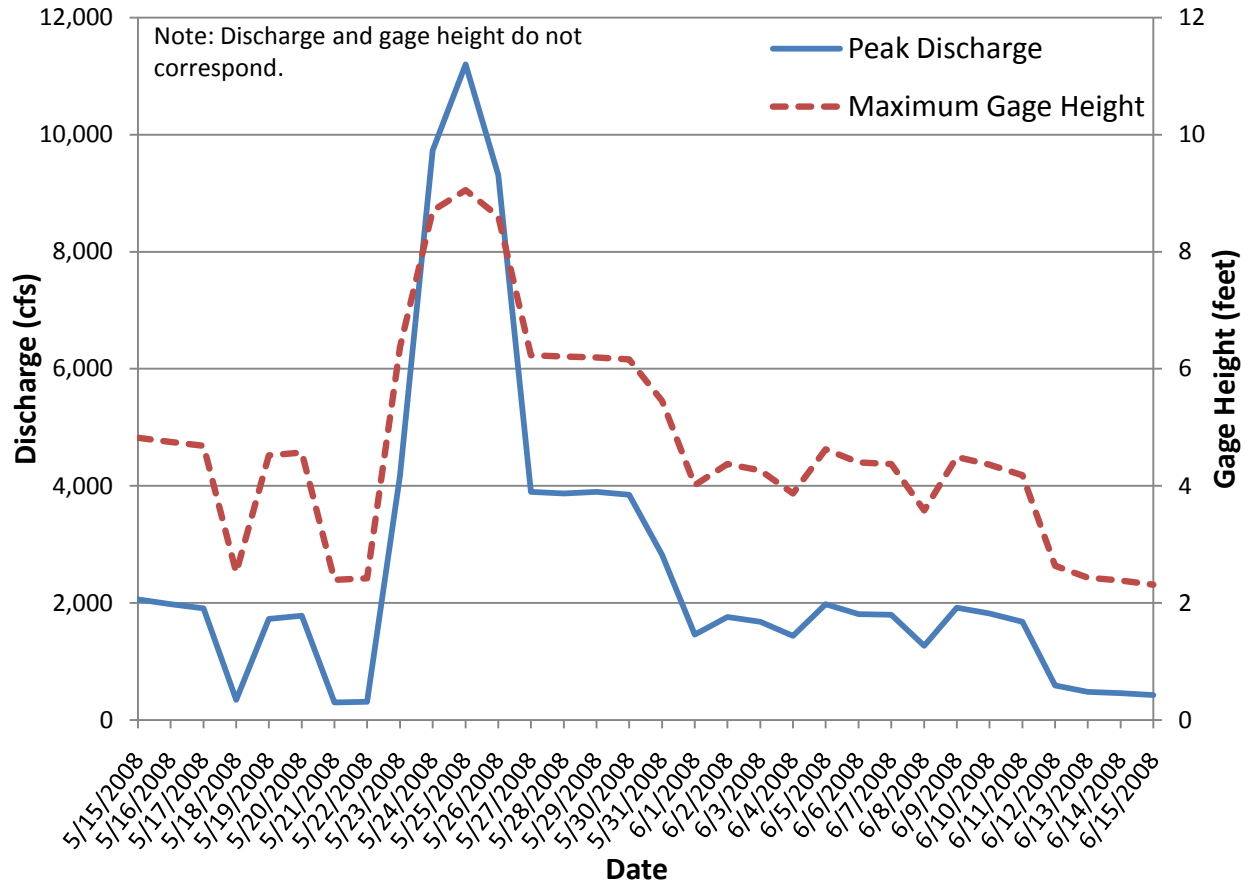
Figure 4 – Provisional Daily Peak Discharge and Gage Height 15/15/2008 to 06/15/2008, Platte River near Overton Nebraska (USGS Gage 06768000)

The USGS and NWS use different stage-discharge relationships at each gage location so NWS flood stage exceedance is presented independent of discharge. At the Overton gage, peak gage height exceeded the NWS flood stage of 7.0 feet on three consecutive days. At the Kearney gage,

the flood stage of 6.0 feet was exceeded on three consecutive days. At the Grand Island gage, the flood stage of 6.5 feet was exceeded on one day. Figures 4 – 6 present the provisional gage records for the Overton, Kearney, and Grand Island stream gages. Please note that discharge and gage height do not correspond.

The combination of saturated soils due to above average rainfall and the large storm event on May 23rd and 24th resulted in a peak Platte River flow of 13,400 cfs in the habitat reach. This flow was recorded on May 26th at the USGS gage near Kearney, NE (06770200), near the midpoint of the reach. The peak flow at the upstream end of the reach was 11,200 cfs, recorded on May 25th at the USGS gage near Overton, NE (06768000). The peak flow at the downstream end of the reach was 12,900 cfs, recorded on May 27th at the USGS gage near Grand Island, NE (06770500).

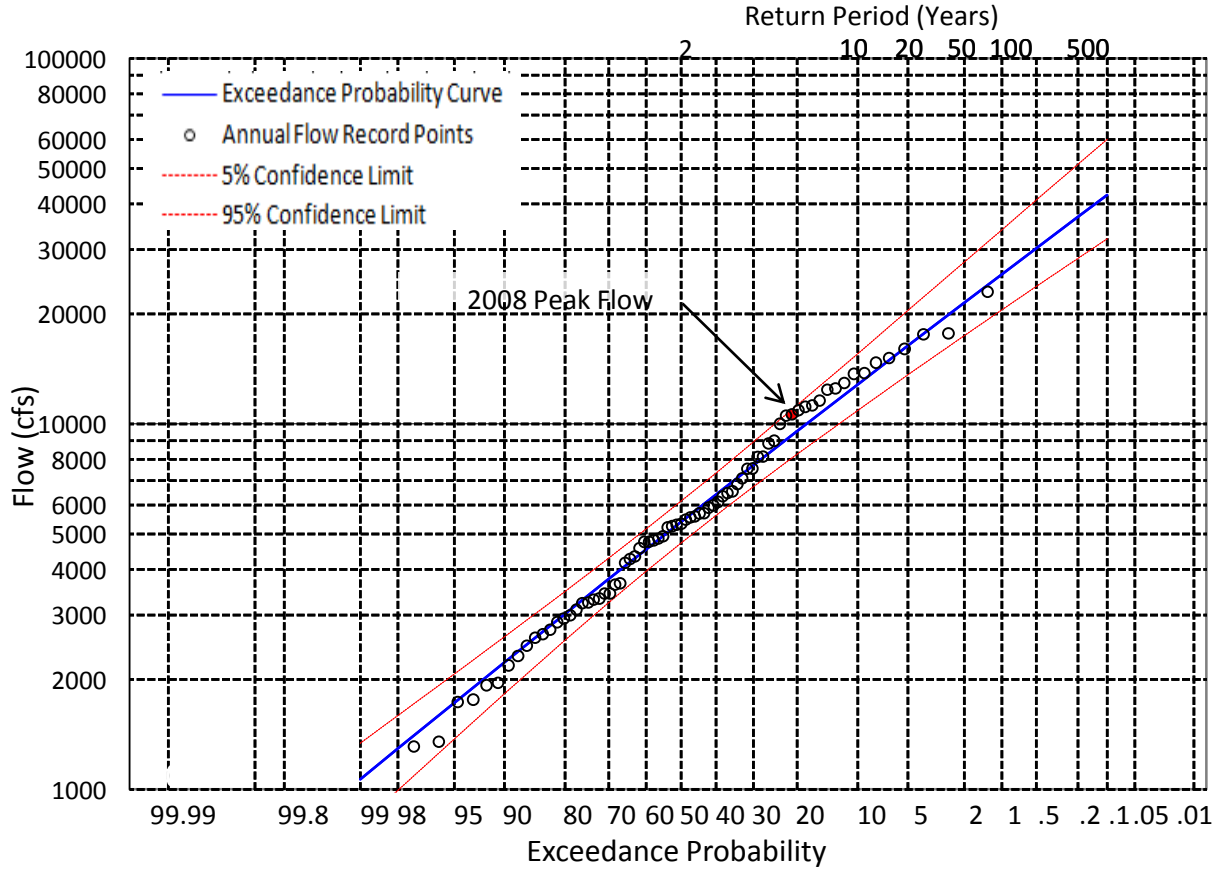
Figure 10 – Three-Day Mean Peak Flow Exceedance Probability Curve, Platte River near Grand Island Nebraska 1934-2008 (USGS Gage 06770500)

The three-day mean peak flow return frequency for the May event was also calculated at the Grand Island gage using annual three-day mean peak flows for the period of record. The three-day mean peak flow for the three highest flow days during the May event was 10,553 cfs. The calculated flow exceedance probability this mean peak flow is on the order of 23%, which equates approximately to a four year return period. The three-day mean peak exceedance probability is similar to the single day peak exceedance probability of 19% at the Grand Island gage. This indicates that the flood flow duration during the May event is similar to historic flows of approximately the same magnitude. Figure 10 presents the three-day mean peak Platte River flow exceedance probability curves at the Grand Island Gage.

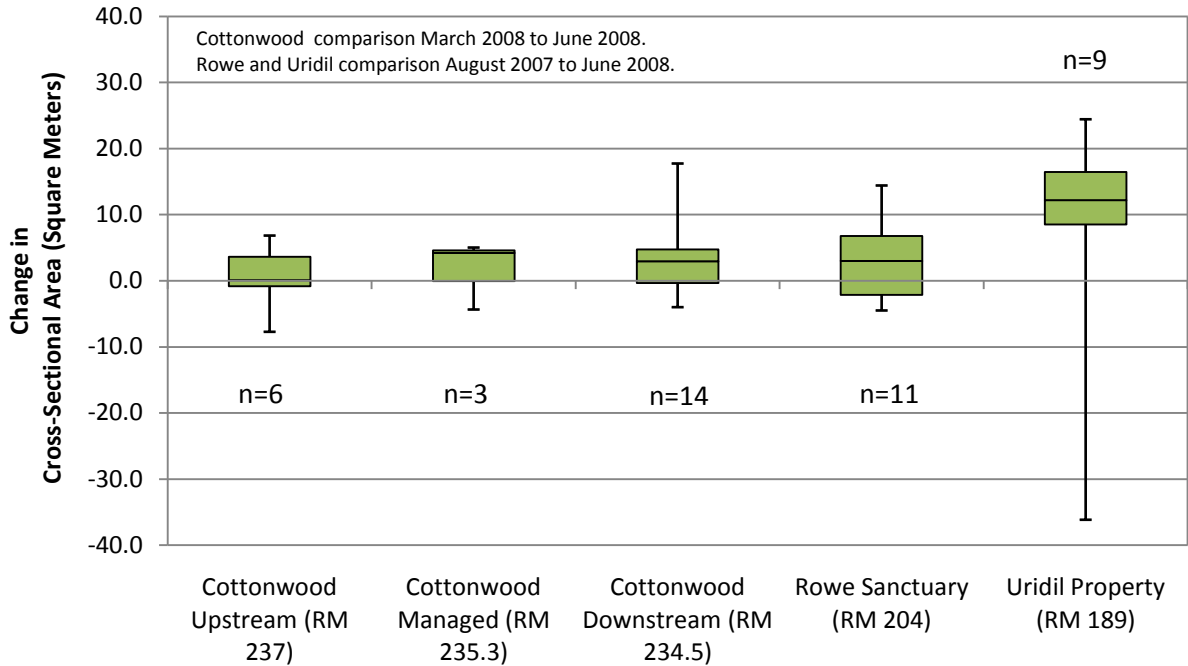
Figure 14 – USGS Transect Survey Comparison - Change in Transect Cross-Sectional Area

The general transect survey dates for the Cottonwood Ranch transect comparison are March 2008 and June 2008. The general transect survey dates for the Rowe and Uridil transect comparison are August 2007 and June 2008. A comparison of the transect surveys is presented below in Figures 11 -14. Transect location figures and plots are located in Appendix C. The comparison results for all transect subsets are presented as quartile plots that include minimum, 25th percentile, median, 75th percentile, and maximum values of individual cross section comparisons within the subset. With the exception of the Cottonwood Downstream subset, the comparison indicates thalweg deepening as evidenced by generally negative changes in minimum channel elevation. In contrast, general increases in average and maximum channel elevations were recorded along with a generally positive difference (difference = 2007 area - 2008 area) in cross sectional flow area. Long-term average annual difference in cross-sectional area of plus or minus approximately one m² can be categorized as either aggradational (+) or degradational (-) given that a channel in equilibrium may fluctuate more than one m² within a single year and maintain stability (Holburn et al. 2006). Thalweg deepening would be consistent with channel degradation while the positive difference in survey cross section areas indicates a stable to aggradational channel.

As discussed in Section IV, the transect survey analysis indicates post-event reach-wide thalweg deepening. This contrasts with a stable to aggrading general channel cross section as indicated by positive changes in average channel elevation, maximum channel elevation, and cross section area. For most transects, these channel changes were not significant enough to be easily observable on-site or in a 2007-to-2008 comparison of aerial photography. Though this dataset is limited in scope, the lack of significant cross section changes (like island scouring and building of new in-channel bar features) related to this magnitude of flow appears to reinforce the need for the clearing and leveling component of the flow-sediment-mechanical management strategy.

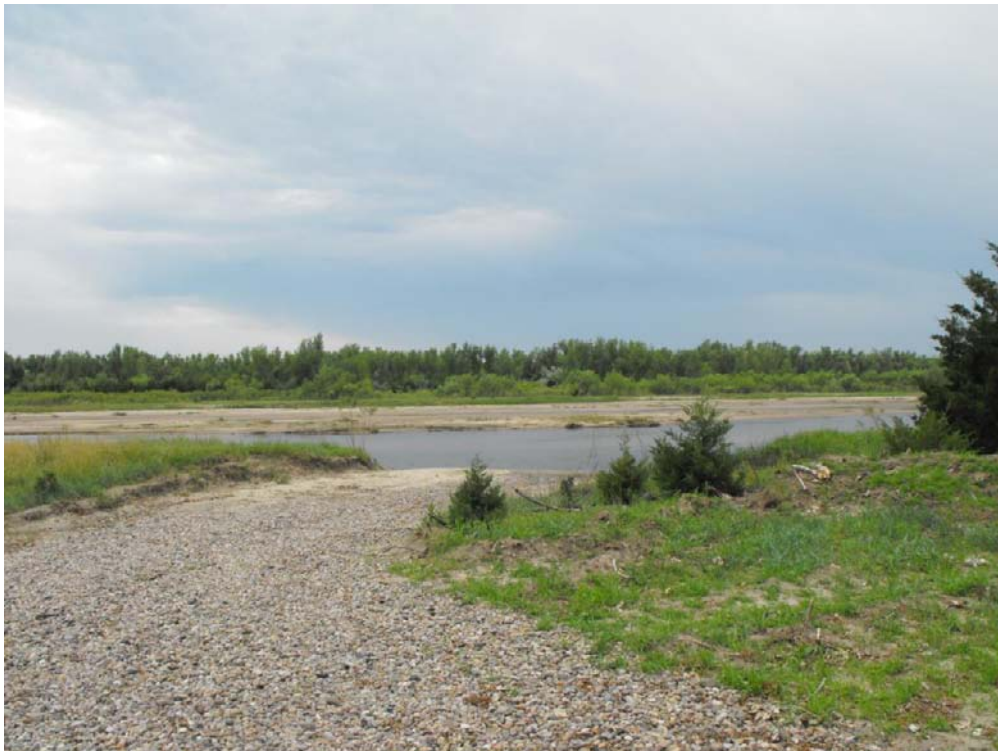
Photograph 4 – June 16, 2008 looking south from airboat ramp at west edge of property (870 cfs).

A photo log documenting channel conditions at the Wyoming Property before, during, and after the May high flow event is included in Appendix A. Visual observations following the event indicate that the high flows increased the areal extent of bare sand on the property. However, the majority of this additional area is in the form of large longitudinal and point bars connected to either the north or south channel bank. An example of a large post-high flow event point bar can be seen along the opposite (south) bank in Photo Log Photograph #4, taken from the airboat ramp.

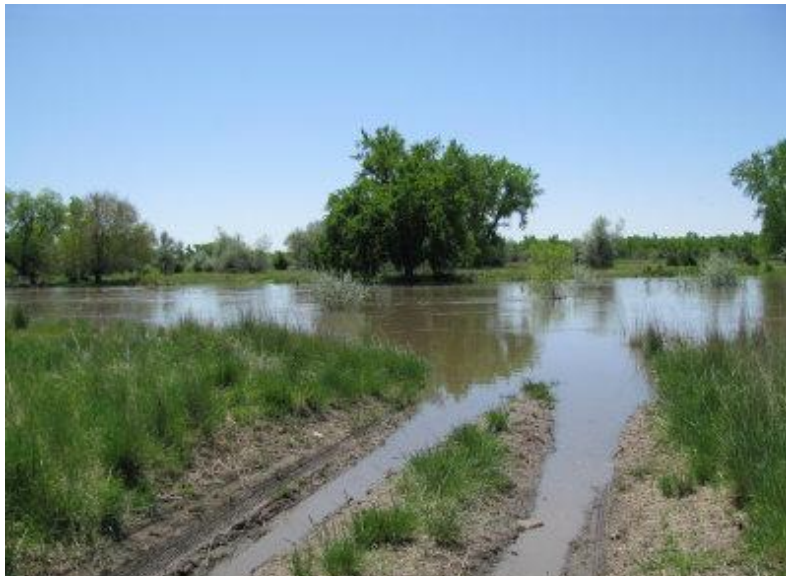
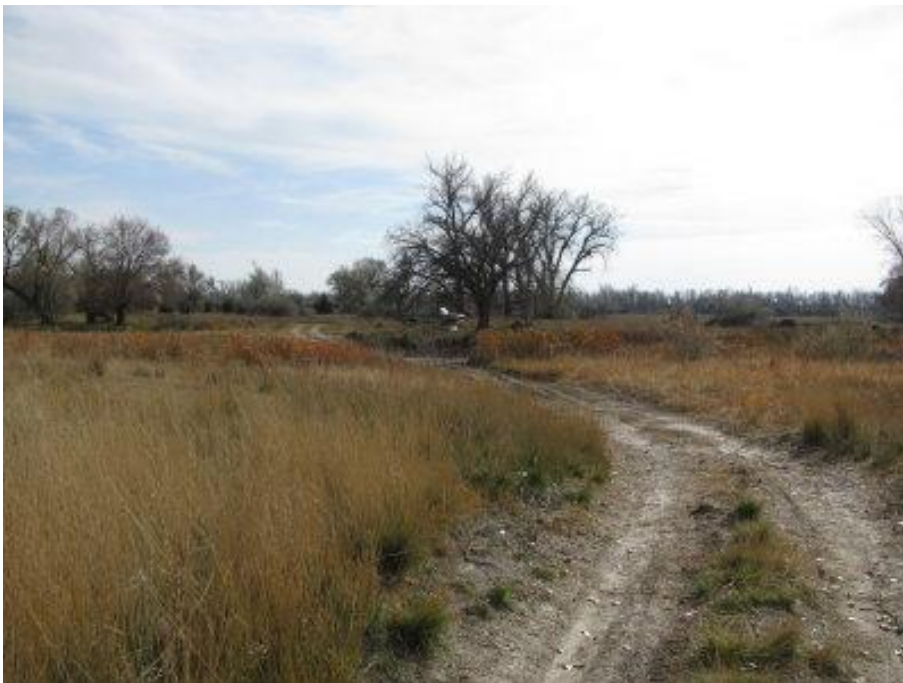
North channel of the NPPD Cottonwood Ranch Property, photos taken from the gate on the north side looking south. The total flow at Overton on May 25 was 11,200 cfs with a peak stage of 9.62, flow on the middle channel at Cottonwood Ranch was 7,290 cfs with a peak stage of 8.38. this channel at low flows is actually Spring Creek but connects to the river at higher flows. Max flow of Spring Creek on May 25, 2008 was 475 cfs with a pak stage of 9.62. Peak flows on November 4, 2008 were Overton 636 cfs (stage 3.25), Cottonwood Ranch 548 cfs (stage 4.23) and Spring Creek 36 cfs (stage 3.97). No obvious changes in vegetation, channel width or depth were noted in this channel.

Photograph 1 – May 25, 2008.

Photograph 2 – November 4, 2008.

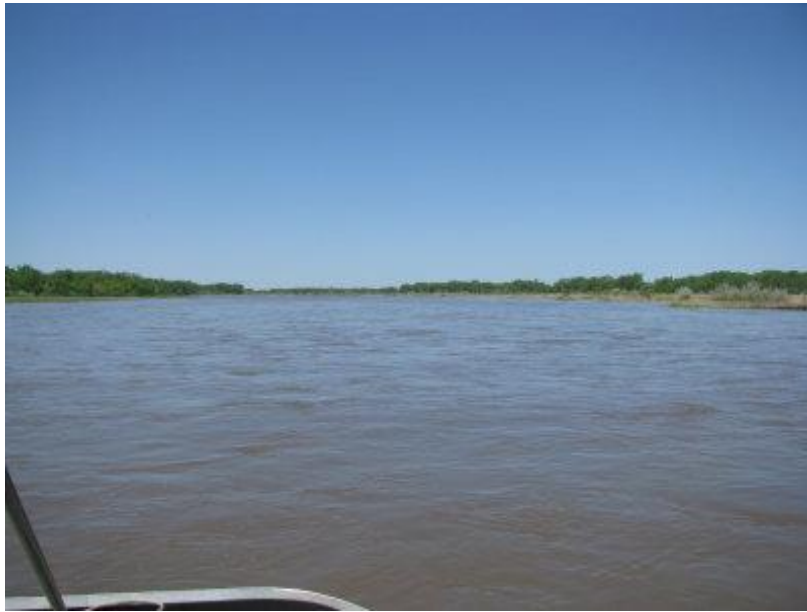
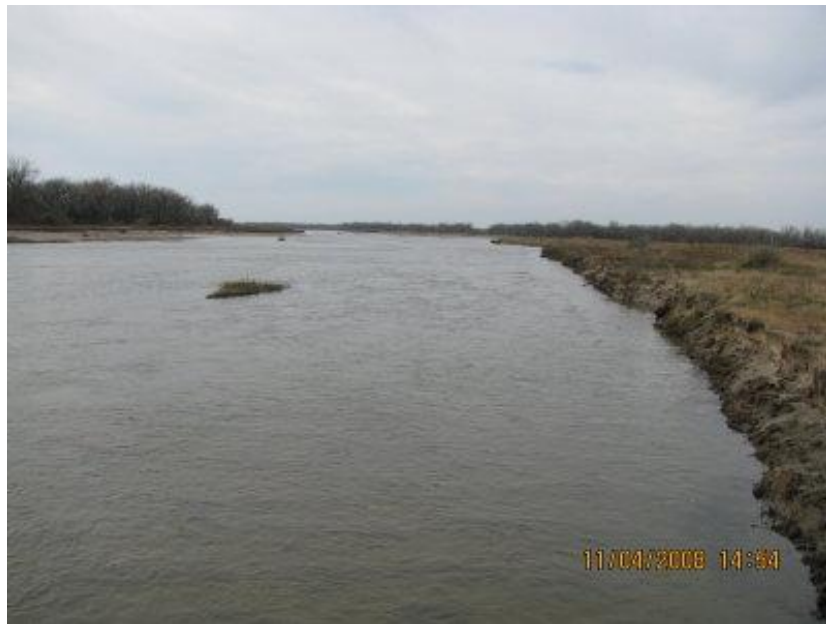
Main channel Cottonwood Ranch Property River Mile 235 looking west, May 25, 2008 flow 7290 cfs (stage 8.38), November 4, 2008 flow 518cfs (stage 4.23) gauge 0.9 miles downstream. No sandbars were formed that would be exposed at 1200 cfs. No scour of islands with vegetation. Significant bank erosion on north bank that was mechanically modified to be vegetation free and verticle, little or no erosion on south bank, which has not been modified. Picture 4 shows small island that is patch of phragmites roots that was less then 10 feet from bank prior to flow, approximately 40 feet from bank.

Photograph 3 – Main Channel Cottonwood Ranch Property May 25, 2008

Photograph 4 – Main Channel Cottonwood Ranch Property November 4, 2008

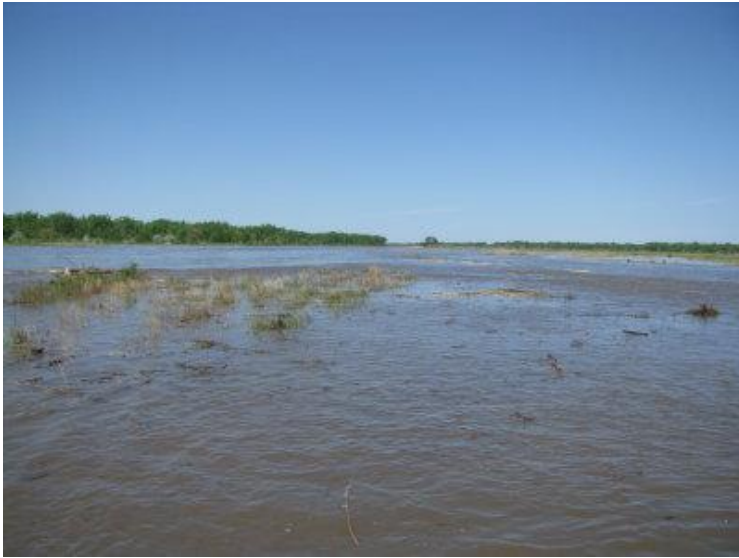
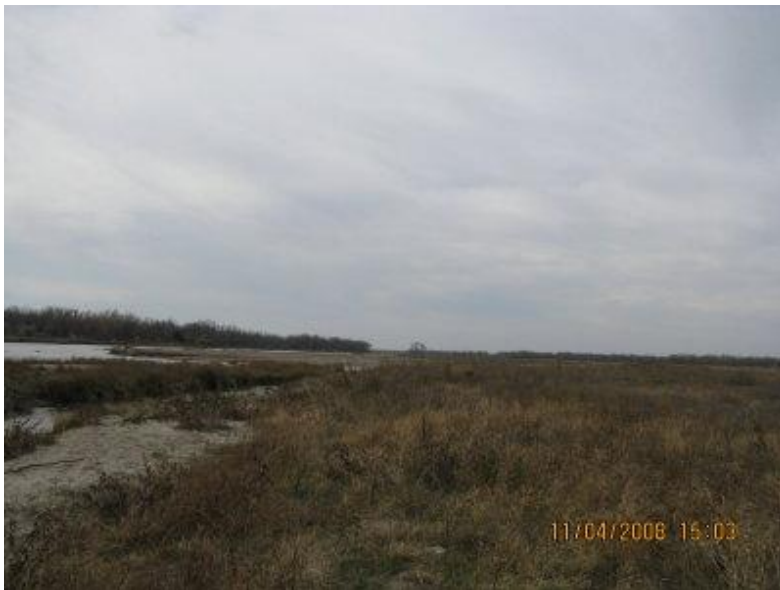
Main channel Cottonwood Ranch Property River Mile 234.5 looking west, May 25, 2008 flow 7290 cfs (stage 8.38), November 4, 2008 flow 518cfs (stage 4.23) gauge 0.4 miles downstream. No sandbars were formed that would be exposed at 1200 cfs. No scour of vegetation. May flow totally inundated the east tern and plover island. This island was free of vegetation but suffered no significant erosion. Did vegetate within one month of flow. Tern and plover island seen in upper portion of photograph 6 has been disked in October 2008.

Photograph 5 – May 25, 2008.

Photograph 6 – November 4, 2008.

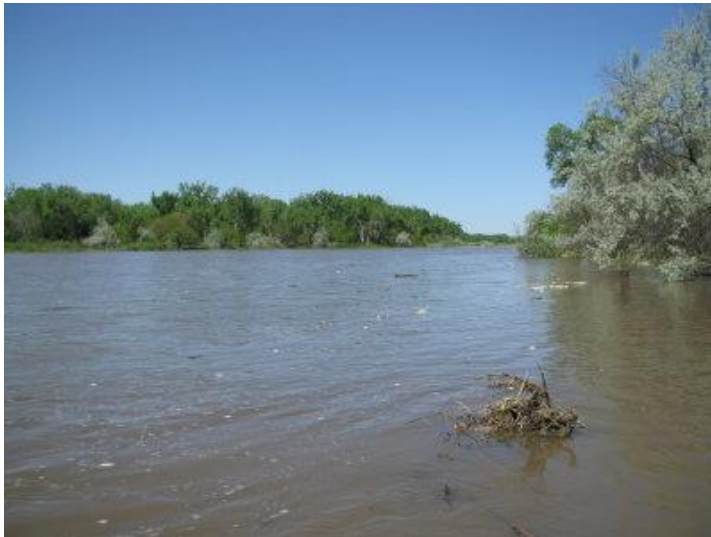
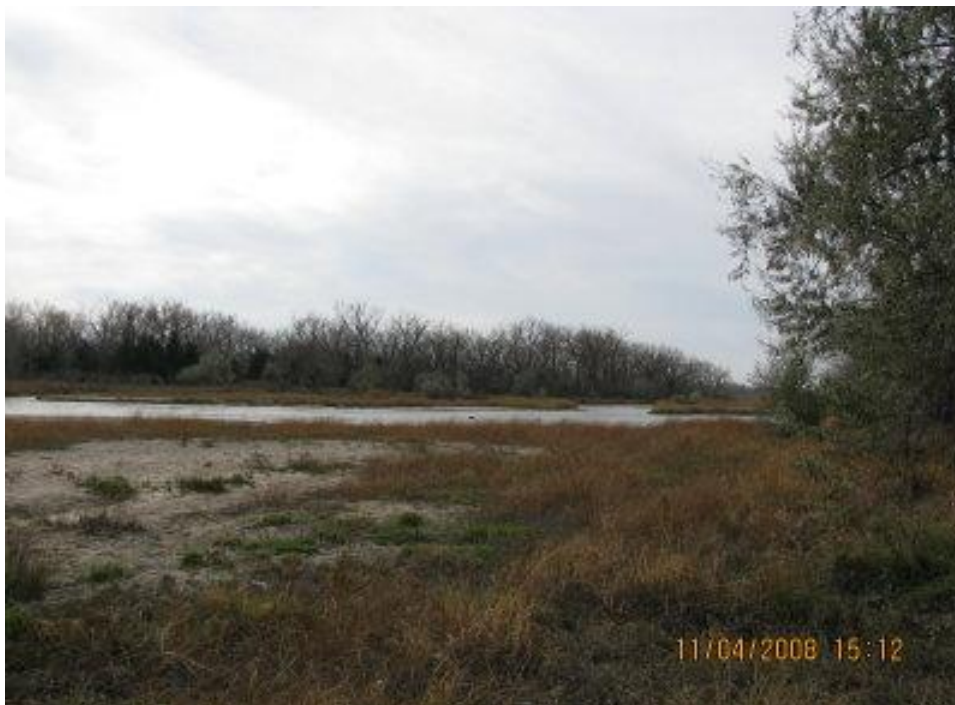
Main channel Cottonwood Ranch Property River Mile 234 looking west, May 25, 2008 flow 7290 cfs (stage 8.38), November 4, 2008 flow 518cfs (stage 4.23) gauge 0.2 miles upstream. No sandbars were formed that would be exposed at 1200 cfs. No scour of vegetation. Did deposit sand on vegetated bars and terraces raising the elevation of those land forms, but not enough to form barren bar.

Photograph 7 – May 25, 2008

Photograph 8 – November 4, 2008

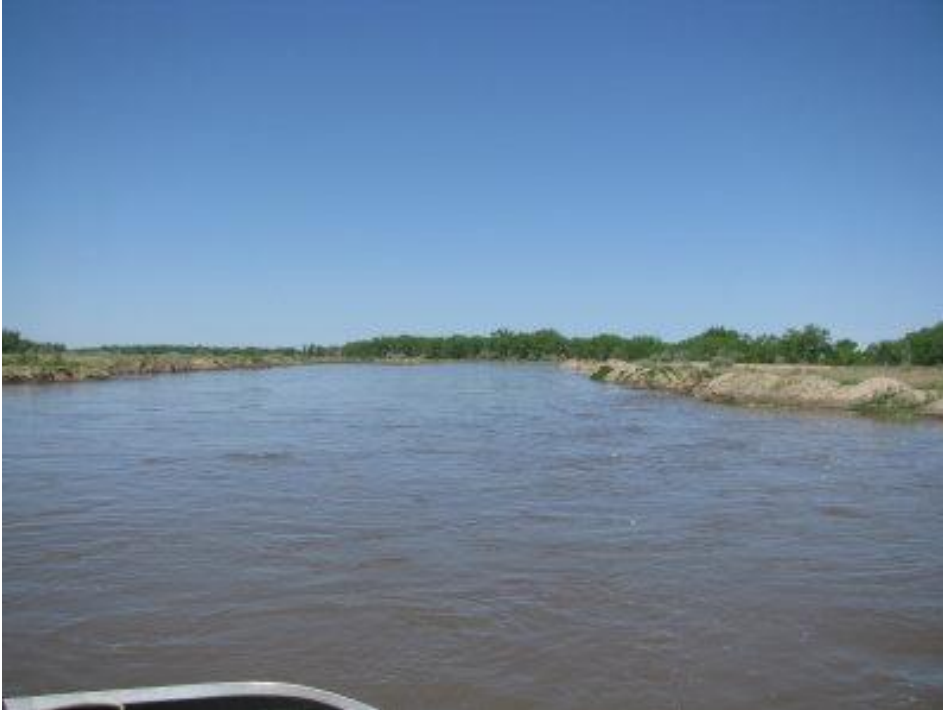
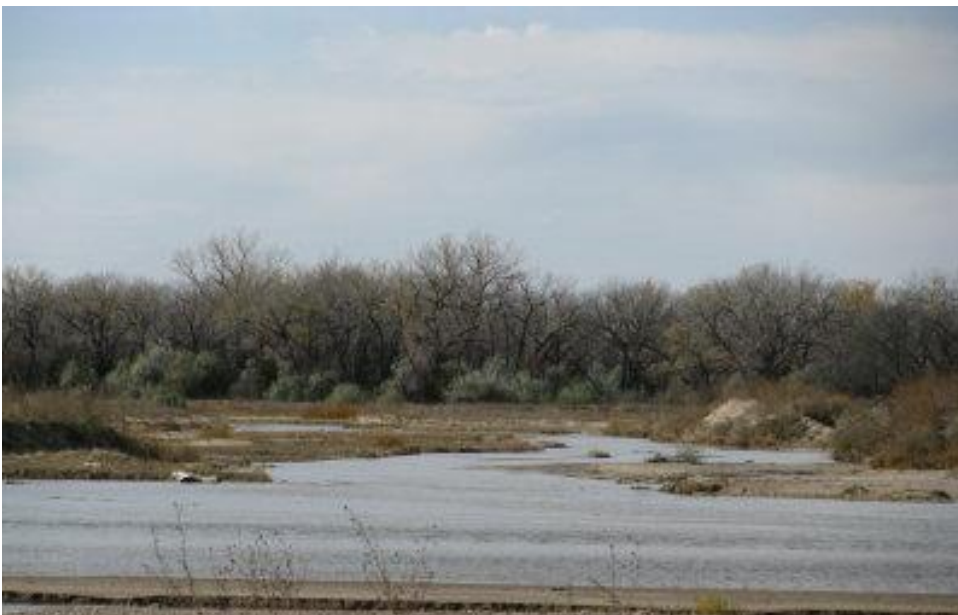
Man-made channel Cottonwood Ranch Property River Mile 236 looking northwest, May 25, 2008 total flow main channel 7290 cfs (stage 8.38), November 4, 2008 flow 518cfs (stage 4.23) gauge 1.9 miles downstream. Sand from channel was stock piles on banks thinking high flow would erode banks and mobilize sand. Some erosion occurred but much of the material remains and is now vegetated.

Photograph 9 – May 25, 2008

Photograph 10 – November 4, 2008 looking....

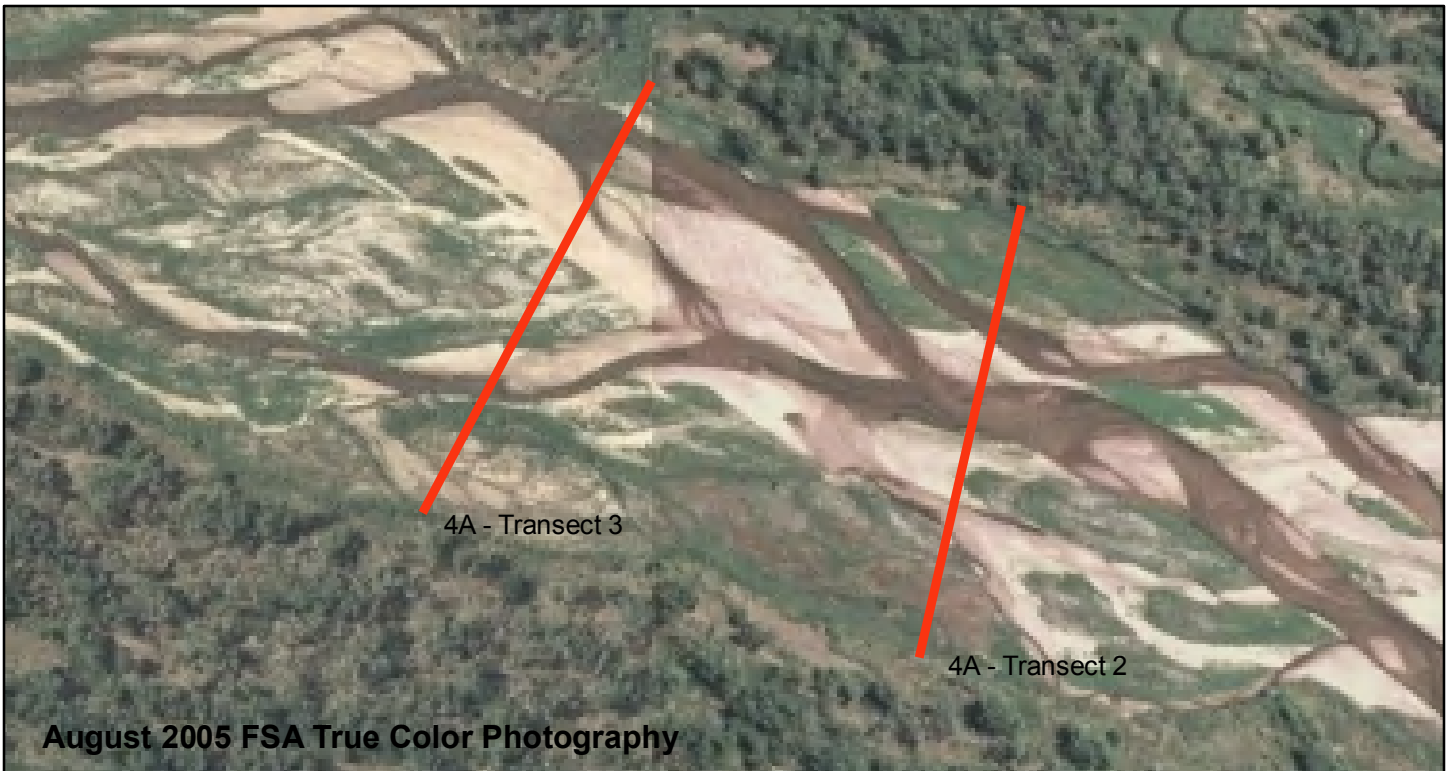
Figure B-1

STUDY SITE 4A
TRANSECT LOCATIONS

A comparison of September 2005 and June 2008 Bureau transect surveys is presented in Table 4. Transect location figures and plots are located in Appendix B. The 2008 to 2005 transect survey comparison indicates reach-wide thalweg deepening as evidenced by negative changes in minimum channel elevation for seven out of ten transects. In contrast, general increases in average and maximum channel elevations were recorded along with a generally positive difference (difference = 2005 area - 2008 area) in cross sectional flow area. Long-term average annual difference in cross-sectional area of plus or minus approximately one m² can be categorized as either aggradational (+) or degradational (-) given that a channel in equilibrium may fluctuate more than one m² within a single year and maintain stability (Holburn et al. 2006). Thalweg deepening would be consistent with channel degradation while the positive differences in survey cross section area indicate a stable to aggradational channel.

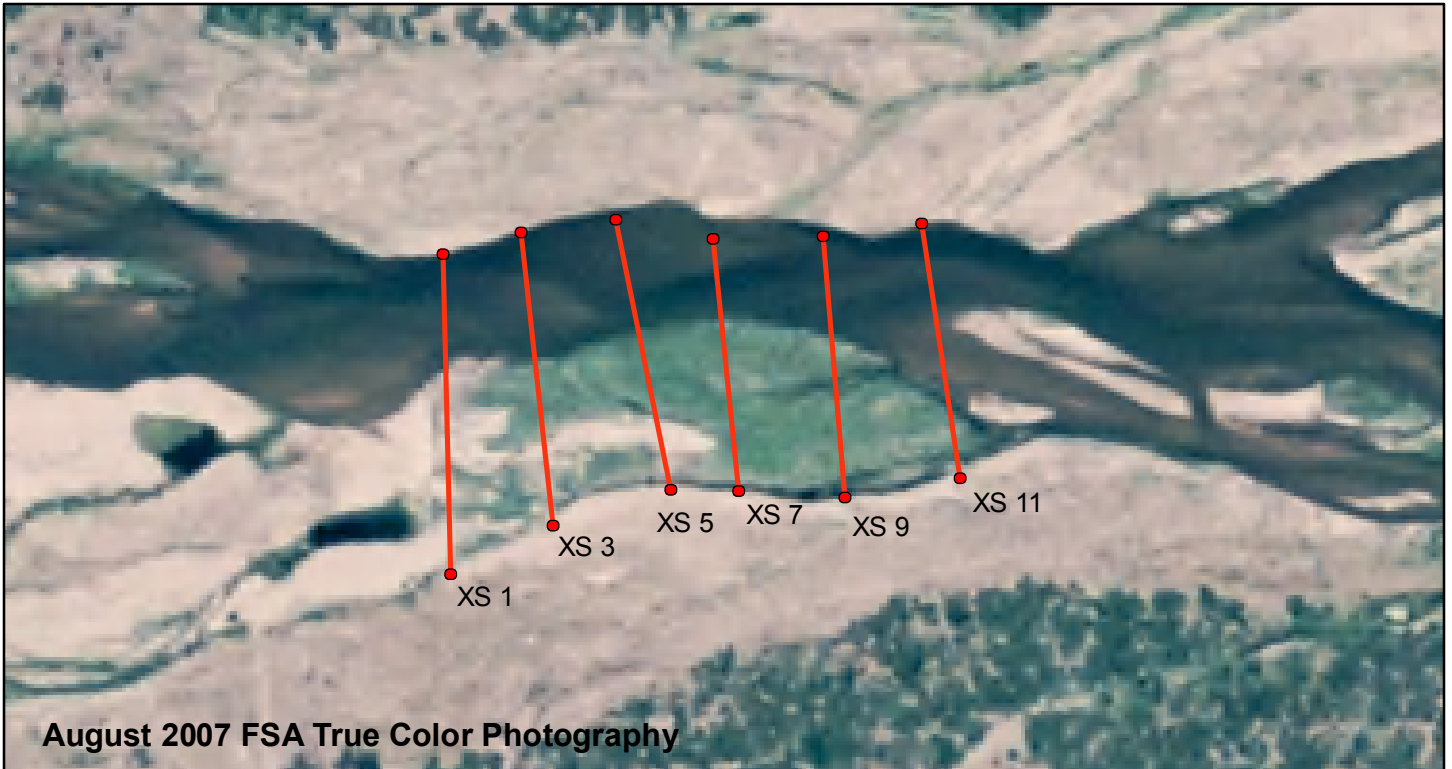
Figure C-1

COTTONWOOD RANCH
INPUT REACH
TRANSECT LOCATIONS

The USGS transects have been divided into five subsets located in a total of three geographic locations. The first three subsets are located within the NPPD Cottonwood Ranch property in the Overton to Elm Creek bridge segment. NPPD is actively widening the channel and augmenting sediment in the central portion of the property. The first USGS transect subset, labeled Cottonwood Input, is located upstream of the widening and augmentation activities. The second subset, labeled Cottonwood Managed, is located in the area being widened and where site-specific sediment augmentation is occurring. The third subset, Cottonwood Output, is located downstream of the widening and augmentation activities. The fourth set is located within Audubon Rowe Sanctuary in the Minden to Gibbon bridge segment. The fifth is located on the Platte River Whooping Crane Maintenance Trust Uridil Property in the Shelton to Wood River bridge segment.

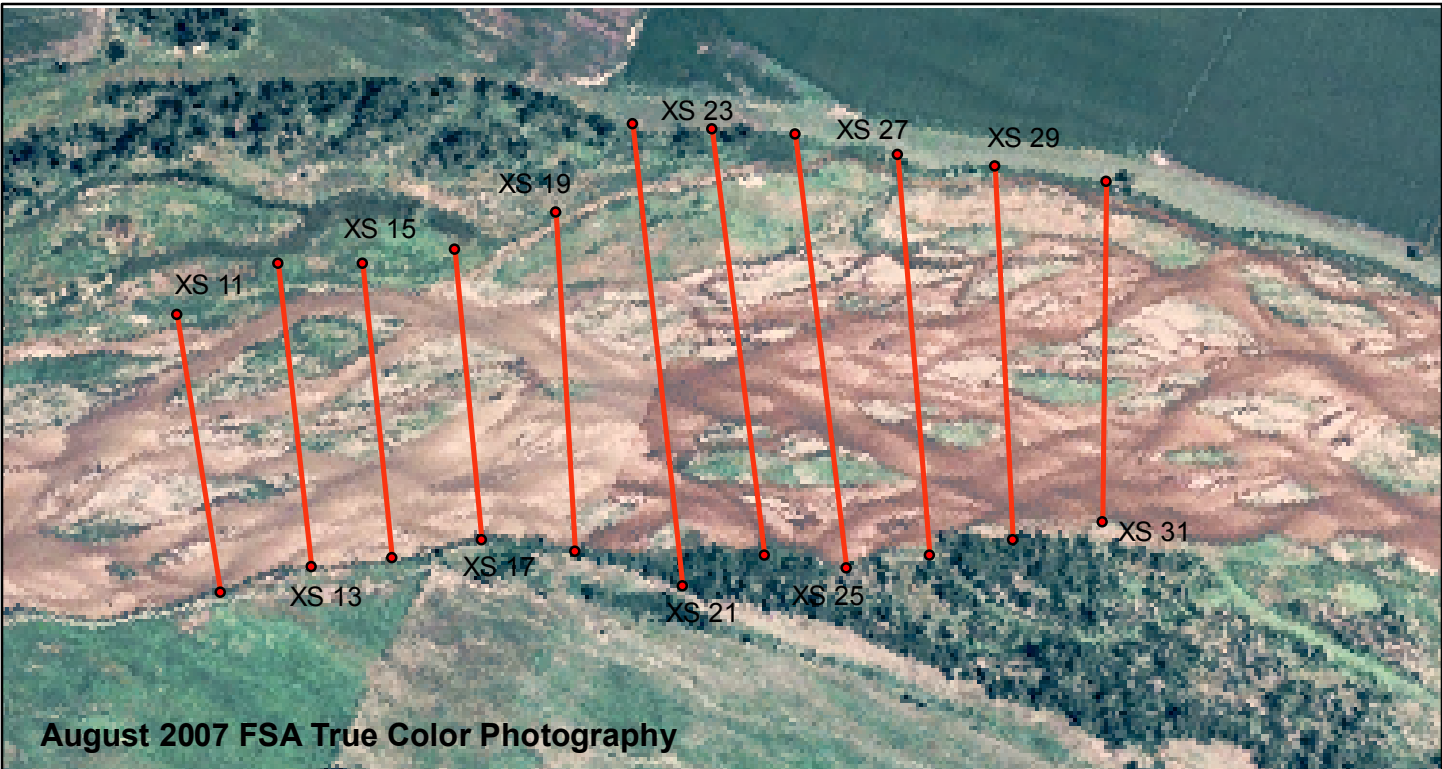
Figure C-4

ROWE SANCTUARY
TRANSECT LOCATIONS
