PLATTE RIVER RECOVERY IMPLEMENTATION PROGRAM

YEAR 2 (2010) FINAL REPORT

Channel Geomorphology and In-Channel Vegetation Monitoring of the Central Platte River

March 2011

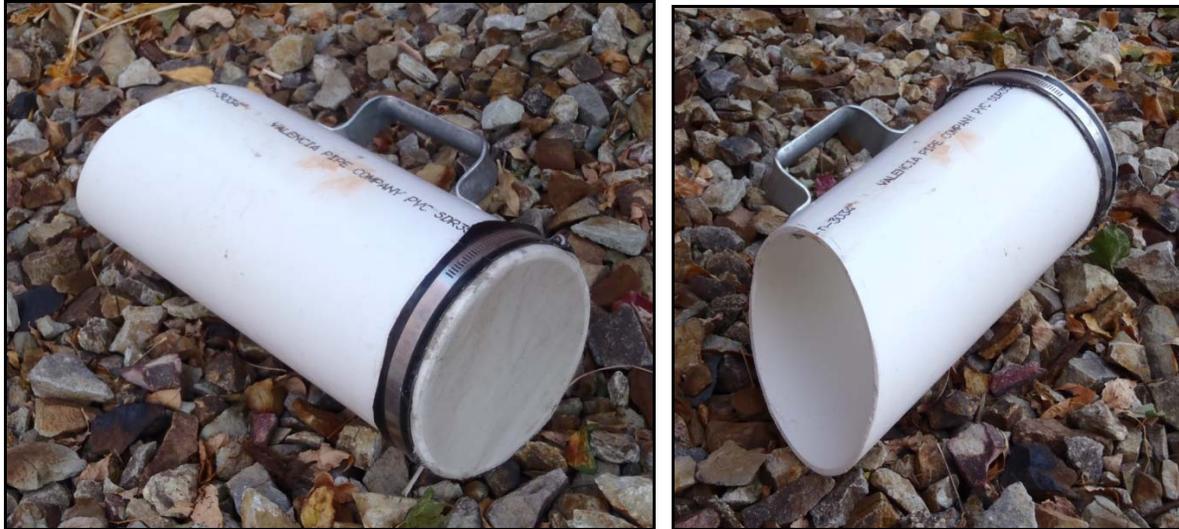
Figure 4.1. Pipe dredge used to collect bed material samples.

Based on the protocol, bed sediment samples were to be collected using a steel cylinder core sampler. However, because of the coarseness of the material, it became evident during the 2009 sampling effort that using the steel cylinder core sampler defined in the protocol was both difficult and impractical. It was extremely difficult to push or drive the core sampler into the bed and bar material and often the amount of material retrieved was small, thus requiring the need to conduct multiple samplings at the sample site. Instead, a 6-inch diameter and 12-inch long piece of PVC pipe, beveled at one end and covered with a 200 micron mesh at the other end, would be more practical for collecting bed material samples and would likely provide the same results. The pipe dredge is shown in **Figure 4.1**. The pipe dredge was pushed 6 to 8 inches deep at an angle into the bed of the channel with the opening facing upstream. The mesh at the end of the pipe allowed the water in the pipe to pass through the pipe with minimal loss of the sample material. All bed samples collected from the main channel and any secondary channels were transferred to individual sample bags that were labeled with the sampled anchor point, transect ID, sample number, and the date the sample was taken per the protocol. All sample locations were georeferenced using the Trimble GeoXT handheld GPS unit.

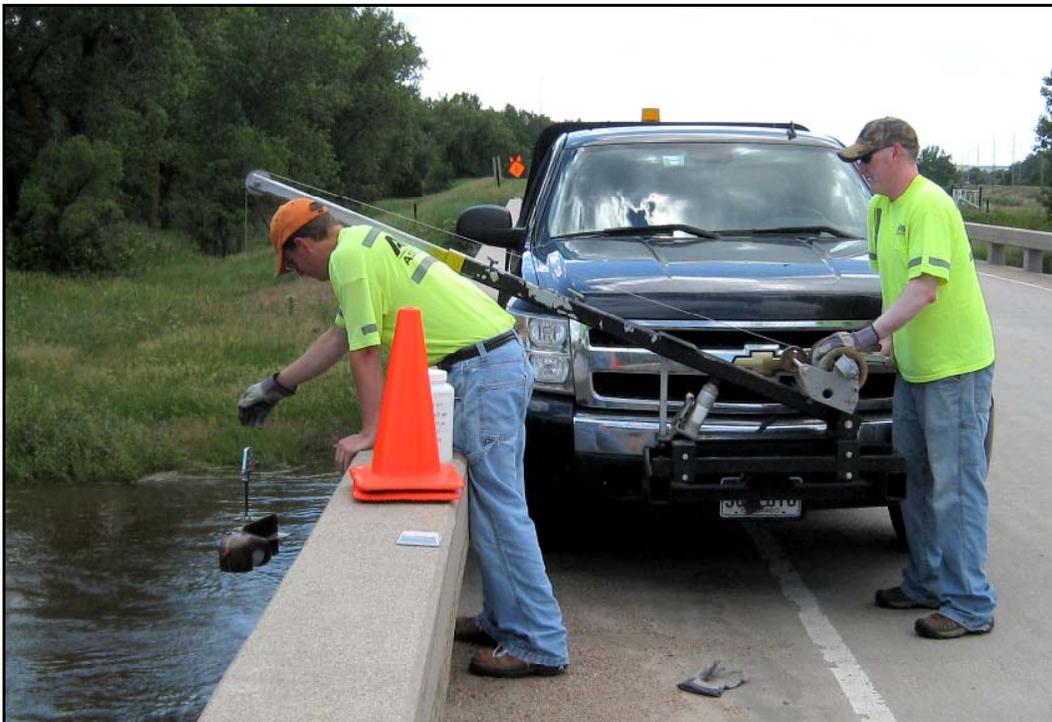
Figure 5.2. View of US DH-76 suspended sediment sampler cable suspended with a B-56 sounding reel on a truck-mounted crane system.

The 20 depth-integrated suspended sediment samples were collected at each bridge site during the >5,000 cfs flow increment using a truck mounted, cable suspended, US DH-76 sampler (**Figure 5.2**). The USGS B-56 sounding reel was again used to suspend the sampler. The samples were collected at a constant transit rate at each section. The DH-76 pint sampler bottles collected were combined into a larger container to make a single composite sample for that bridge site.
