2013 Platte River Data Analysis Report

Channel Geomorphology and In-channel Vegetation

**Platte River Recovery
Implementation Program**

August 1, 2014

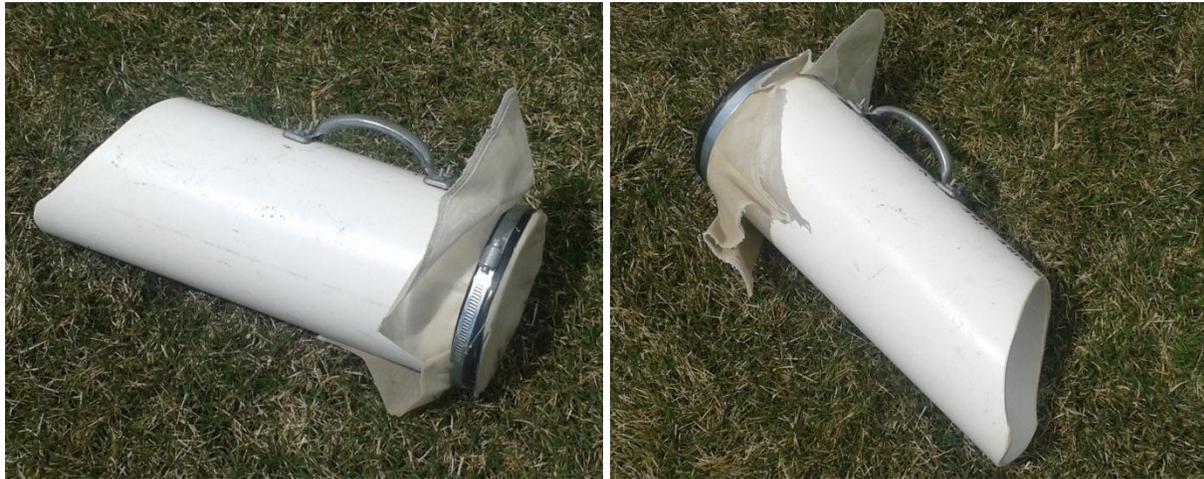
Figure 2.3. Pipe dredge used to collect bed-material samples.

Up to 10 bulk bed-material samples and at least one composite bar material sample were collected at each AP in accordance with the Monitoring Protocol. Typically, each transect was subdivided into three segments, and a representative bed material sample was collected from each segment, insuring that one sample was taken from near the thalweg and the other two taken from the lowest elevation surface in other two segments. The 2012 and 2013 samples were analyzed in Tetra Tech's Fort Collins soils laboratory to determine the particle size gradations. Samples collected by the previous contractor in 2009, 2010 and 2011 analyzed in a similar manner at a local soils laboratory. The samples were collected using a sampler constructed from a 6-inch diameter by 12-inch long PVC pipe, beveled at one end and covered with a 200-micron mesh at the other end (**Figure 2.3**). In collecting the samples, the sampler was pushed 6 to 8 inches deep at an angle into the bed of the channel at the sampling location. The resulting sample sizes for the 2013 data ranged from about 360 to 2,600 g and averaged about 840 g. Sample sizes in the earlier years were similar to the 2013 samples. Since the samples were often collected from below the water, the sampler was oriented with the opening facing upstream so that the water could drain from the sampler with minimal loss of the sample material. All bed samples collected from the main and secondary channels were transferred to individual sample bags that were labeled with the sampled AP, transect ID, sample number, and date, and the sample locations were determined using an RTK GPS roving unit.

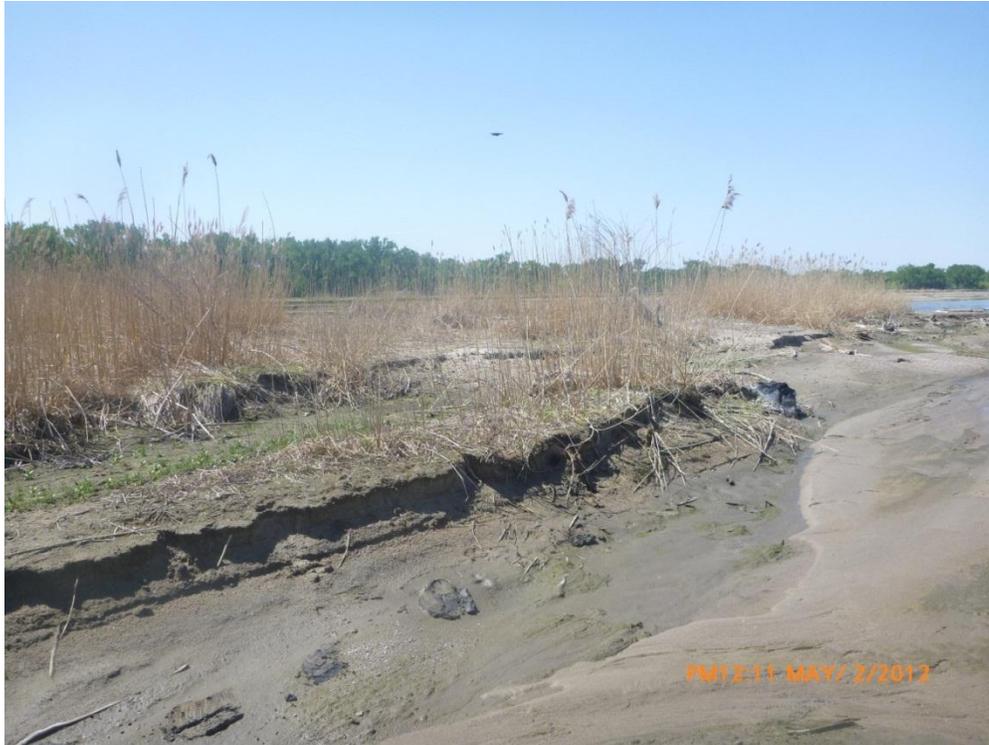
Figure 4.33. Typical lateral erosion and undercutting of the edge of a sand bar with common reed in the Elm Creek Complex.

The inundation depth at the maximum discharge (D_{max}) was selected as a surrogate for the effects of high flows, since the maximum velocities and shear stresses at the individual points are not available. A two-dimensional model has been developed for the Elm Creek Complex, however, that can provide an indication of the range of anticipated velocities for different flow depths. While the hydraulic characteristics of the APs will vary to some degree from those at the Elm Creek Complex, the range of variability in the relationship between depths and velocities is probably similar. Based on a comparison of the maximum water-surface from the existing 1-dimensional HEC-RAS model with the elevations of the individual quadrats that contained common reed, about 27 percent of the quadrats were not inundated during the growing season in 2009; this decreased to only 3 percent in 2010 and 7 percent in 2011, and then increased to 74 percent in 2012 and 54 percent in 2013 (**Figure 4.31**). About ten percent of the quadrates containing common reed were inundated to a depth of at least 1.2 feet in 2009, 2.7 feet in 2010, 2.6 feet in 2011, and 0.7 feet in 2012 and 1.6 feet in 2013 (see 90% grid line in Figure 4.9). Based on results from the Elm Creek 2D model, maximum velocities at locations with depths in this range are about 6 fps, and most areas have velocities between 1.5 and 4 fps (**Figure 4.32**). Pollen-Bankhead et al. (2011) found that very high velocities, well above those that occur in the Platte River, are required to uproot established common reed plants (**Figure 4.33**); thus, it is unlikely that this process is responsible for the reduction in common reed during the monitoring period. If common reed is removed by the direct action of the water, the most likely process is through lateral erosion and undercutting of the sandbars and banklines on which the plants are growing (**Figure 4.34**). While this does occur in the study reach, field observations indicate that it occurs only in limited areas, primarily on the heads, and to a lesser extent along the margins of, sand bars. The thick, rhizomatous root structure appears to be very effective in binding the soil and limiting the rate and magnitude of lateral erosion and undercutting in areas where common reed is abundant.
