# **Platte River Recovery Implementation Program (PRRIP)**

## **SYSTEM-SCALE GEOMORPHOLOGY AND VEGETATION MONITORING REPORT**

**2017 - 2020**

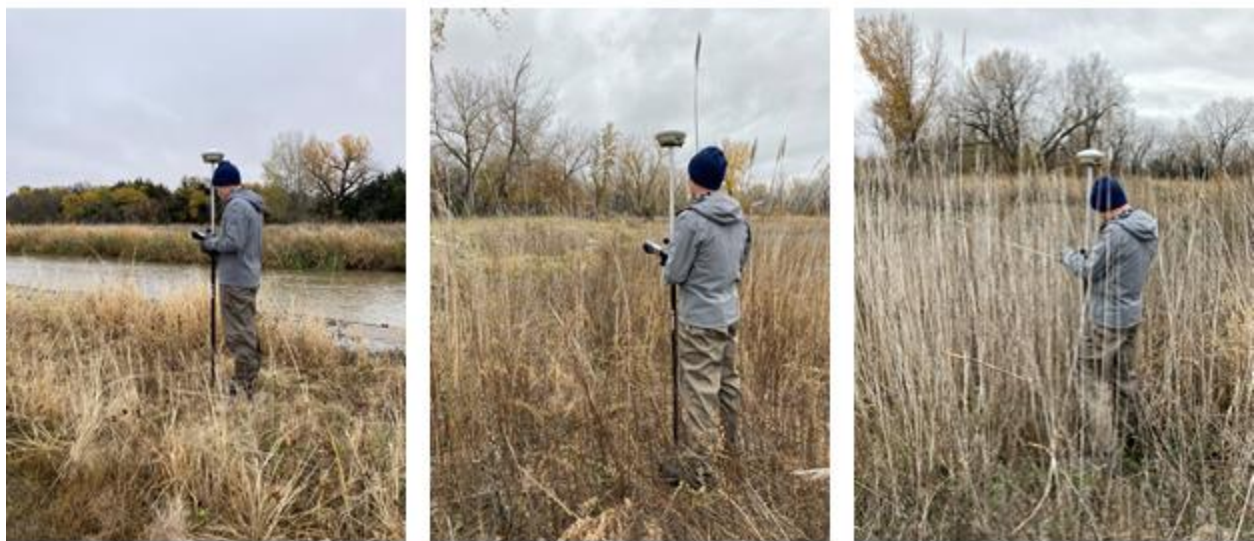
**Figure 17.** Three patches of in-channel grass observed on the Platte in November of 2021 with variable height, density, and color. Researcher is 6 ft tall.

The systematic difference between visual and object-based classification may in part due to the lack of elevation or vegetation height data in the visual classification methods. Visual observers rely primarily on vegetation density to interpret vegetation height. One land cover that exemplifies potential problems with this method is grass. In-channel grasses on the Platte may range from 0-6 ft tall and at any height may be highly variable in color and density (Figure 17). Determining whether each patch is greater or less than 2 ft based on visual interpretation of aerial imagery alone is inherently subjective.
