## Nebraska Public Power District

### **RE: Recharge Analysis for Temporary appropriations A-19607 and A-19608**

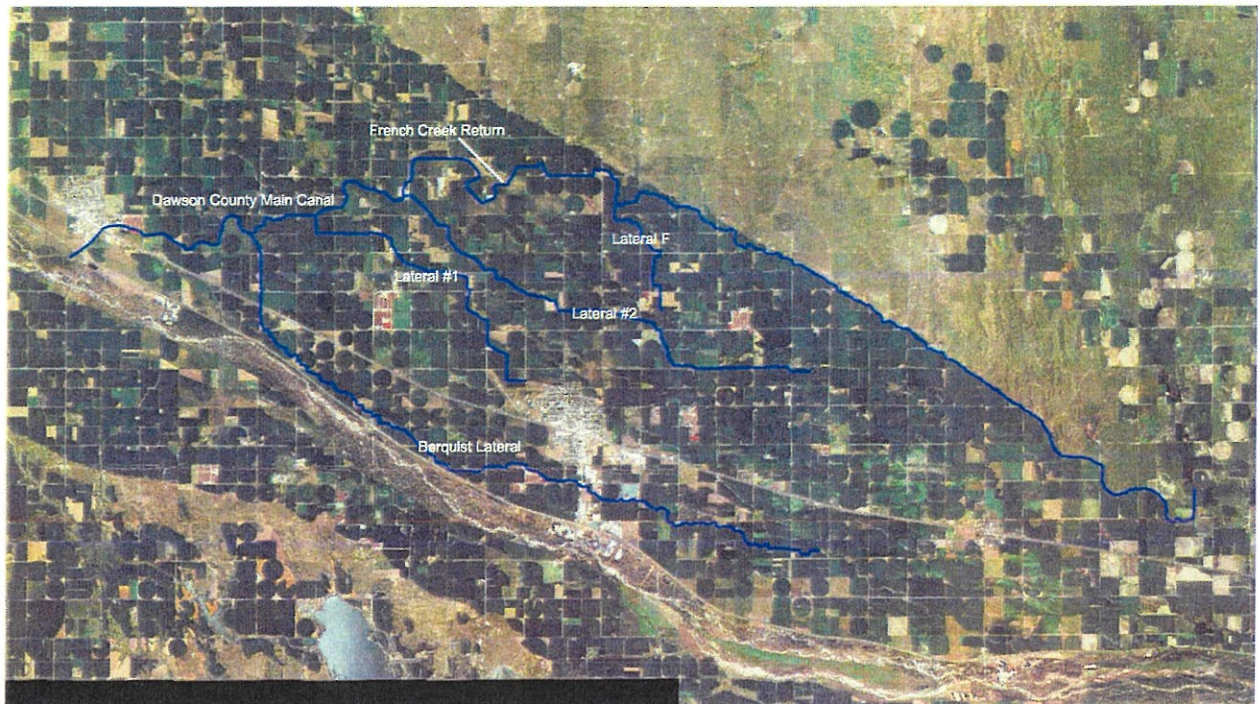
The portions of the canal which recharged groundwater during this period can be found on the map below.

The Gothenburg Canal ceased operating for irrigation needs on September 7, 2018. Subsequently, water was diverted into the canal for groundwater recharge as shown below. Note that on September 10, only laterals were used while the main canal was used for delivering water to Central Platte NRD's B-1 Reservoir. There was a total of 617 AF of water recharged.

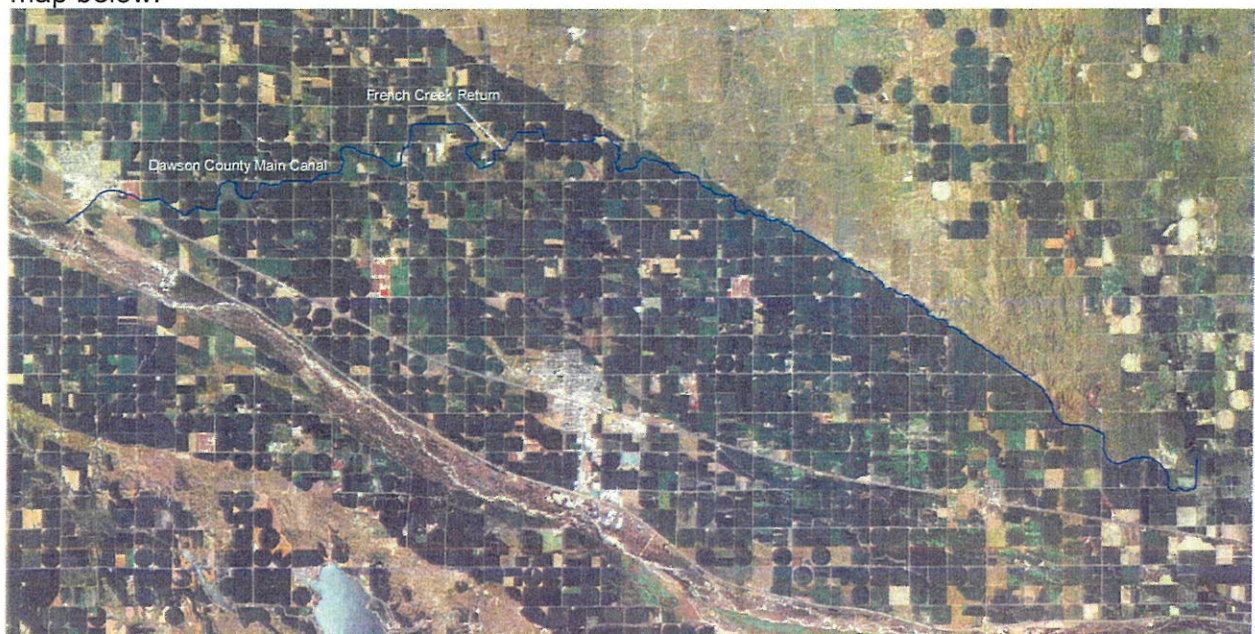
The portions of the canal which recharged groundwater during this period can be found on the map below.

The Dawson County Canal began operating for groundwater recharge on April 8, 2019 as shown below. It began irrigation operations on April 22, 2019. There was a total of 479 AF of water recharged.
