# MEMORANDUM

ANDERSON CONSULTING ENGINEERS, INC.  
Civil • Water Resources • Environmental

**DATE:** January 21, 2015 **ACE PROJECT NO.:** NEHEADWATERS04-04  
**TO:** Jerry Kenny, Headwaters Corporation  
**FROM:** Michelle Martin, P.E., Anderson Consulting Engineers, Inc.  
Brad Anderson, P.E., Anderson Consulting Engineers, Inc.  
**SUBJECT:** North Platte Choke Point: Investigation of Channel Modifications Upstream of Highway 83

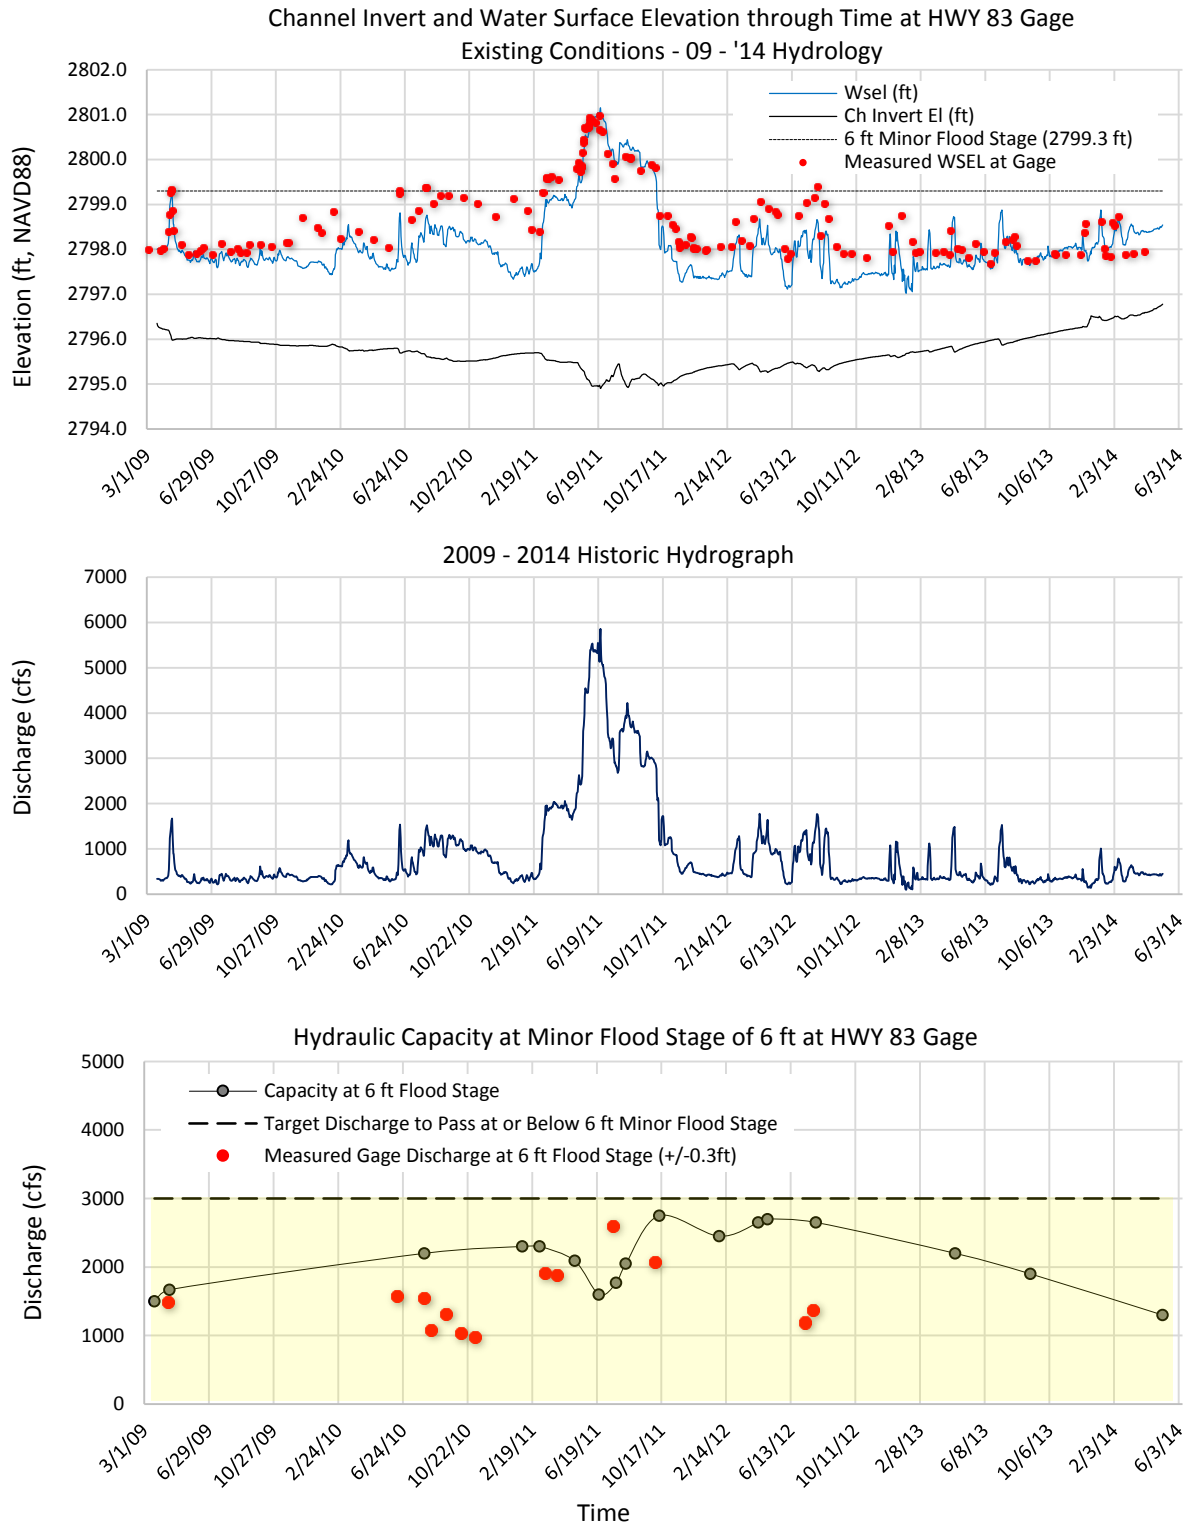
Figure 2 compares the computed water surface elevation with measured data at the HWY 83 gage, along with the 2009 to 2014 historic hydrograph, and a plot of hydraulic capacity at flood stage also compared with gage data. More detailed model results are provided in Figures A-1 through A-3 provided in Attachment A. Results of the sediment transport modeling for Run 1 indicate that the model provides a reasonably accurate simulation of changes in water surface elevation and hydraulic capacity at the HWY 83 gage.

At the start of the simulation, hydraulic capacity (at 6-foot flood stage) is approximately 1,500 cfs, increasing to 2,300 cfs at the start of the 2011 flood. At the peak of the 2011 flood, sediment deposition reduces flood capacity to 1,600 cfs. On the receding limb of the 2011 flood hydrograph, hydraulic capacity increases to a high of 2,750 cfs. This compares well with gage data and observation of 2,600 cfs. Following the flood, model results show that the hydraulic capacity is steadily reduced to 1,500 cfs over a 2-year period. Gage data indicates that the capacity was diminished to approximately 1,100 cfs within one year of the 2011 flood. The model is able to reproduce changes in hydraulic capacity with reasonable accuracy, however, the temporal rate of change is noticeably different than the field observations. Channel response in the model appears to occur at a slower rate than what has been observed in the field. This could be attributed to use of a standard sediment transport equation, coarsening of the bed material, changes in upstream sediment sources, or changes in channel geometry that may have occurred after the 2009 LiDAR was collected.

**Figure 2. Run 1-Existing Condition 2009 to 2014 Hydrology, 2009 to 2014 Historic Hydrograph (top), Hydraulic Capacity at Minor Flood Stage at HWY 83 Gage (bottom).**

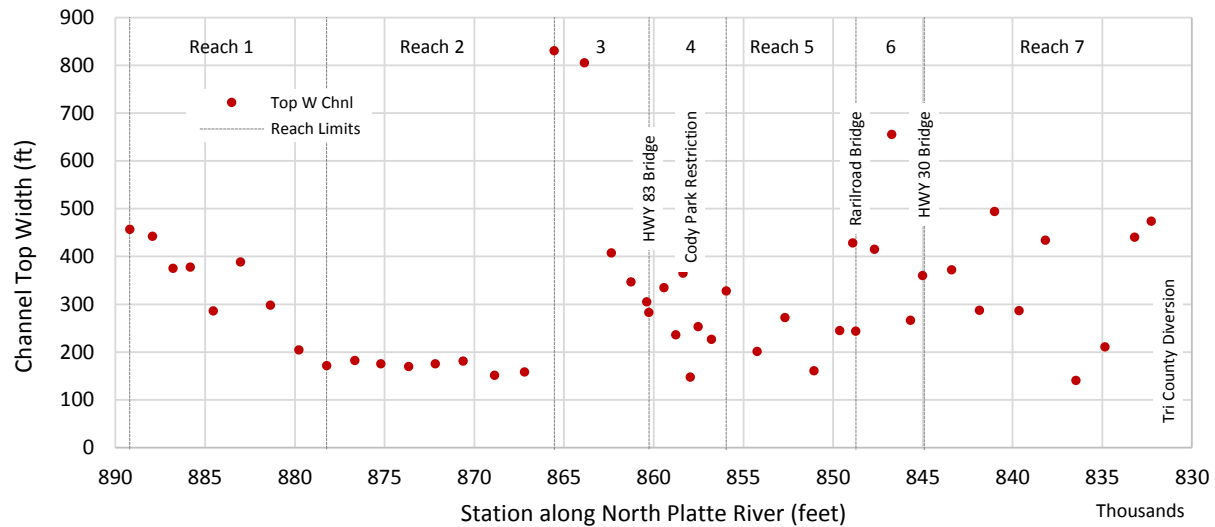
Figure 3. North Platte River Channel Top Width through Choke Point Study Reaches

The Choke Point study reach was split into seven SIAM reaches based upon planform geometry, location of hydraulic structures, and changes in hydraulic parameters (e.g., streampower, shear stress, velocity, etc.). Choke Point SIAM reaches are summarized in Table 2 and illustrated in Figure 1. A plan view map of each reach is provided in Figures B-1 through B-7 in Attachment B. During review of hydraulic parameters and plan view geometry, it was noted that SIAM Reach 2 seemed to stand out when compared against other reaches. In particular, SIAM Reach 2 has an extremely narrow, single-threaded channel with an average width of 170 feet. This is distinctly different from other reaches in that SIAM Reach 2 does not have any mid-channel bars or braiding and is almost half as narrow as all other reaches, see Figure 3.

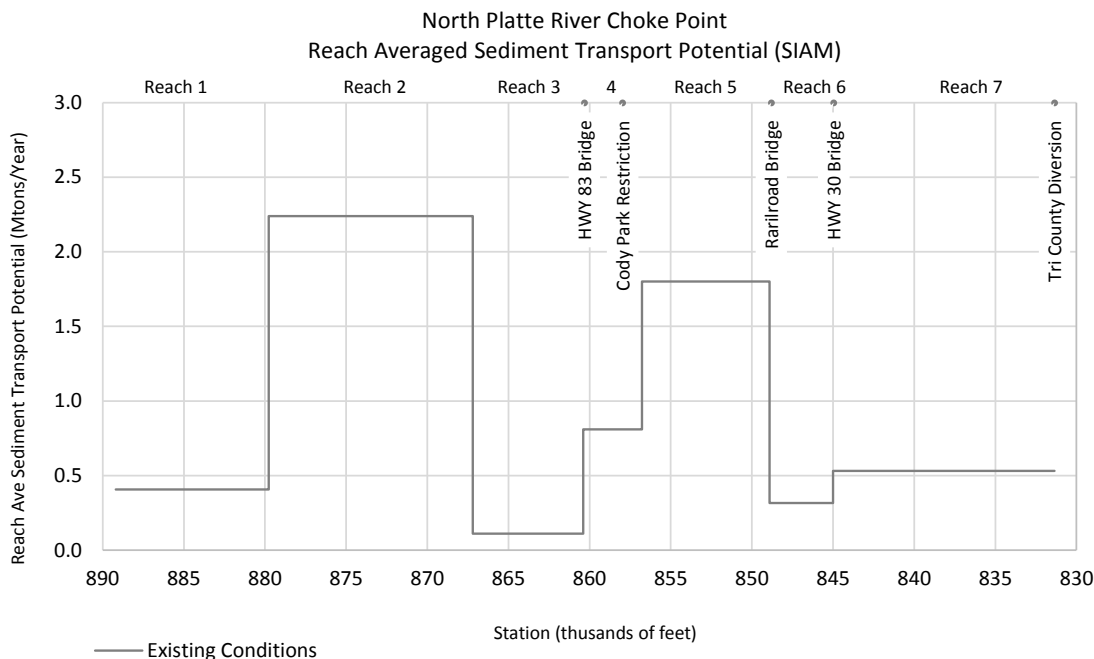
Estimated reach-average sediment transport capacity computed using SIAM is shown graphically in Figure 4. The transport capacity of SIAM Reach 2 is extremely high when compared with surrounding reaches (it is 5.5 times higher than SIAM Reach 1, 20 times higher than SIAM Reach 3, and 3 times higher than SIAM Reach 4). Assuming an availability of sediment supply, SIAM Reach 2 is acting as a transport and supply reach to depositional reaches located both upstream and downstream of Highway 83. The imbalance of transport capacity is likely contributing to deposition occurring through the Highway 83 Bridge and downstream through the Cody Park Restriction. The transport capacity imbalance can explain why channel improvement alternatives downstream of Highway 83 were ineffective at maintaining long-term hydraulic capacity. Previous analyses conducted in 2012 attempted to increase the transport capacity between Highway 83 and the Cody Park Restriction, however increases were not enough to overcome the large amounts of sediment that Reach 2 is capable of moving. It is evident that reduction in the transport capacity in Reach 2 would need to be achieved in order to maintain hydraulic capacity at flood stage downstream of Highway 83. Furthermore, reduced transport capacity in Reach 2 would likely need to be coupled with improvements downstream of Highway 83.

**Figure 4. North Platte River Choke Point Reach-Averaged Sediment Transport Potential**

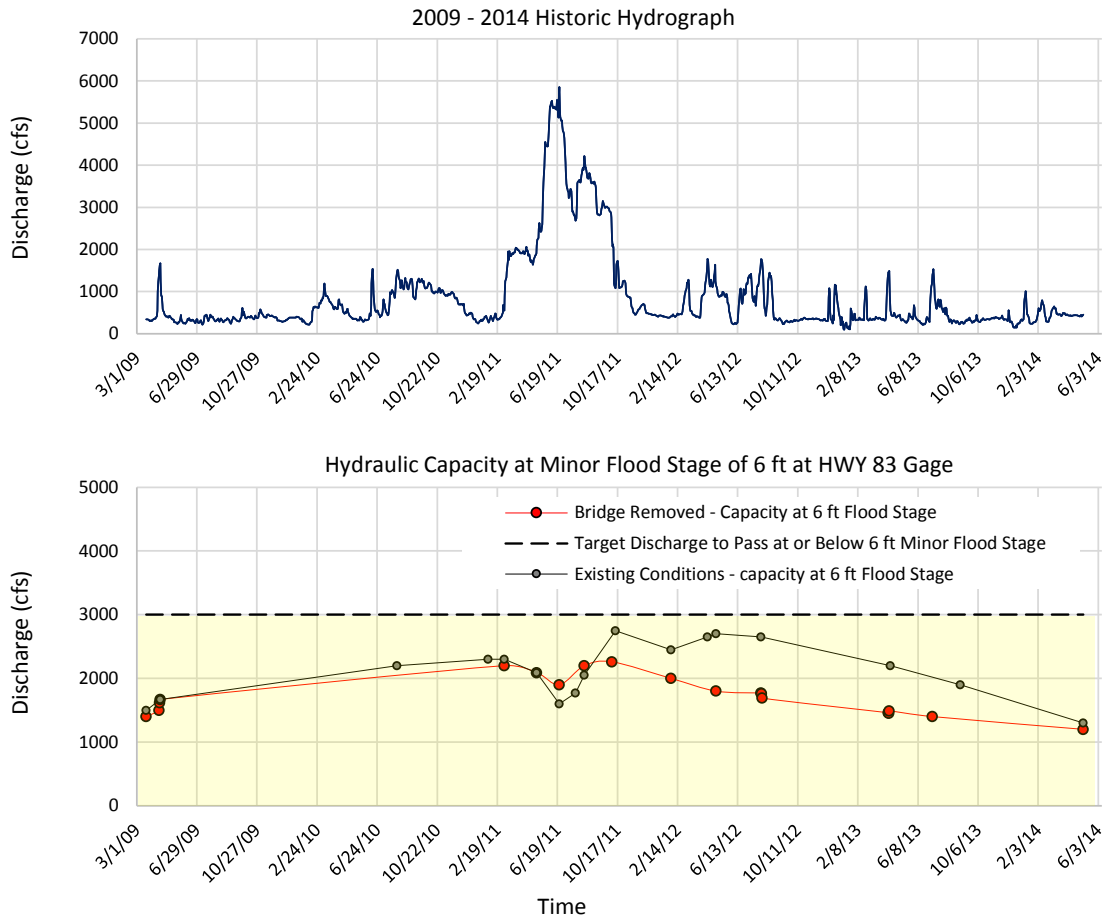
Figure 5. Run 2 HWY 83 Bridge Removed - 2009 to 2014 Historic Hydrograph (top) and Hydraulic Capacity at Minor Flood Stage at HWY 83 Gage for Existing Conditions and Removal of the Highway 83 Bridge (bottom).

There has been uncertainty about the impact of the Highway 83 Bridge on the sediment transport and the diminishing of hydraulic capacity. Consequently, the Highway 83 Bridge was removed from the model geometry and a simulation conducted with the 2009 to 2014 historic hydrograph. Figure 5 shows the 2009 - 2014 hydrograph along with a comparison of the computed hydraulic capacity at minor flood stage for existing conditions and removal of the Highway 83 Bridge. More detailed model results are provided in Figures A-4 through A-6 provided in Attachment A. Results indicate that removal of the bridge does not improve hydraulic capacity relative to existing conditions. The bridge provides some constriction of flow which actually increases sediment transport allowing for some scour through the bridge near the gage during the 2011 flood. Removal of the bridge would reduce transport capacity and would not

improve hydraulic capacity at minor flood stage. Removal or modification to the Highway 83 bridge is not a feasible solution to hydraulic capacity issues, therefore further modeling of Highway 83 Bridge removal was not pursued.

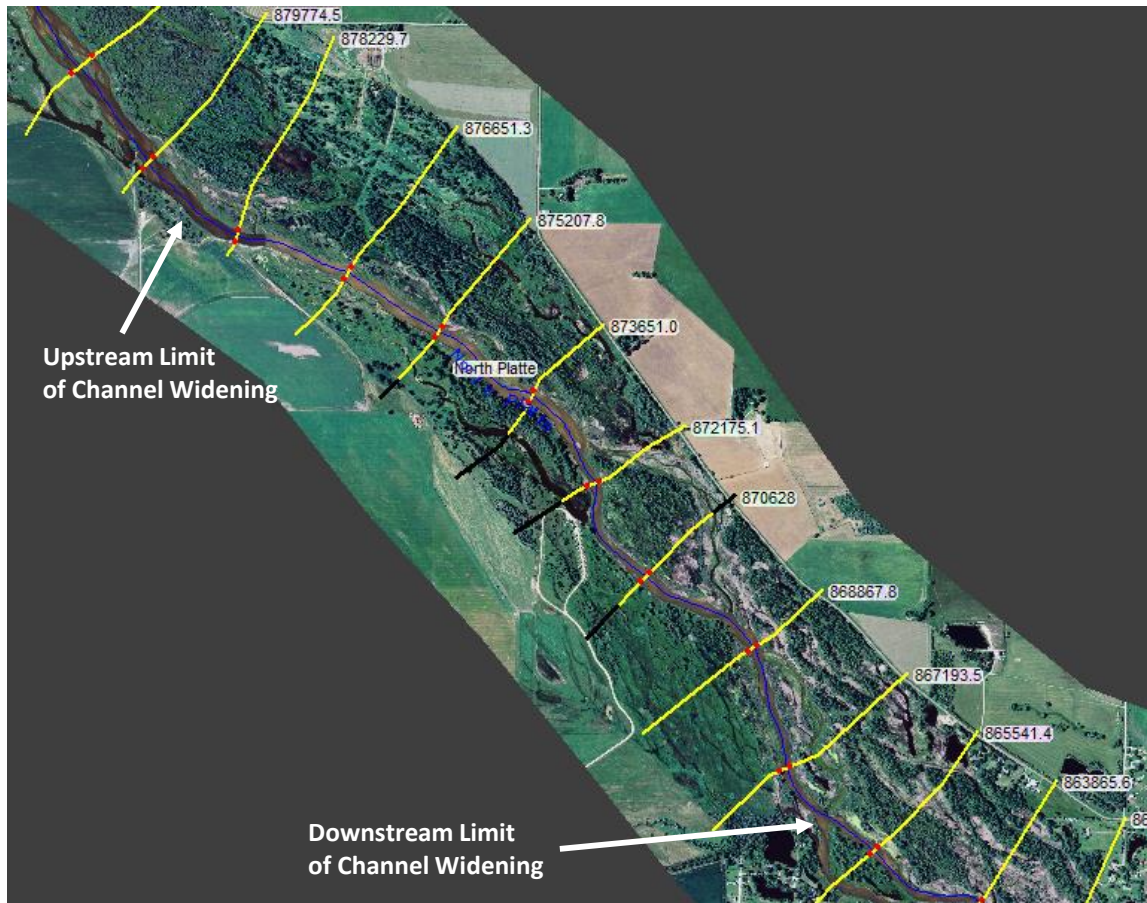
Figure 6. Limits of Channel Widening upstream of Highway 83. Channel would be widened to 350 feet.

Channel modifications along SIAM Reach 2, located upstream of Highway 83, are proposed in order to reduce sediment transport capacity of the reach. Channel modifications include widening of the channel to 350 feet along with some channel excavation to create a more constant channel slope. Channel widening was simulated between stations 878229 to 867193, see Figure 6. Modification to the channel slope is shown graphically in Figure 7. Reach-average sediment transport capacity for the channel modification was computed using SIAM and compared with existing conditions, see Figure 8. Proposed channel modifications upstream of Highway 83 reflect a reduction in transport potential in Reach 2 of approximately 75%. To further evaluate the effect of channel modification upstream of Highway 83 on hydraulic capacity, a 1D sediment transport model simulation was conducted and the results presented in the following section.

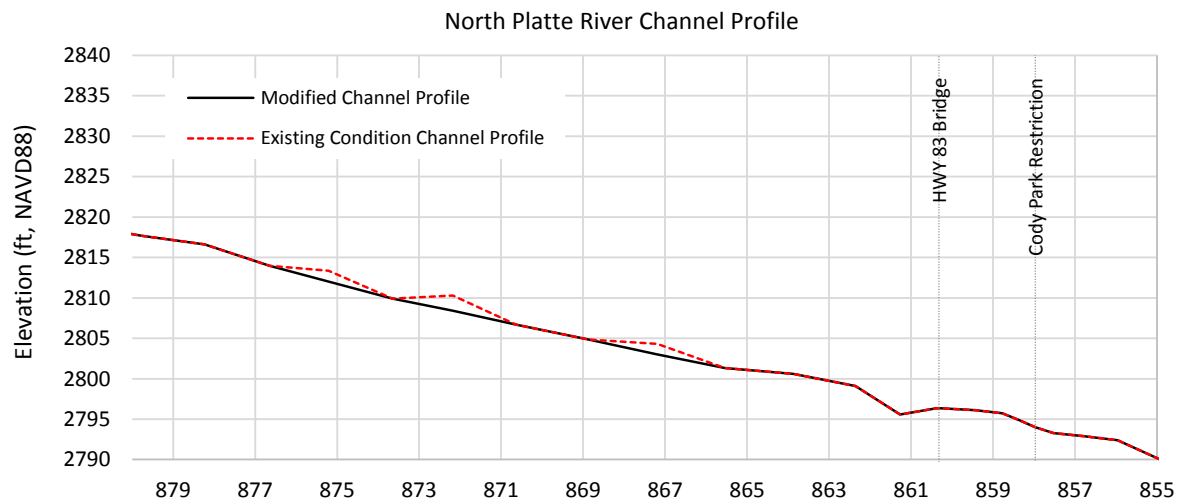
Figure 7. North Platte River Channel Profile – Existing and Modified Conditions Upstream of Highway 83

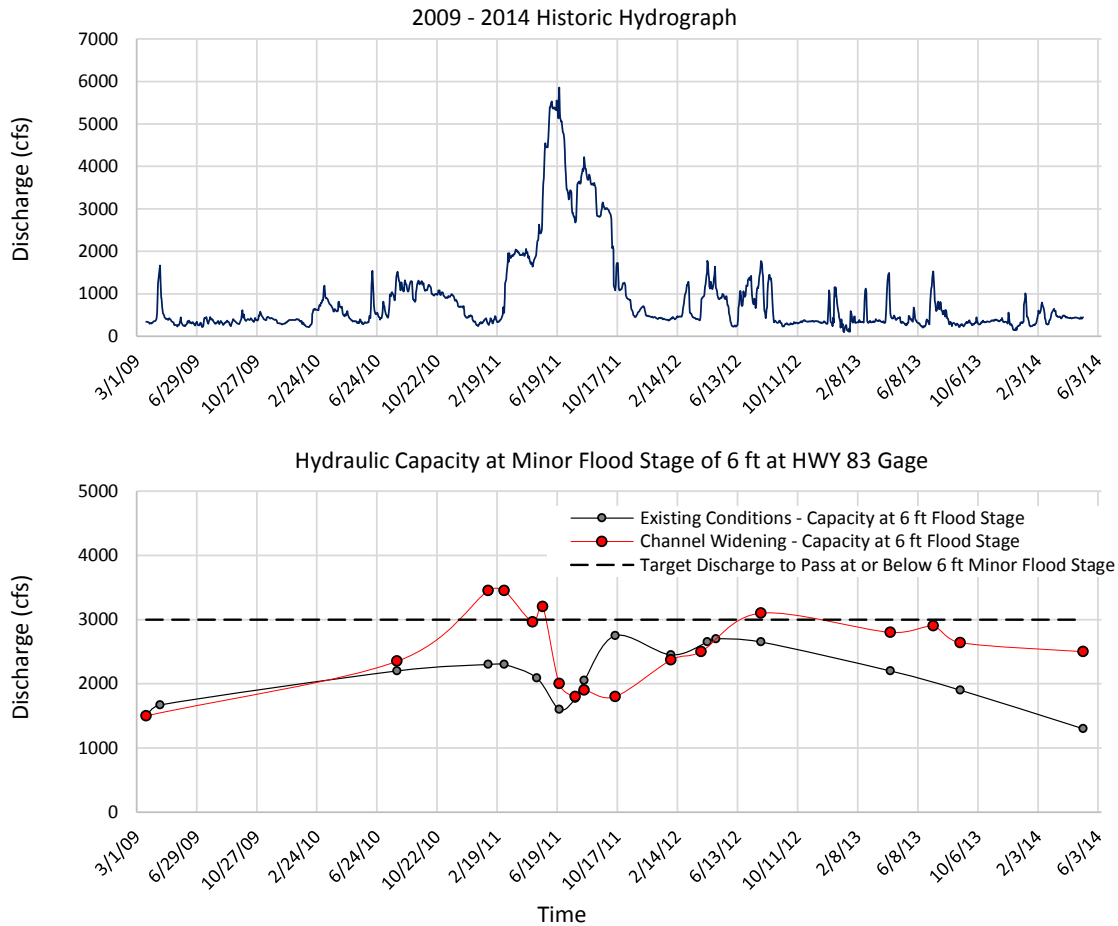
**Figure 9. Run 3-Alternative C, Channel Widening Upstream of Highway 83 - 2009 to 2014 Historic Hydrograph (top) and Hydraulic Capacity at Minor Flood Stage at HWY 83 Gage for Existing Conditions and Channel Widening Upstream of Highway 83 (bottom).**

Run 3 was conducted to determine if channel modifications upstream of Highway 83 were capable of reducing the transport capacity upstream of Highway 83 and thus decreasing the sediment load to reaches downstream of Highway 83 under 2009 to 2014 hydrologic conditions. Figure 9 shows the 2009 to 2014 historic hydrograph along with a comparison of the computed hydraulic capacity at minor flood stage for existing conditions and channel widening upstream of Highway 83. More detailed model results are provided in Figures A-7 through A-9 provided in Attachment A. Results show that hydraulic capacity is increased to 3,450 cfs prior to the 2011 flood event. At the peak of the flood, capacity is reduced to 2,000 cfs but recovers back to 3,000 cfs within a year after the flood. Hydraulic capacity then dips below 3,000 cfs for the remainder of the simulation. Reduction in the transport capacity of the reach upstream of Highway 83 where channel modifications are made results in deposition occurring in that reach by the end of the 5-year simulation. Figure 10 shows the cumulative mass bed change over the simulation period for existing conditions and Alternative C. The reach upstream of Highway 83 is generally degradational (indicated on the figure by a negative number). The results reflect that reaches upstream have become generally aggradational, indicating that there has been a reduction in transport capacity in Reach 2. Channel improvements upstream of Highway 83 alone will not meet the target objective. However, channel improvements upstream of Highway 83 combined with alternatives downstream of Highway 83 may be able to achieve long-term hydraulic capacity objectives.

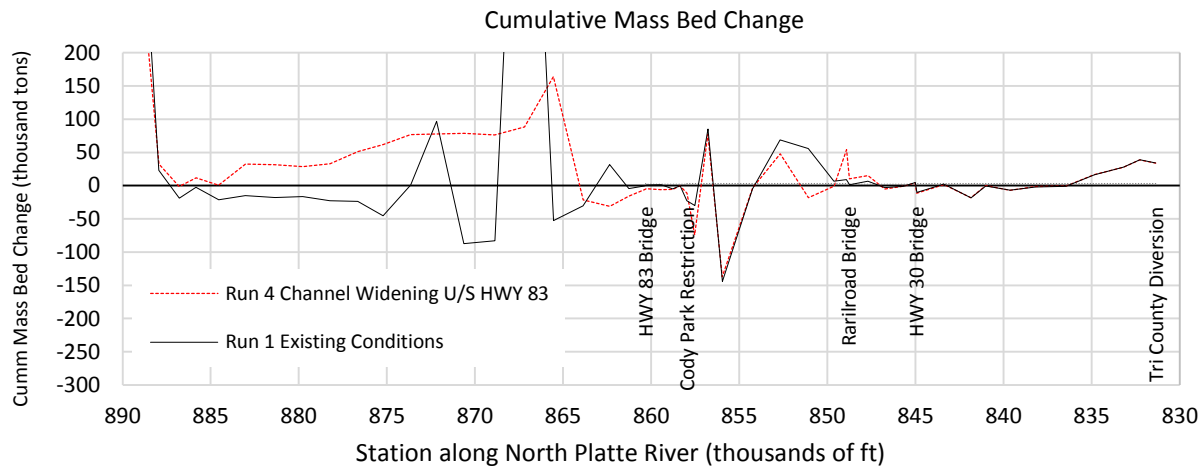
**Figure 10. Cumulative Mass Bed Change 2009 – 2014 Hydrograph, Existing Conditions vs Alternative C-Channel Widening**

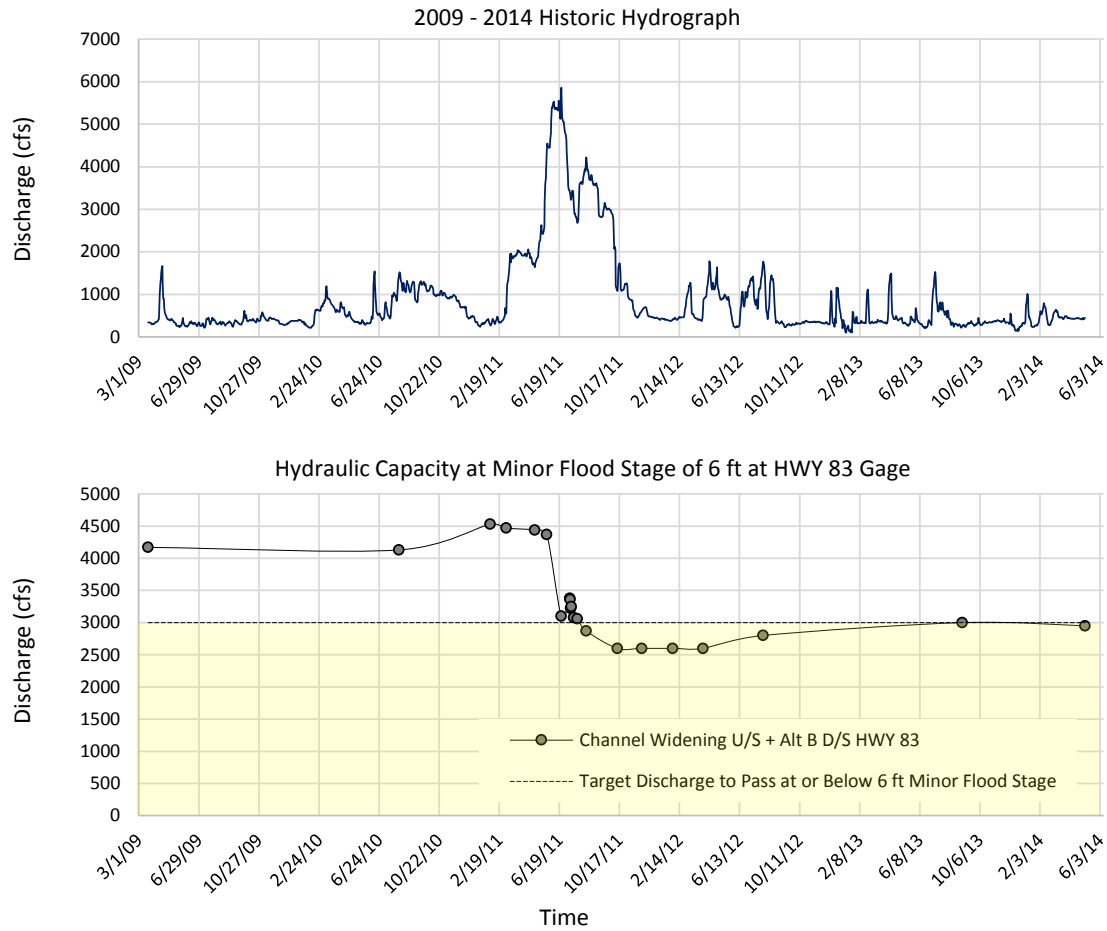
This run was conducted to determine the effectiveness of this combination of channel improvements under the 2009 to 2014 hydrologic conditions. Figure 12 shows the 2009 to 2014 historic hydrograph along with a comparison of the hydraulic capacity at minor flood stage computed by the 1D sediment transport model. More detailed model results are provided in Figures A-10 through A-12 provided in Attachment A. Initial hydraulic capacity is 4,200 cfs due to dredging and channel widening associated with Alternative D downstream of Highway 83. Hydraulic capacity is increased to 4,500 cfs at the start of the 2011 flood. At the peak of the flood capacity is reduced to 3,000 cfs and decreases to 2,600 cfs during the receding limb of the flood. However, hydraulic capacity recovers to 3,000 cfs approximately 2 years after the flood event.

**Figure 12. Run 4-Alternative D, Channel Widening Upstream of Highway 83 + Dredging Downstream of Highway 83 (2009 to 2014 Historic Hydrograph) (top) and Hydraulic Capacity at Minor Flood Stage at HWY 83 Gage (bottom).**

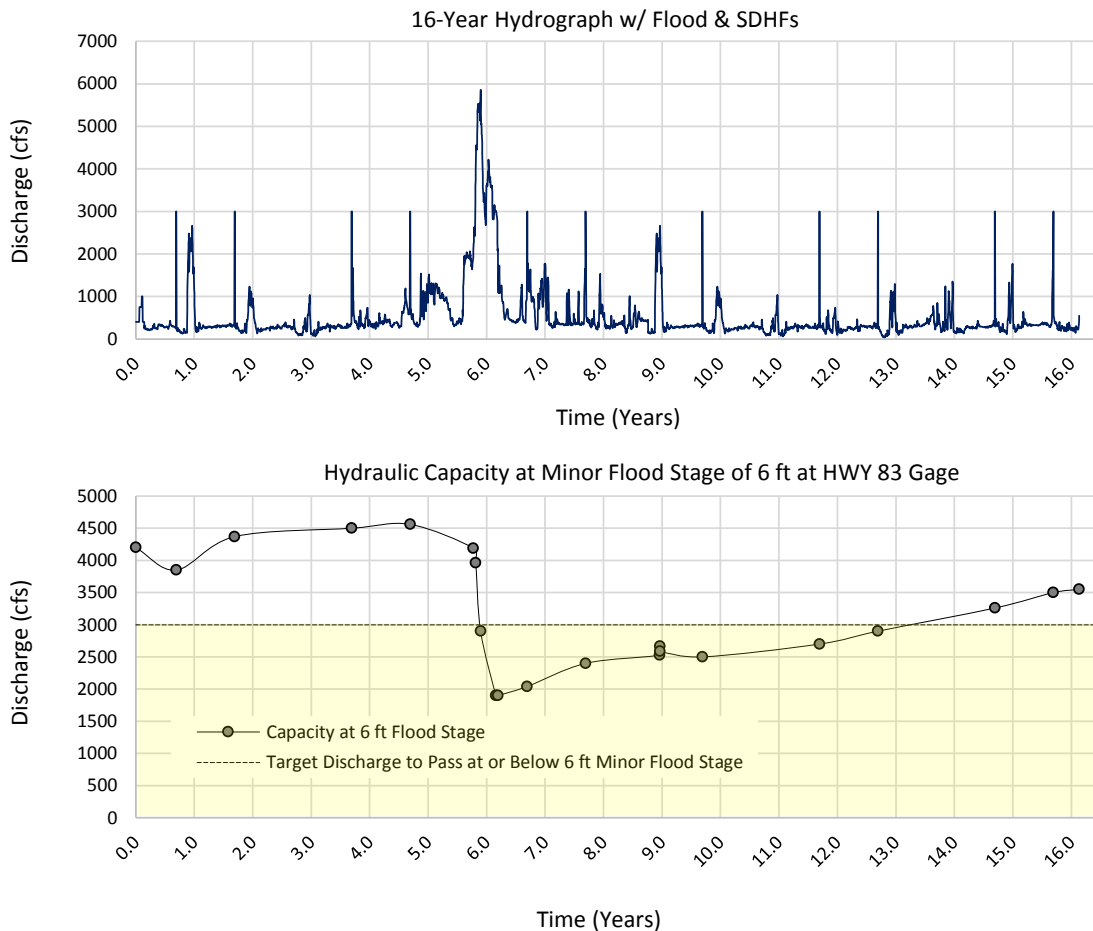
This simulation was conducted to determine the long-term performance of combined improvements under hydrologic conditions that consider both SDHFs and flood conditions. Figure 14 shows the 16-year hydrograph with the 2011 flood and SDHFs along with the computed hydraulic capacity at minor flood stage for channel widening upstream of Highway 83 and dredging downstream of Highway 83. More detailed model results are provided in Figures A-13 – A-16 provided in Attachment A. Initial hydraulic capacity is 4,200 cfs due to dredging and channel widening downstream of Highway 83. Hydraulic capacity is increased to 4,500 cfs by year five prior to the flood. At the peak of the flood, occurring around year

six, hydraulic capacity is reduced to approximately 2,000 cfs. After the flood, hydraulic capacity steadily increases to 3,000 cfs by year thirteen. This scenario is not able to maintain the hydraulic capacity objective after the occurrence of 2011 flooding. This would mean that additional channel maintenance would be required after significant flood events.

**Figure 14. Run 5-Alternative D, Channel Widening Upstream of Highway 83 + Dredging Downstream of Highway 83 - 16-Year Hydrograph with Flood and SDHFs (top) and Hydraulic Capacity at Minor Flood Stage for Channel Widening Upstream of Highway 83 + Dredging Downstream of Highway 83 (bottom).**

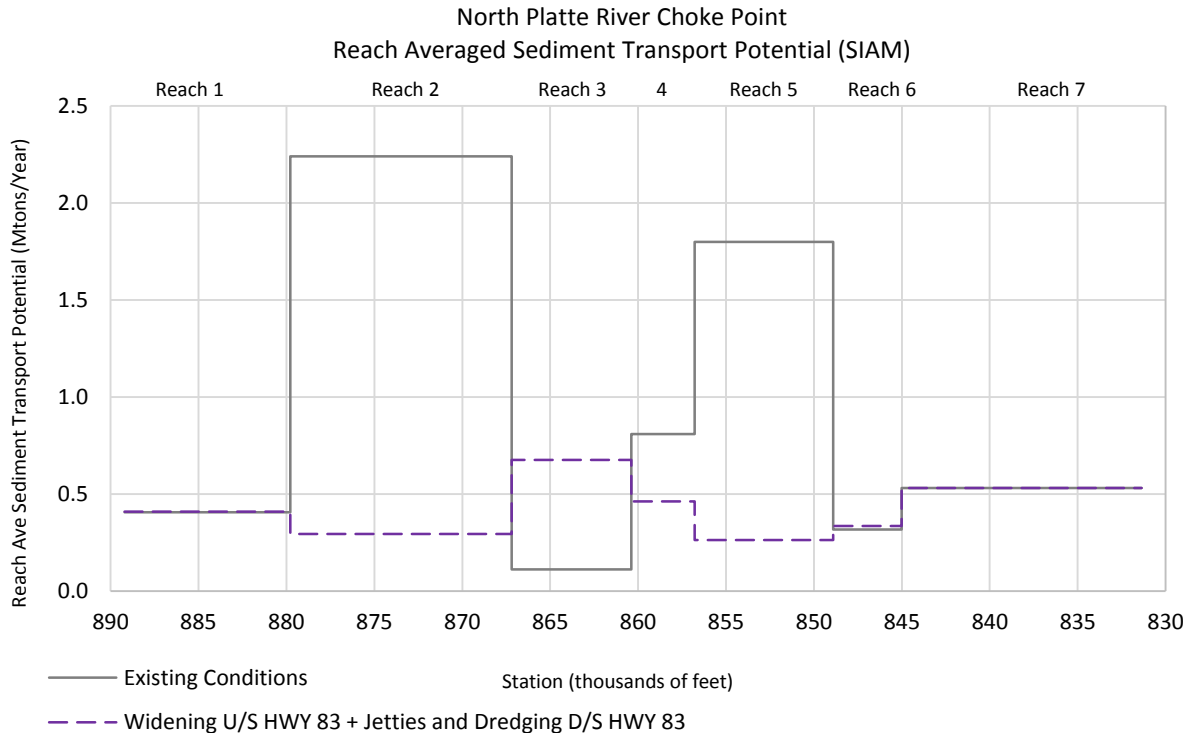
Reach-average sediment transport capacity for the channel modifications associated with Alternative E was computed using SIAM and compared with existing conditions, see Figure 17. Proposed channel modifications upstream of Highway 83 reflect a reduction in transport potential in Reach 2 of approximately 75%. Transport capacity has been significantly increased in Reach 3. A decrease in capacity is noted in Reaches 4 and 5. Note that the combination of improvements associated with Alternative E have resulted in a homogenization or evening out of sediment transport capacity throughout the length of the study reach. Consistency in the rate of sediment transport potential from reach to reach should result in a more balanced system.

**Figure 17. North Platte River Choke Point Reach-Averaged Sediment Transport Potential, Existing vs Alternative D (Widening U/S HWY 83 + Jetties and Dredging D/S HWY 83).**

This simulation was conducted to determine the long-term performance of Alternative E combined improvements under hydrologic conditions that consider both SDHFs and historic flooding. Figure 18 shows the 16-year hydrograph with the 2011 flood and SDHFs along with the computed hydraulic capacity at minor flood stage for Alternative E. More detailed model results are provided in Figures A-17 – A-20 provided in Attachment A. Initial hydraulic capacity is 3,200 cfs, which is due to the placement of jetties/bendway weirs, dredging and channel widening downstream of Highway 83. Hydraulic capacity is increased to 5,000 cfs between year five and six just prior to the flood. At the peak of the flood, occurring around year six, hydraulic capacity is reduced to approximately 3,200 cfs. Within 2 years after the flood hydraulic capacity steadily increases up to 4,700 cfs and remains above 4,000 cfs for the remainder of the 16-year period. The Alternative E improvements are able to meet and maintain the hydraulic capacity target over the long-term simulation. This is attributed to the combination of reduced hydraulic capacity upstream of the Highway 83 and increased capacity by use of jetties/bendway weirs downstream of Highway 83, see Figure 17.

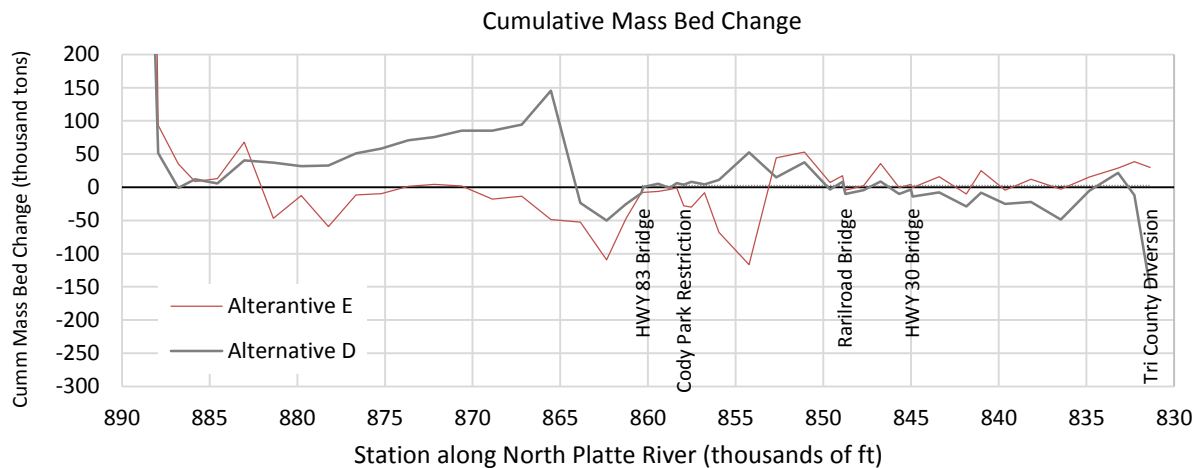
Figure 19 shows the cumulative mass bed change over the simulation period for Alternative E compared with Alternative D. Figure 19 indicates that Reaches 2, 3, and 4 are at equilibrium or degradational (indicated on the figure by a negative number). This is attributed to the consistency in transport capacity upstream and downstream of Highway 83 resulting in a more balanced system.

**Figure 19 Cumulative Mass Bed Change – Comparison of Alternative D and Alternative E 16-Year Hydrograph w/ SDHFs**

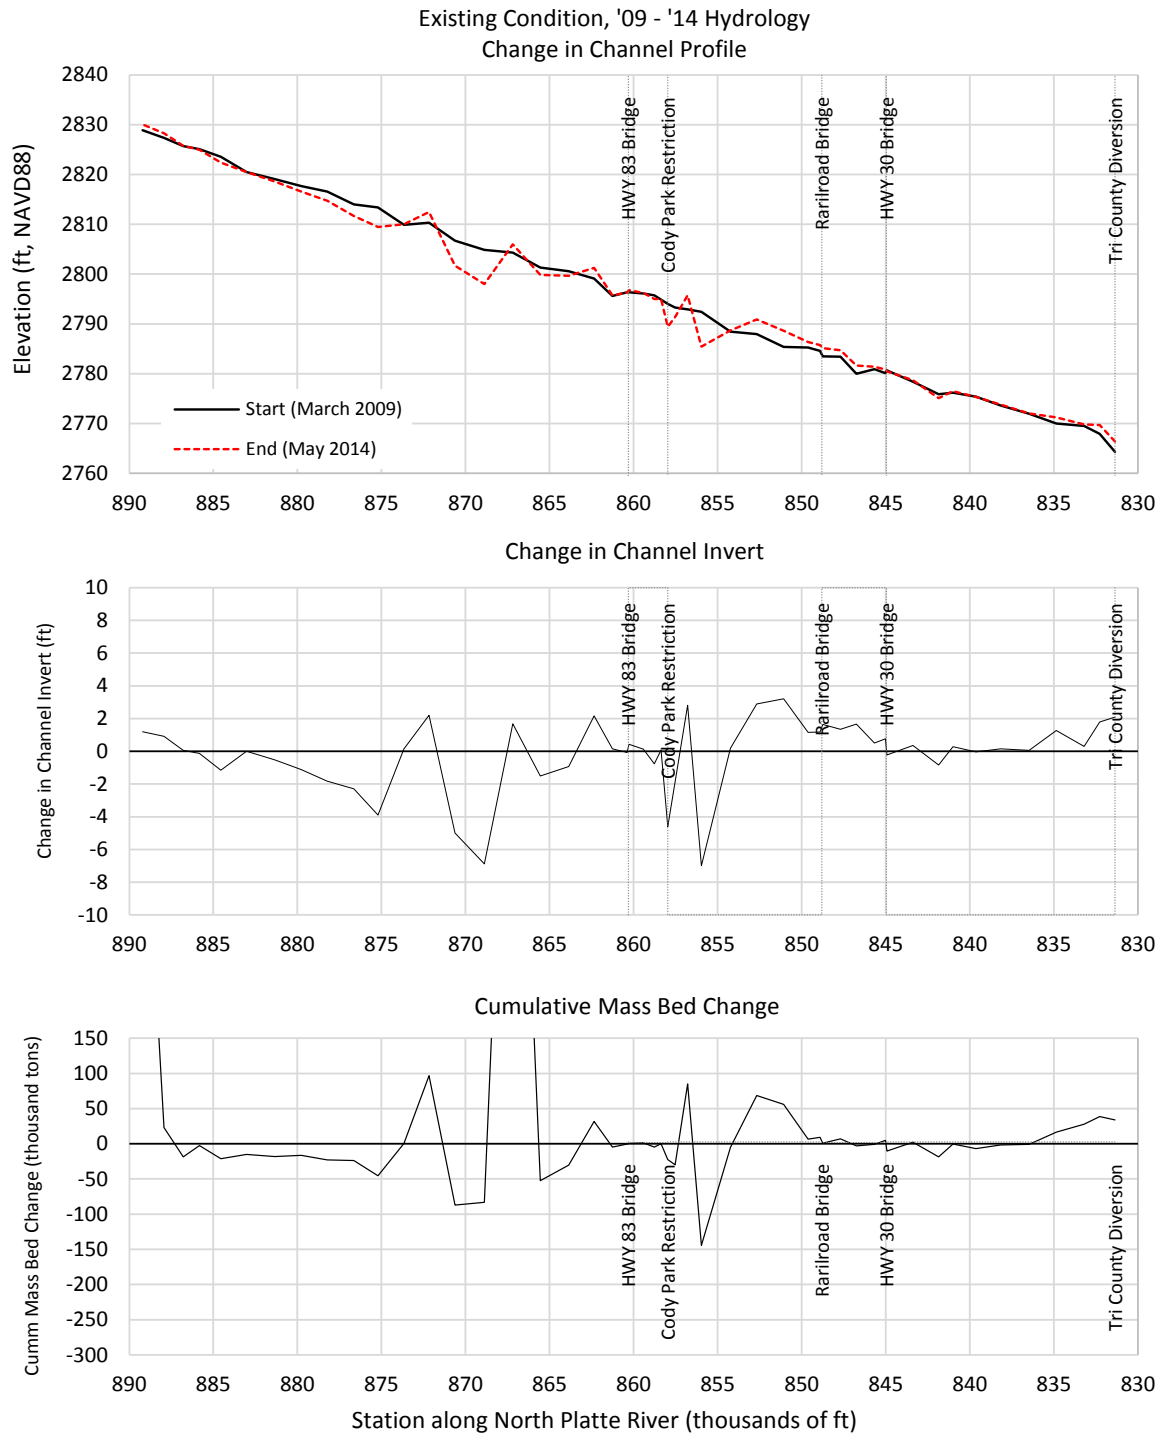
**Figure A-1 Spatial Results, Run 1 Alt A Existing Condition 2009 – 2014 Hydrology – Channel Profile at Start and End (top), Change in Channel Invert Elevation (middle), and Cumulative Mass Bed Change (bottom).**

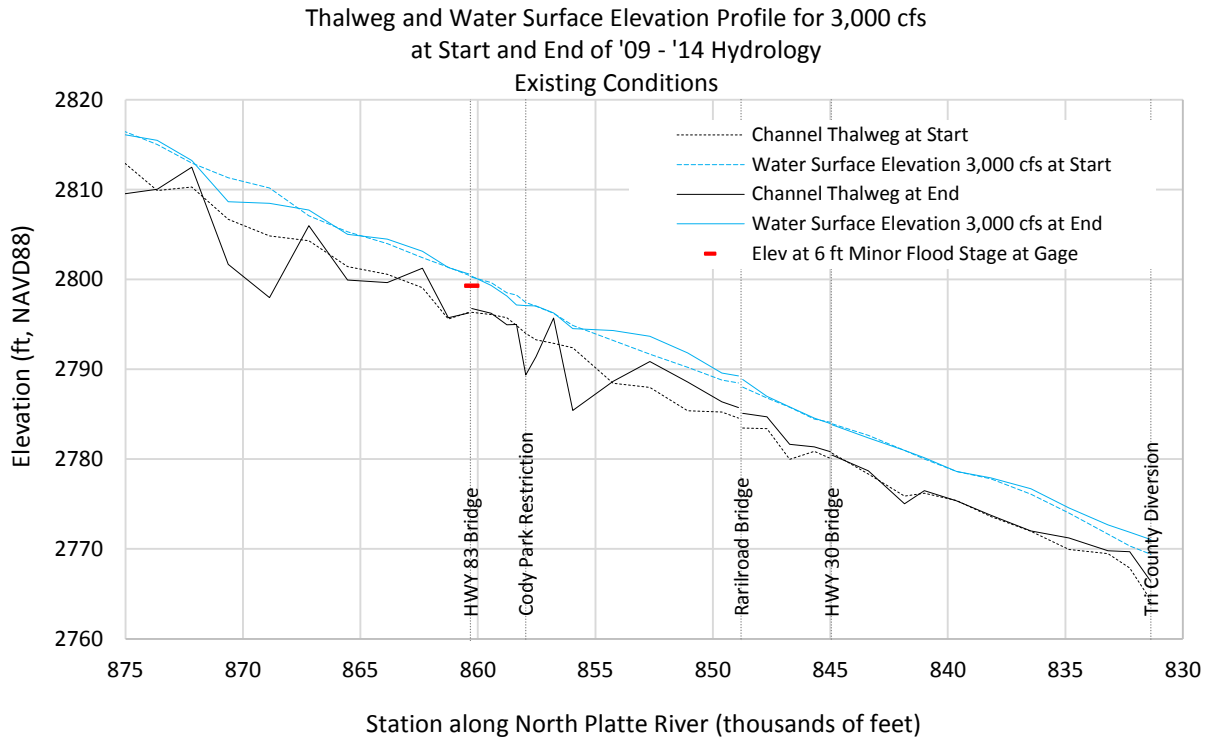
**Figure A-3 Profile of Channel Thalweg and Water Surface Elevation at 3,000 cfs at Start and End of 2009 – 2014 Hydrology for Run 1 Alt A Existing Conditions.**

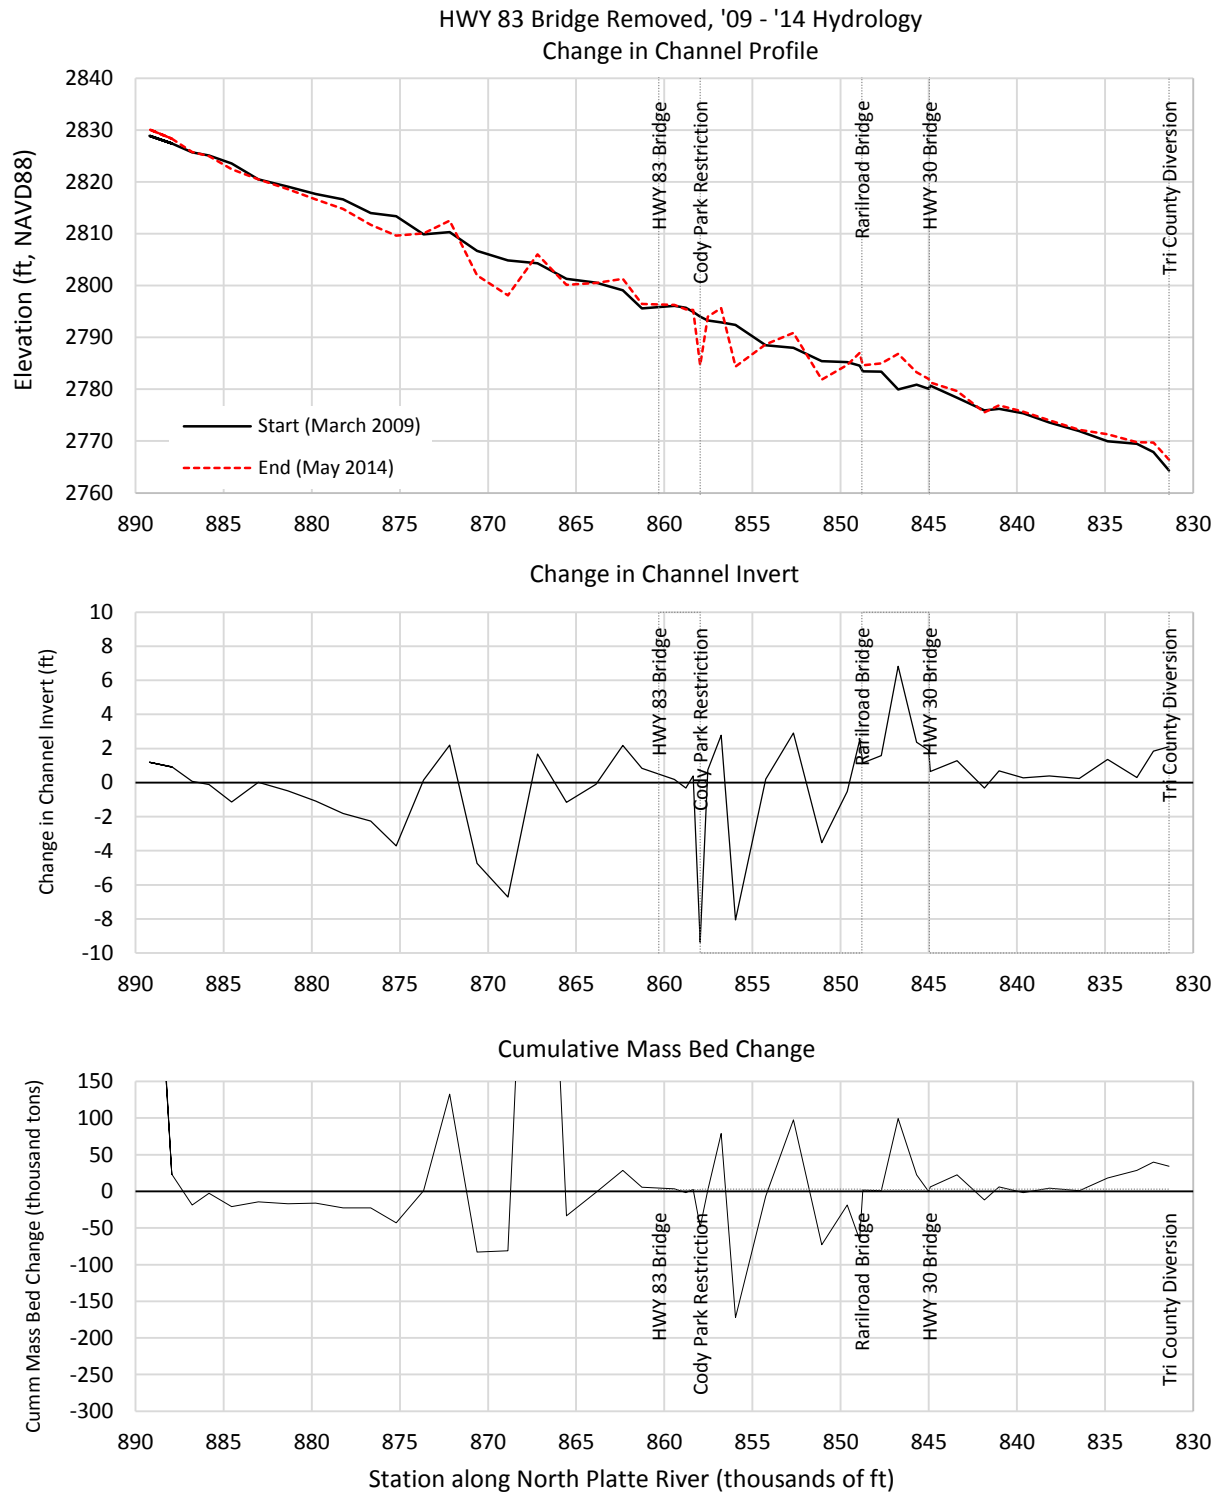
**Figure A-4 Spatial Results, Run 2 Alt B HWY 83 Bridge Removed 2009 – 2014 Hydrology – Channel Profile at Start and End (top), Change in Channel Invert Elevation (middle), and Cumulative Mass Bed Change (bottom).**

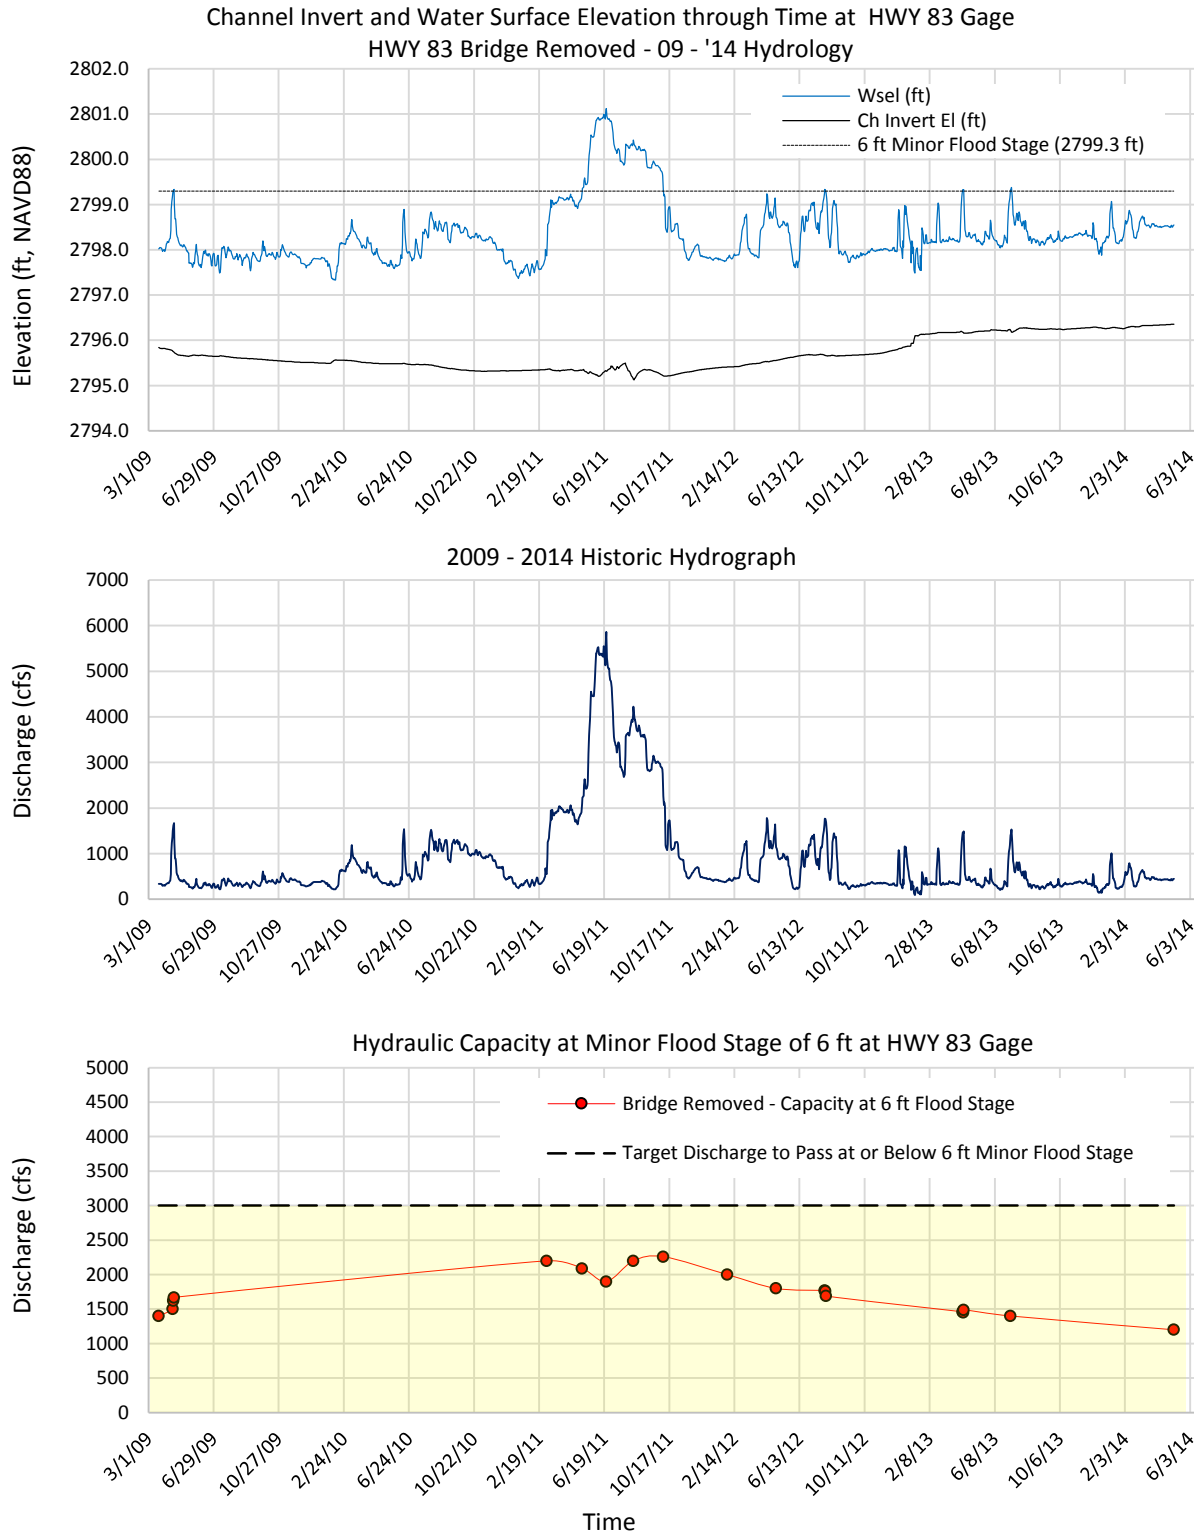
**Figure A-5 Results through Time, Run 2 Alt B HWY 83 Bridge Removed 2009 – 2014 Hydrology – Channel Invert and Water Surface Elevation at HWY 83 Gage (top), 2009 – 2014 Daily Discharge Hydrograph (middle), and Hydraulic Capacity at Minor Flood Stage at HWY 83 Gage (bottom).**

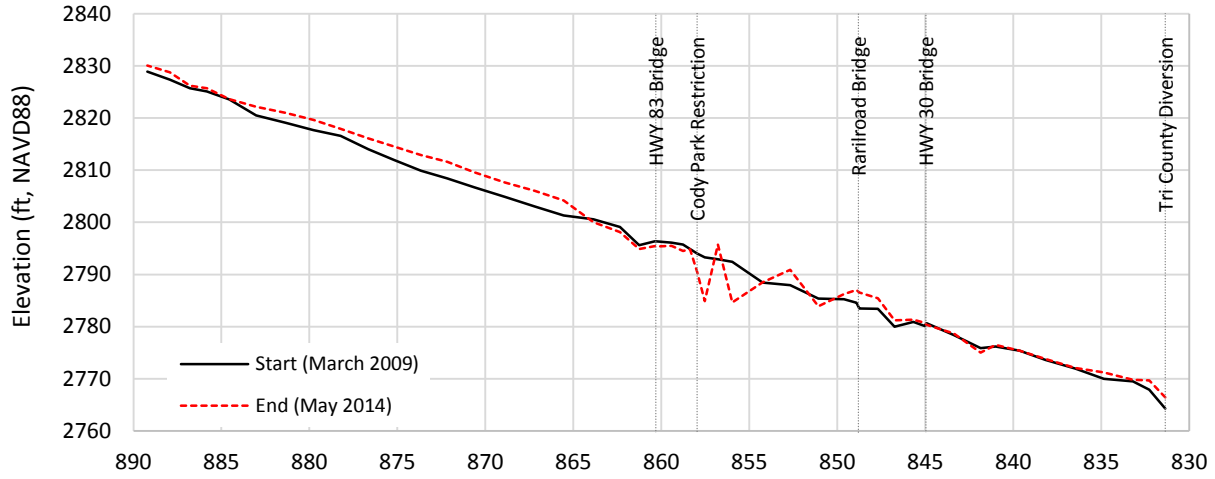
Figure A-7 Spatial Results, Run 3 Alt C Channel Widening U/S HWY 83 2009 – 2014 Hydrology – Channel Profile at Start and End (top), Change in Channel Invert Elevation (middle), and Cumulative Mass Bed Change (bottom).

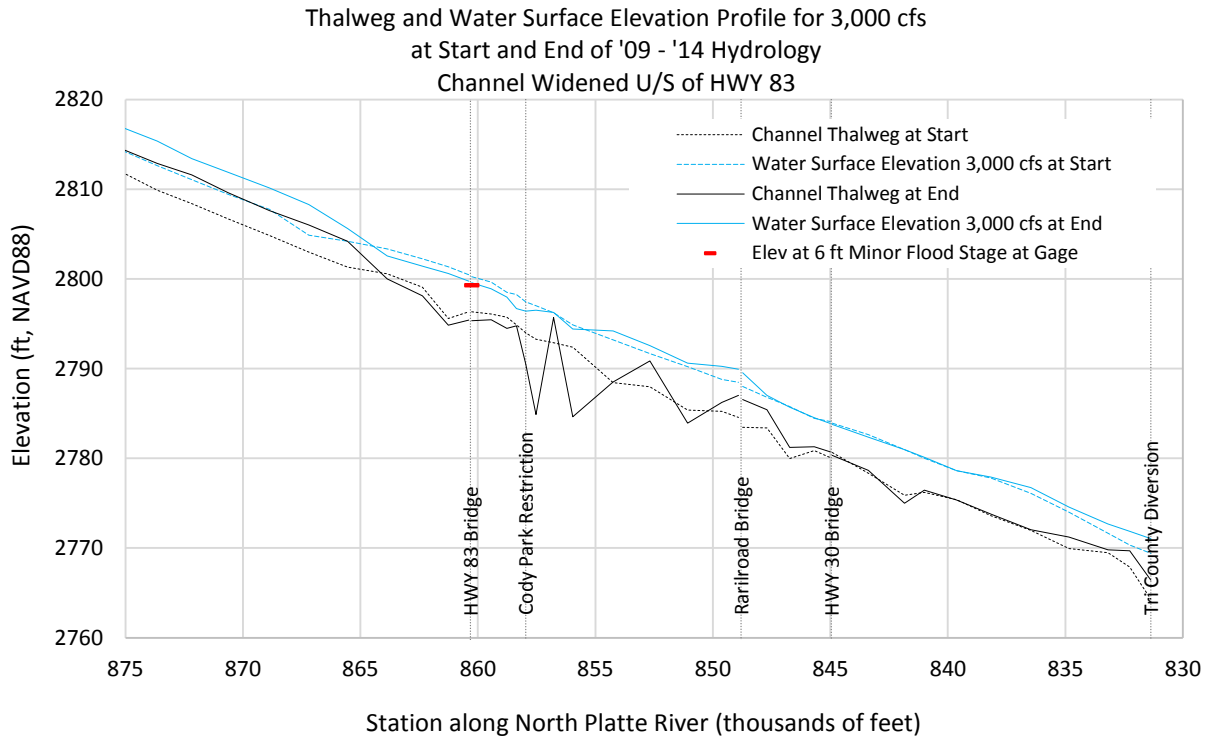
**Figure A-9 Profile of Channel Thalweg and Water Surface Elevation at 3,000 cfs at Start and End of 2009 – 2014 Hydrology for Run 3 Alt C Channel Widening U/S HWY 83.**
