# MEMORANDUM

ANDERSON CONSULTING ENGINEERS, INC.  
Civil • Water Resources • Environmental

**DATE:** January 21, 2015 **ACE PROJECT NO.:** NEHEADWATERS04-04  
**TO:** Jerry Kenny, Headwaters Corporation  
**FROM:** Michelle Martin, P.E., Anderson Consulting Engineers, Inc.  
Brad Anderson, P.E., Anderson Consulting Engineers, Inc.  
**SUBJECT:** North Platte Choke Point: Investigation of Channel Modifications Upstream of Highway 83

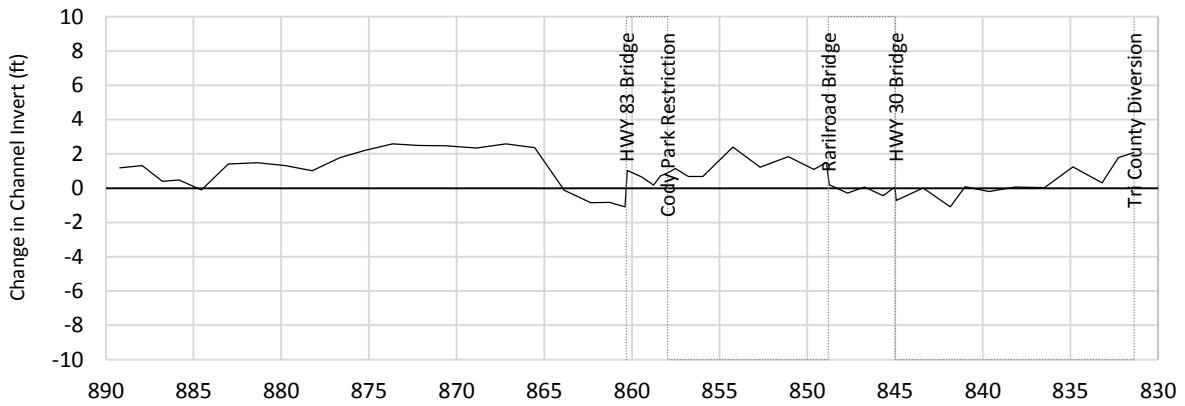
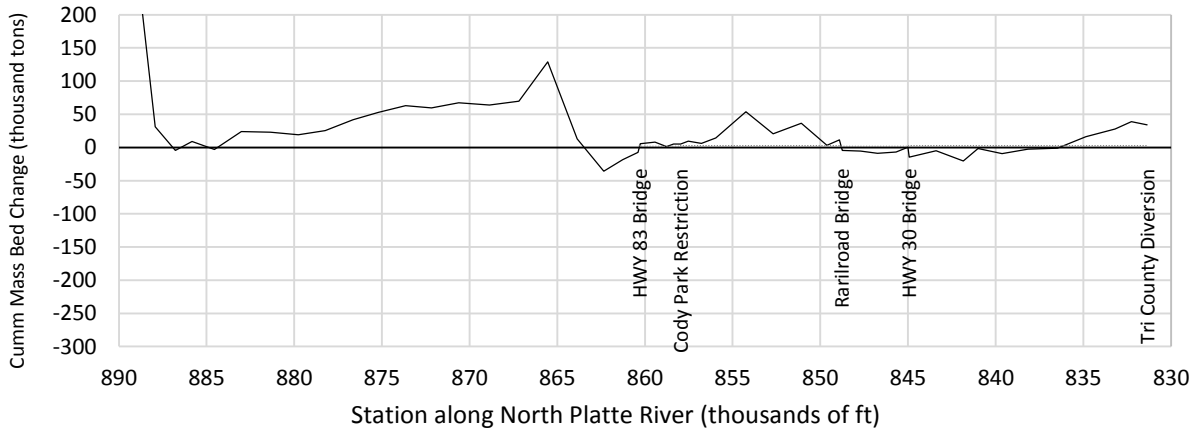
Figure A-10 Spatial Results, Run 4 (Alt D) Channel Widening U/S HWY 83 + Dredging D/S HWY 83 2009 – 2014 Hydrology – Channel Profile at Start and End (top), Change in Channel Invert Elevation (middle), and Cumulative Mass Bed Change (bottom).

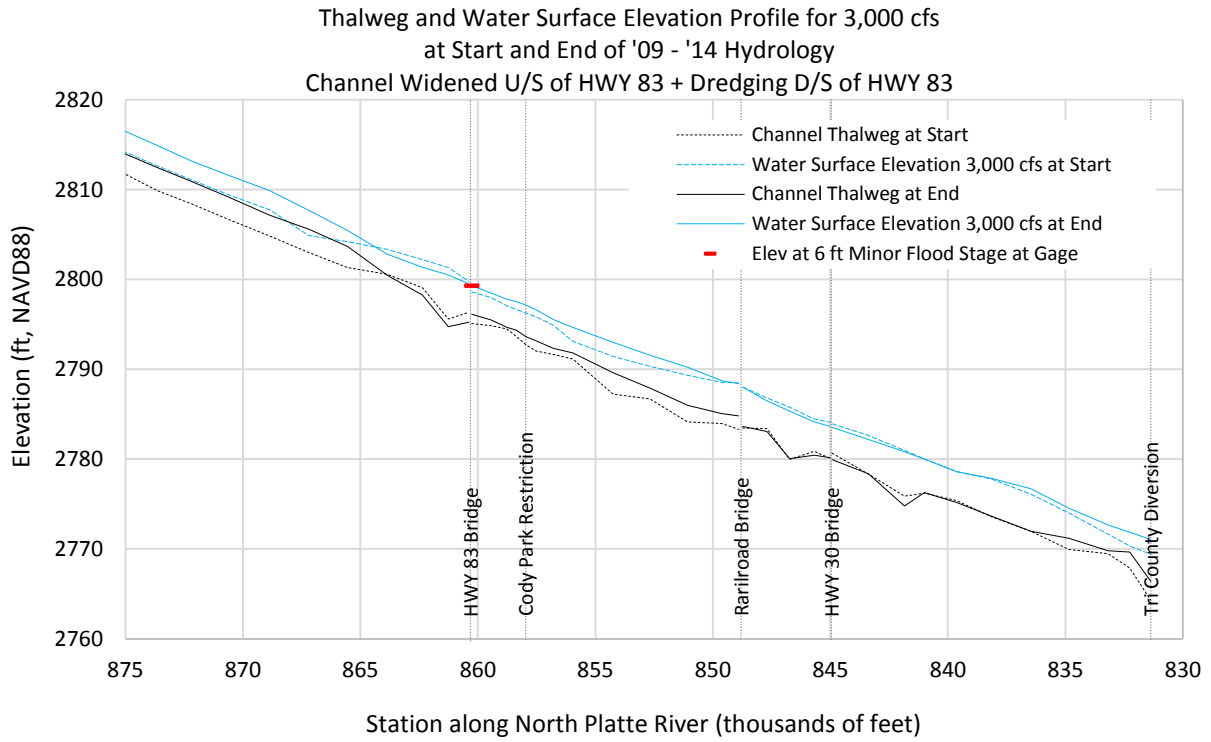
**Figure A-12 Profile of Channel Thalweg and Water Surface Elevation at 3,000 cfs at Start and End of 2009 – 2014 Hydrology for Run 4 (Alt D) Channel Widening U/S HWY 83 + Dredging D/S HWY 83.**

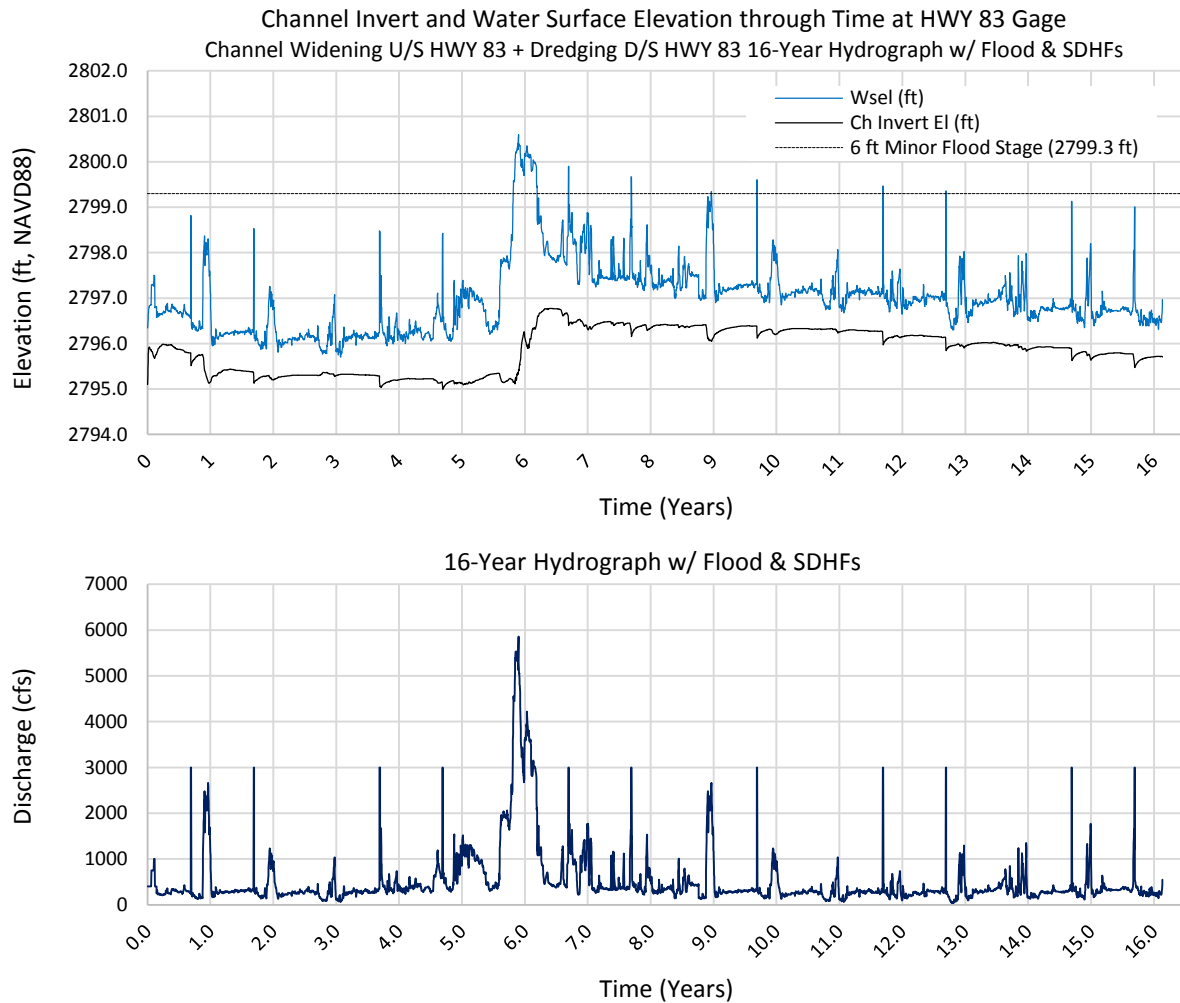
**Figure A-14 Results through Time, Run 5 (Alt D) Channel Widening U/S HWY 83 + Dredging D/S HWY 83 16-year Hydrograph w/ Flood and SDHFs - Channel Invert and Water Surface Elevation at the HWY 83 Gage (top), 16-year Daily Discharge Hydrograph w/ Flood and SDHFs (bottom).**

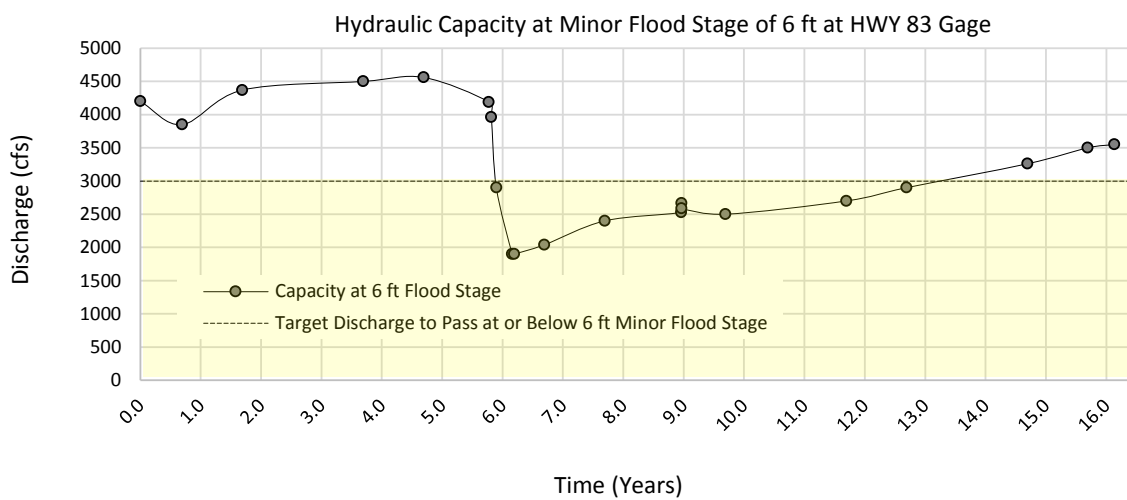
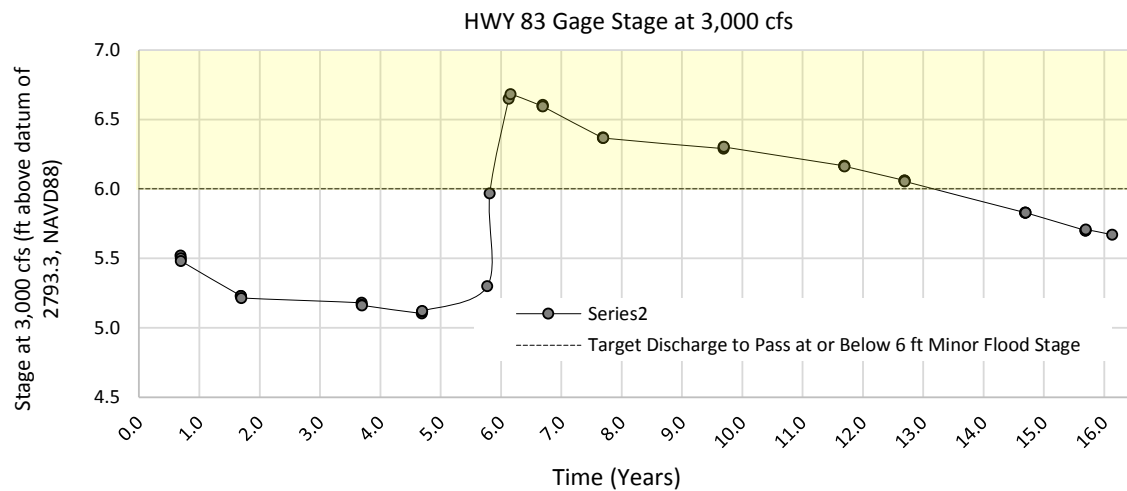
**Figure A-15 Capacity at HWY 83 Gage through Time, Run 5 (Alt D) Channel Widening U/S HWY 83 + Dredging D/S HWY 83 16-year Hydrograph w/ Flood and SDHFs – 16-year Daily Discharge Hydrograph w/ Flood and SDHFs (top), Hydraulic Capacity at Minor Flood Stage (middle), and Stage at 3,000 cfs (bottom).**

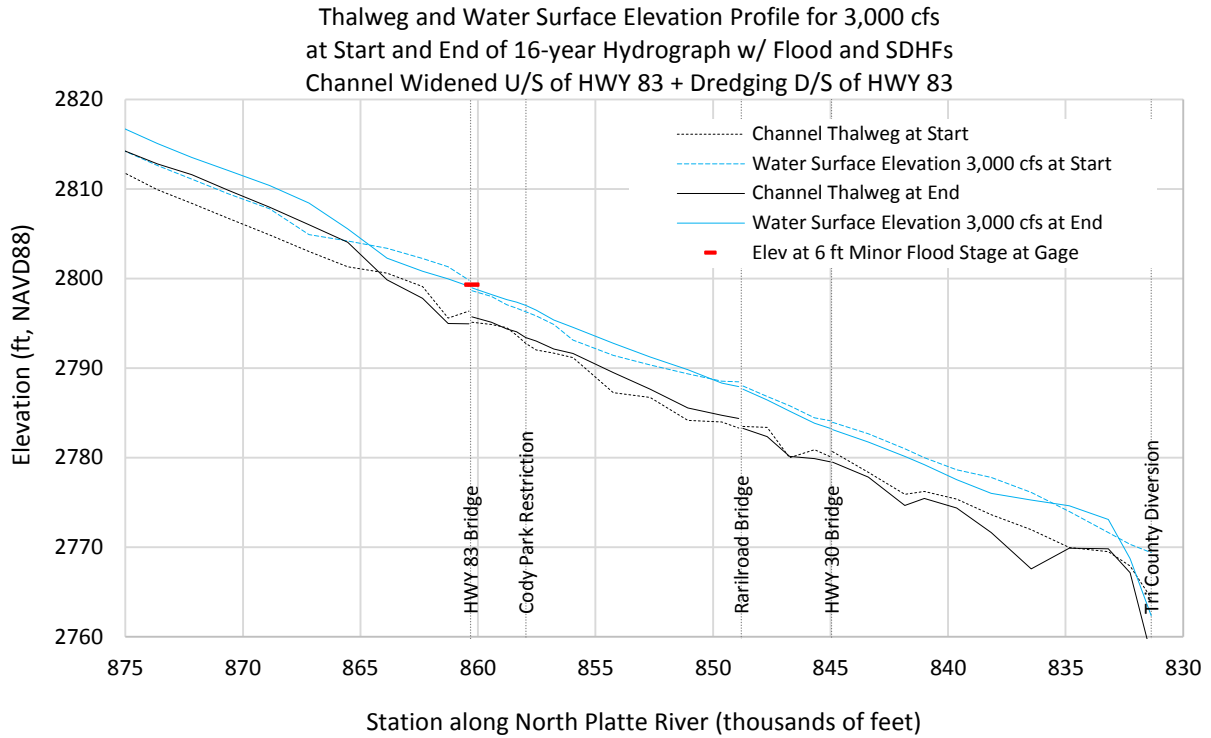
**Figure A-16 Profile of Channel Thalweg and Water Surface Elevation at 3,000 cfs at Start and End of 16-year Hydrograph w/ Flood and SDHFs for Run 5 (Alt D) Channel Widening U/S HWY 83 + Dredging D/S HWY 83.**

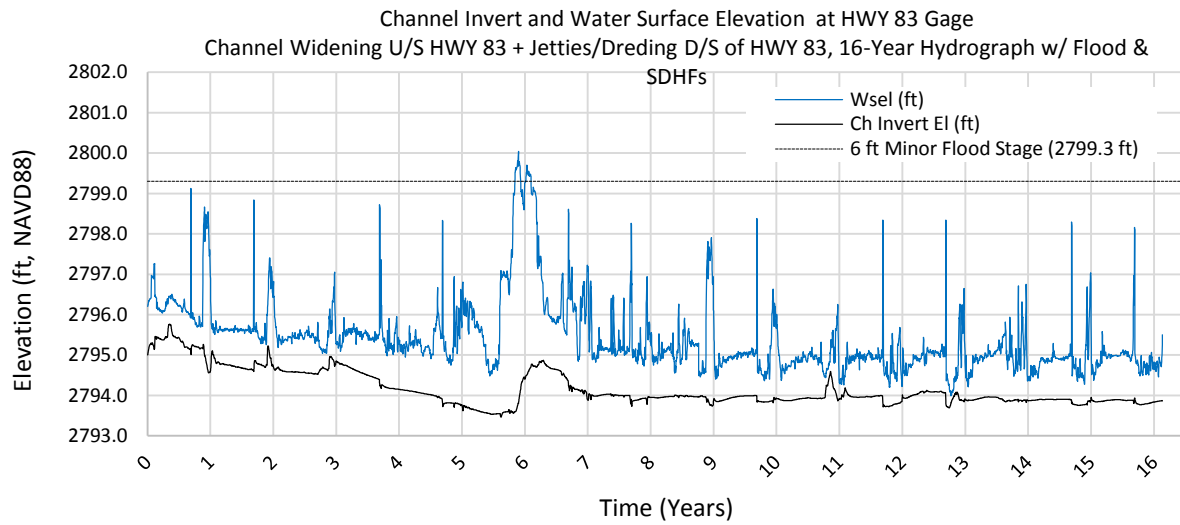
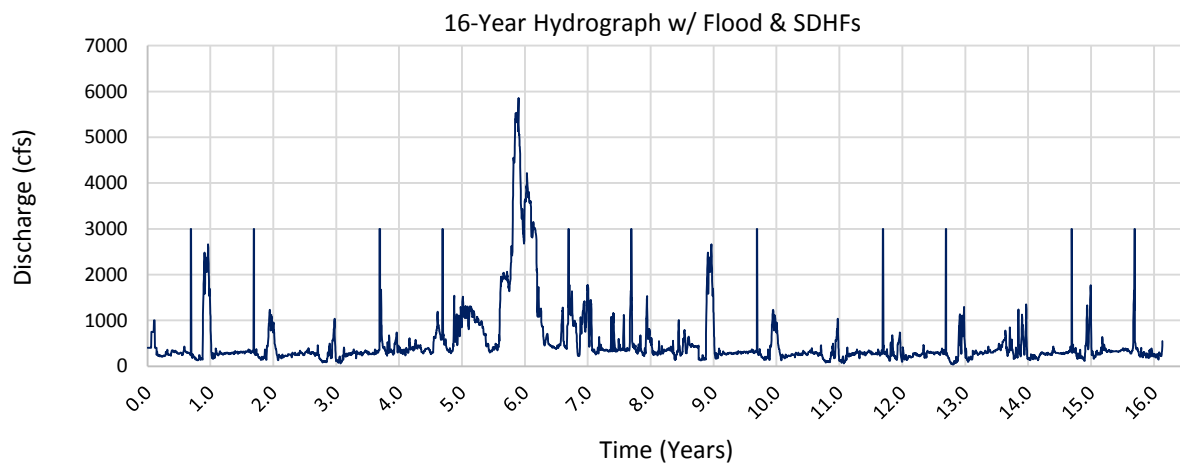
**Figure A-18 Results through Time, Run 6 (Alt E) Channel Widening U/S HWY 83 + Jetties and Dredging D/S HWY 83 16-year Hydrograph w/ Flood and SDHFs - Channel Invert and Water Surface Elevation at the HWY 83 Gage (top), 16-year Daily Discharge Hydrograph w/ Flood and SDHFs (bottom).**

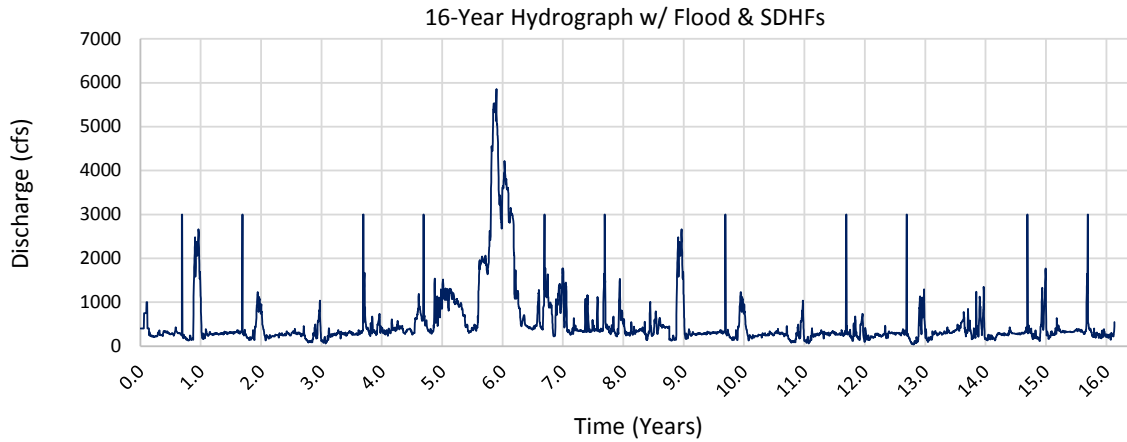
**Figure A-19 Capacity at HWY 83 Gage through Time, Run 6 (Alt E) Channel Widening U/S HWY 83 + Jetties and Dredging D/S HWY 83 16-year Hydrograph w/ Flood and SDHFs – 16-year Daily Discharge Hydrograph w/ Flood and SDHFs (top), Hydraulic Capacity at Minor Flood Stage (middle), and Stage at 3,000 cfs (bottom).**

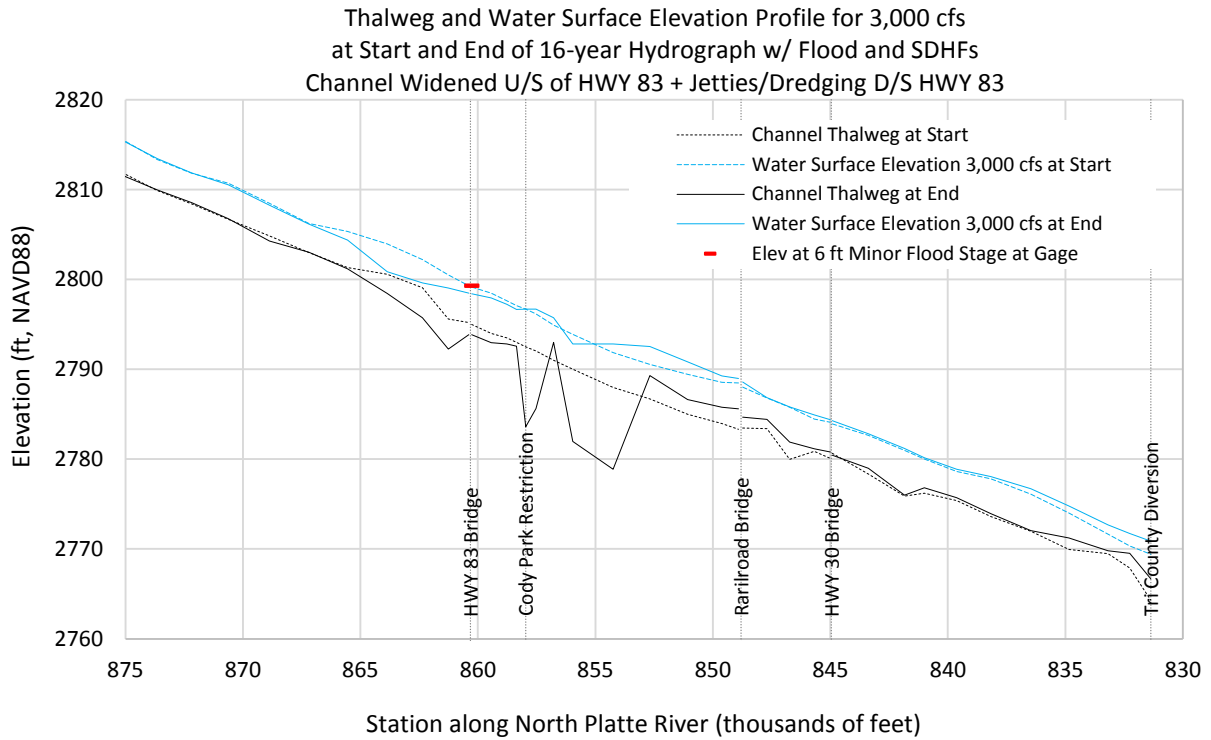
**Figure A-20 Profile of Channel Thalweg and Water Surface Elevation at 3,000 cfs at Start and End of 16-year Hydrograph w/ Flood and SDHFs for Run 6 (Alt E) Channel Widening U/S HWY 83 + Jetties and Dredging D/S HWY 83.**

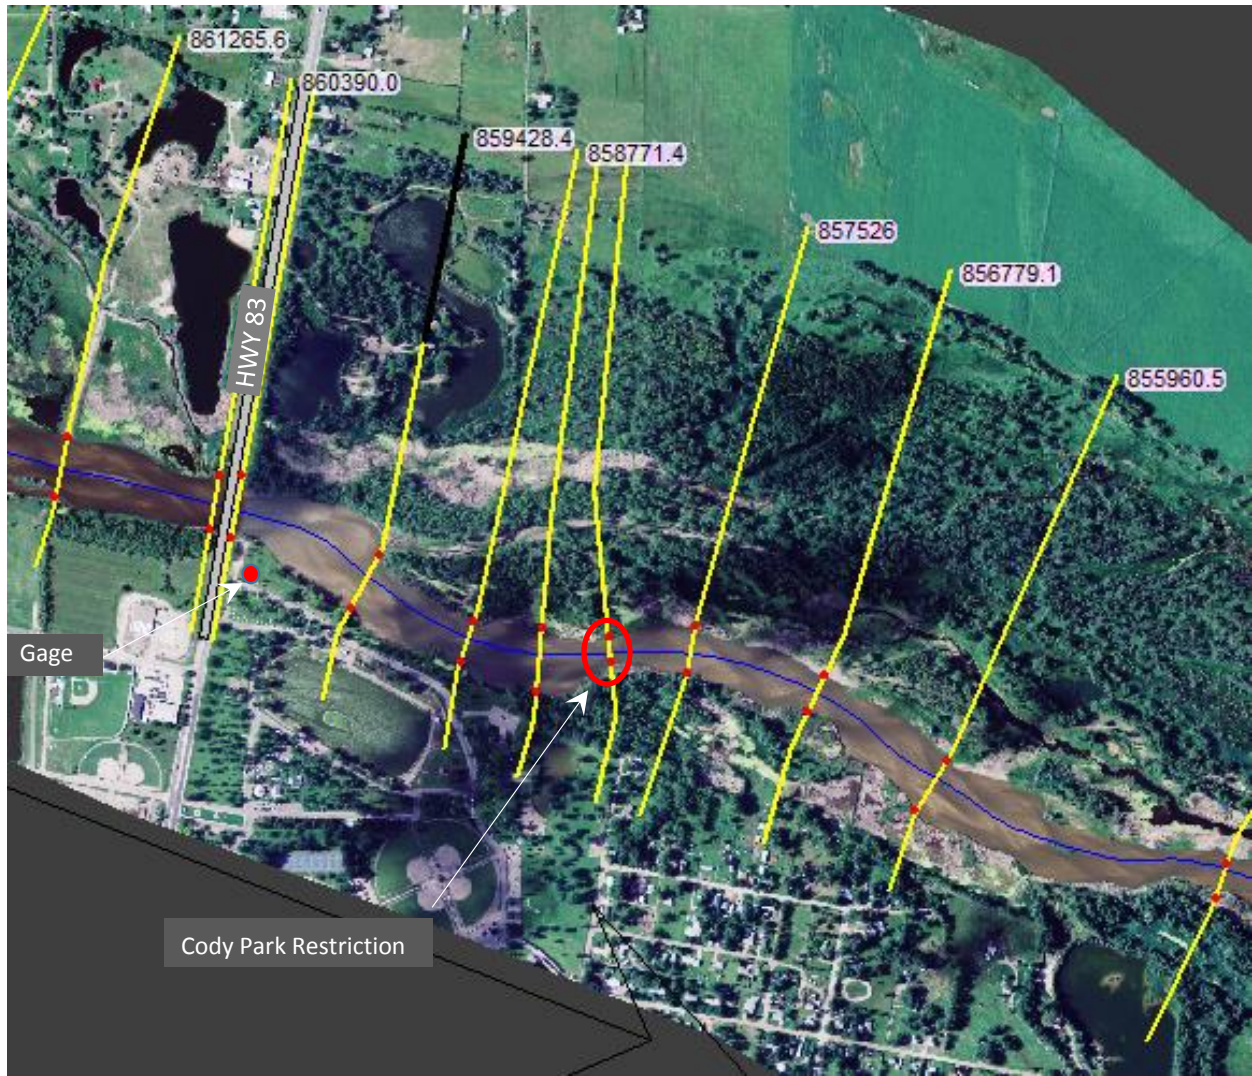
Figure B-4 Choke Point SIAM Reach 4 – HWY 83 to Cody Park Restriction, Station 860268 – 856779
