THE PLATTE RIVER CHANNEL: HISTORY AND RESTORATION

U.S. Department of the Interior
Bureau of Reclamation
TECHNICAL SERVICE CENTER
Denver, Colorado
April 2004

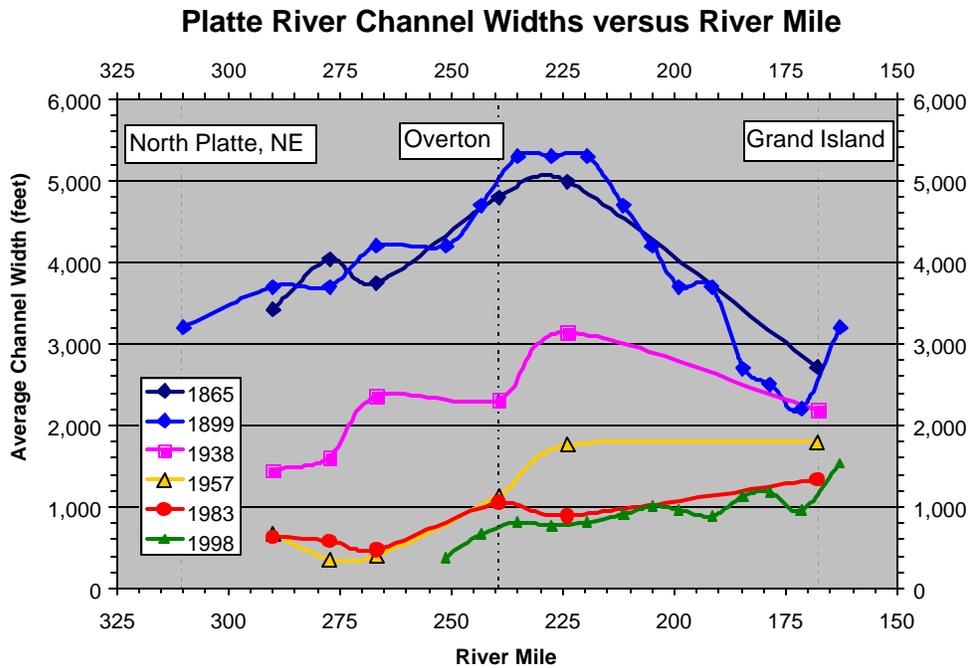
Figure 1.3 Reductions in unvegetated channel width in the central Platte River. Distance along the Platte River is denoted as river mileage beginning at Plattsmouth, Nebraska (River Mile 0) and increasing in the upstream direction.

The historically unvegetated river channel has narrowed substantially in the central Platte River over the last 100 years (Figure 1.3), reducing active channel widths by as much as 80 to 90 percent (Simons & Associates, 2000). Sand bars that are used for nesting by Piping Plovers and Interior Least Terns are now found infrequently, if at all, in the central Platte River. While other reaches have experienced less change, the central Platte River has generally experienced narrowing of the unvegetated channel width throughout its length, with greater percentage reductions in width in the upper reaches and smaller percentage reductions with distance downstream (Figure 1.4).

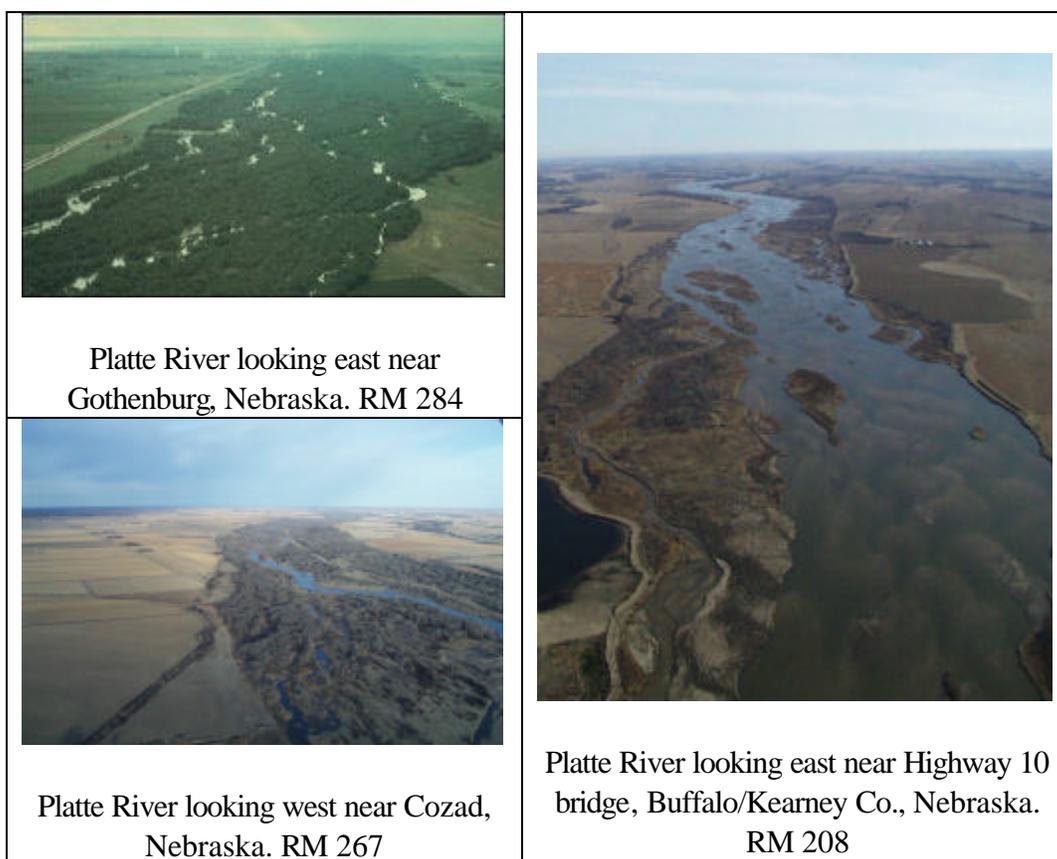
Figure 1.4 Photos of the central Platte River illustrating spatial variations in the narrowing of unvegetated widths and spatial variation in plan form. RM denotes river mile measured upstream from Plattsmouth, Nebraska (RM 0).

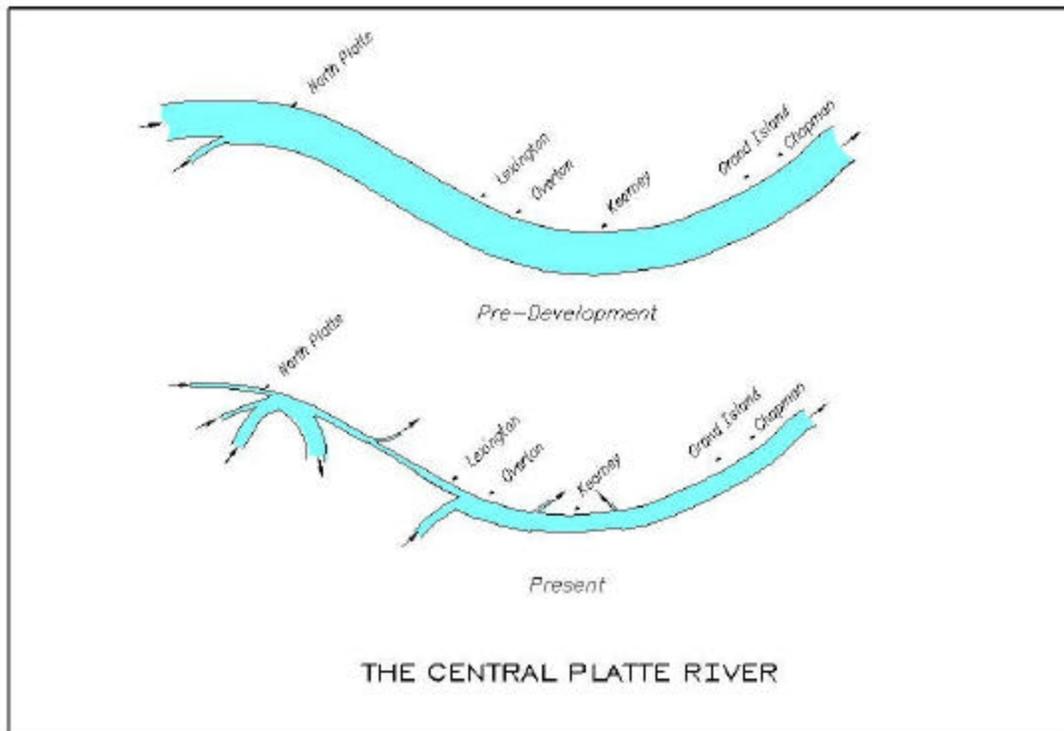
Figure 1.5 A comparison of the central Platte River flows and basin structure between the Pre-Development period and the twentieth century. The river width is scaled to represent average annual flows.

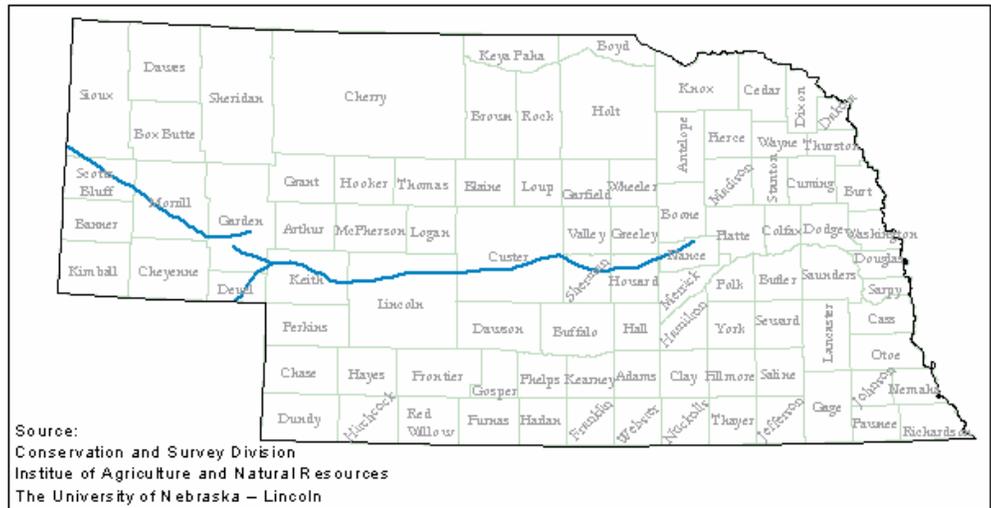
a. Platte River at the end of Tertiary Period

Figure 2.1 Evolution of the Platte River alignment.

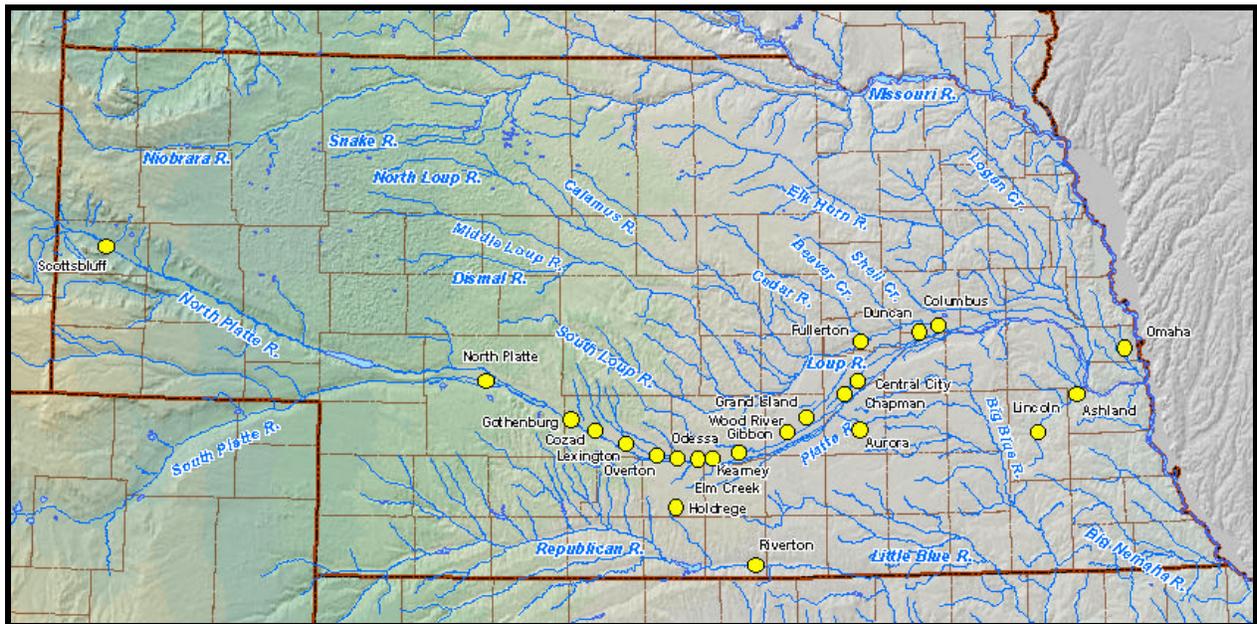
Figure 2.3 The North Platte, South Platte and Platte Rivers in Nebraska.

The general channel profile and bed materials also provide further information about the river morphology. From North Platte, Nebraska to Grand Island Nebraska (Figure 2.3), the Platte River generally flows on approximately 100 to 200 feet of alluvial deposits of sand and gravel that overlay bedrock.

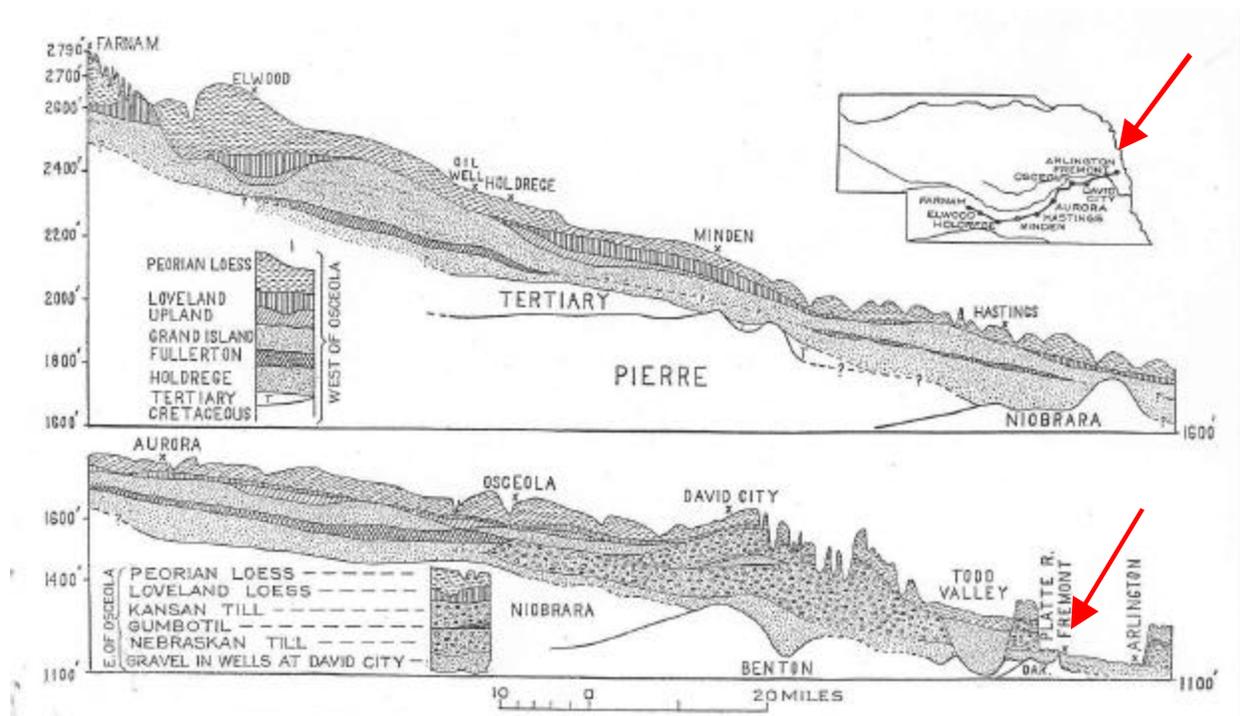
Figure 2.4 Geologic section from Farnam, in southwestern Dawson County, to Arlington, in Washington County, Nebraska, shows shallow location of bedrock under the Platte River at Fremont Nebraska, downstream of Columbus, Nebraska (taken from Lugin & Wenzel, 1938).

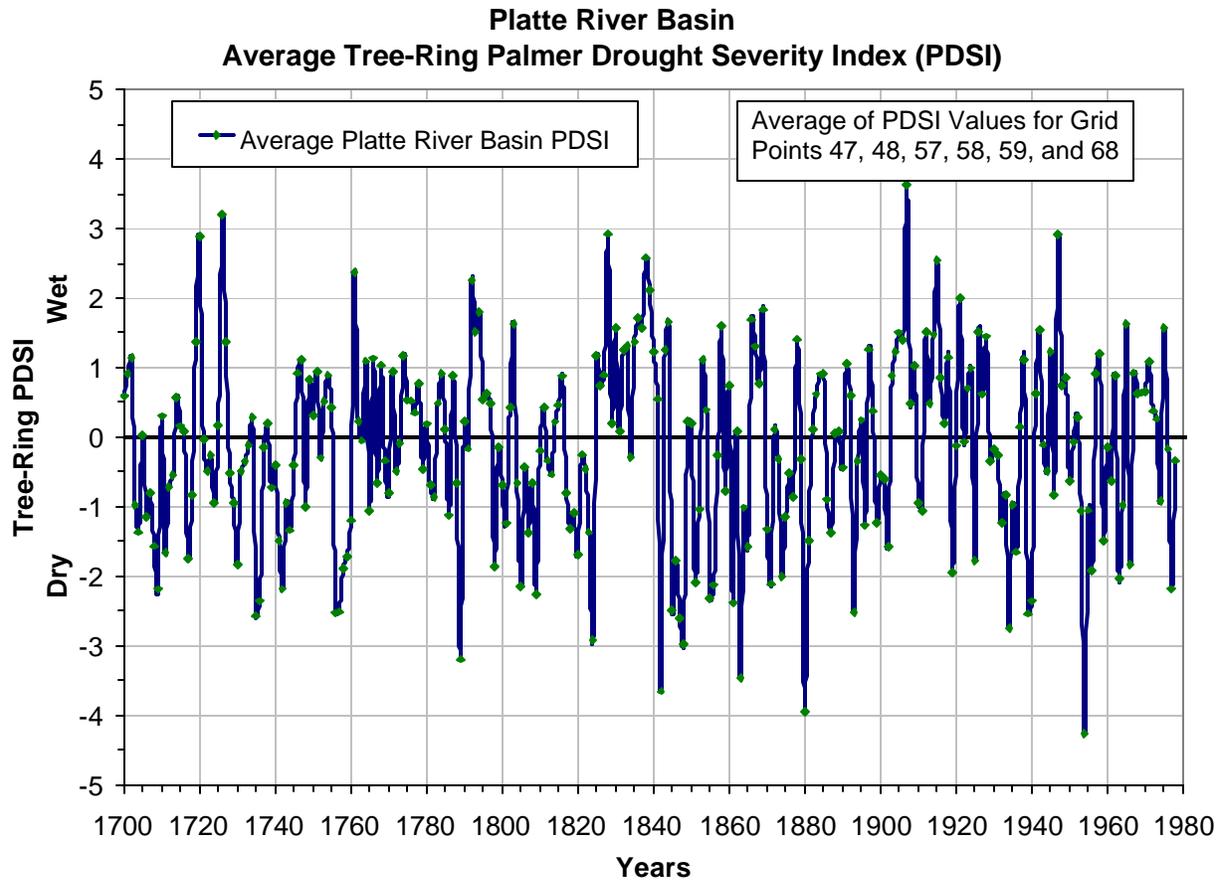
Figure 2.13 An average palmer drought severity index (PDSI) for the Platte River Basin based on tree-ring data (Cook, et al., 1996b). The PDSI value shown is the average for grid points 47, 48, 57, 58, 59 and 68 (Figure 2.12).

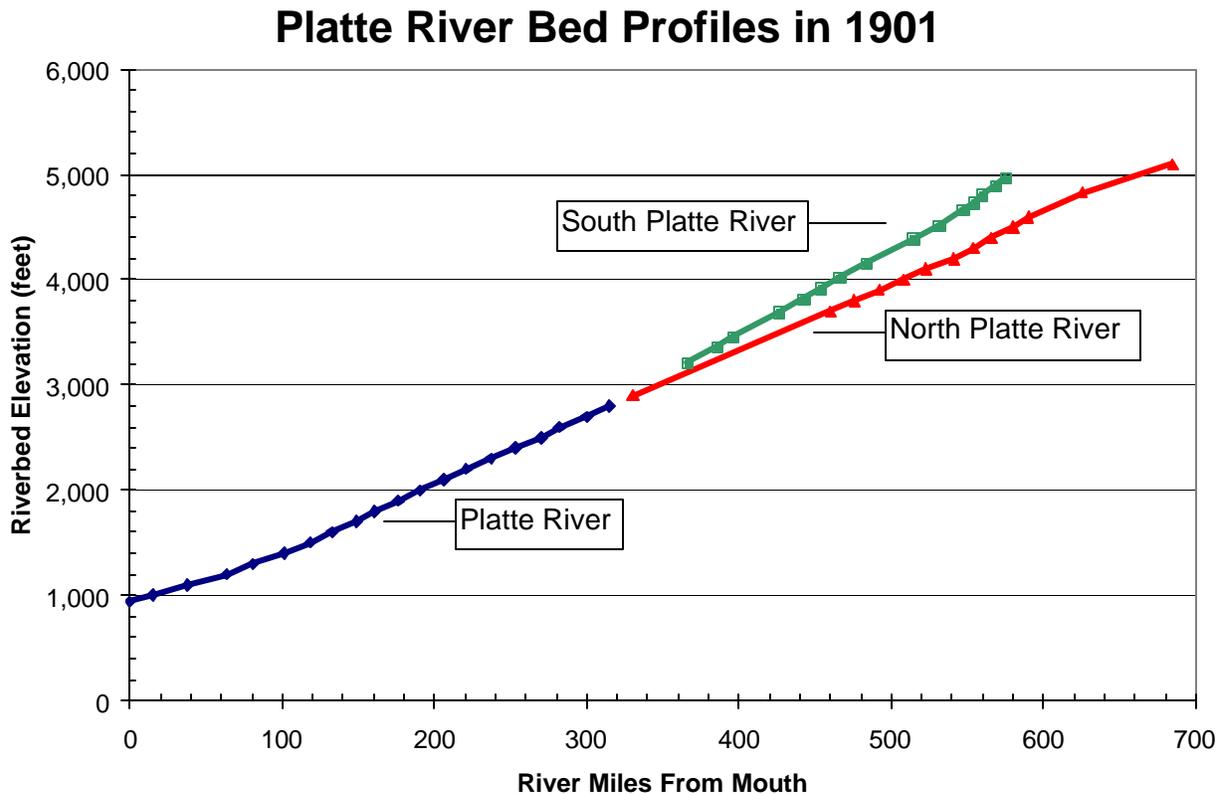
Figure 2.14 Longitudinal profile of the Platte River bed in 1901 (Gannett's Slope).

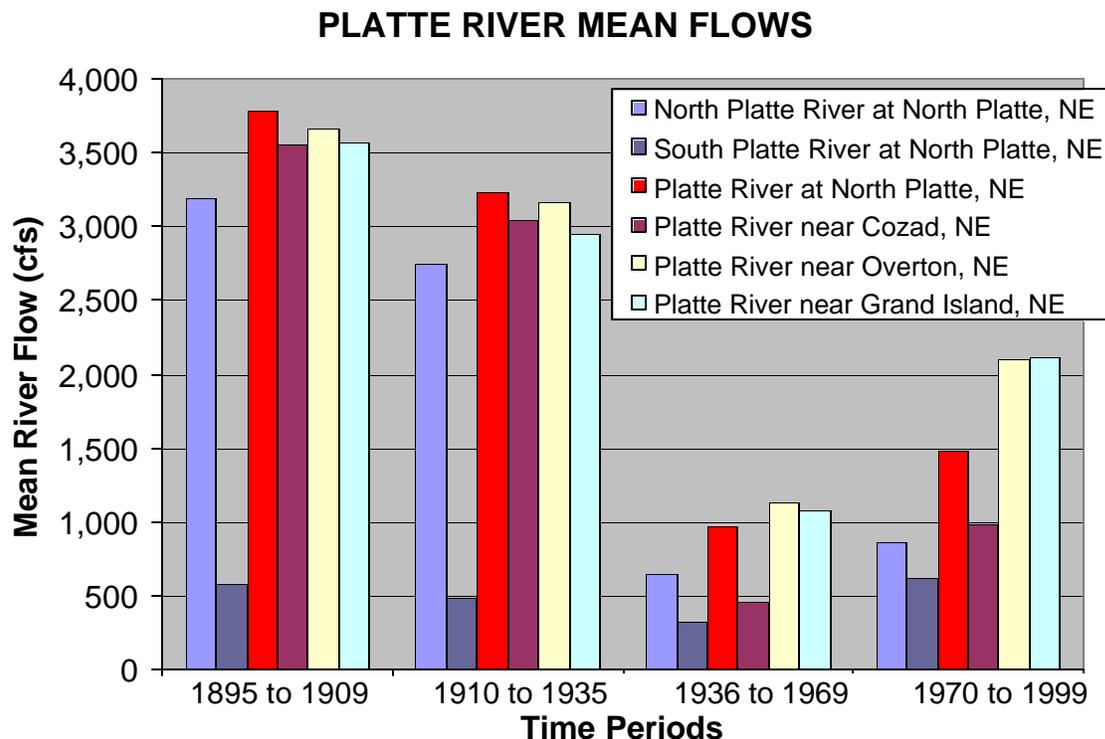
Figure 3.1 Platte River mean flows (Randle and Samad, 2003).

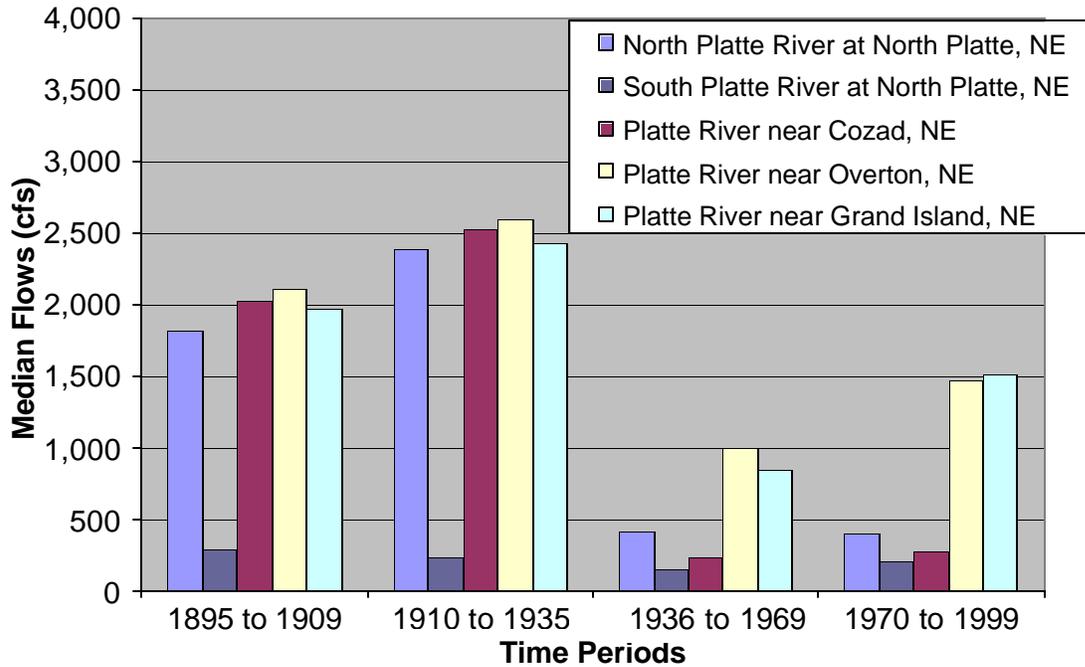
Figure 3.2 Platte River median flows (Randle and Samad, 2003).

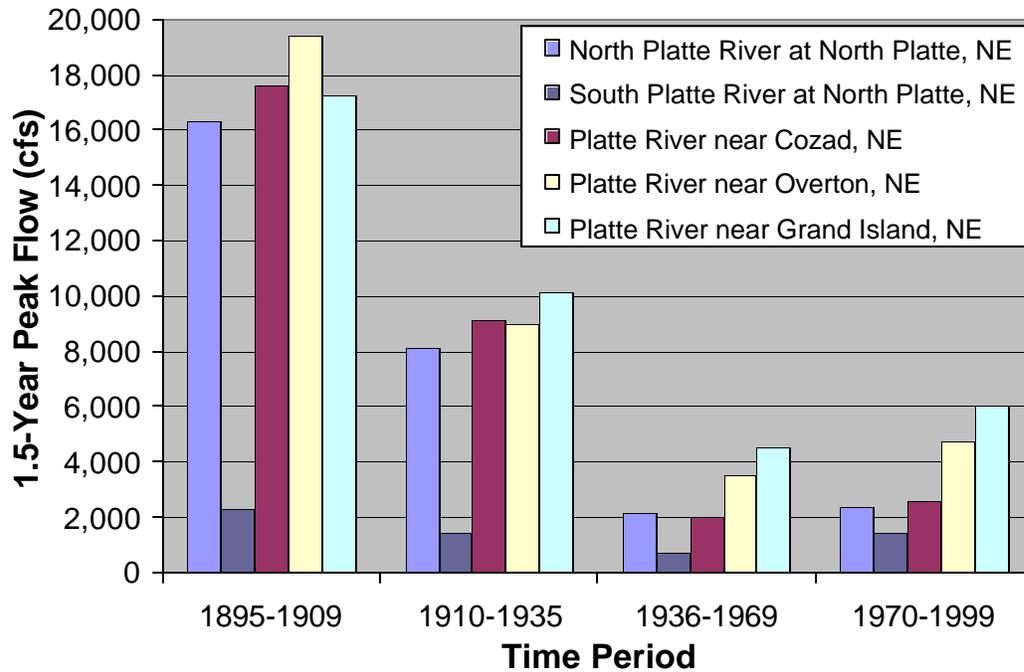
Figure 3.3 Platte River 1.5-year flood peak flows (Randle and Samad, 2003).

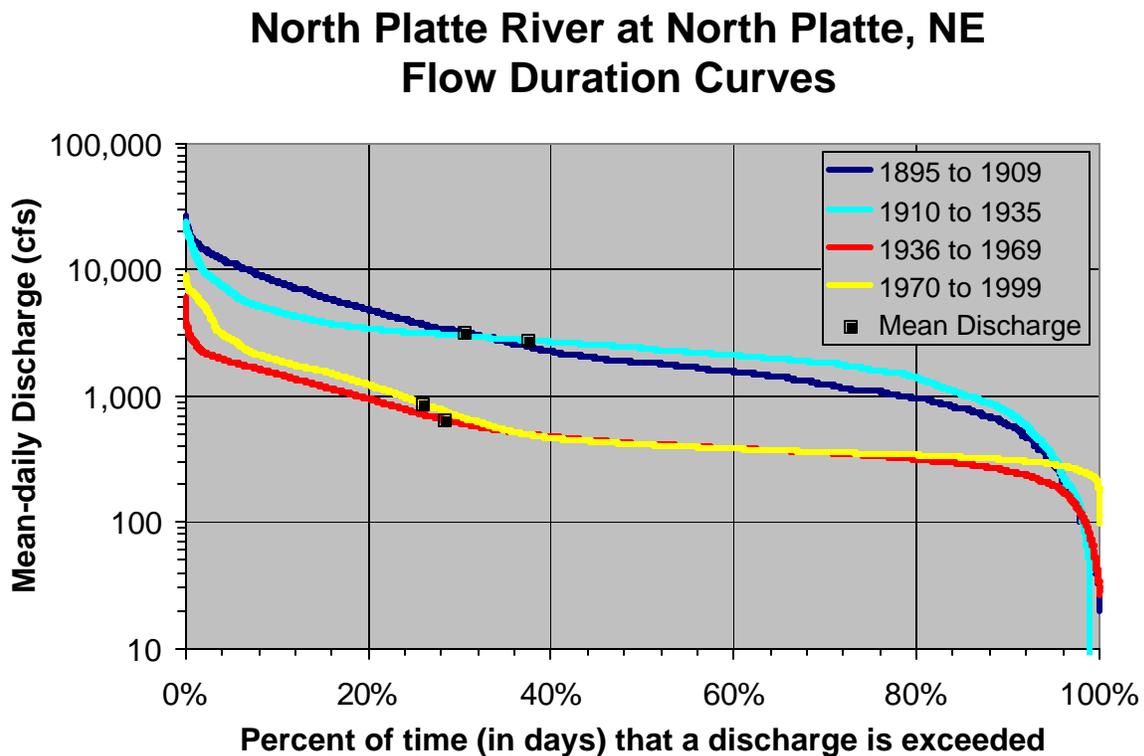
Figure 3.4 North Platte River at North Platte, Nebraska flow-durations curves (Randle and Samad, 2003).

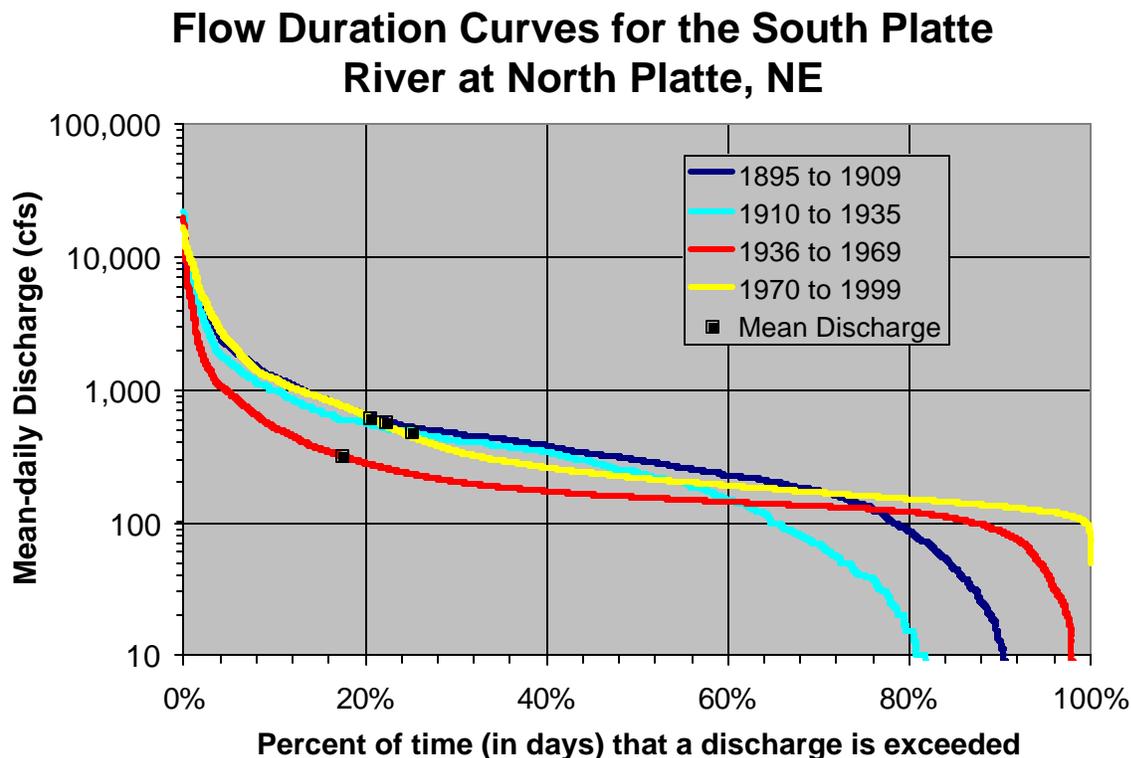
Figure 3.5 South Platte River at North Platte, Nebraska flow-durations curves (Randle and Samad, 2003). The mean flow for the first, second, and fourth time periods are very similar (Table 3.4).

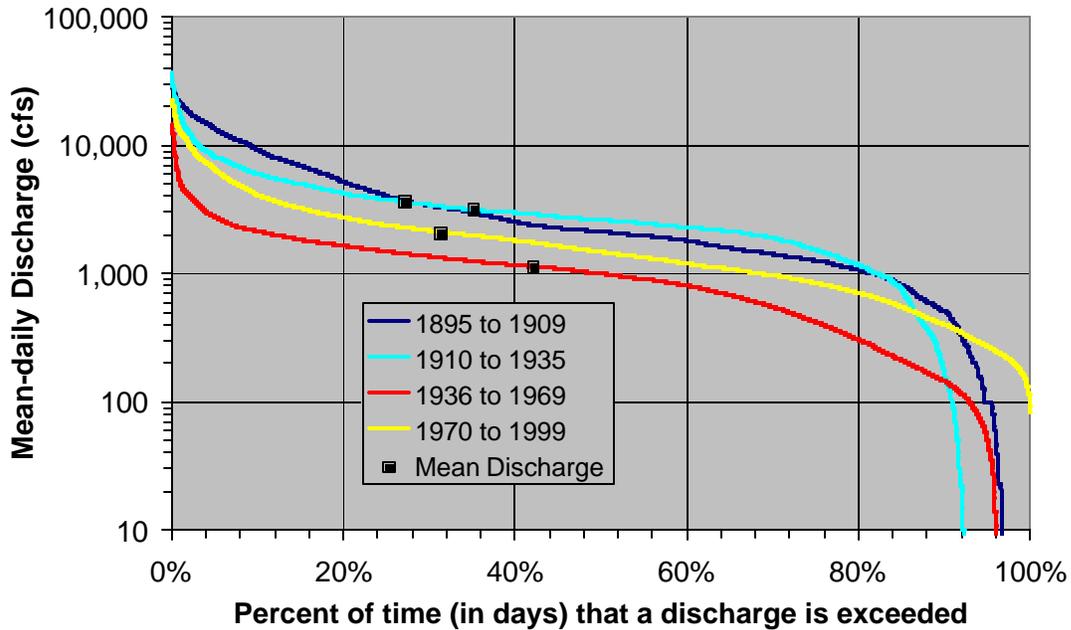
Figure 3.7 Platte River near Overton, Nebraska flow-durations curves (Randle and Samad, 2003).

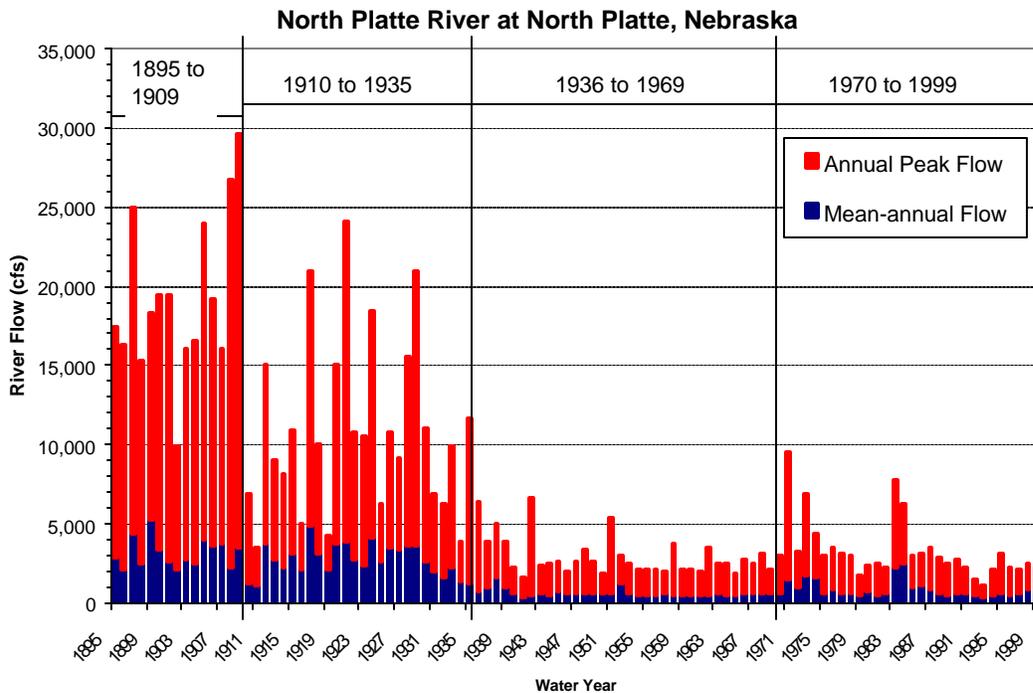
Figure 3.12 North Platte River at North Platte, Nebraska mean annual flow and annual peak flow (Randle and Samad, 2003).

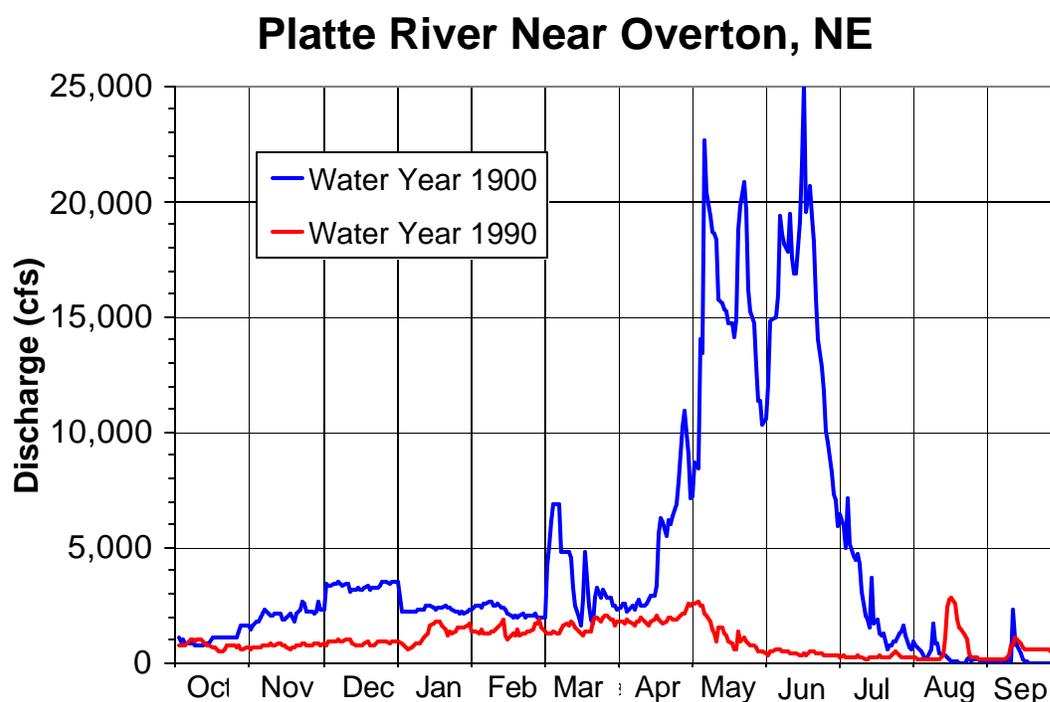
Figure 3.13 The comparison of hydrographs for water years 1900 and 1990 provide an example of how the annual flow volume and annual peak flow have substantially decreased over the twentieth century in response to water resource development in the Platte River Basin.

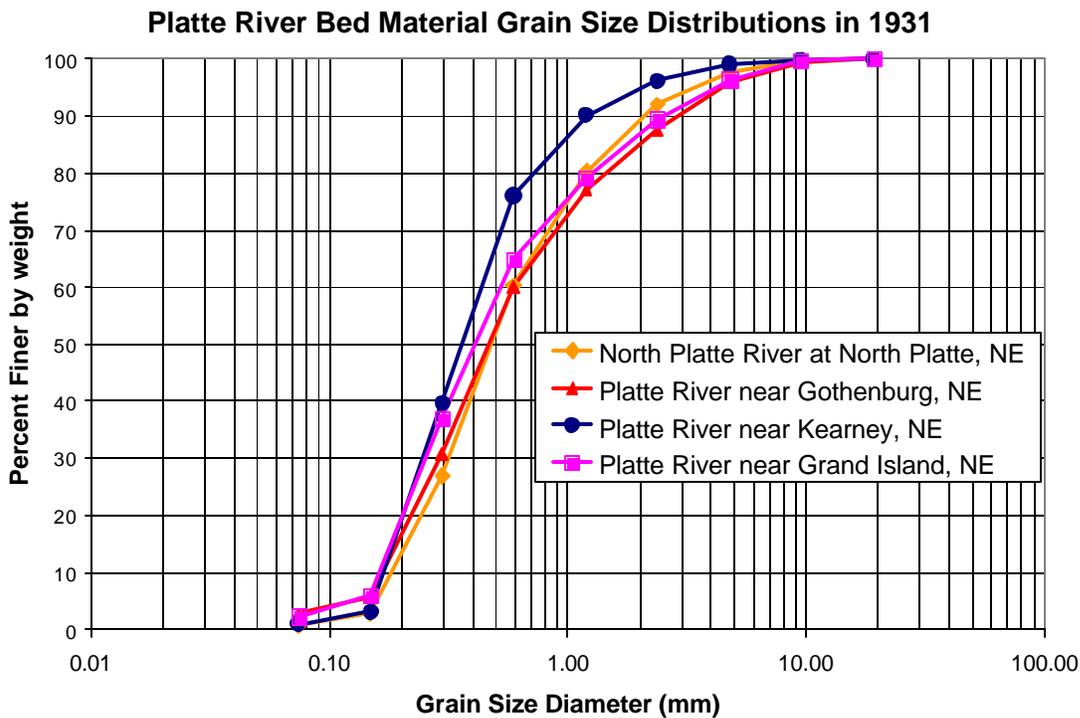
Figure 3.14 Platte River Bed Material Grain Size Distributions in 1931 (U.S. Army Corps of Engineers, 1935).

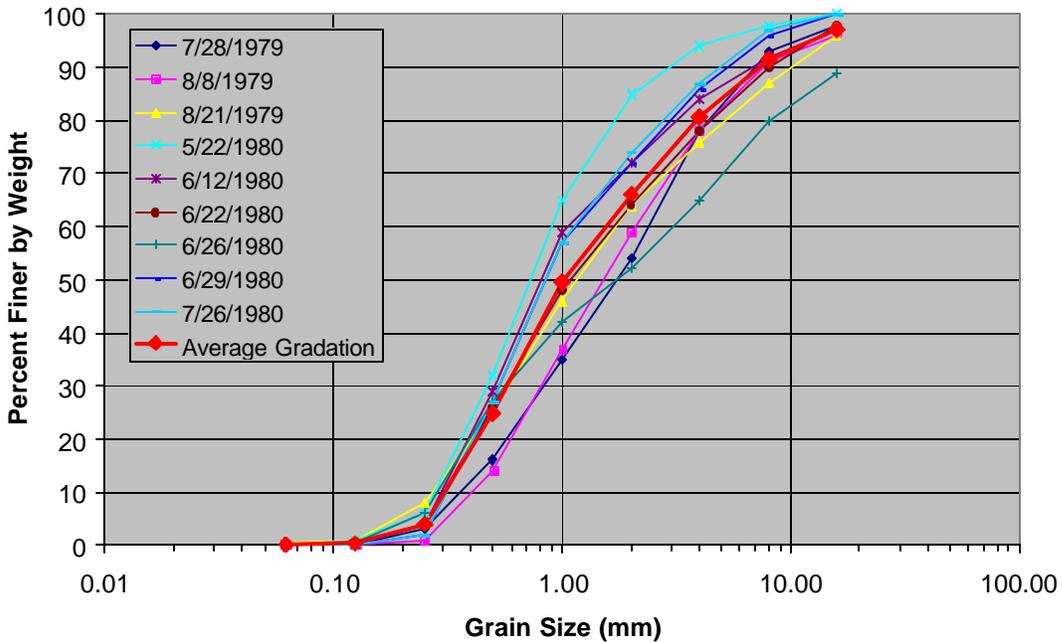
Figure 3.16 Bed Material Grain Size Distributions of the South Platte River at North Platte, Nebraska in 1979-1980.

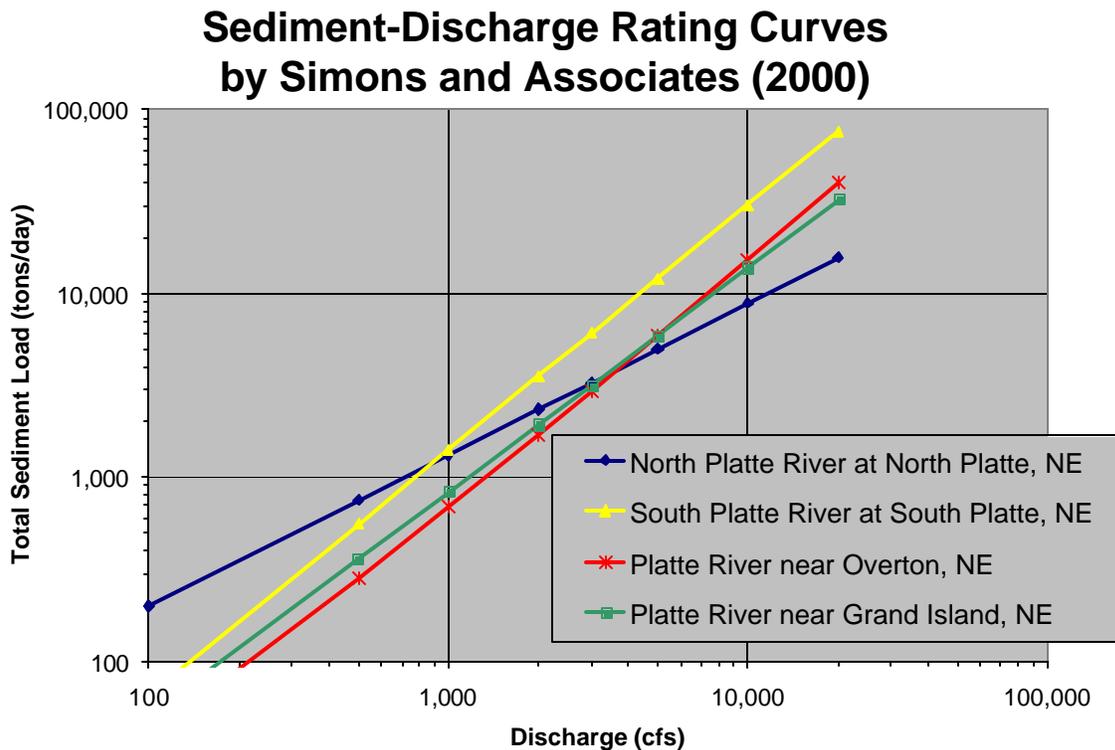
Figure 3.17 Platte River Sediment-Discharge Rating Curves by Simons and Associates (2000).

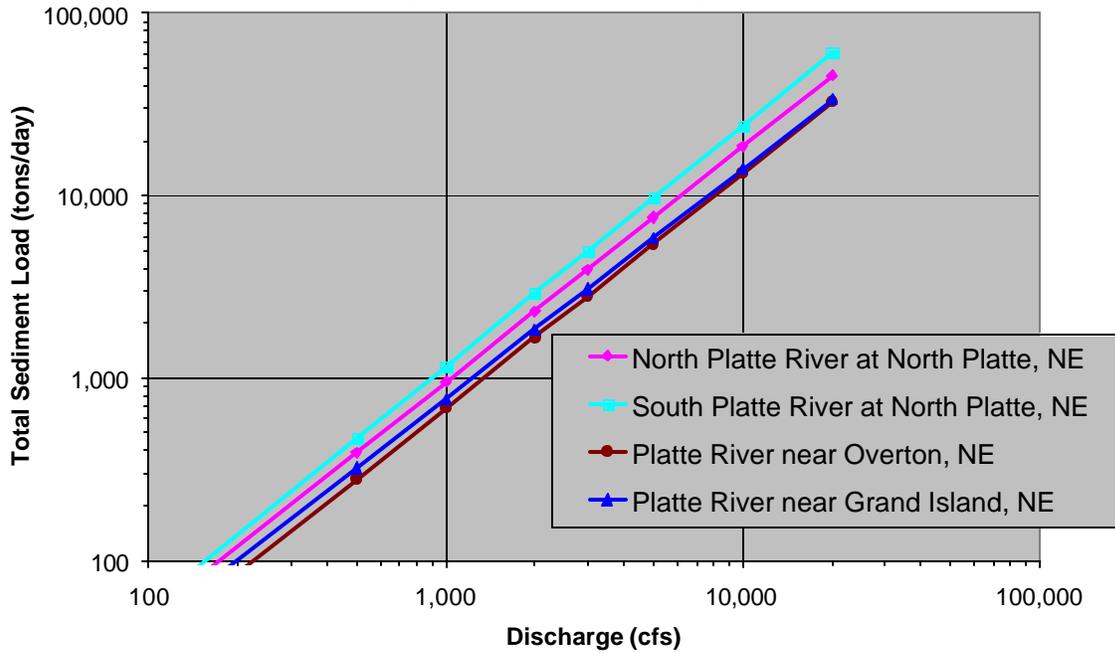
Figure 3.18 Platte River Sediment-Discharge Rating Curves by Kircher (1983).

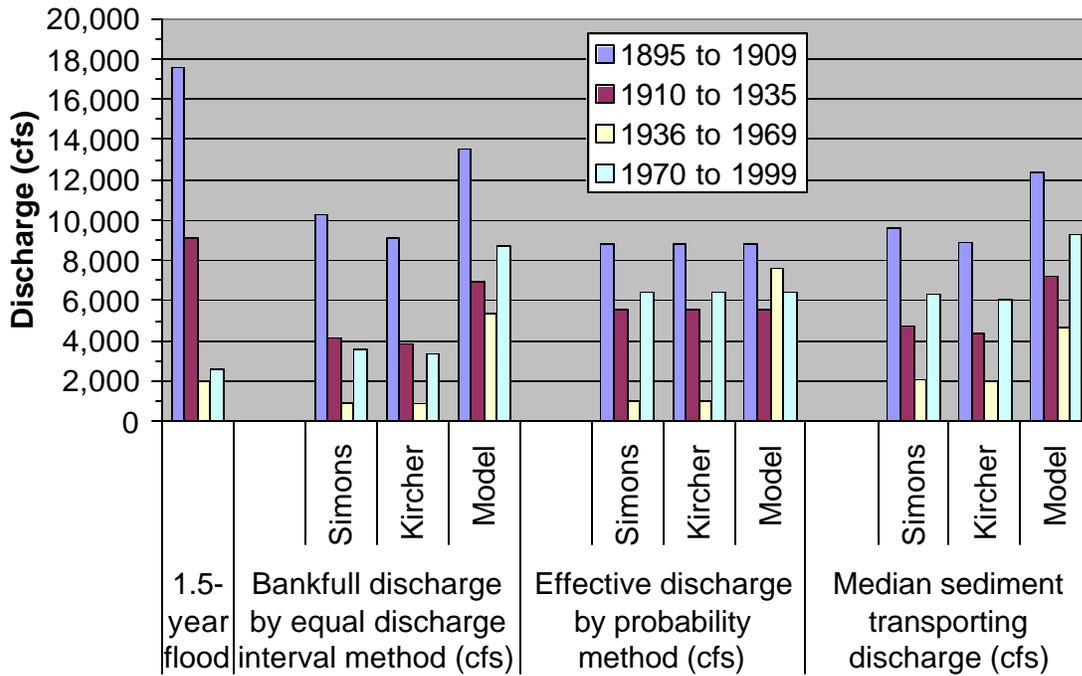
Figure 3.22 Comparison of bankfull discharge indicators for the Platte River near Cozad, Nebraska.

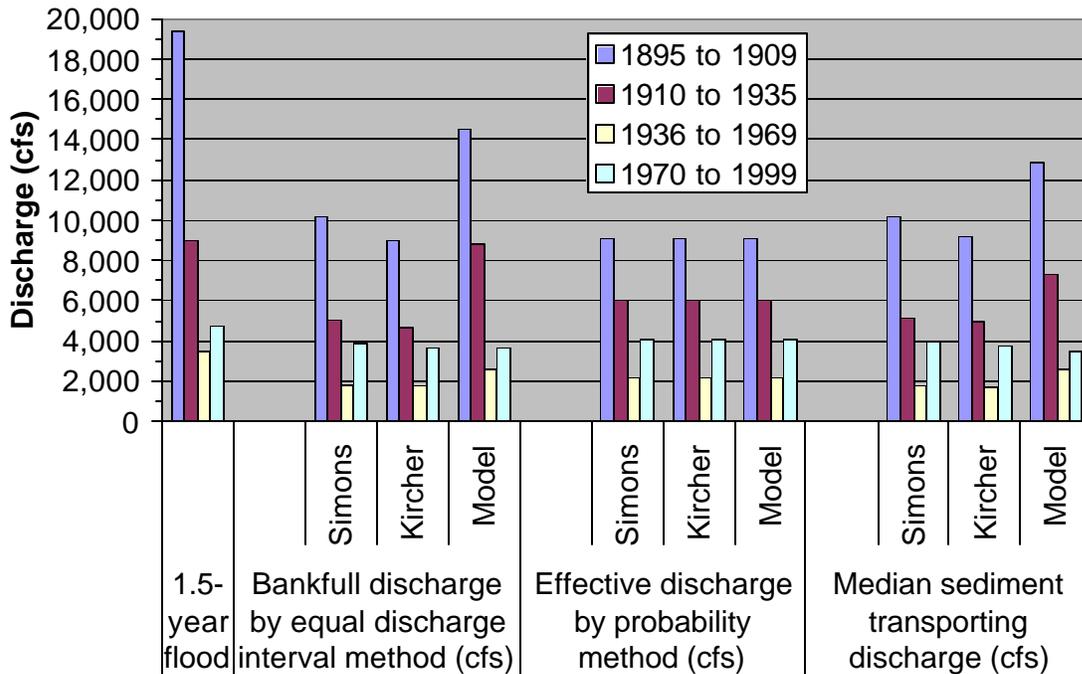
Figure 3.23 Comparison of bankfull discharge indicators for the Platte River near Overton, Nebraska.

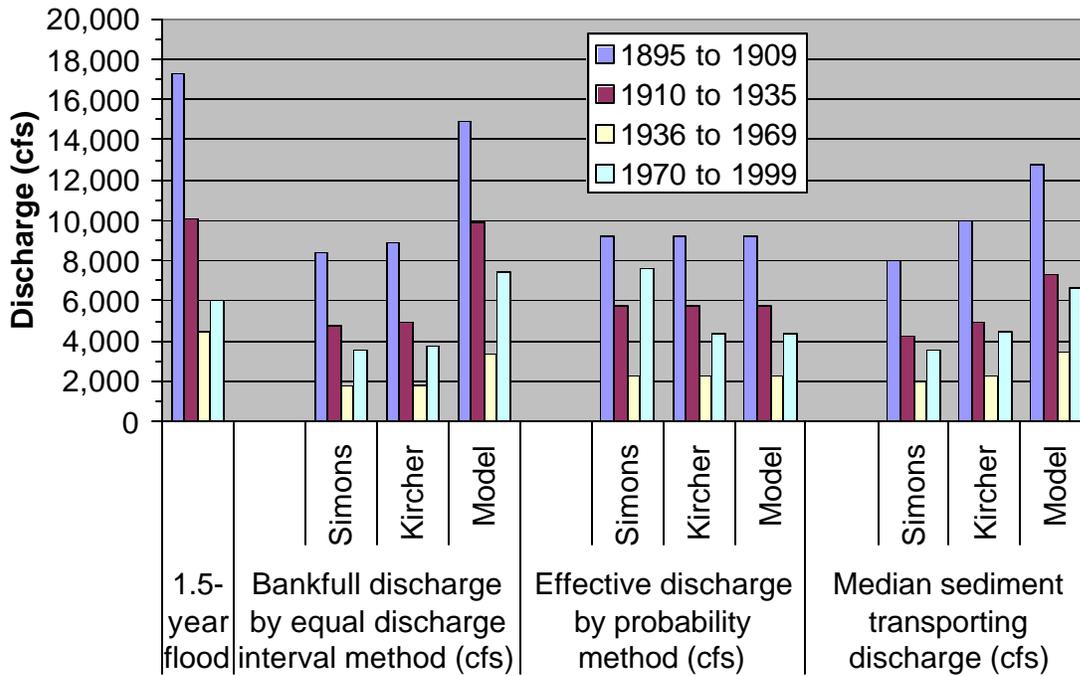
Figure 3.24 Comparison of bankfull discharge indicators for the Platte River near Grand Island, Nebraska.

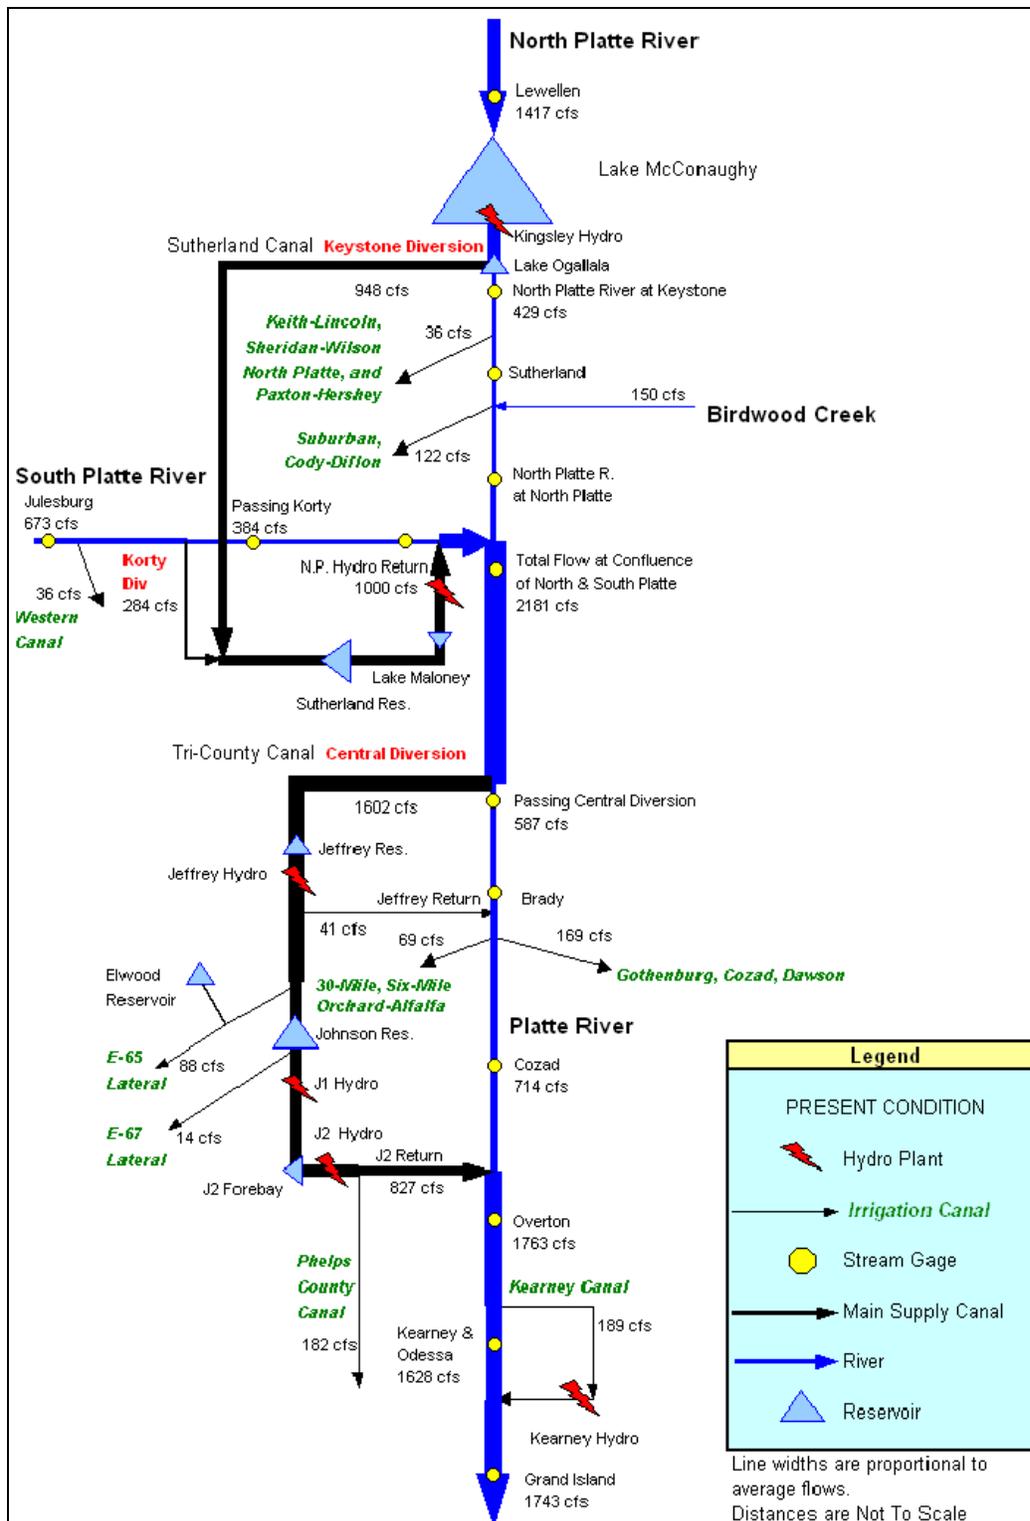
Figure 3.25 Schematic of Water Resource Infrastructure along the North Platte, South Platte, and Platte Rivers. The width of each channel is scaled to the average annual flow rate for the period 1947 to 1994.

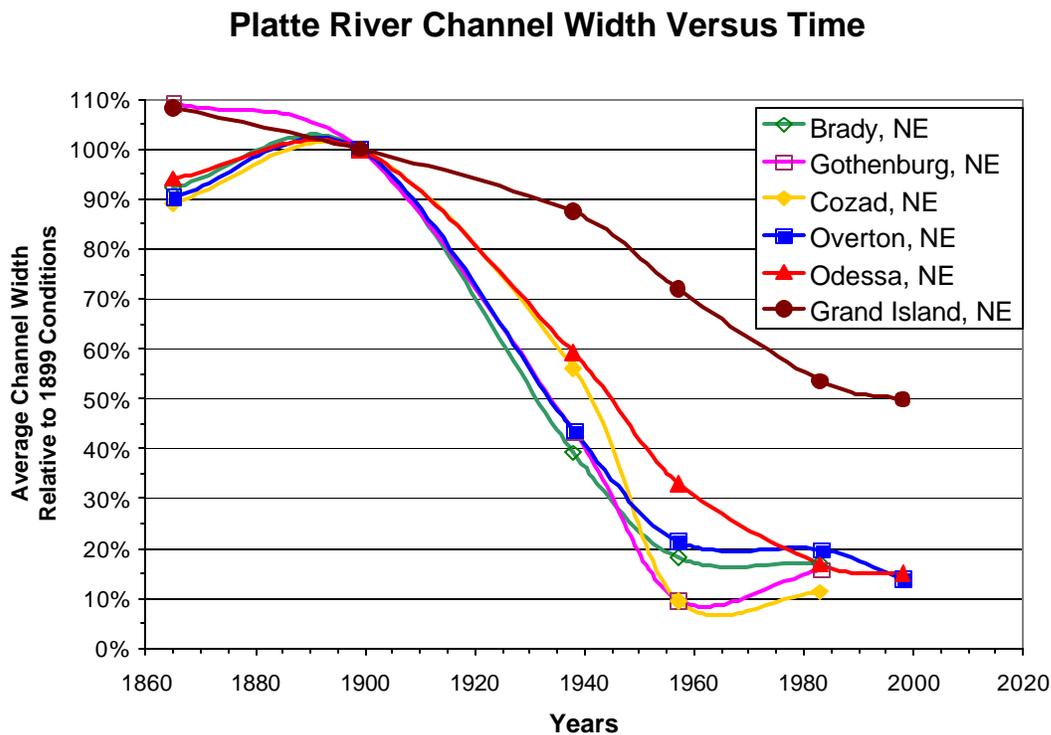
Figure 4.1 Comparisons of active channel width versus time for various locations along the Platte River.

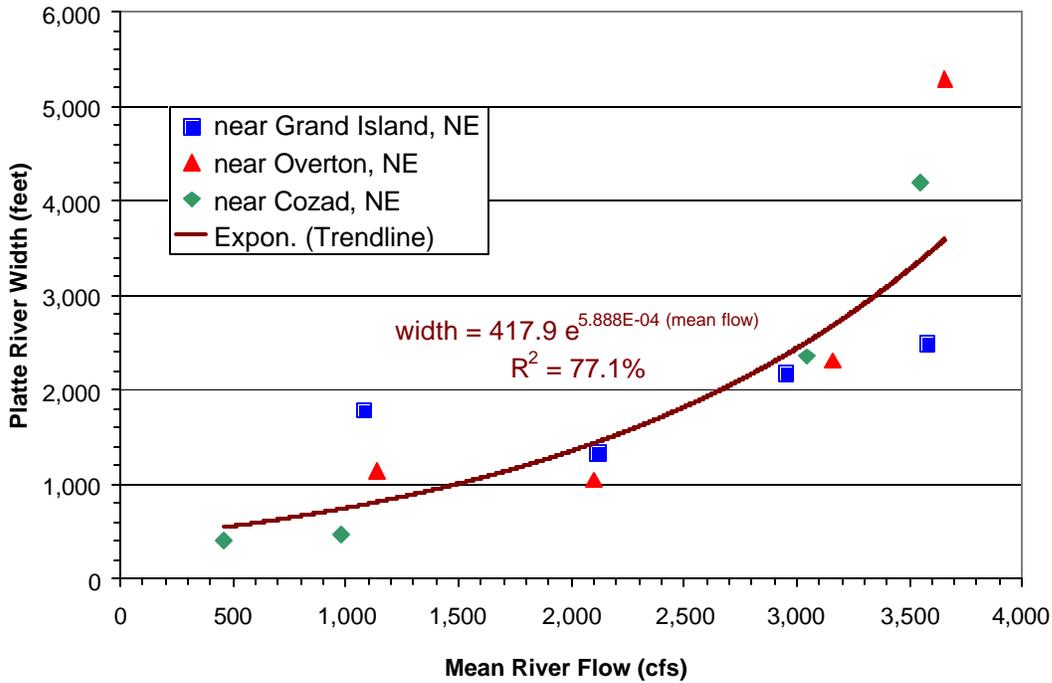
Figure 4.2a Exponential correlation of Platte River Width to the mean flow rate for locations near Cozad, Overton, and Grand Island, Nebraska.

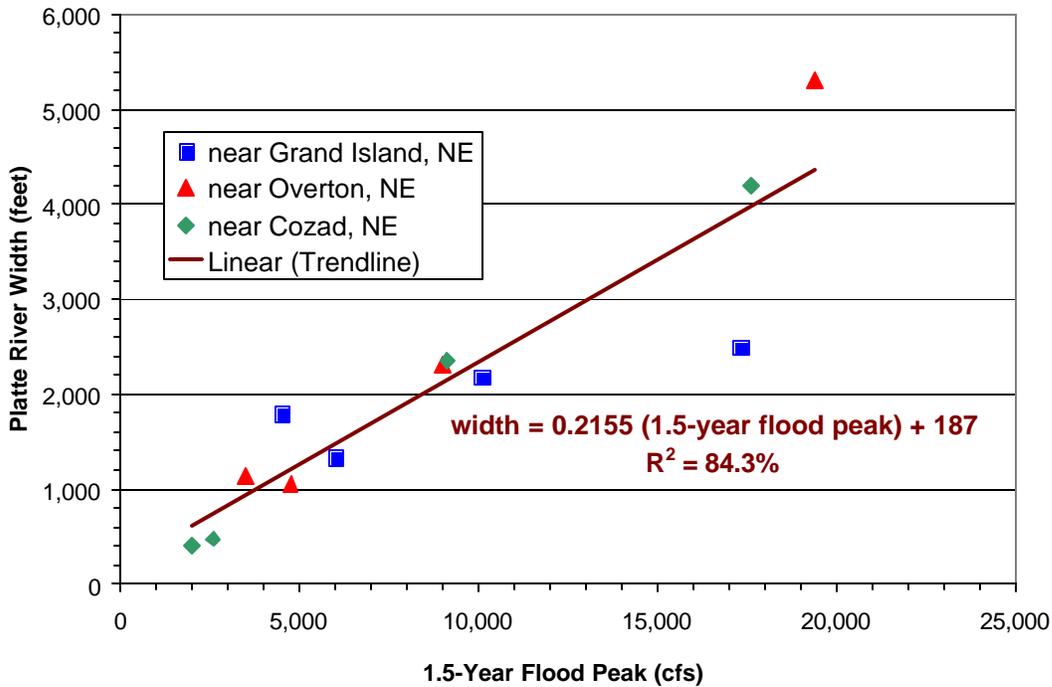
Figure 4.2b Linear correlation of Platte River Width to the 1.5-year flood peak for locations near Cozad, Overton, and Grand Island, Nebraska.
