THE PLATTE RIVER CHANNEL: HISTORY AND RESTORATION

U.S. Department of the Interior
Bureau of Reclamation
TECHNICAL SERVICE CENTER
Denver, Colorado
April 2004

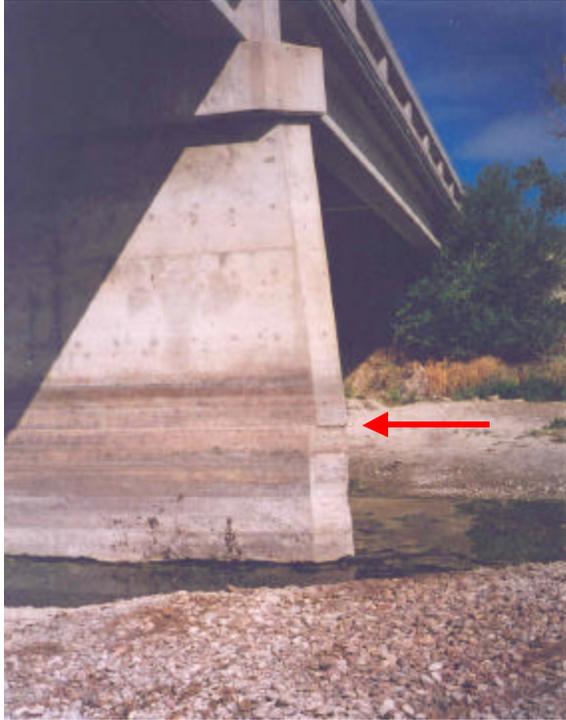
Figure 4.3a. Looking at the downstream end of the Keystone Bridge pier that was constructed in 1979. The form marks on the pier show original channel bed elevation. The base of the pier ends a couple of inches above the water surface. The pier has a pile foundation which is currently exposed (Figure 4.3d) due to channel degradation and local scour.

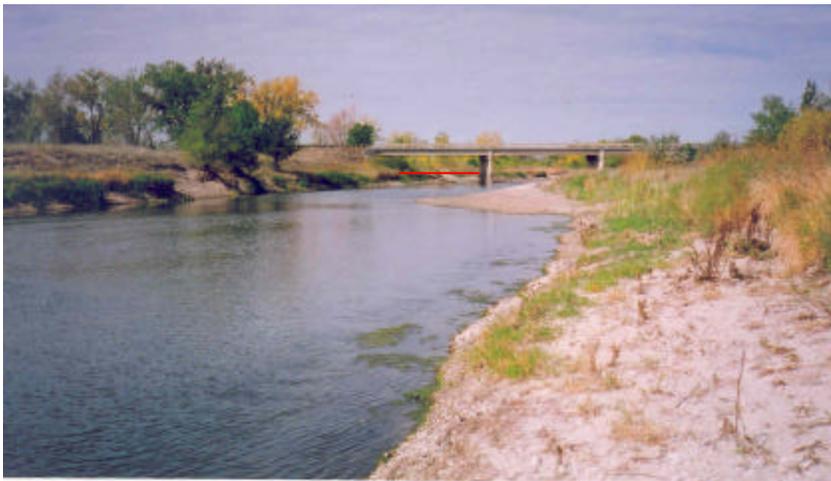
Figure 4.3b. Looking upstream toward the Keystone bridge. Note the incised geometry of banks and break in bank line consistent with top of form line on piers.

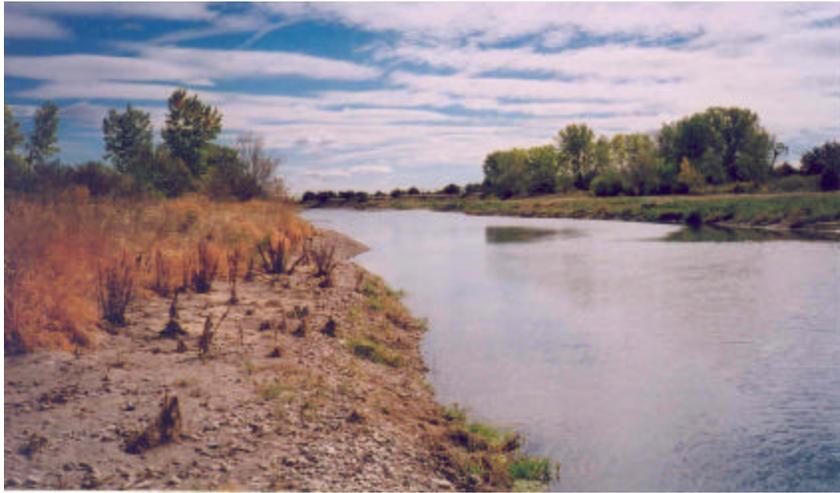
Figure 4.3c. Looking downstream from the left bank, approximately 100 yards downstream of Keystone Bridge. Note the incised channel bed and steep banks.

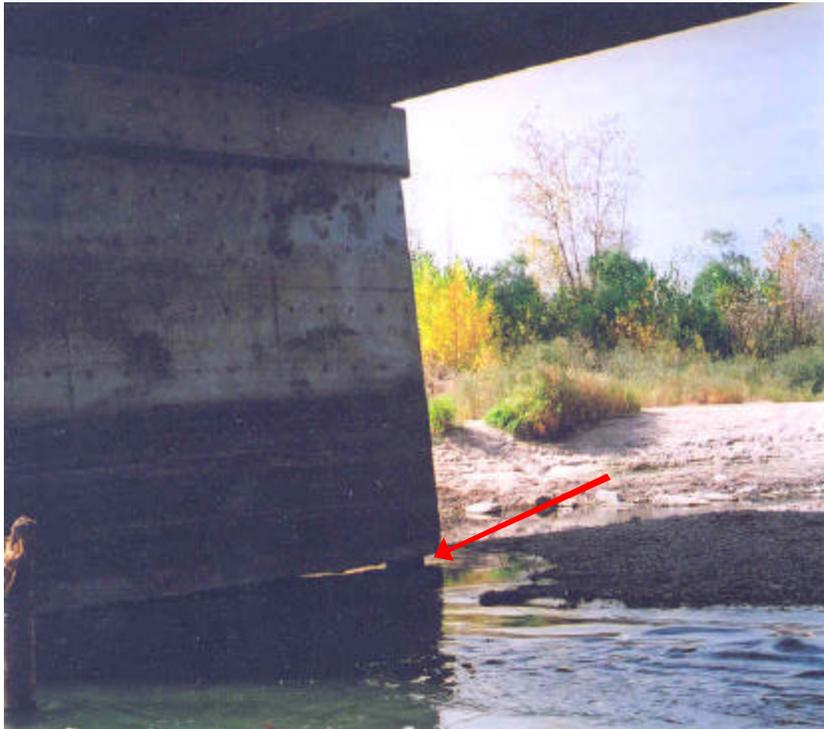
Figure 4.3d. Looking at the upstream end of the Keystone bridge pier, showing the gap between the base of the pier and the water surface. The outline of the exposed foundation pile is discernable in the gap.

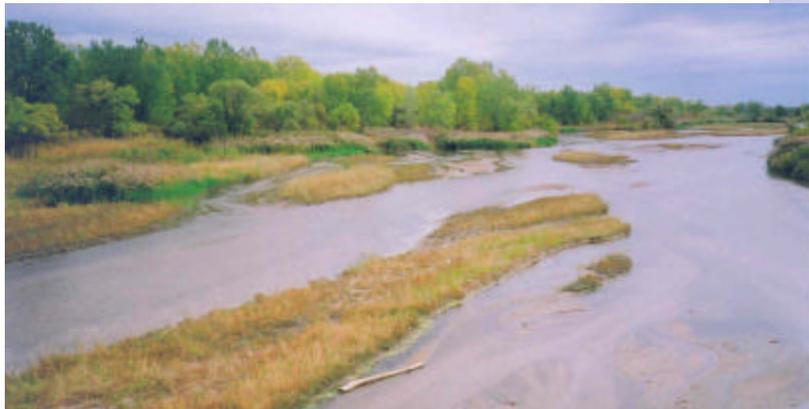
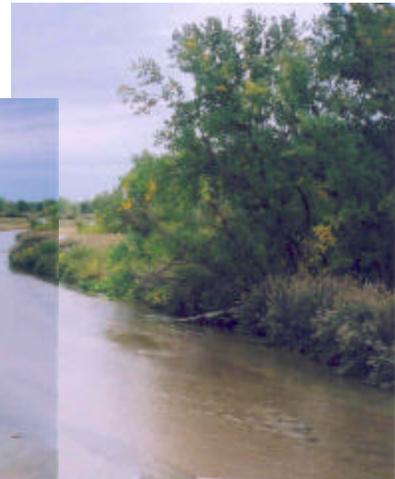
Figure 4.4a above. Looking downstream from the Lexington Bridge, just upstream of the Johnson-2 return channel (RM 251.5). The channel has stable, shallow banks.

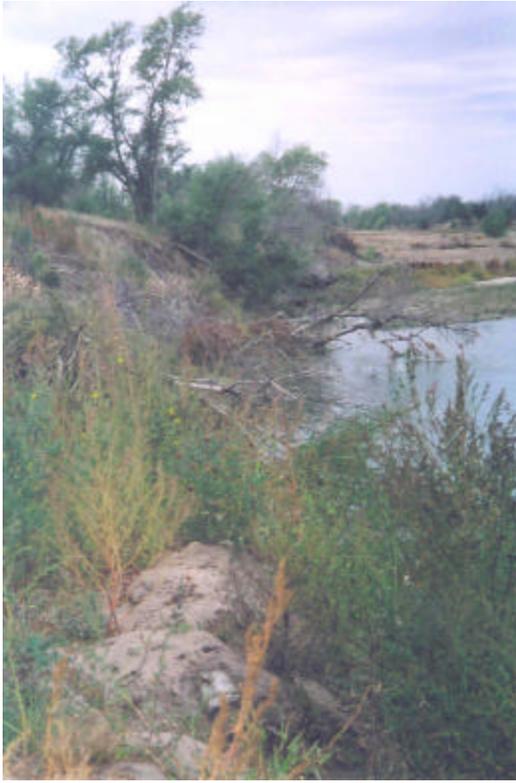
Figure 4.4c left. Looking upstream along the south channel, downstream of the J2 return. The high steep bank is actively eroding in this reach of incised channel.

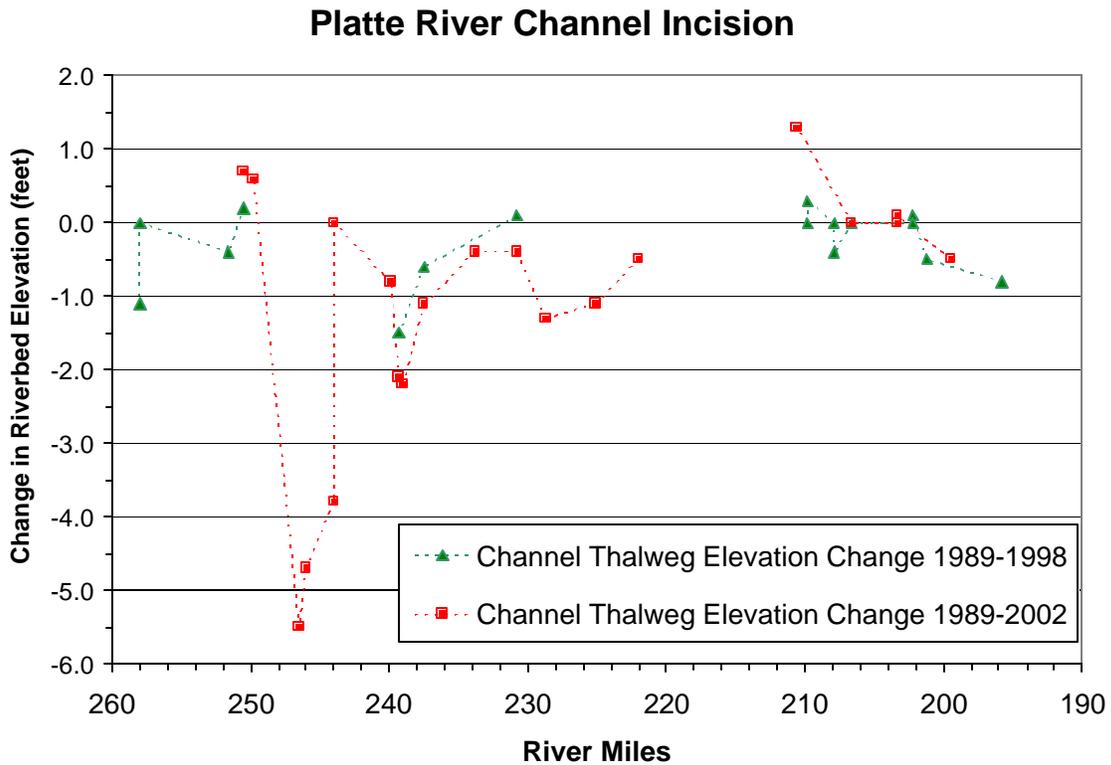
Figure 4.5 Measurement of channel thalweg incision along the Platte River reach downstream from the Johnson-2 Return channel (river mile 247).

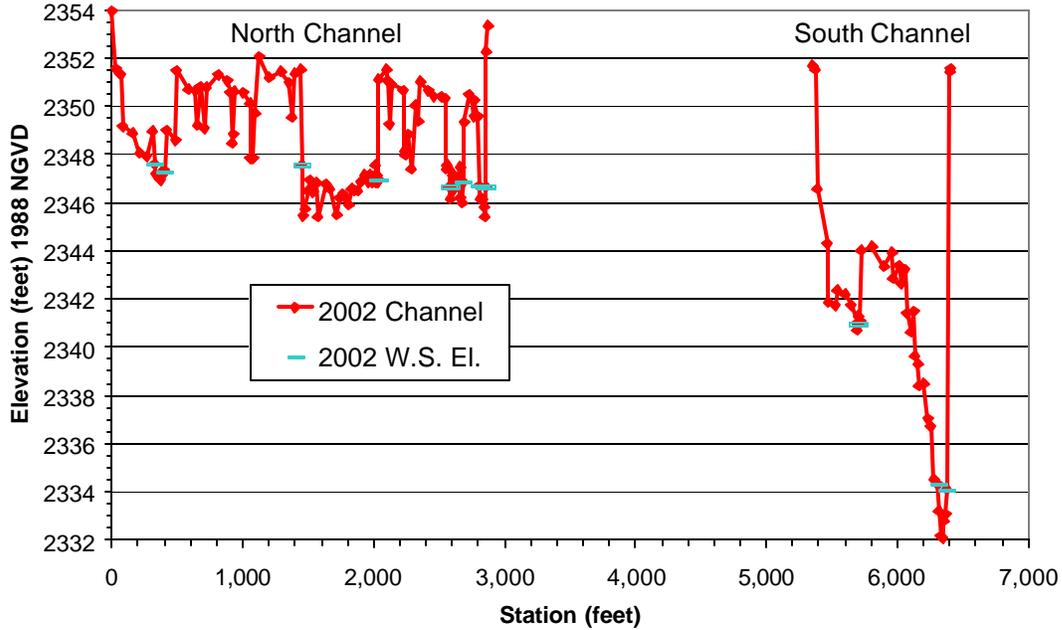
Figure 4.6a Platte River at mile 246.5, both north and south channels. The Johnson-2 Return channel delivers clear water into the south channel, which causes incision. At the time of the 2002 channel survey, the thalweg of the south channel was 13.3 feet lower than the thalweg of the north channel.

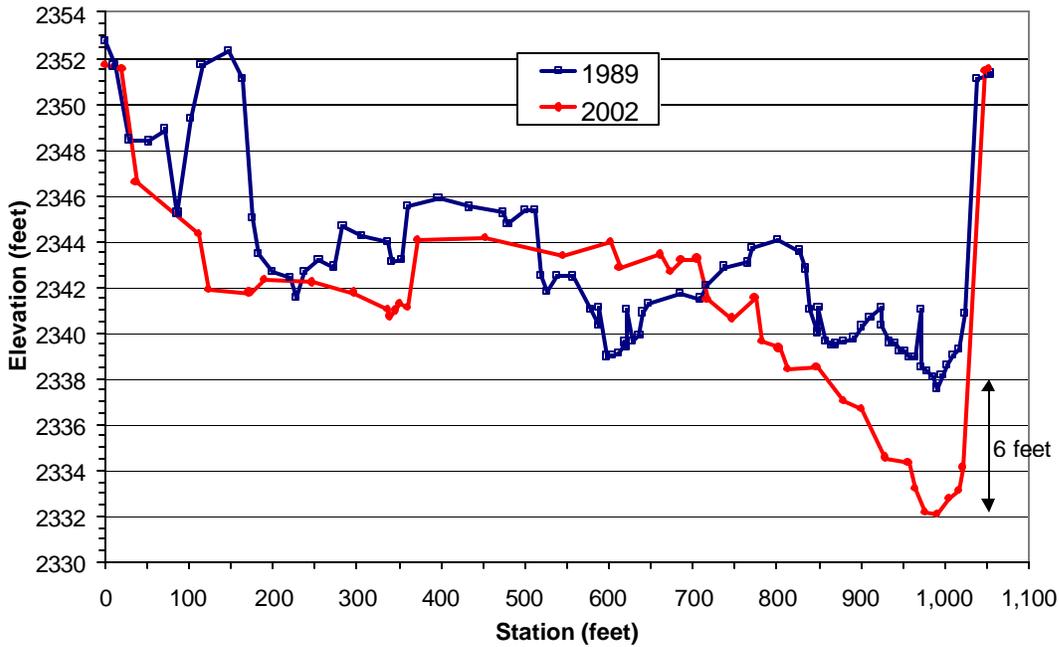
Figure 4.6b Comparison of 1989 and 2002 Platte River channel cross section surveys for river mile 246.5 south channel.

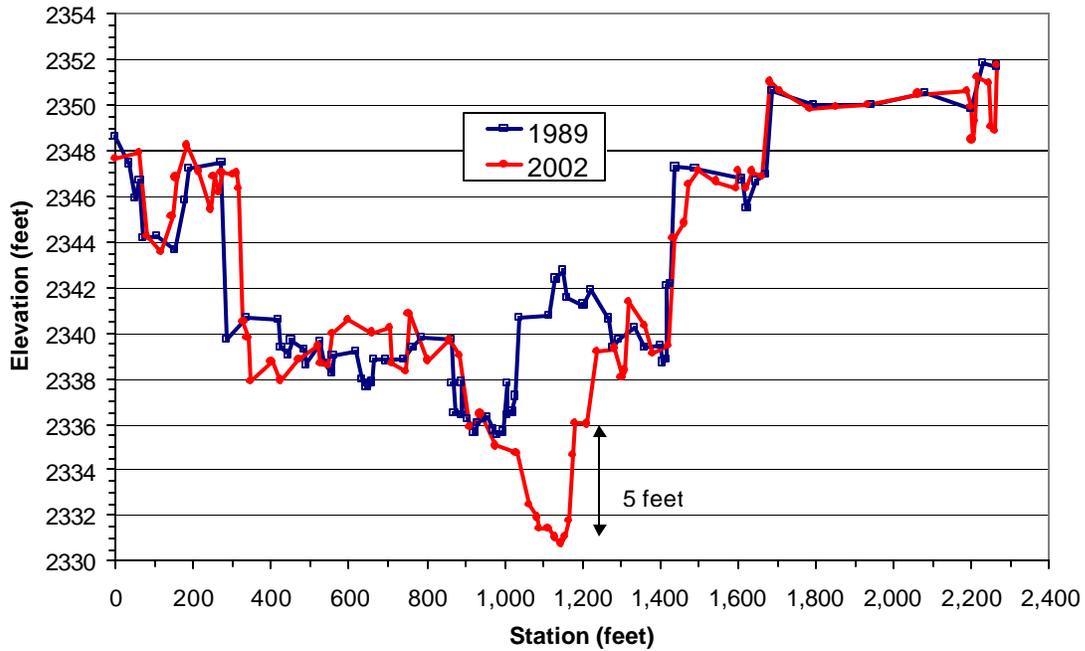
Figure 4.7 Comparison of 1989 and 2002 Platte River channel cross section surveys for river mile 246.0.

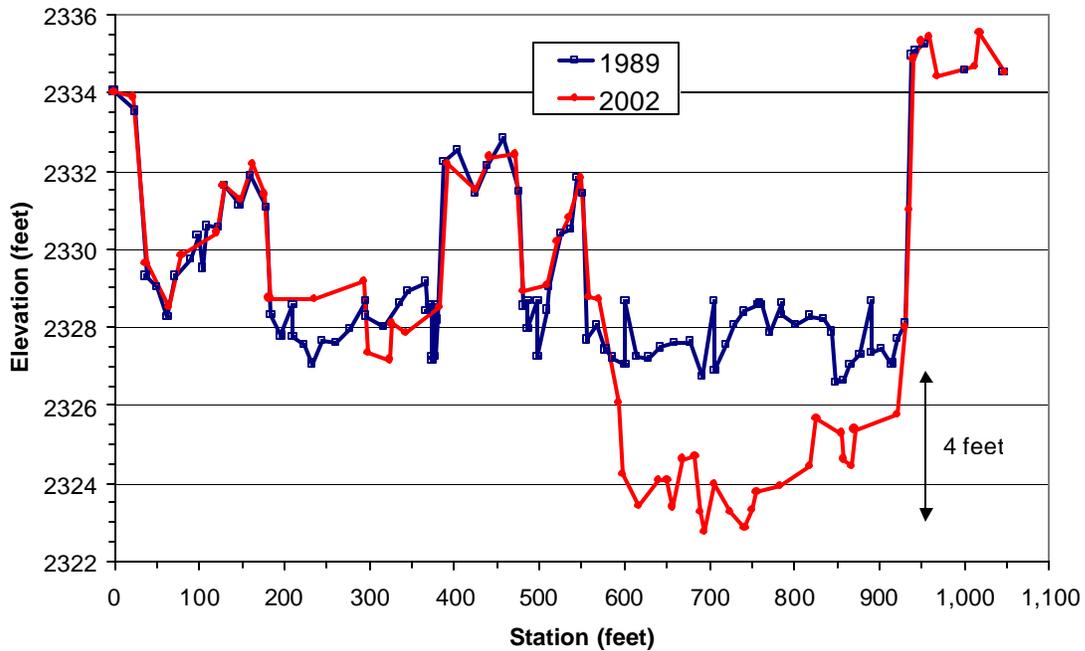
Figure 4.8 Comparison of 1989 and 2002 Platte River channel cross section surveys for river mile 244.0 south channel.

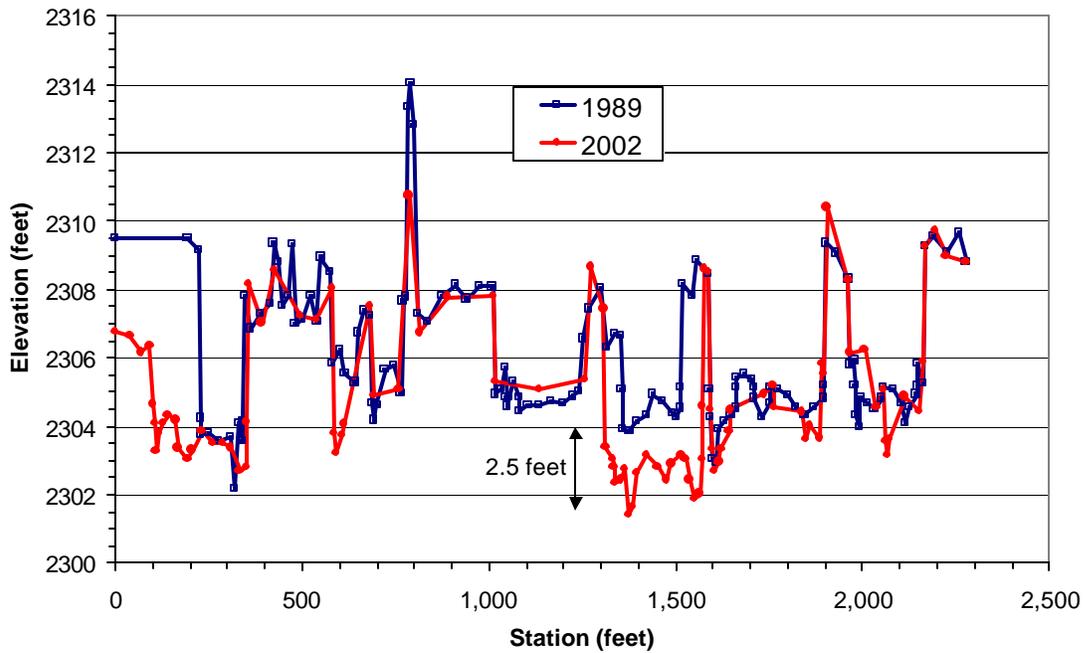
Figure 4.9 Comparison of 1989 and 2002 Platte River channel cross section surveys for river mile 239.9.

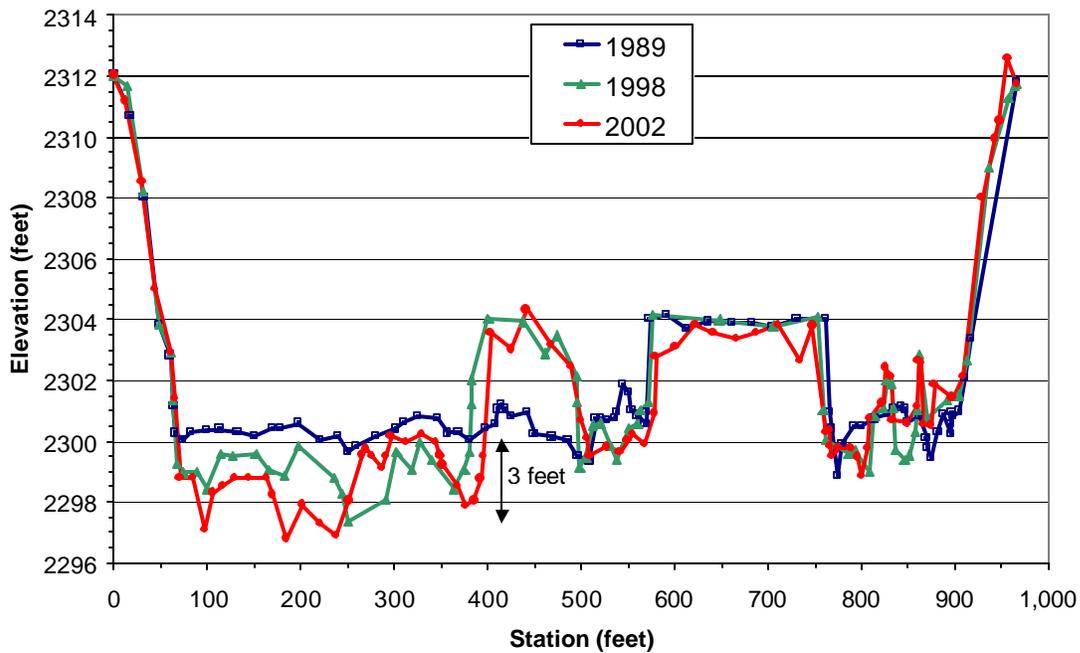
Figure 4.10 Comparison of 1989, 1998, and 2002 Platte River channel cross section surveys for river mile 239.3.

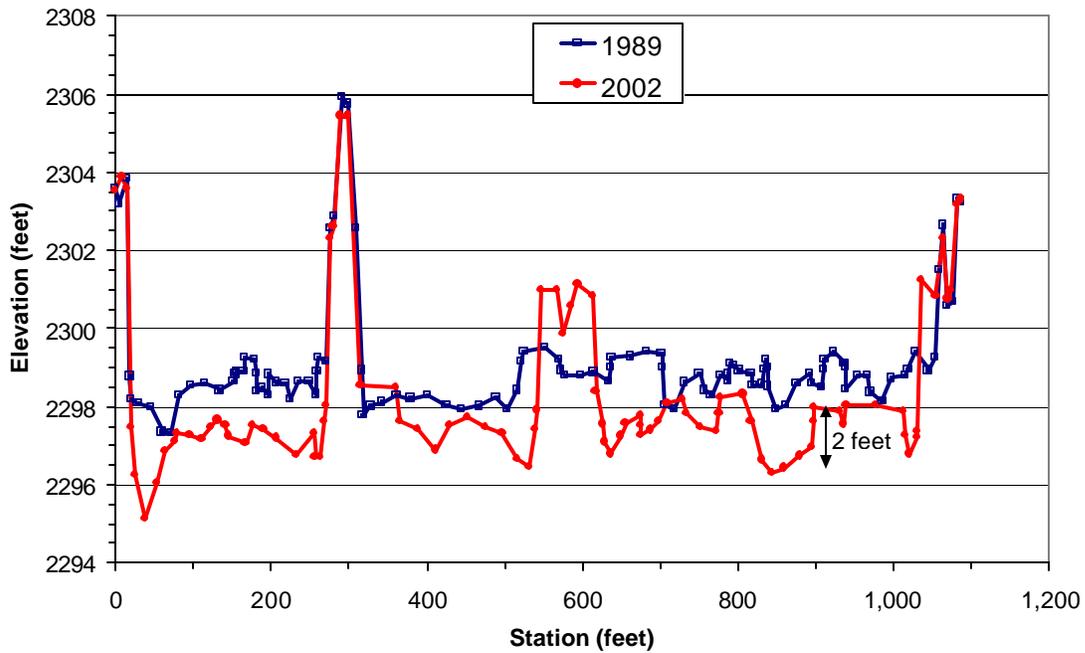
Figure 4.11 Comparison of 1989 and 2002 Platte River channel cross section surveys for river mile 239.0.

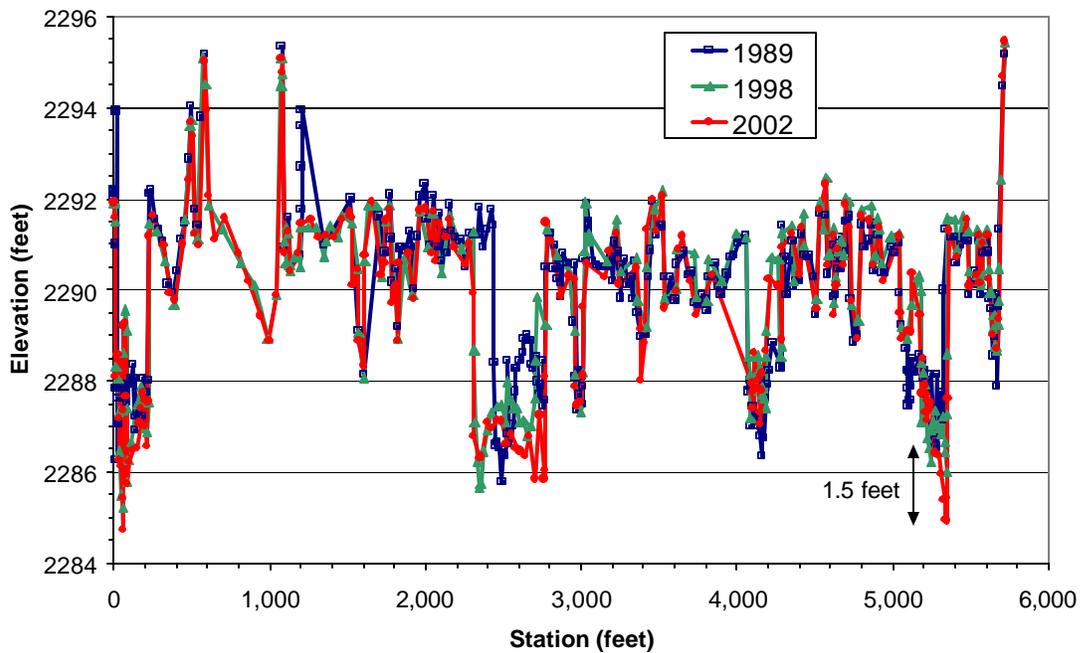
Figure 4.12 Comparison of 1989, 1998, and 2002 Platte River channel cross section surveys for river mile 237.5.

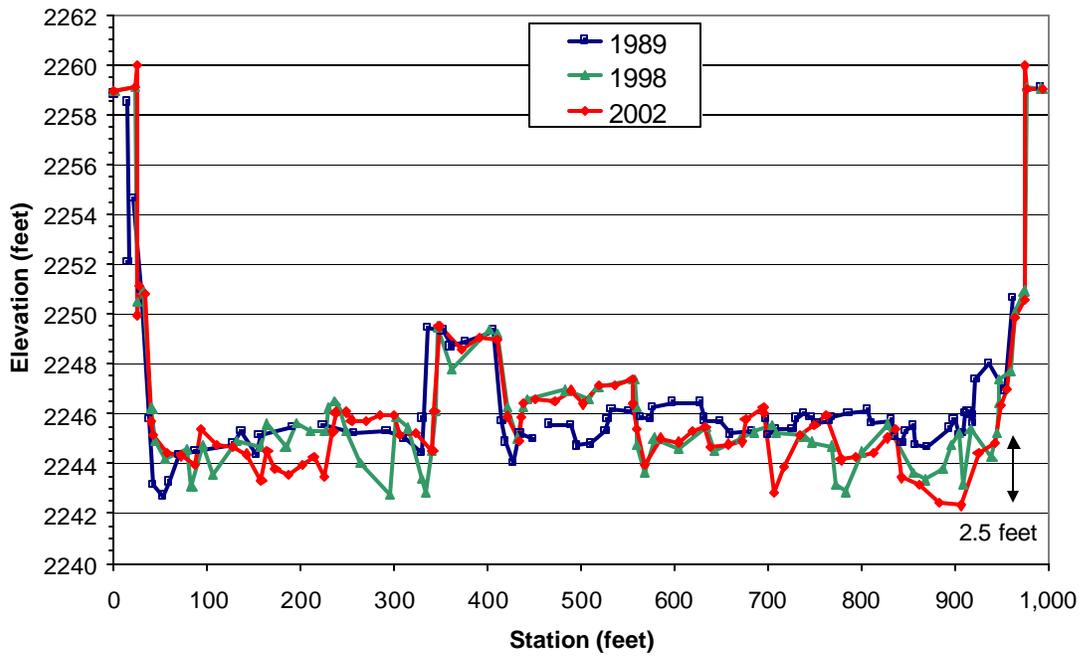
Figure 4.13 Comparison of 1989, 1998, and 2002 Platte River channel cross section surveys for river mile 230.8.

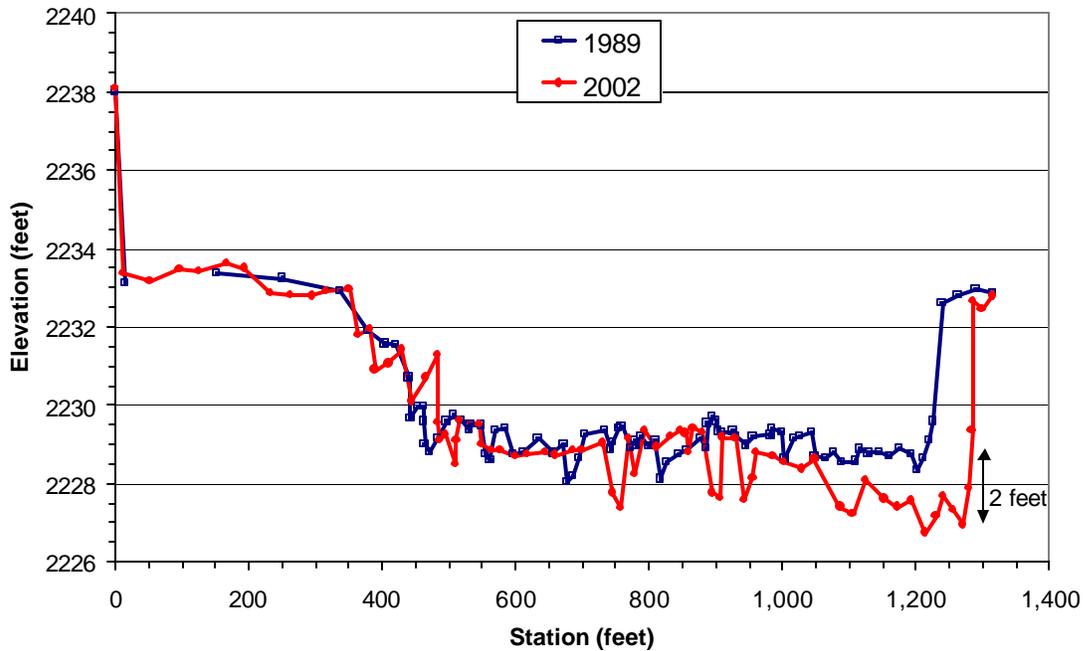
Figure 4.14 Comparison of 1989 and 2002 Platte River channel cross section surveys for river mile 228.7.

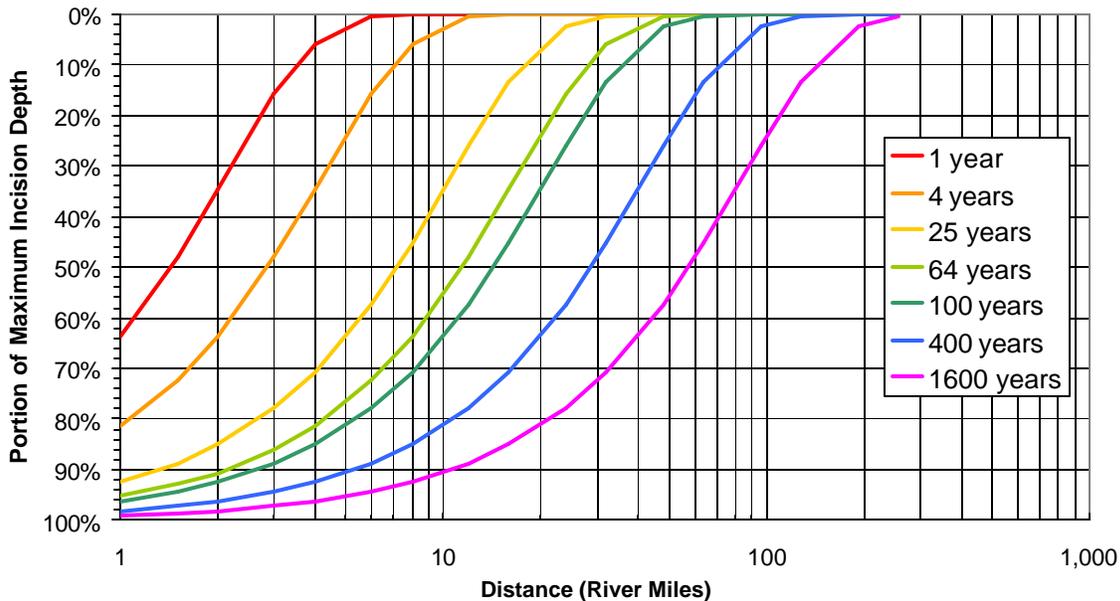
Figure 4.16 Estimated downstream progression of clear-water channel incision of the Platte River, based on de Vries as presented by Graf (1998).

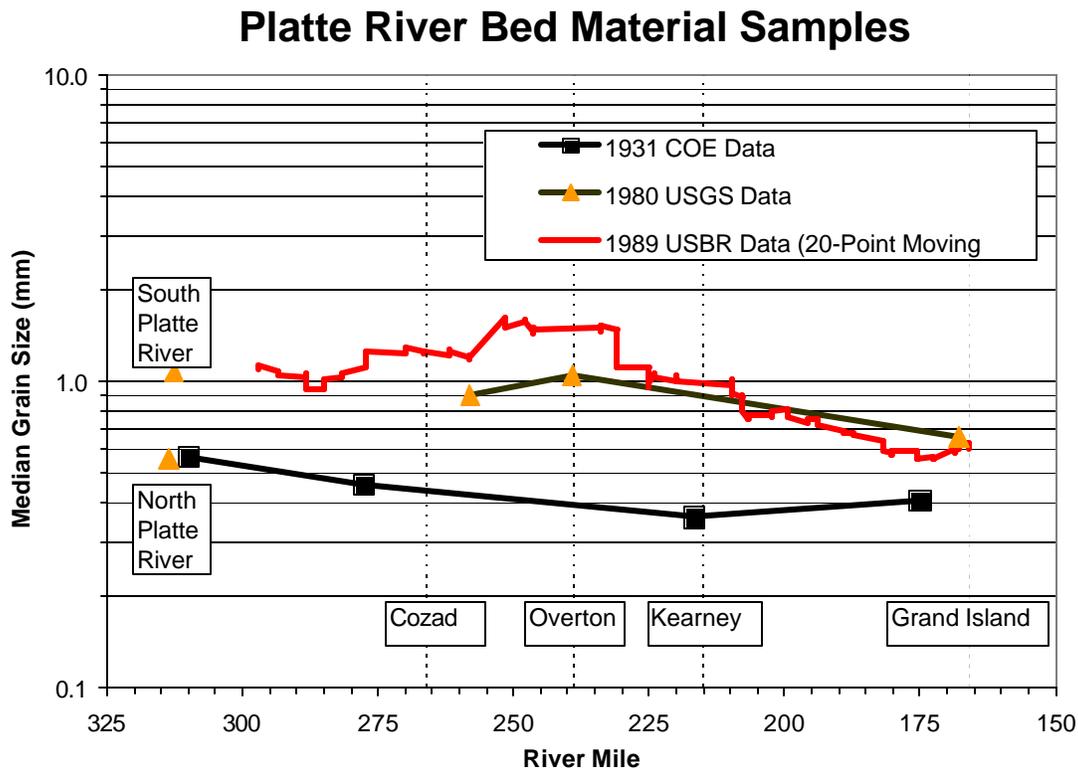
Figure 4.17 Median bed-material grain size comparisons between 1931, 1980, and 1989. Bed material data were collected from the Platte River channel near bridges in 1931 and 1980 and along many points along the river (at bridges and between bridges) in 1989. The river velocity and bed-material grain size both tend to increase at bridge constrictions, but the data in 1989 are as coarse, or coarser, than in 1980.

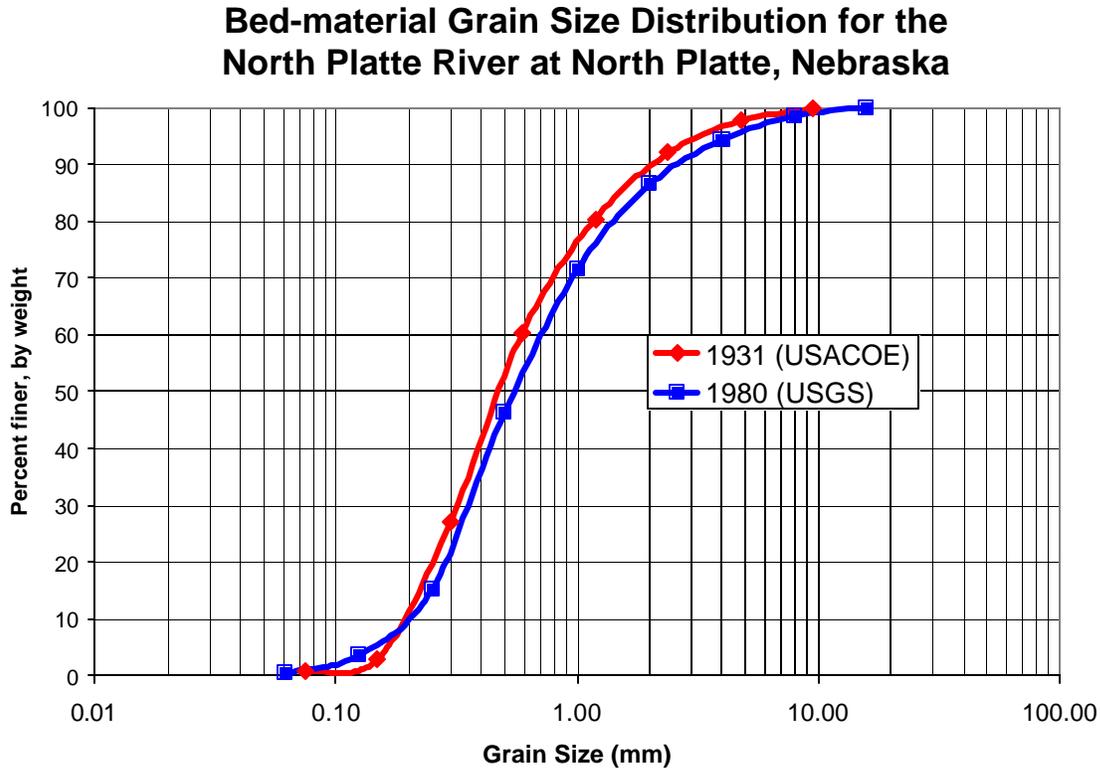
Figure 4.18 Bed-material grain size distributions in 1931 and 1980 for the North Platte River at North Platte, Nebraska.

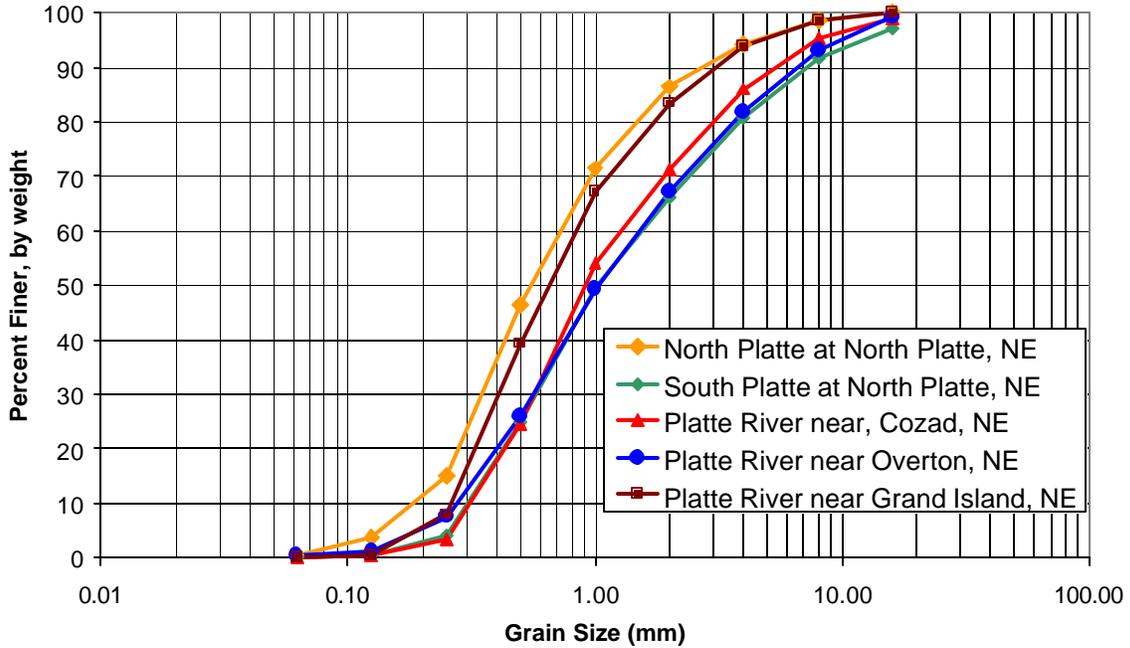
Figure 4.19 Bed-material grain size distributions in 1979 and 1980 by Kircher (1983) for the North Platte, South Platte, and Platte Rivers.

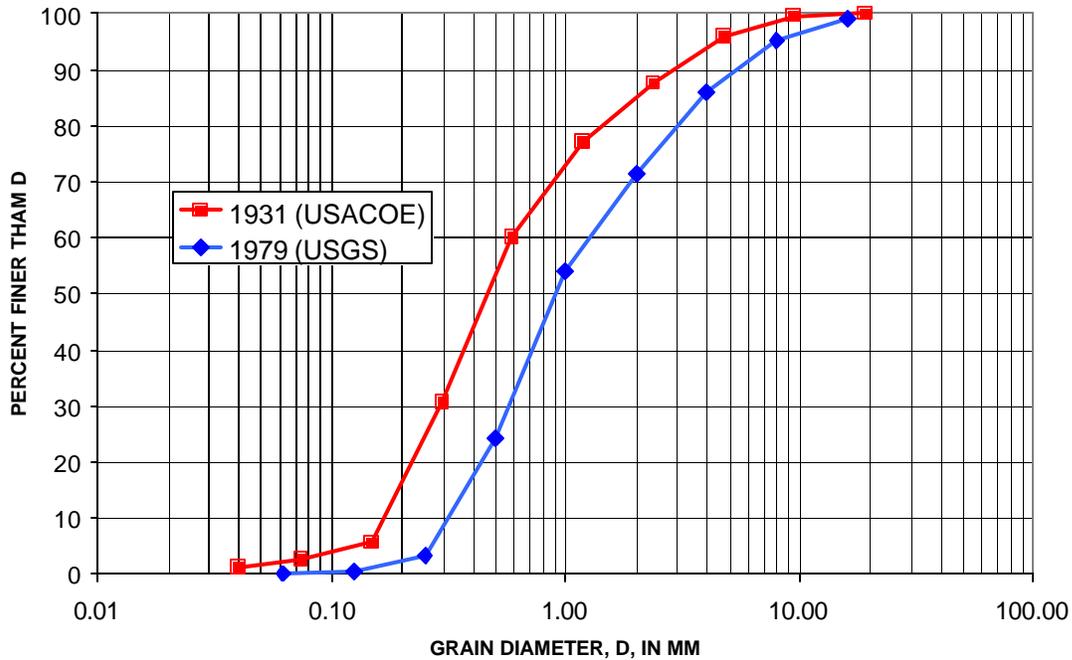
Figure 4.20 Bed-material grain size distributions in 1931 and 1979 for the Platte River near Cozad and Gothenburg, Nebraska.

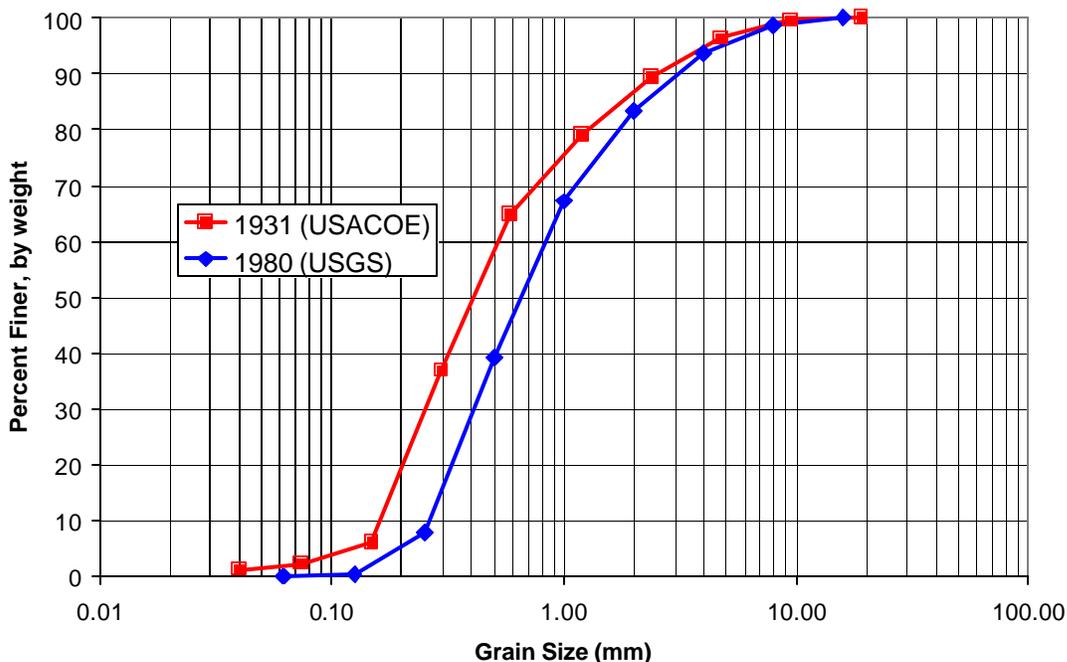
Figure 4.21 Bed-material grain size distributions in 1931 and 1980 for the Platte River near Grand Island, Nebraska.

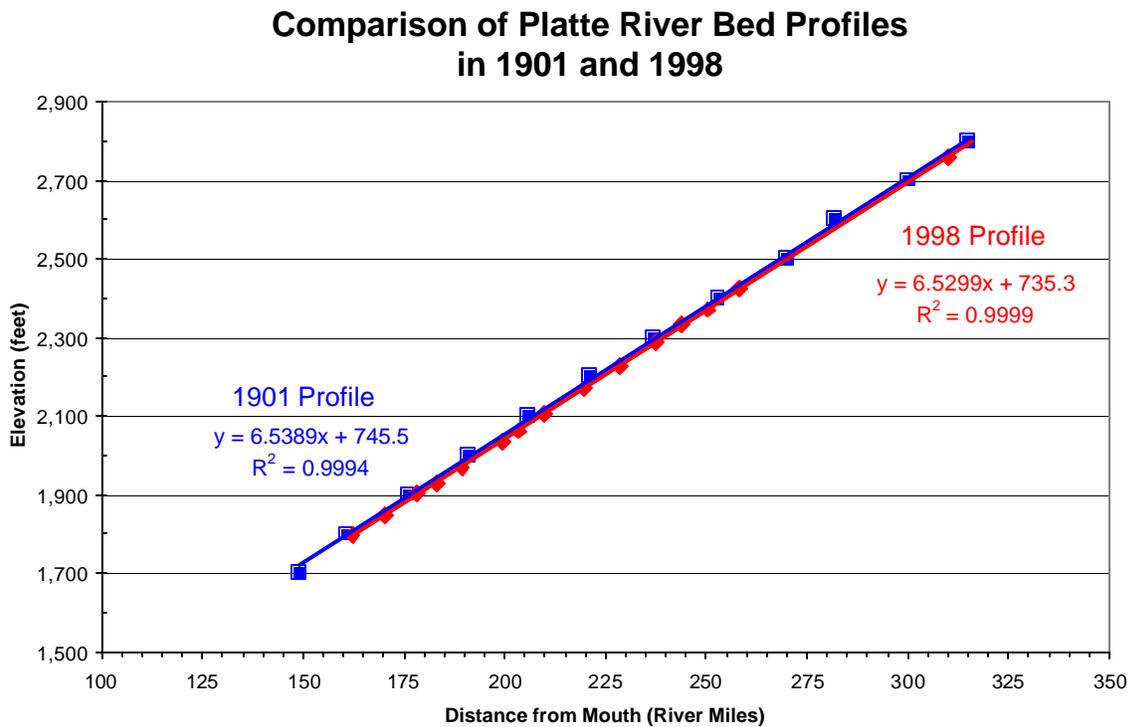
Figure 4.22 Comparison of 1901 and 1998 Platte River bed profiles.

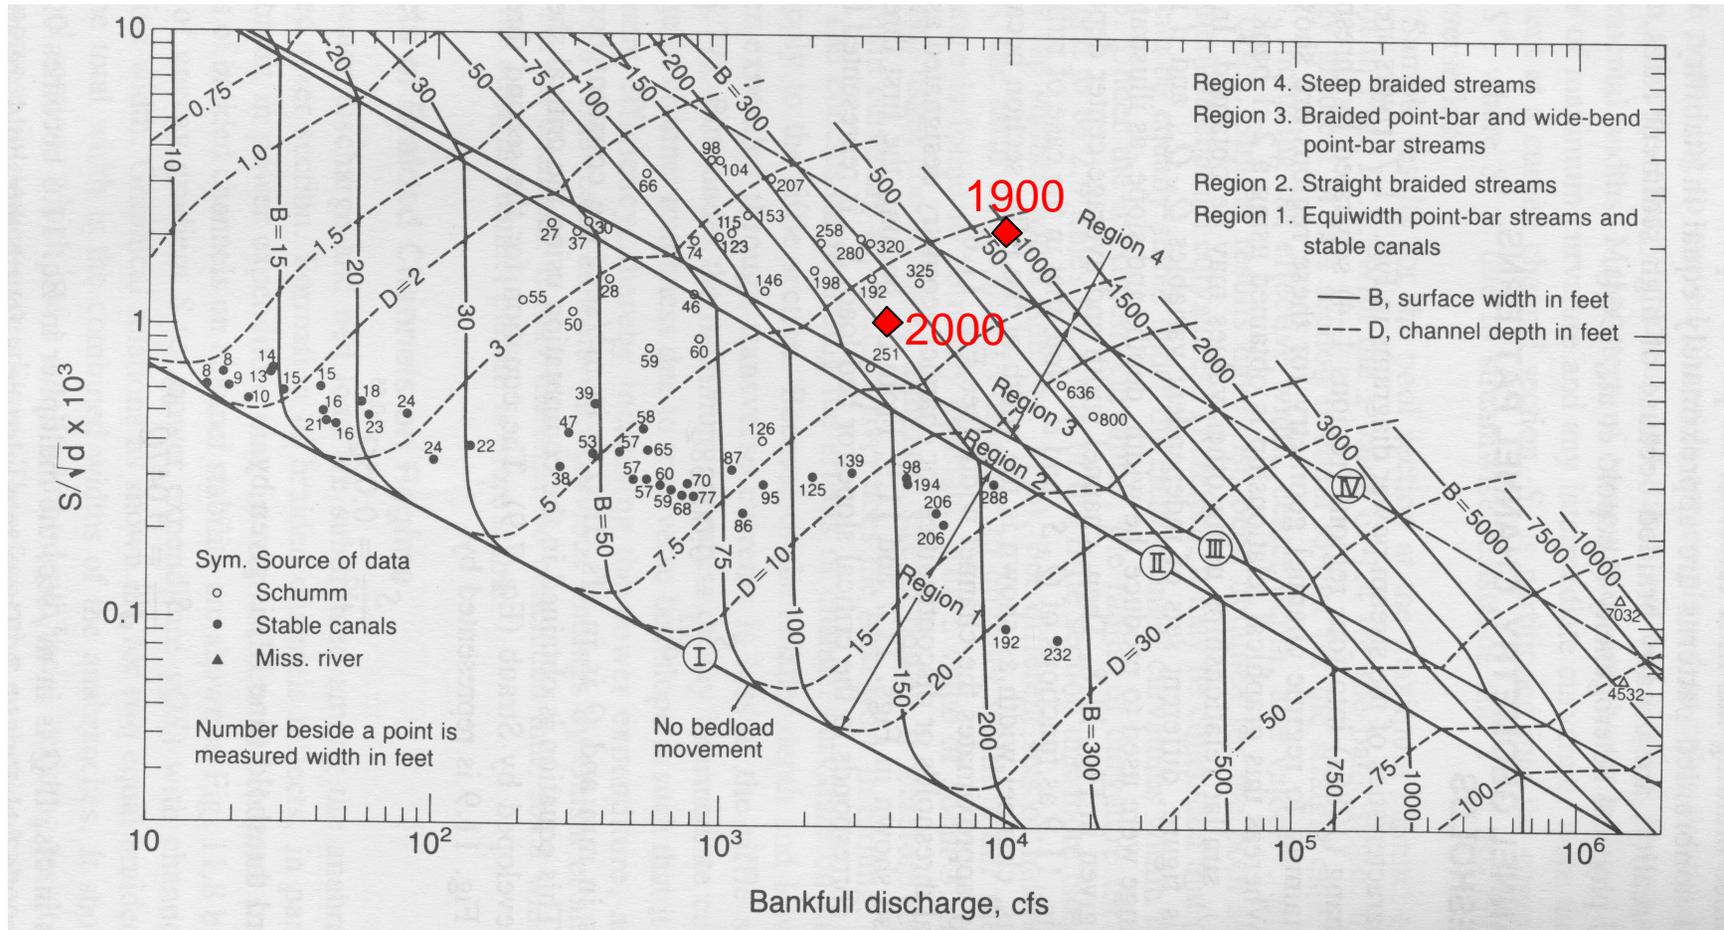
Figure 4.23 Regime channel bed geometry for sand bed rivers, from Chang (1985). For the historic Platte River channel (1900), the bankfull discharge was about 10,000 cfs, the median grain size was about 0.4 mm, and the slope was 0.00126. Therefore, the term $[(S/d^{0.5})1000]$ was equal to 2.0. For the present Platte River channel (2000), the bankfull discharge is about 4,000 cfs, the median grain size near Overton, Nebraska is about 1.5 mm, and the slope is still 0.00126. Therefore, the term $[(S/d^{0.5})1000]$ is now equal to 1.0. Based on the classification by Chang (1985), the Platte River evolved from a steep braided channel (Region 4) to a braided point-bar and wide bend point-bar channel (Region 3).

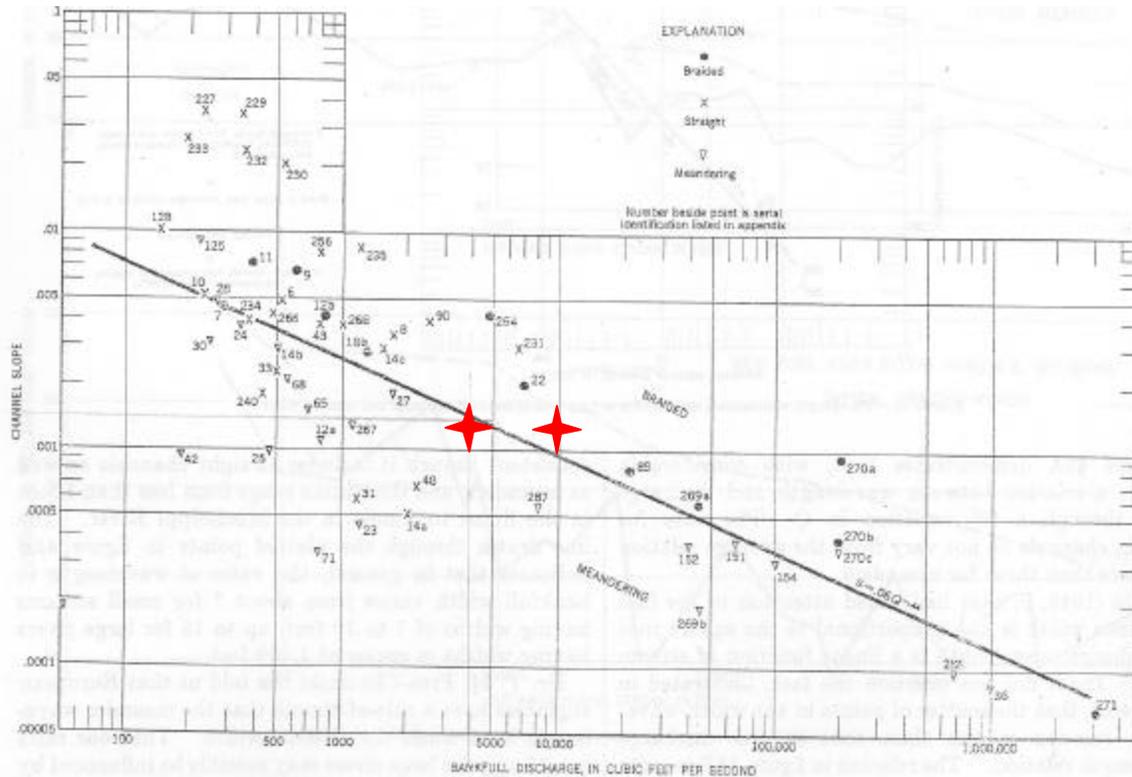
Figure 4.24 A regime diagram for natural channels based on channel slope and bankfull discharge, taken from Leopold and Wolman (1957). Points shown are a slope of 0.00126 and a flow of 10,000 cfs for the Platte River in 1900, and a slope of 0.00126 and a flow of 4,000 cfs for the Platte River in 2000.

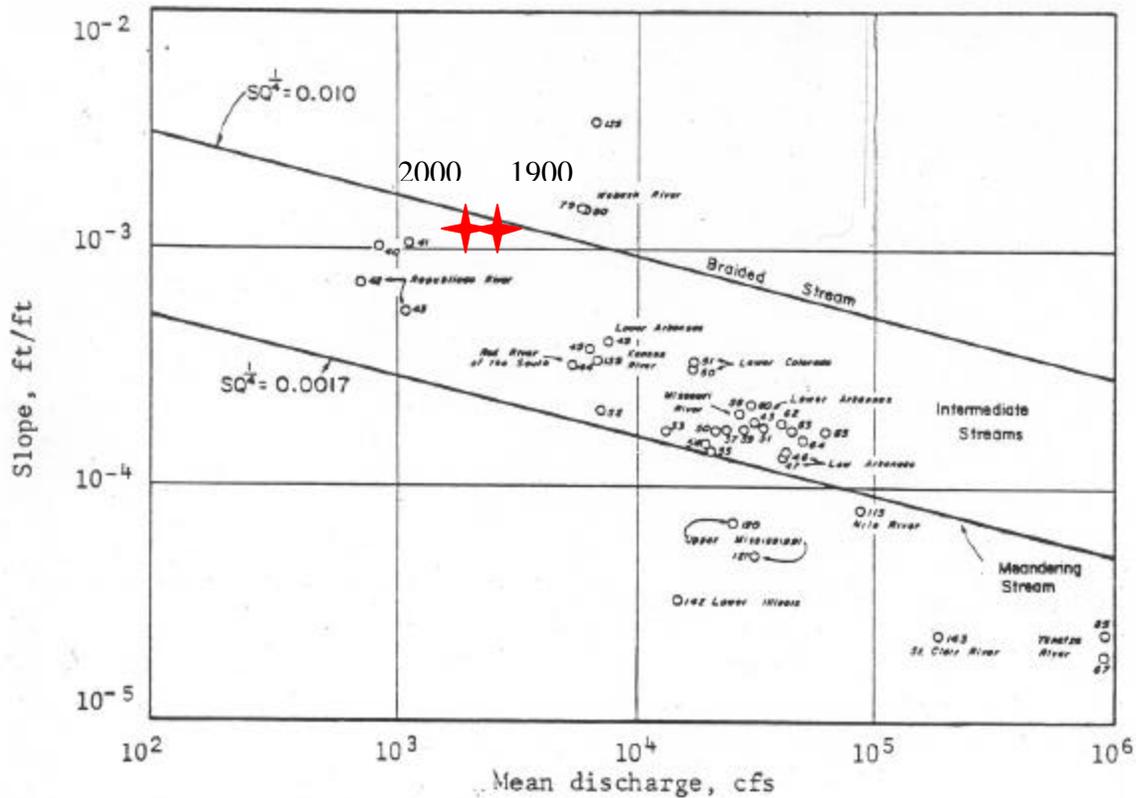
Figure 4.25 Lane's (1957) regime diagram for sandbed streams based on slope and mean discharge, taken from Richardson, et al. (1990). Red points shown are for the central Platte River with a slope of 0.0026 ft/ft and a mean discharge of 3,700 cfs for the year 1900, and a mean discharge of 2,100 cfs for the year 2000.

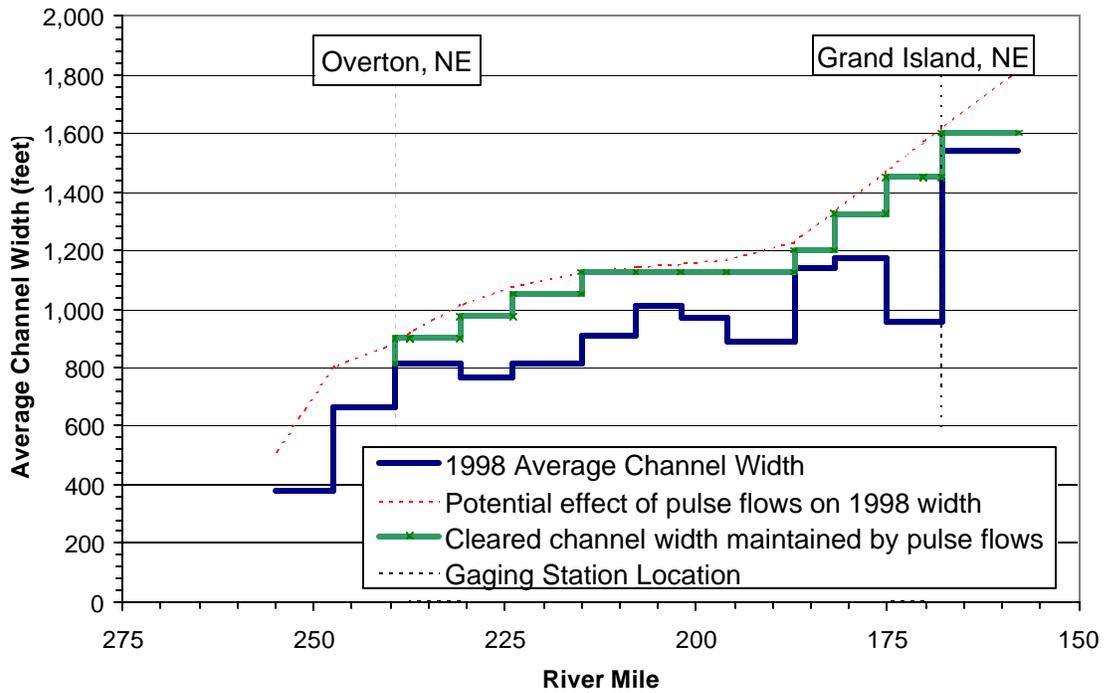
Figure 5.1 Future potential for sustained average channel width with mechanical clearing and leveling of wooded islands and pulse flows.

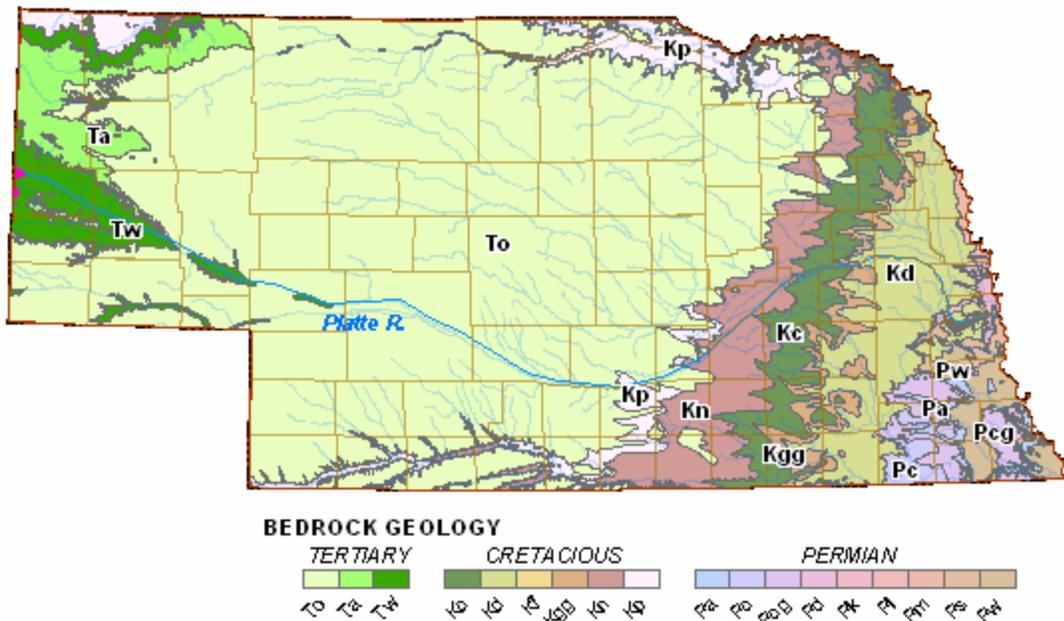
Figure A.1 Nebraska bedrock geology (Conservation and Survey Division, University of Nebraska-Lincoln, 1996a).

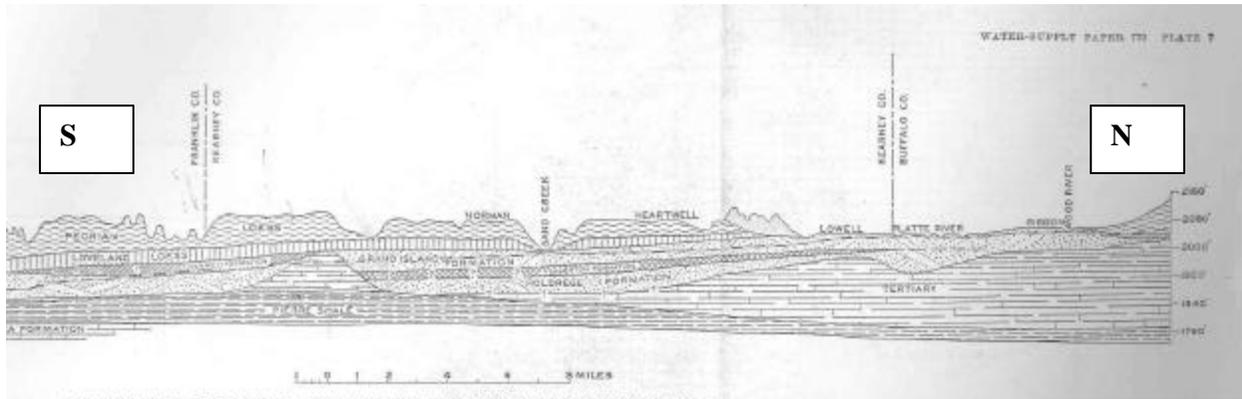
Figure A.4 North-south geologic profile from Gibbon to Riverton, Nebraska, taken from Lugn & Wenzel, 1938.
